# Georgia Conference of Home Inspectors

2470 Windy Hill Rd SE Ste 300  
Marietta GA 30067-8621  
Inspector: Ronald Coker

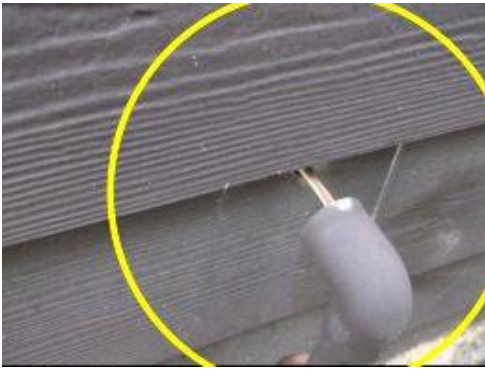
Some sections of siding and/or trim were deteriorated, loose, split and/or warped. Recommend that a qualified person repair, replace or install siding or trim as necessary.

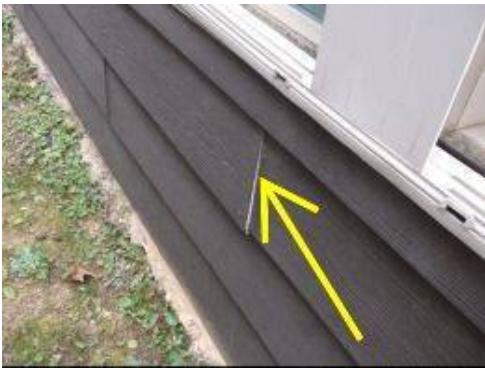
Siding butt joints have shrank and the spaces should be caulked and sealed periodically.

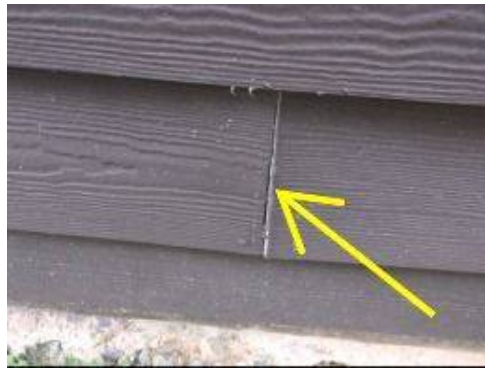
Siding butt joints need caulk and sealing with water resistant caulk. Fasteners need to be replaced.

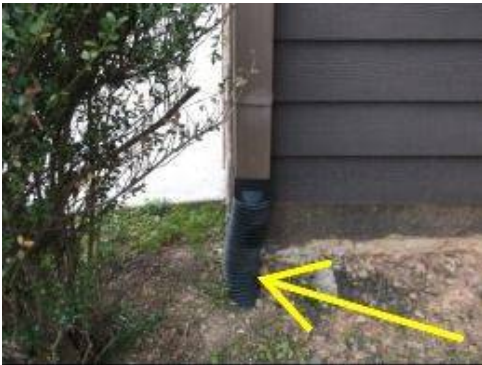
Caulk was in some areas. For example, at siding butt joints. Recommend that a qualified person renew or install caulk as necessary. Where gaps are wider than 1/4 inch, an appropriate material other than caulk should be used. For more information, visit: <http://www.reporthost.com/?CAULK>
- 
- 9) There are several 'french drains' observed at the downspouts which enter above ground, however, no discharge ends were found on the property. Inquire of the builder, if and where discharge pipes are located. Water flowing from the downspouts should be diverted away from the foundation.

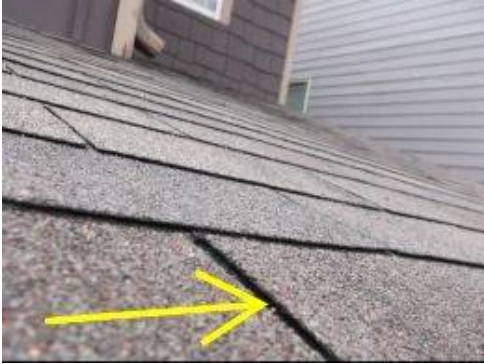
Some composition shingles were cracked and/or broken. Leaks can occur as a result. This is a conducive condition for wood-destroying organisms. Recommend that a qualified contractor repair as necessary. For example, by replacing shingles.

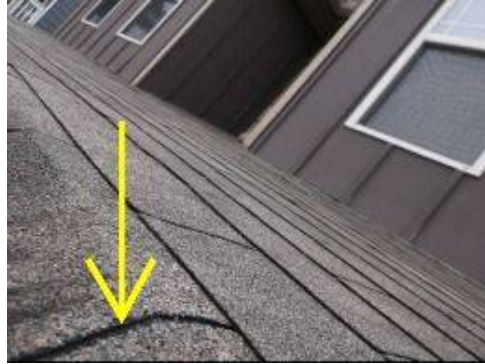
Several shingles above garage gutters are brittle and breaking off. Recommend further evaluation by a qualified roofing company for repair/replacement of broken shingles/

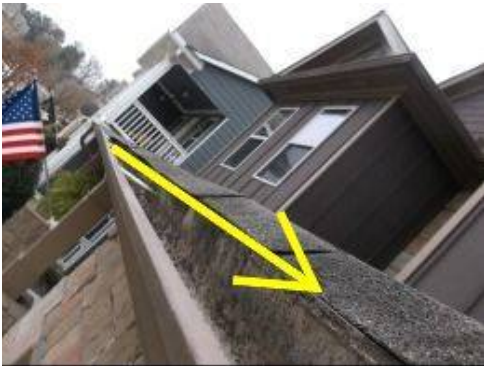
Several roofing shingles are brittle and broken. Repair and/or replace.

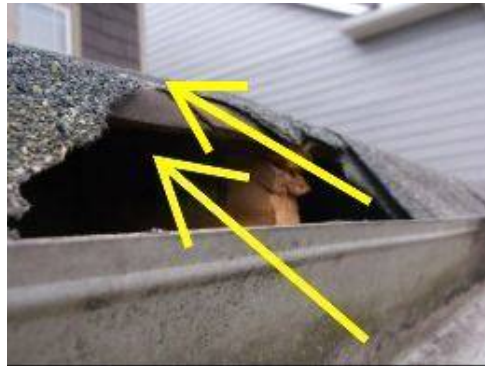
Water is standing inside the front gutters. The front gutters are improperly sloped.

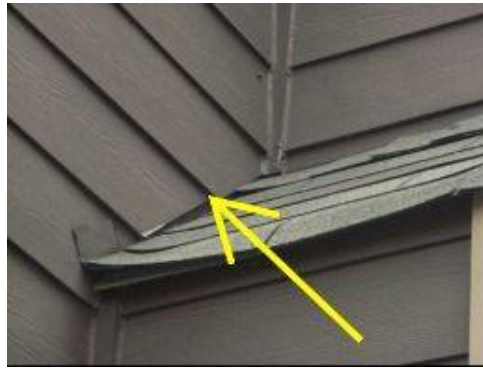
**Photo 10-6**  
Flashing visible from rear yard.

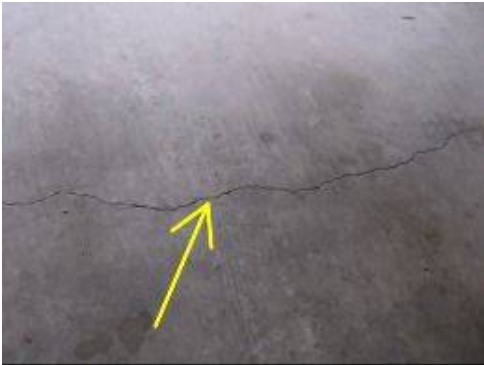
15) Oil stains on surface of concrete garage floor.

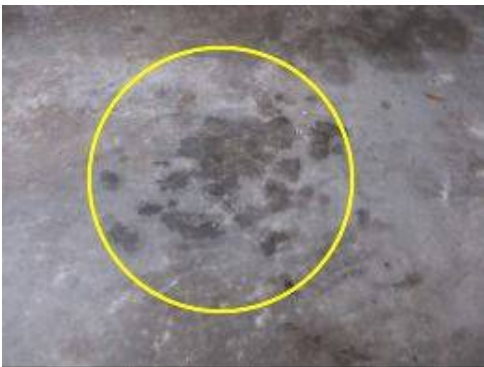
Oil stains on surface of concrete garage floor.

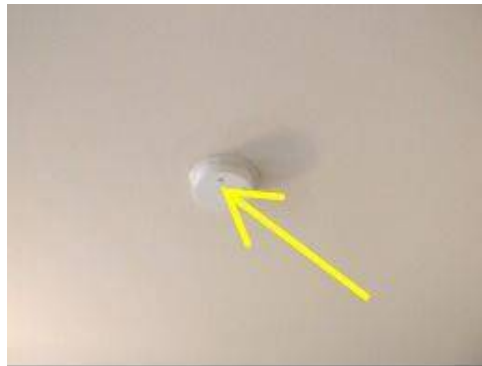
Upstairs walk in closet missing diffuser globe.

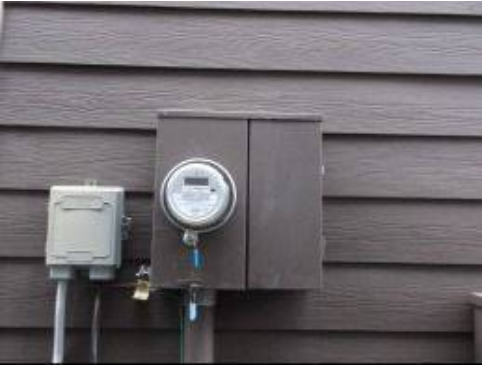
Replace all smoke detectors. Smoke detectors should be replaced when they are approx. ten years old. Older units tend to malfunction over time.

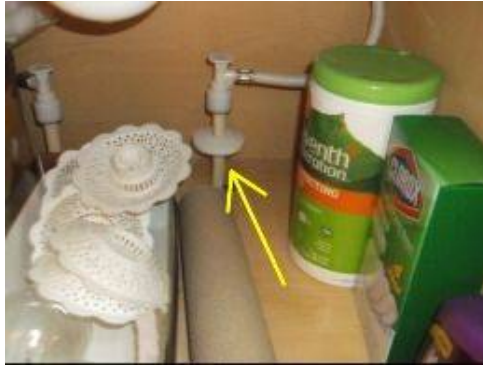
Water pressure measured at 40 psi. Recommend raising the pressure to a minimum 60 psi to insure all fixtures supply sufficient water. Hose bib is leaking and needs repair.

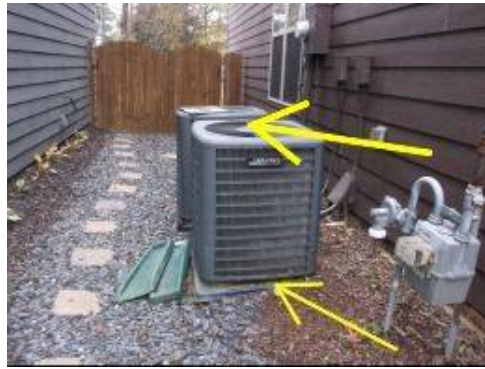
Both Air Conditioning compressor/condenser units are not resting level on an anti-vibration pad as required. Units should be raised a minimum of 3" above ground.

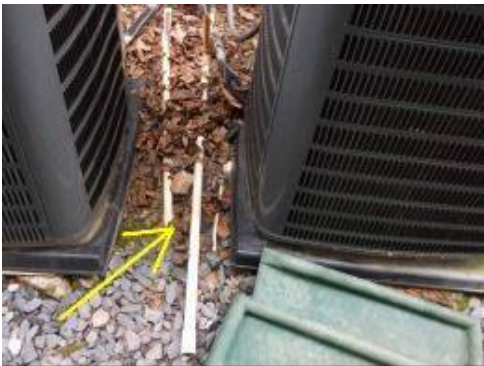
The estimated useful life for most heat pumps and air conditioning condensing units is 10-15 years. This unit appeared to be near and/or 9+ yrs this age and/or its useful lifespan and may need replacing or significant repairs at any time. Recommend budgeting for a replacement in the near future.

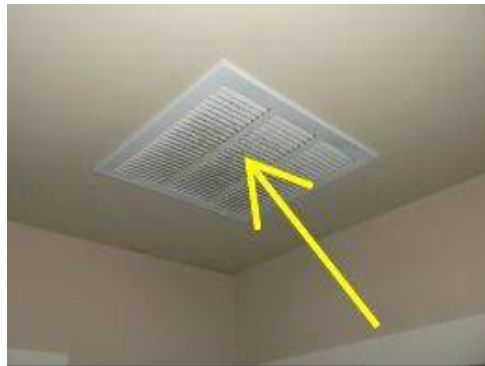
Condensate line for upstairs air handler is embedded in the ground and clogged with soil and debris. Repair as soon as practical, to prevent water from backing up into the handler.

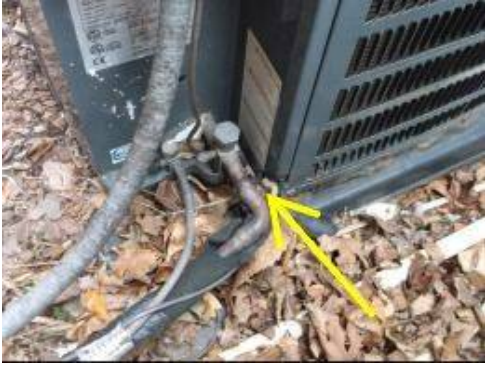
Insulation on the heat pump or air conditioning condensing unit's refrigerant lines was deteriorated or missing in some areas. This may result in reduced efficiency and increased energy costs. Recommend that a qualified person replace or install insulation as necessary.

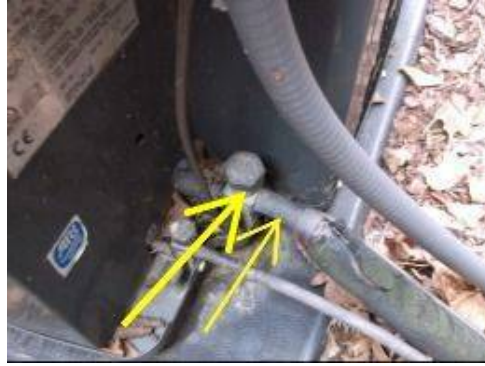
Air Conditioning refrigerant lines have insulation deteriorated. Replace as necessary.

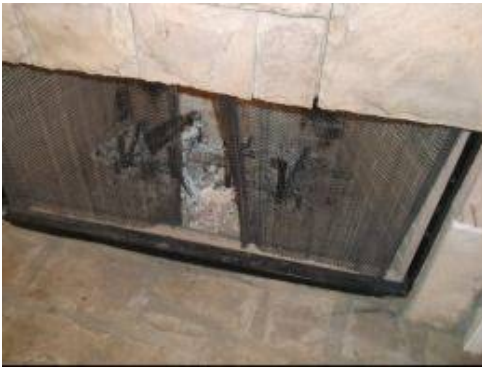
<http://www.reporthost.com/?CSIA>

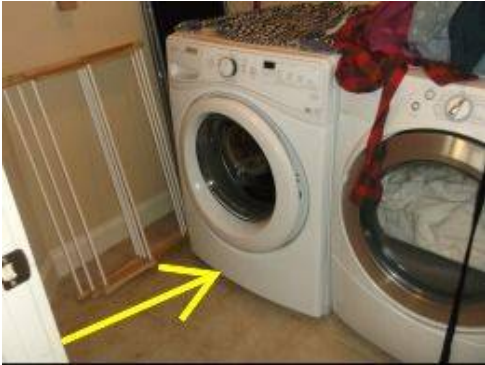
**29)** Overflow drip-pan was not installed in the laundry room. Drip pans should be installed below automatic washers. If the washer overflows or leaks, the water fills the drip pan and is diverted to the outside via the discharge pipe. This prevents water from leaking into the drywall ceilings below and causing moisture damage.

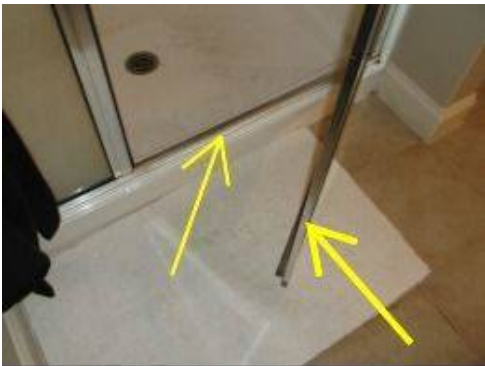
Caulk and seal around jacuzzi tub in master bathroom.

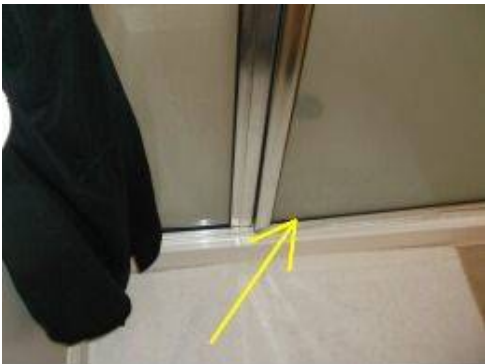
Master bath shower needs thorough cleaning, sanitizing and deodorizing prior to use. The shower doors stick inside the frame and is difficult to open and close. Repair door and frame as necessary.

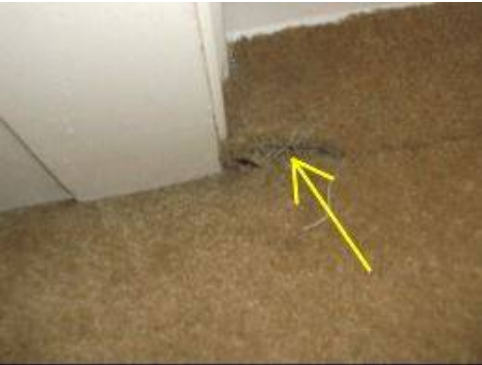
**Photo 29-9**  
Carpet is torn at the seams at entrance to master bathroom. Repair as necessary.

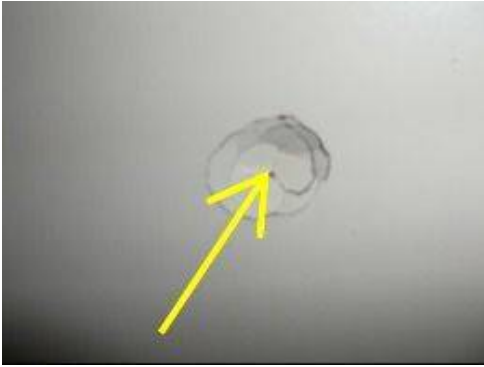
**Photo 30-1**  
Impact damage to bedroom door in master bedroom.

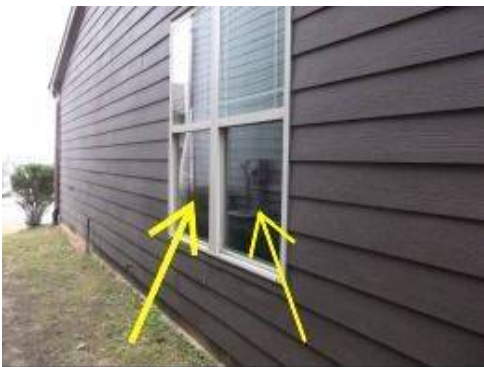
**Photo 31-1**  
Exterior screens missing from several windows.

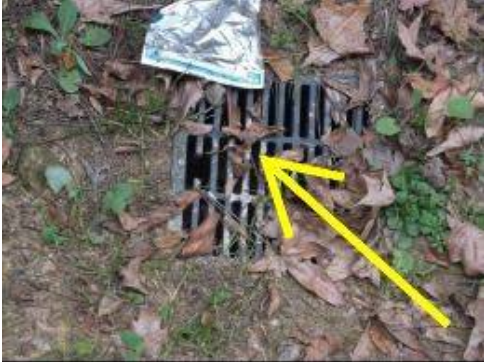
**Photo 3-1**  
Yard drain is clogged with leaves and debris. Clean out drain to allow for proper drainage away from the foundation.

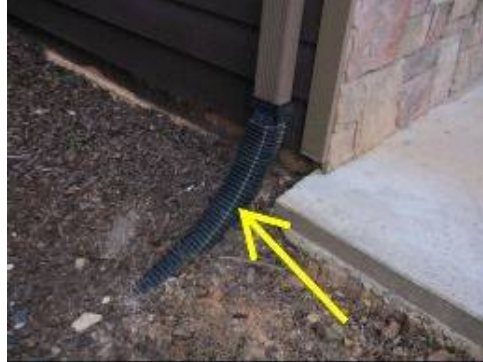
**Photo 3-2**  
Downspout extension embedded in the soil. No discharge pipe was located during the inspection.

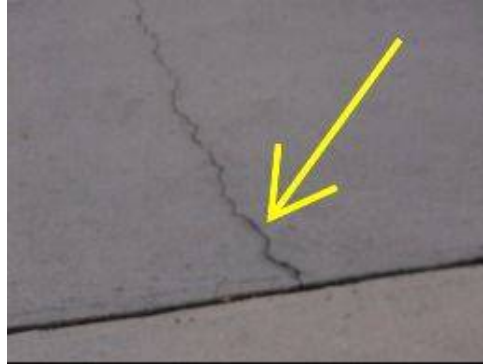
**Photo 3-4**  
Minor crack in driveway.

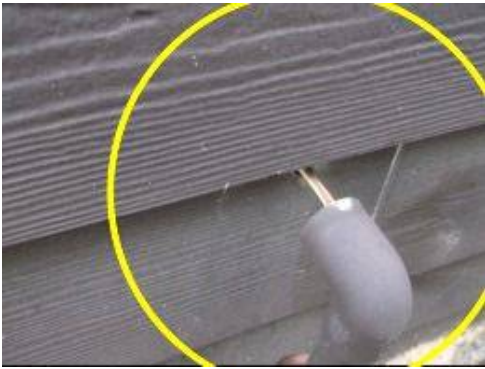
- Some sections of siding and/or trim were deteriorated, loose, split and/or warped. Recommend that a qualified person repair, replace or install siding or trim as necessary.

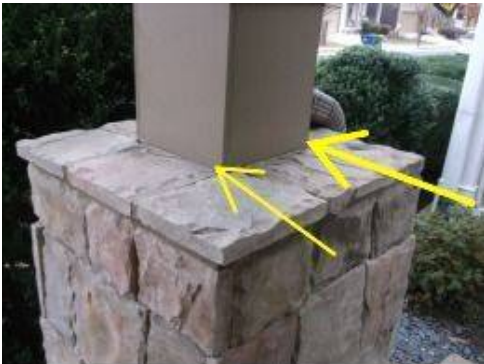
**Photo 6-1**  
Mortar joints cracked at front porch support columns.

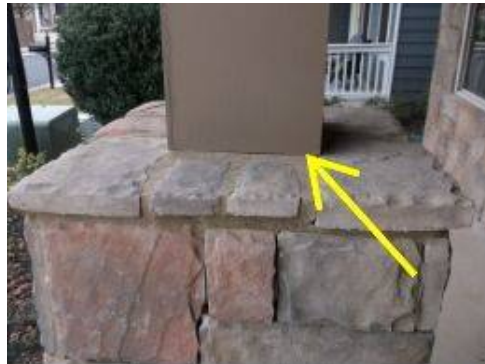
**Photo 6-2**  
Minor cracks in the mortar joints at the front support columns.

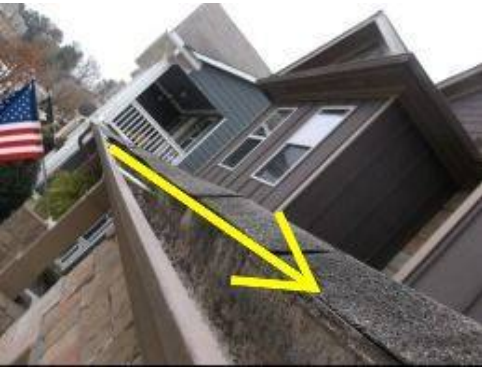
**Photo 10-3**  
Water is standing inside the front gutters. The front gutters are improperly sloped.

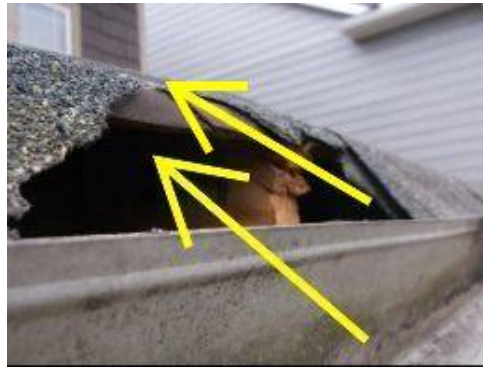
**Photo 10-4**  
Roofing shingle at front entrance above garage has broken off and needs replacement. Contact qualified roofing company.

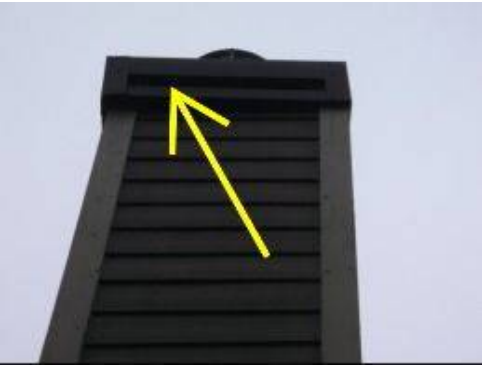
**Photo 10-5**  
Metal chimney cap appears to be improperly installed from ground level. Further evaluation is recommended.

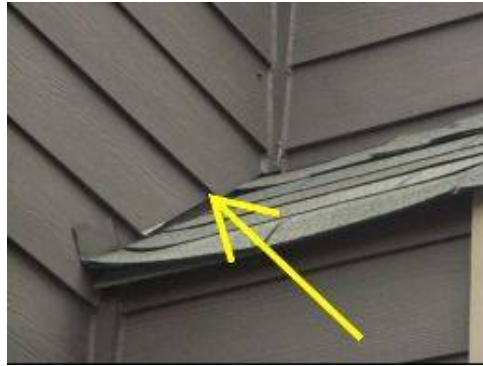
**Photo 10-6**  
Flashing visible from rear yard.

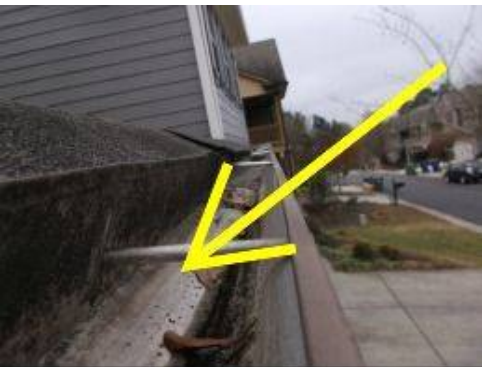
**Photo 11-1**  
Front gutters are improperly sloped such that water is being retained inside the gutters. The standing water is 'wicking' into the soffit causing moisture intrusion.

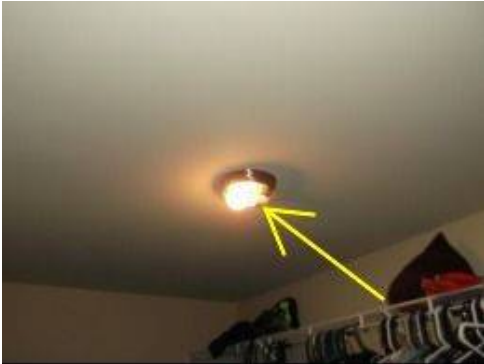
- One or more globes or covers for light fixtures were missing or damaged. Recommend replacing as necessary to avoid exposed bulbs at automatic garage door opener

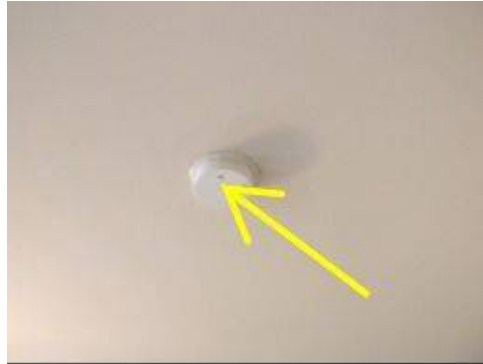
Upstairs walk in closet missing diffuser globe.

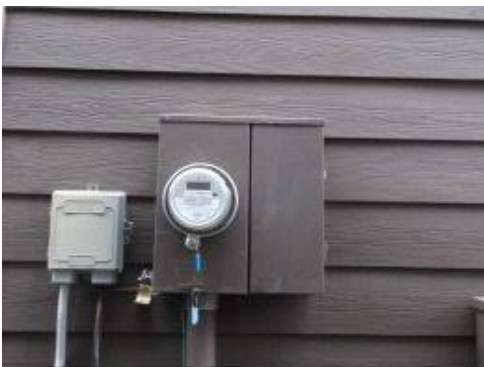
Replace all smoke detectors. Smoke detectors should be replaced when they are approx. ten years old. Older units tend to malfunction over time.

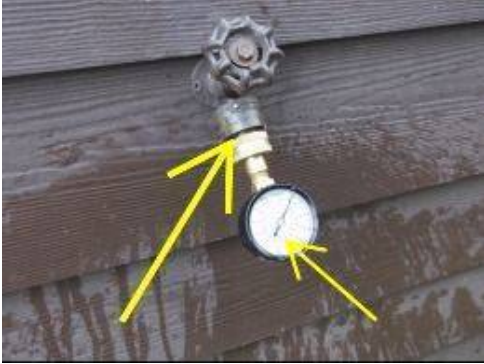
qualified specialist evaluate the irrigation system for other defects (e.g. leaks, damaged or malfunctioning sprinkler heads) and repair if necessary.

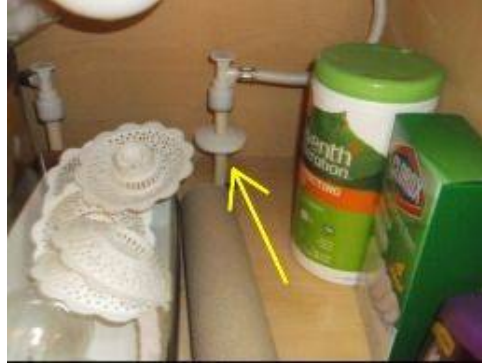
Water pressure measured at 40 psi. Recommend raising the pressure to a minimum 60 psi to insure all fixtures supply sufficient water. Hose bib is leaking and needs repair.

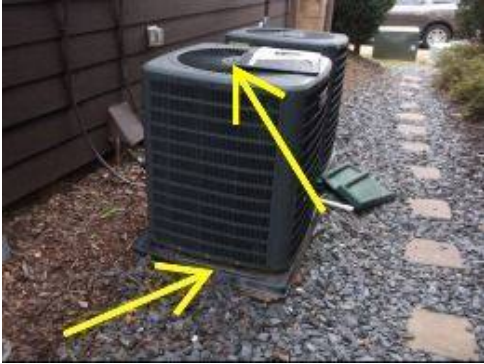
<http://www.reporthost.com/?ANFURINSP> Air conditioning compressor/condenser unit did not have the proper label attached, thus, the inspector was unable to fully evaluate the heat pump.

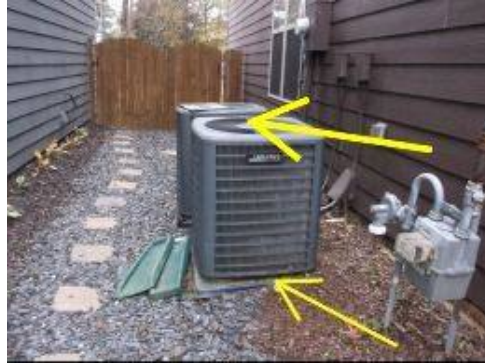
Both Air Conditioning compressor/condenser units are not resting level on an anti-vibration pad as required. Units should be raised a minimum of 3" above ground.

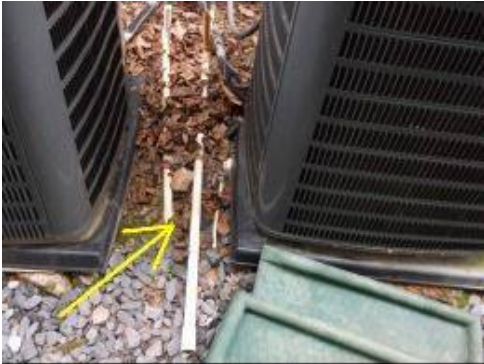
- The estimated useful life for most heat pumps and air conditioning condensing units is 10-15 years. This unit appeared to be near and/or 9+ yrs this age and/or its useful lifespan and may need replacing or significant repairs at any time. Recommend budgeting for a replacement in the near future.

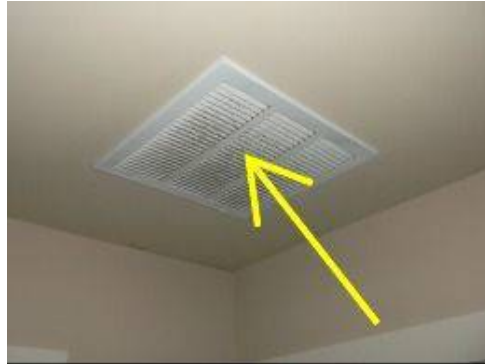
Condensate line for upstairs air handler is embedded in the ground and clogged with soil and debris. Repair as soon as practical, to prevent water from backing up into the handler.

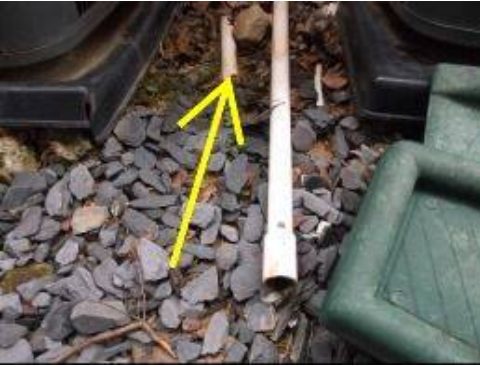
**Photo 23-1**  
Clogged Air Cond. condensate line.

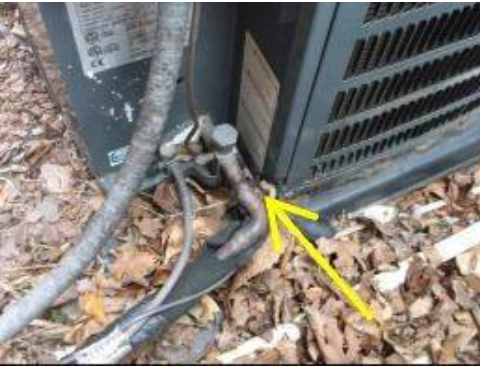
**Photo 24-1**  
Air Conditioning refrigerant lines have insulation deteriorated. Replace as necessary.

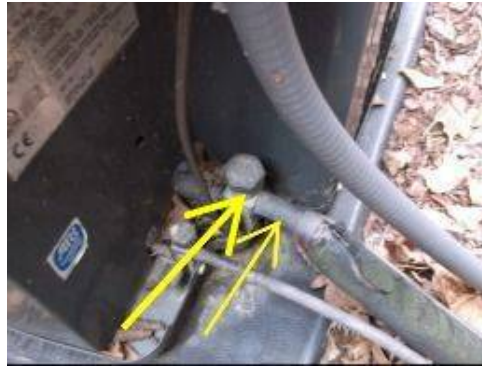
**Photo 24-2**  
Insulation deteriorated at A/C unit refrigerant line.

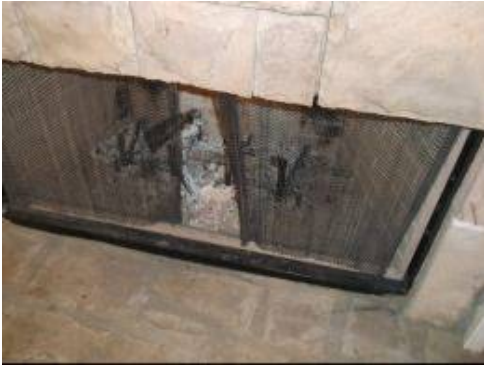
- One or more wood-burning fireplaces or stoves were found at the property. When such devices are used, they should be professionally inspected and cleaned annually to prevent creosote build-up and to determine if repairs are needed. The National Fire Protection Association states that a "Level 2" chimney inspection should be performed with every sale or transfer of property with a wood-burning device. Recommend consulting with the property owner about recent and past servicing and repairs to all wood-burning devices and chimneys or flues at this property. Recommend that a qualified specialist evaluate all wood-burning devices and chimneys, and clean and repair as necessary. Note that if a wood stove insert is installed, it may need to be removed for such an evaluation. For more information, search for "chimney inspection" at: <http://www.reporhost.com/?CSIA>

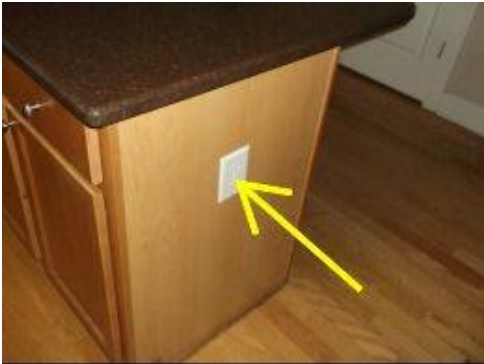
- Gaps, no caulk, or substandard caulking were found between countertops and backsplashes. Water may penetrate these areas and cause damage. Recommend that a qualified person repair as necessary. For example, by installing caulk.

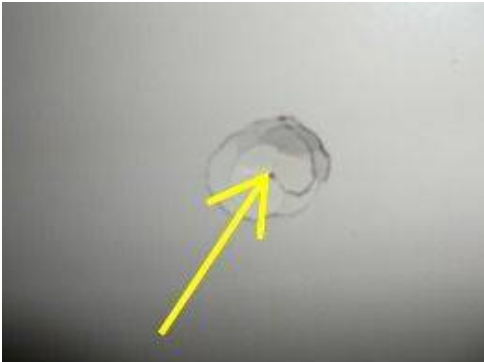
**Photo 30-1**  
Impact damage to bedroom door in master bedroom.

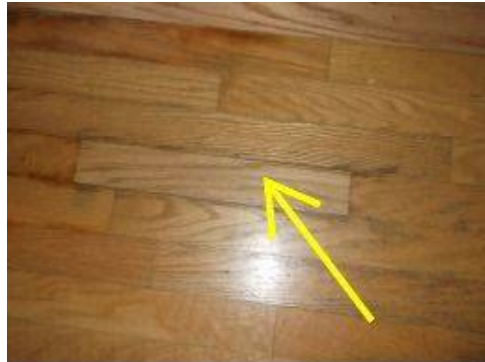
**Photo 30-2**  
Laminate flooring in family room appears to have been repaired or a section replaced. Inquire of current owner or tenant if this is the case.
