Georgia Conference of Home Inspectors

2470 Windy Hill Rd SE Ste 300
Marietta GA 30067-8621
Inspector: Ronald Coker

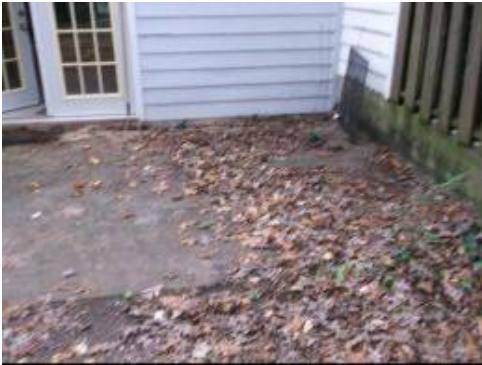
- 3) **i** Minor deterioration (e.g. cracks, holes, settlement, heaving) was found in sidewalks or patios, but no trip hazards were found. The client may wish to have repairs made for cosmetic reasons.

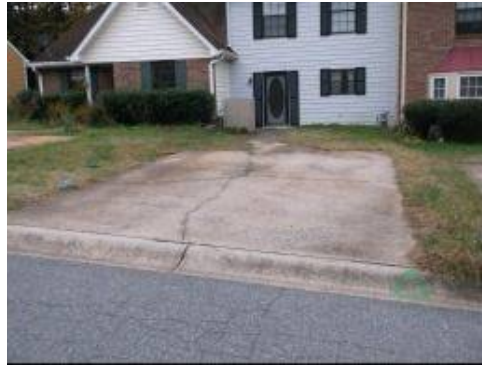
Leaves and twigs have accumulated on the back patio. This could indicate improperly sloping of the concrete patio.

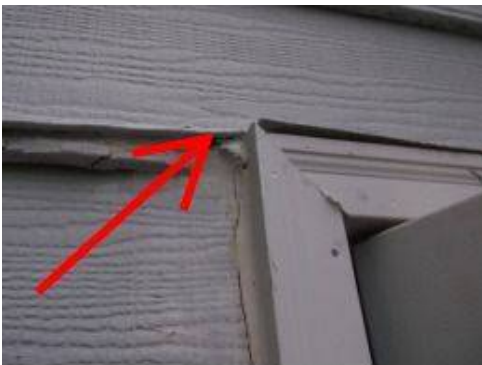
- 4) **🔨** Some sections of siding and/or trim were deteriorated. Recommend that a qualified person repair, replace or install siding or trim as necessary.

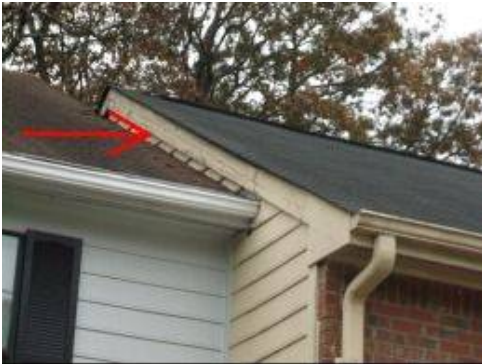
Substandard repairs were found at one or more locations on the roof surface. Leaks can occur as a result. This is a conducive condition for wood-destroying organisms. Recommend that a qualified contractor evaluate and repair per standard building practices. See photos

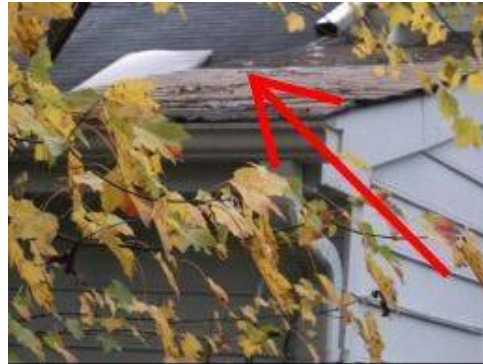
Flashing where the two units roofs meet has substandard flashing where they adjoin. Recommend a qualified roofing contractor make a further evaluation of the entire roof. This roof surface has exceeded its normally expected useful service life and replacement of the current layer of shingles is recommended.

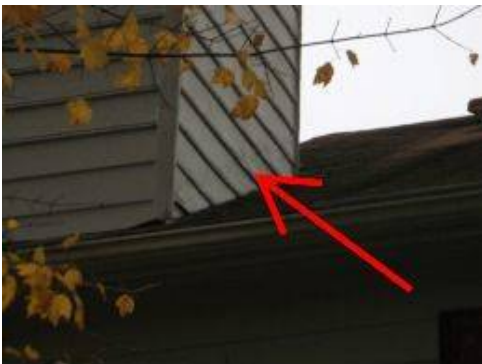
One or more roof flashings were substandard. Leaks can occur as a result. This is a conducive condition for wood-destroying organisms. Recommend that a qualified person repair as necessary.

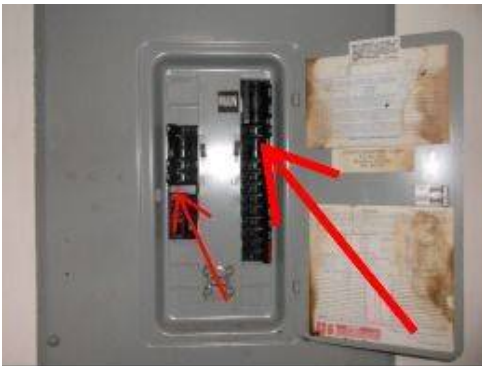
One or more slots where circuit breakers are normally installed were open in panel(s) #A. Energized equipment was exposed and is a shock hazard. Recommend that a qualified person install closure covers where missing.

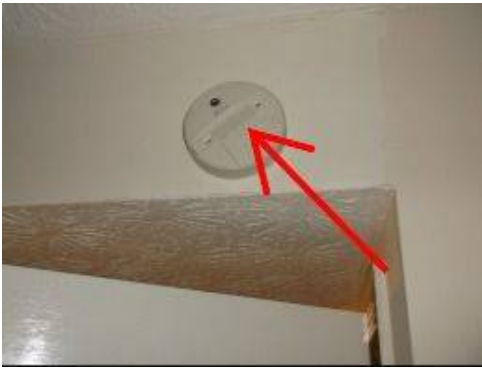
<http://www.reporthost.com/?COALRM>

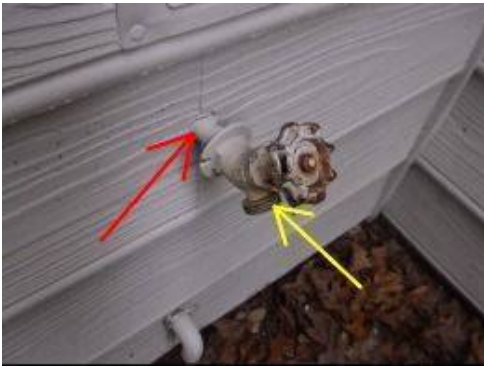
Rear hose bib was not fitted with anti-siphon devices. Recommend that a qualified plumber install on one or more hose bibs for convenience, and per standard building practices (e.g. frost-free with anti-siphon device). Install anti-siphon devices to front and rear hose bibs.

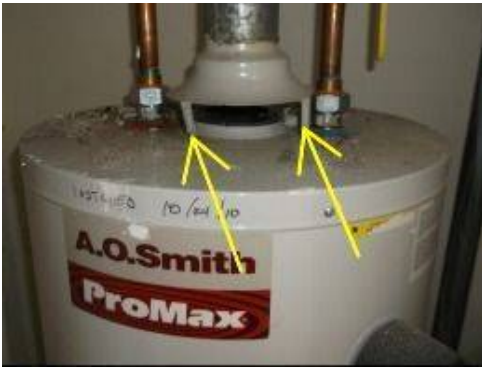
The draft hood for the water heater flue was loose. This is a potential safety hazard due to the risk of exhaust gases entering living spaces. A qualified person should permanently secure the draft hood with appropriate fasteners per standard building practices.

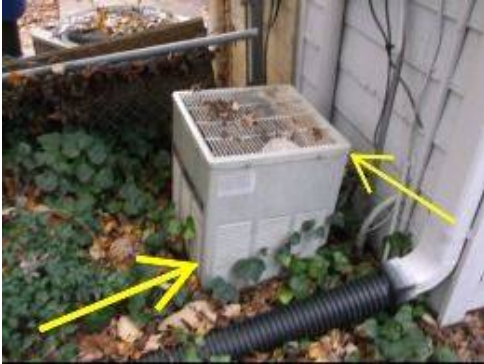
Manufactured 1983. 32 Years old. The A/C has far exceeded its normally expected useful service life. The compressor and fins were covered with rust.

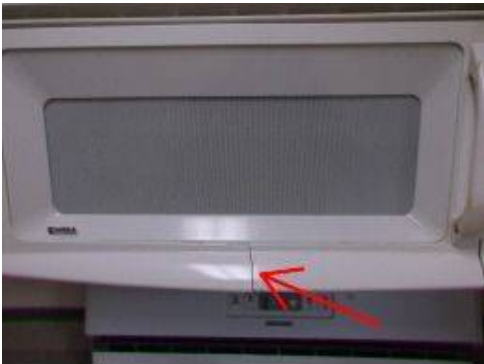
The microwave oven was inoperable. Recommend that a qualified person evaluate and repair or replace as necessary.

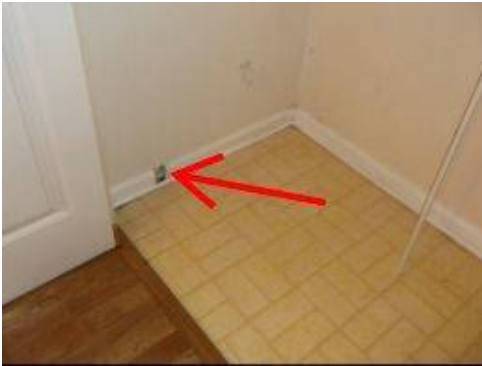
33) Overflow drip-pan was not installed in the laundry room. Drip pans should be installed below automatic washers. If the washer overflows or leaks, the water fills the drip pan and is diverted to the outside via the discharge pipe. This prevents water from leaking into the drywall ceilings below and causing moisture damage.

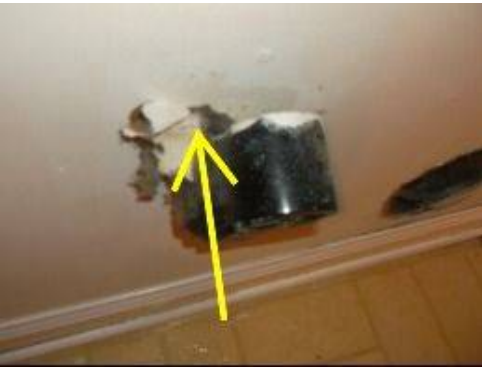
34) Laundry room electrical dryer receptacle is of the old 'three-prong' type. Newer models of dryers are equipped with 'four-prong'

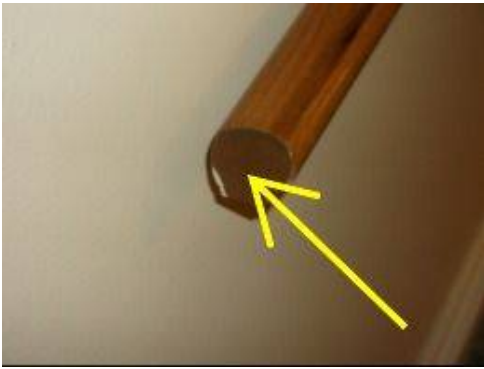
35) + 🛠️ One or more handrails had no "returns" installed, where ends of handrails turn and connect to adjacent walls so objects or clothing will not catch on the open ends. This is a safety hazard. Recommend that a qualified person install returns per standard building practices.

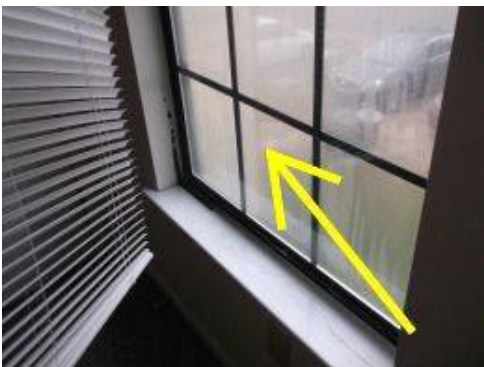
Be aware that evidence of failed seals or desiccant may be more or less visible depending on the temperature, humidity, sunlight, etc. Windows or glass-paneled doors other than those that the inspector identified may also have failed seals and need glass replaced. It is beyond the scope of this inspection to identify every window with failed seals or desiccant.

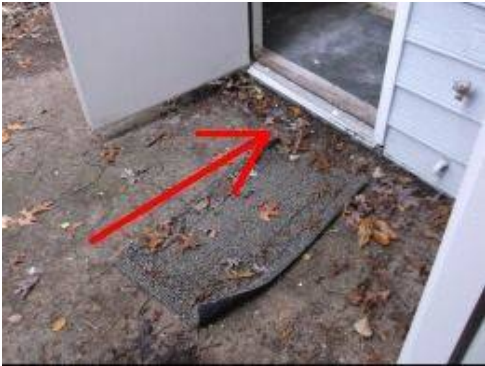
Visible evidence of conditions conducive to wood-destroying organisms: No

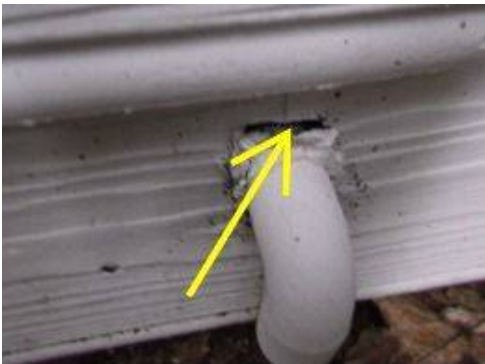
There is evidence of a drywall repair behind the upstairs bathroom toilet bowl. Inquire of the current owner if a recent repair or leak has been repaired.

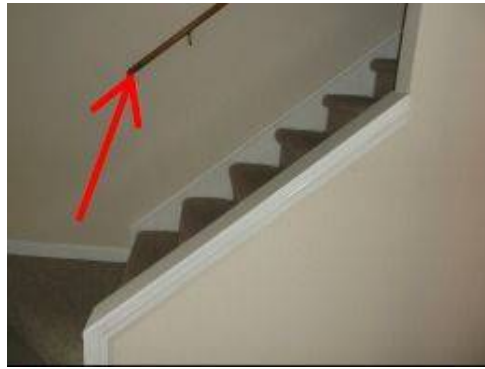
Photo X-6
No returns installed on the upstairs handrails. Open ends of stair handrails could cause sleeves to be caught on the ends and cause potential falls.

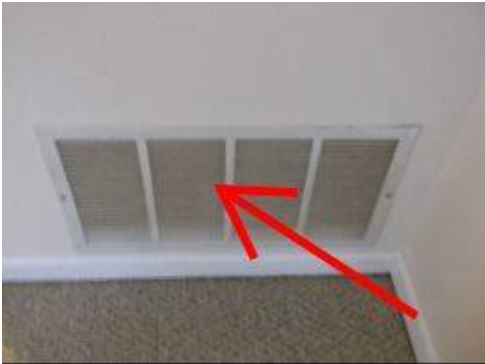
Photo X-7
The furnace air handler grill is dust and grease laden and needs a thorough cleaning.

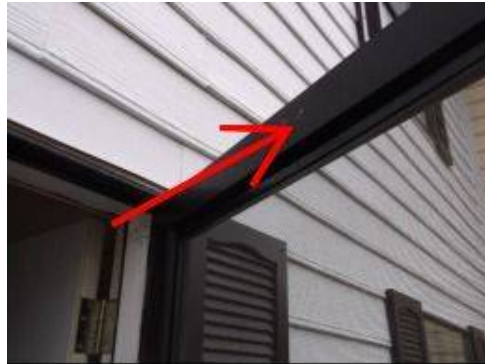
Photo X-8
Pneumatic door closer is missing from the storm door.

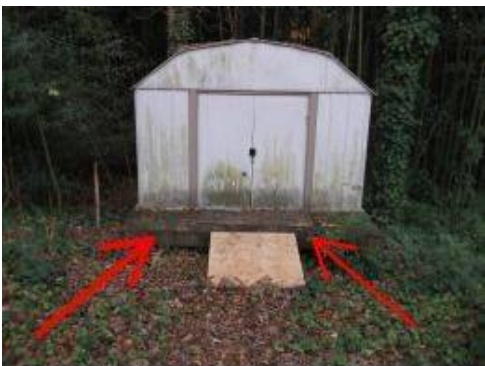
Photo X-9
Outbuildings are excluded from this inspection, however, it should be monitored such that small children do not become entrapped. Also the space underneath is an excellent harbor for rats and snakes. You want to consider installing skirting around the wooden support foundation.

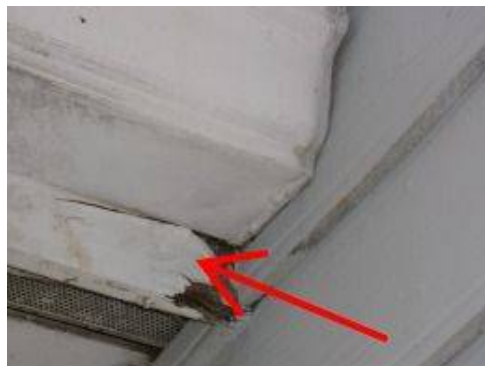
Photo X-10
Gutter is improperly sloped, and water standing inside the gutter is 'wicking' into the wood trim and fascia, causing moisture damage.

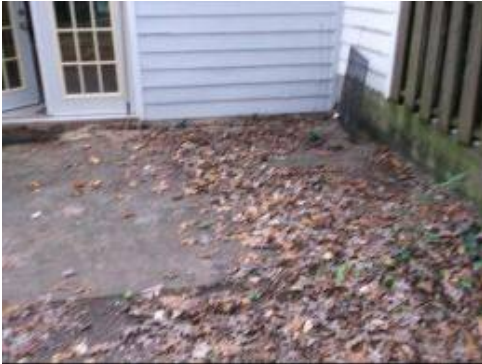
- Minor deterioration (e.g. cracks, holes, settlement, heaving) was found in sidewalks or patios, but no trip hazards were found. The client may wish to have repairs made for cosmetic reasons.

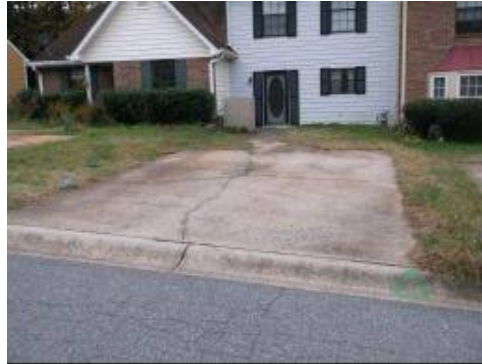
Leaves and twigs have accumulated on the back patio. This could indicate improperly sloping of the concrete patio.

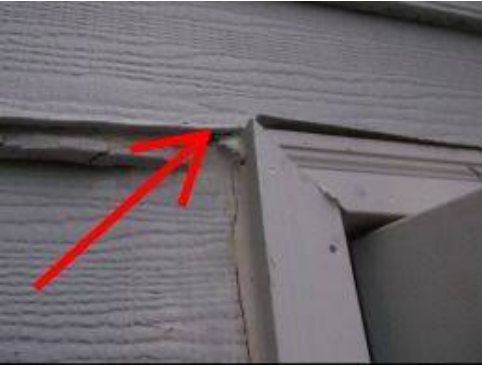
- Some sections of siding and/or trim were deteriorated. Recommend that a qualified person repair, replace or install siding or trim as necessary.

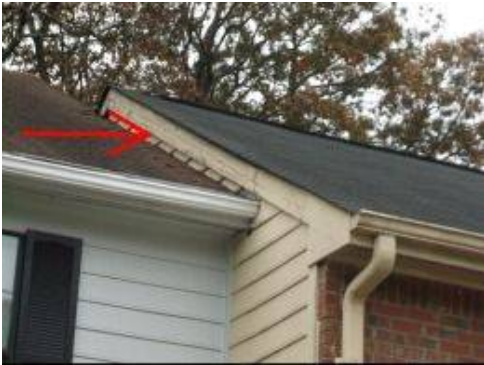
- Substandard repairs were found at one or more locations on the roof surface. Leaks can occur as a result. This is a conducive condition for wood-destroying organisms. Recommend that a qualified contractor evaluate and repair per standard building practices. See photos

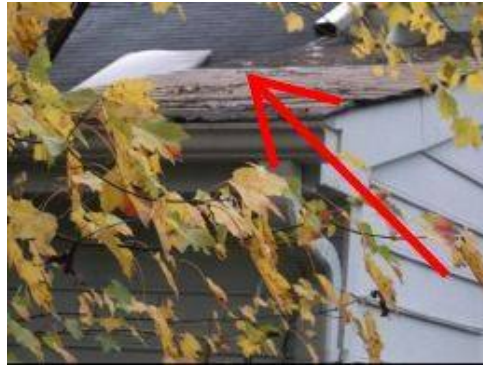
Flashing where the two units roofs meet has substandard flashing where they adjoin. Recommend a qualified roofing contractor make a further evaluation of the entire roof. This roof surface has exceeded its normally expected useful service life and replacement of the current layer of shingles is recommended.

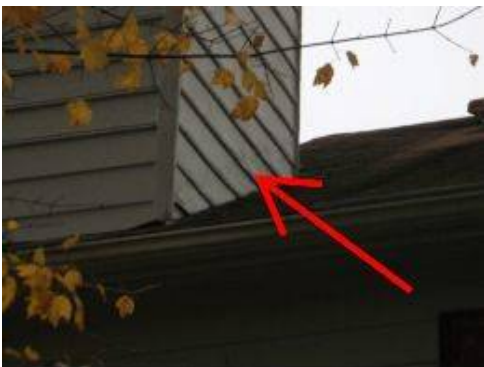
- One or more roof flashings were substandard. Leaks can occur as a result. This is a conducive condition for wood-destroying organisms. Recommend that a qualified person repair as necessary.

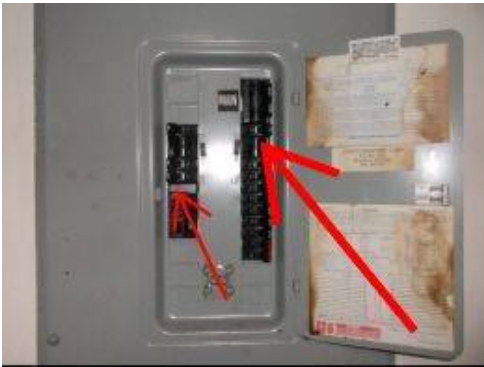
- One or more slots where circuit breakers are normally installed were open in panel(s) #A. Energized equipment was exposed and is a shock hazard. Recommend that a qualified person install closure covers where missing.

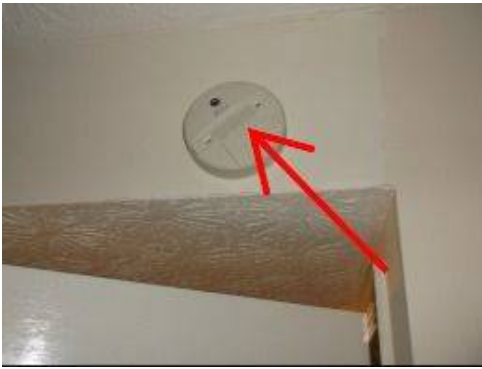
<http://www.reporthost.com/?COALRM>

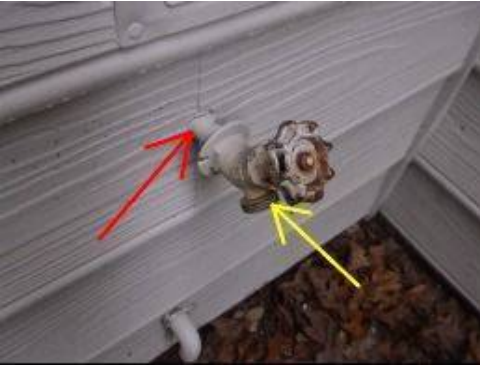
21 🔧 - Rear hose bib was not fitted with anti-siphon devices. Recommend that a qualified plumber install on one or more hose bibs for convenience, and per standard building practices (e.g. frost-free with anti-siphon device). Install anti-siphon devices to front and rear hose bibs.

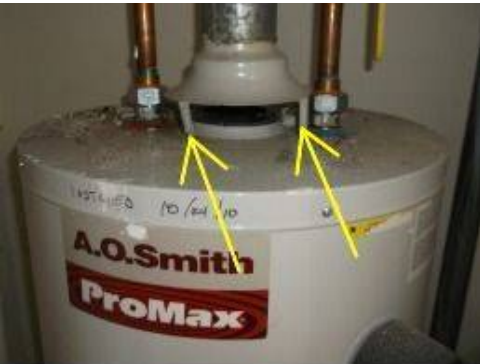
- 23** + 🛠️ - The draft hood for the water heater flue was loose. This is a potential safety hazard due to the risk of exhaust gases entering living spaces. A qualified person should permanently secure the draft hood with appropriate fasteners per standard building practices.

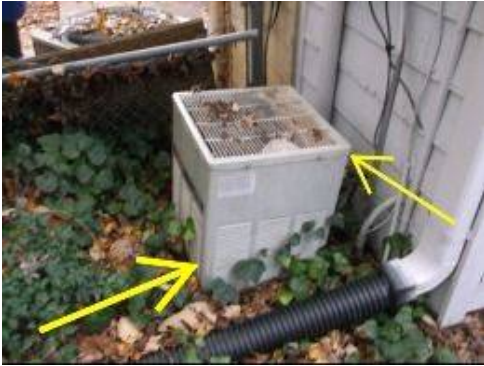
Manufactured 1983. 32 Years old. The A/C has far exceeded its normally expected useful service life. The compressor and fins were covered with rust.

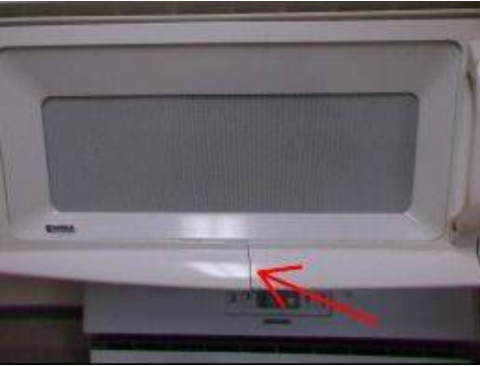
- The microwave oven was inoperable. Recommend that a qualified person evaluate and repair or replace as necessary.

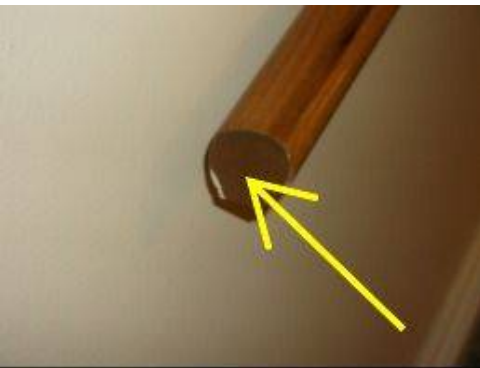
- One or more handrails had no "returns" installed, where ends of handrails turn and connect to adjacent walls so objects or clothing will not catch on the open ends. This is a safety hazard. Recommend that a qualified person install returns per standard building practices.

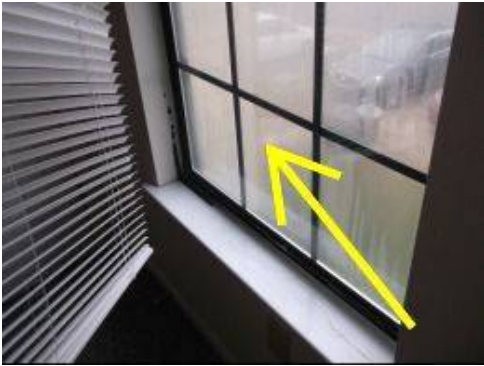
Be aware that evidence of failed seals or desiccant may be more or less visible depending on the temperature, humidity, sunlight, etc. Windows or glass-paneled doors other than those that the inspector identified may also have failed seals and need glass replaced. It is beyond the scope of this inspection to identify every window with failed seals or desiccant.
