TR250 & TR6 Steering & Suspension Adjusting Rear Suspension Camber

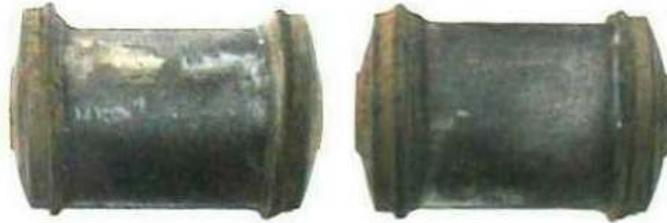
Bushes: The standard bushes are made of rubber with metal sleeves in the middle. After years of use, the sleeves tend to migrate to one side of the bush. Since the forces on the inside and on the outside bushes are different, the amount of sleeve movement can be different enough to cause several degrees of negative camber. The next photo shows a pair of bushes removed from the trailing arm on my '70TR6. Notice that the sleeve on the left has migrated to the top more than the one on the right.

If the bushes are more than ten years old I'd suggested replacement before doing anything to adjust the camber. The standard bushing as well as uprated rubber and poly bushes are available. I installed new standard bushes on my '76 about 18 months ago at the same time I replaced the frame rear cross members, that part of the frame to which the trailing arm brackets attach.

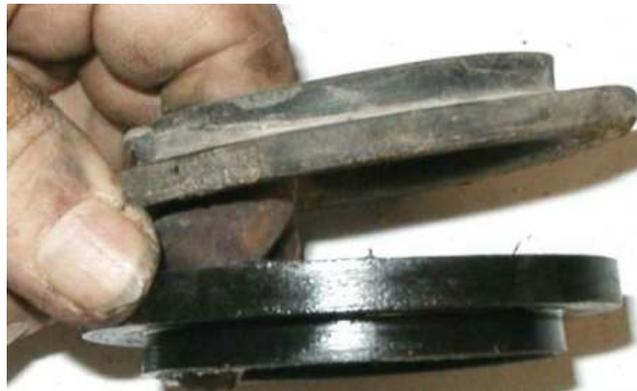
New Packing: When measuring the fitted spring length I noticed the rubber packing pieces at each end of the springs were in bad shape so I decided to replace them first. I purchased the uprated poly packing pieces from TRF. The rubber packing pieces are about ~0.25" thick and the new poly packing pieces are ~ 0.29" thick (photo below)

I decided to install the new packing pieces and measure everything again.

The height increased and the camber improved because of the thicker packing. The height became equal. I noticed that part of one of the old packing on the left side was not under the spring, which might explain how the height changed more on the left side.

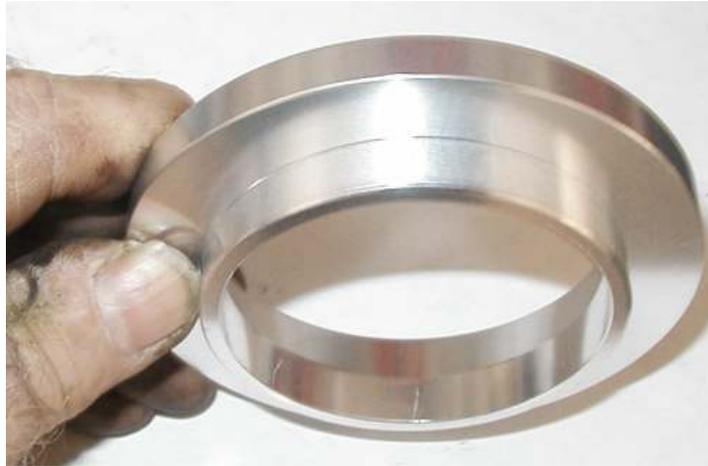
Try Spacers: As mentioned earlier, the factory made available spacers to put under the springs to to fix the negative camber problem. I decided to try a set of spacers next. The spacers (next photo) raise the springs 0.44" and are placed between the spring and the lower packing piece.

Data for my '76 (with new packing pieces & spacers)		
	Left	Right
Front Fender Height	28.0"	28.2"
Rear Fender Height	29.2"	29.2"
Rear Wheel Camber	-0.4°	-0.2°

The spacer height must be in inches and the resulting ride height change is in inches. The 0.44" spacer raised the height 0.8" and increased the camber (in a positive direction) by a little over one degree, matching the calculated values very closely. The wheels looked pretty good with this setup but I thought the height was too high. I also expected the new poly packing to compress slightly making the camber more negative. I decided to remove the packing to lower the height and work on the brackets instead.

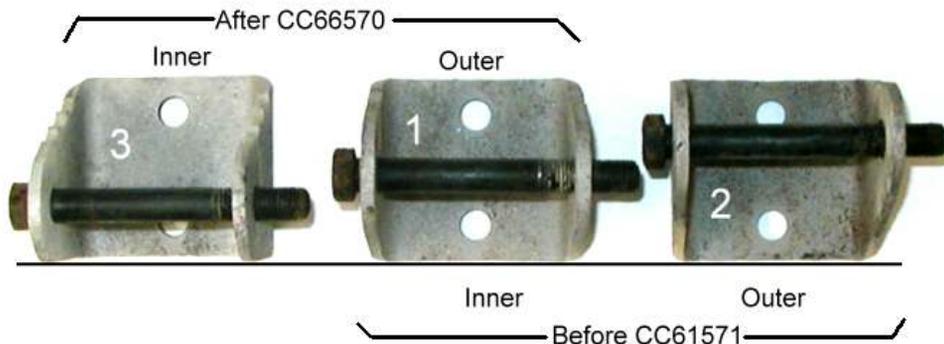
The Brackets: Triumph made three different brackets for the trailing arm as shown in the next photo. The number of notches in the top edges identifies the brackets and is marked on each bracket in the photo. Up to CC61570 a 1- notch bracket was used on the inside and a 2-notch bracket on the outside. Beginning with CC61571 a 3-notch bracket was used on the inside and a 1-notch bracket on the outside.

Brian suggested that it's best to change only one bracket per trailing arm at a time which makes sense. I started with the standard later 1U outer 3U inner configuration. The inner bracket bolt was installed with the head toward the inside and I didn't know if I could get the inside bracket off easily so I decided to try to correct the problem by changing only the outside bracket. (The configuration shown in the manuals has the bolt head toward the inside. In the future I'm going to assemble them with the inner bolt head to the outside and the outer bolt head to the inside to facilitate changing the bracket configuration.)

The 1U-3U configuration has a relative camber of -2.8 degrees. Moving down the table then next entry with the 3U inner bracket is the 2D-3U configuration that has -2.3 degrees relative camber. That is an increase of 0.5 degrees-- not enough. I needed between 1.3 and 1.6 degrees to get to zero camber (the spacer had been removed). The next entry down with the 3U inner bracket is the 3U-3U configuration that has -1.7 degrees relative camber. This is an increase of 1.1 degree. I would have liked a little more increase, but the 3U-3U configuration is the combination with the greatest positive camber with the 3U inner bracket. So I tried that. The results were:

Data for my '76 (with new packing pieces & 3U-3U Bracket configuration)		
	Left	Right
Front Fender Height	28.0"	28.2"
Rear Fender Height	28.5"	28.5"
Rear Wheel Camber	-0.3	-0.0°

This was a slightly greater camber increase than expected and very close to the +1 degrees to -1/4 degrees specification. The road height increased slightly rather than decreasing as predicted from the data in the table. The ride height increase is due to a small second order effect explained in the Geometry note. These results above are barely acceptable. I'd be much happier with the left at about + 0.6 degree and right at +0.3 degree since the left side load is nearly always more than the right side load. I decided to run it for a few weeks and then measure it again.
