Subject: Geotechnical Investigation and Geologic Hazard Report Proposed Felisky Single Family Residence 79532 Ray Brown Road Arch Cape, Clatsop County, Oregon EEI Report No. 20-186-1

GEOTECHNICAL INVESTIGATION AND GEOLOGIC HAZARD REPORT

Proposed Felisky Single Family Residence 79532 Ray Brown Road Arch Cape, Clatsop County, Oregon

EEI Report No. 20-186-1

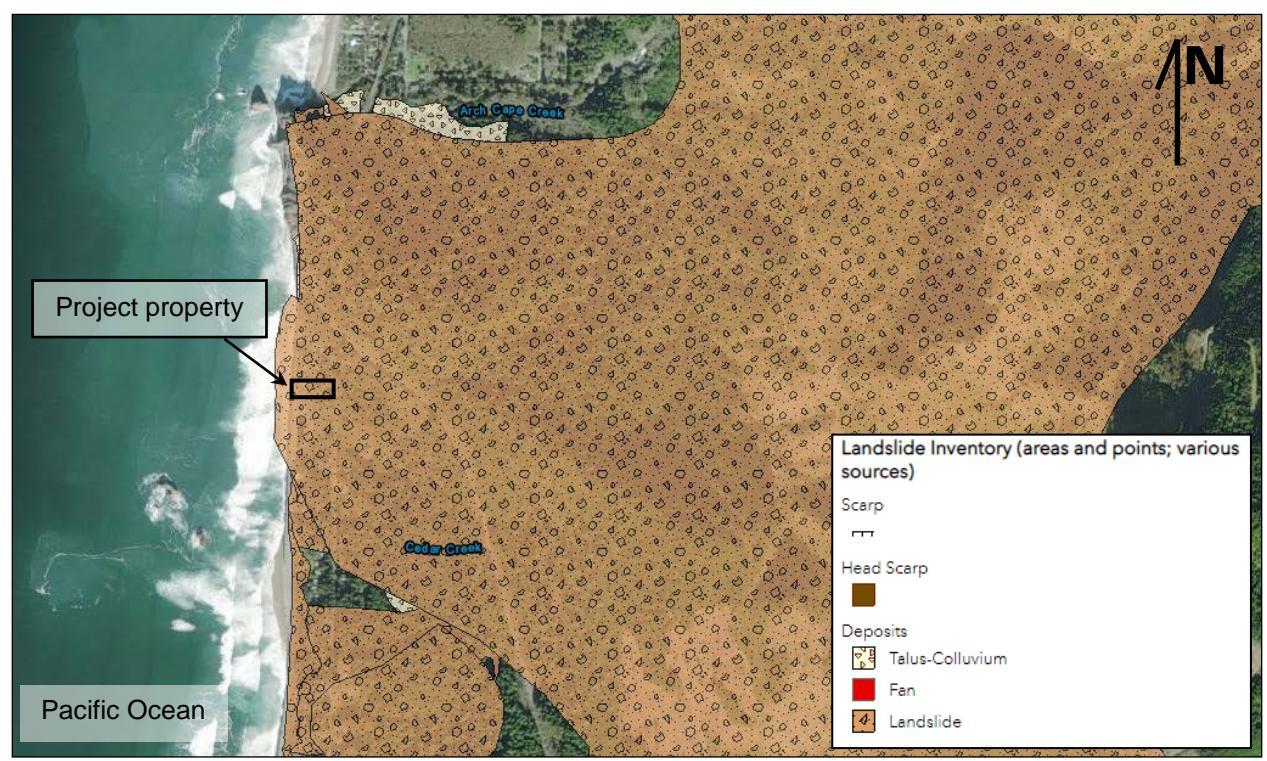
As shown below, the site is located within the boundaries of a very large, ancient landslide as mapped by the Statewide Landslide Inventory Database of Oregon (<u>https://gis.dogami.oregon</u>. gov/maps/slido/)—as are most of the tens of residences in the Cove Beach/Falcon Cove subarea of Arch Cape.

Figure 2: Property is located within a large slide mass (SLIDO 4.1).

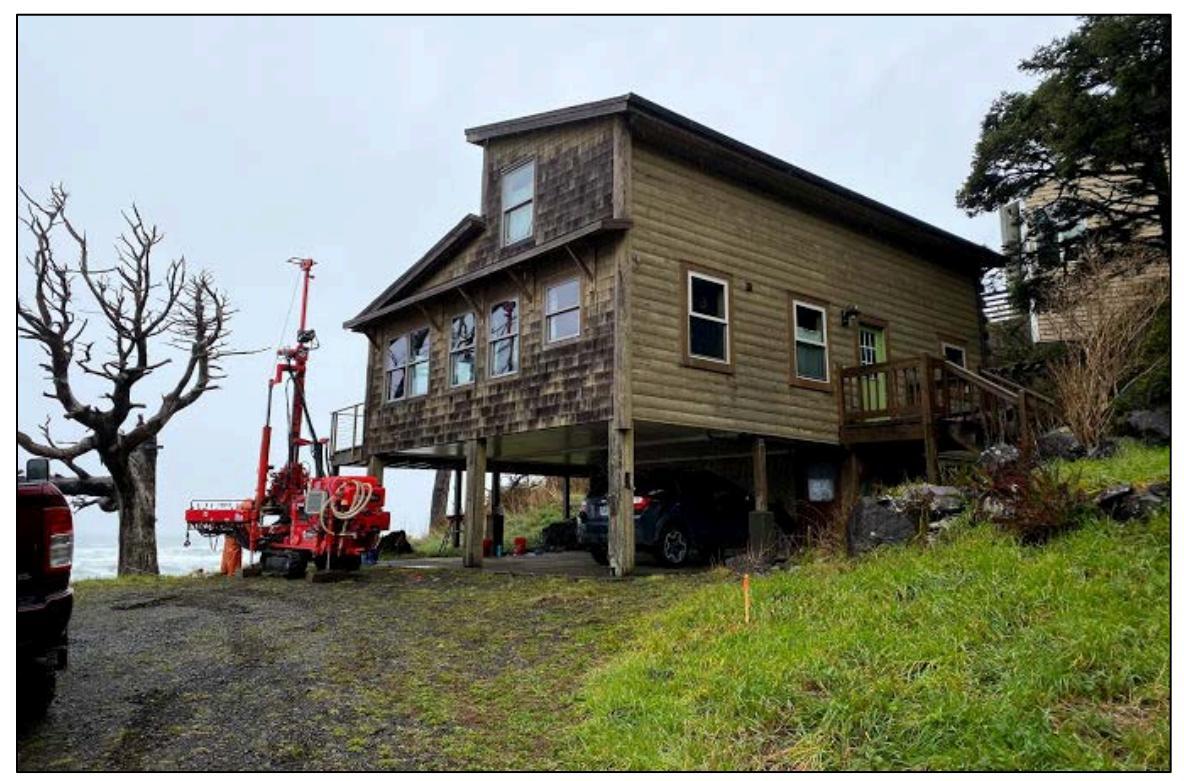
There are scattered trees on the subject property that are generally straight-trunked however some trees are slightly titled and bent. This indicated variable amounts of shallow soil creep, which is common in sloping areas with landslide deposits. See Photos 1 through 3 below.

Photo 1: Current site conditions showing the existing residence on the subject property and hummocky land features, facing west.

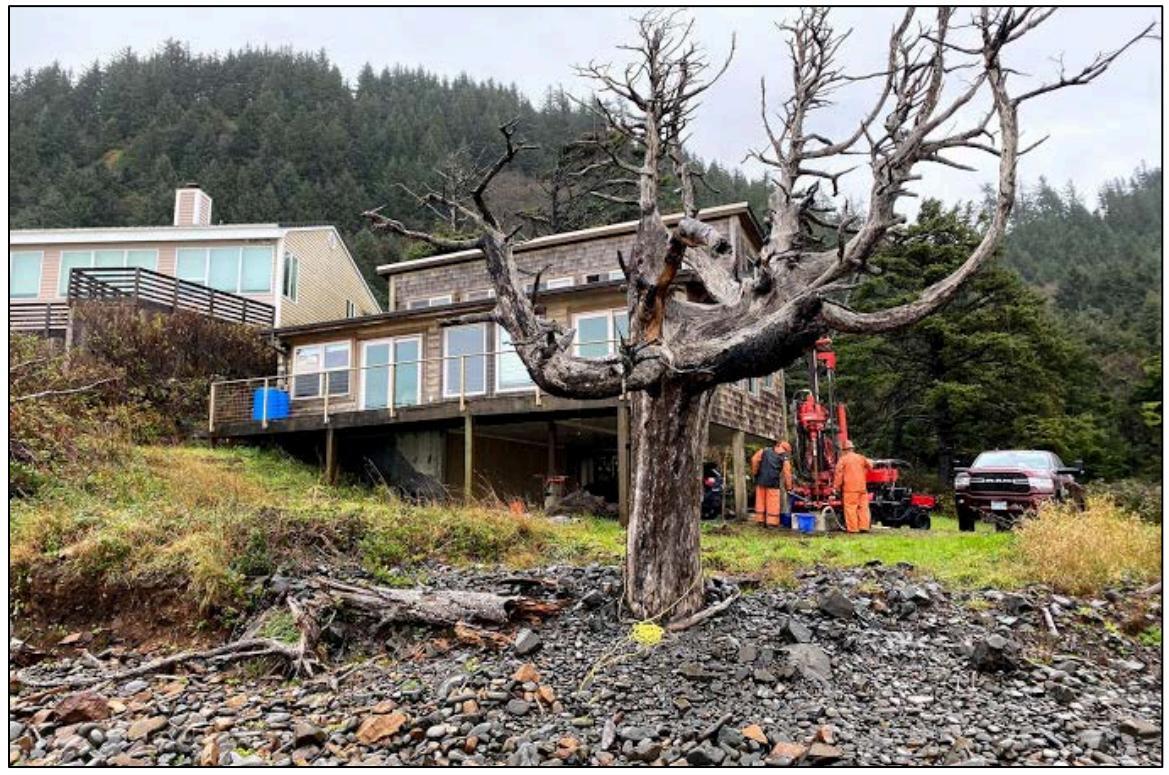
Photo 2: Current site conditions showing the existing residence on the subject property and hummocky land features, facing east.

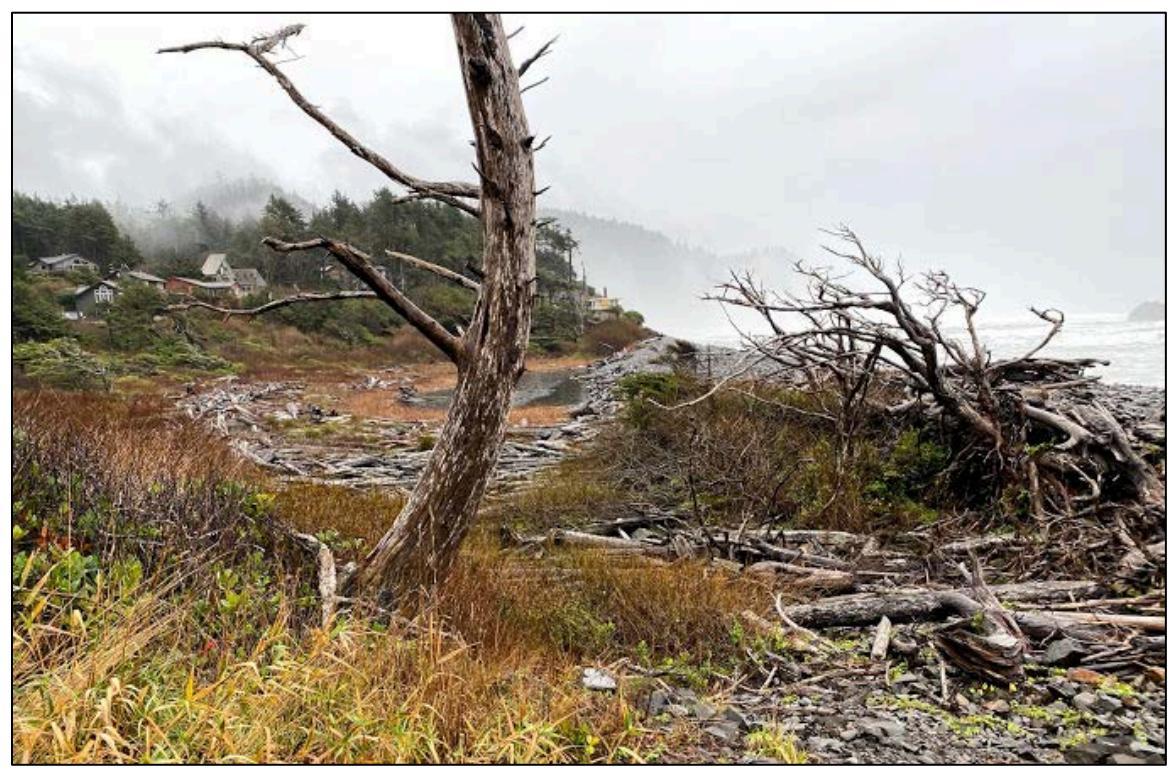
Photo 3: Current site conditions showing a pistol butted tree on the subject property, facing south.

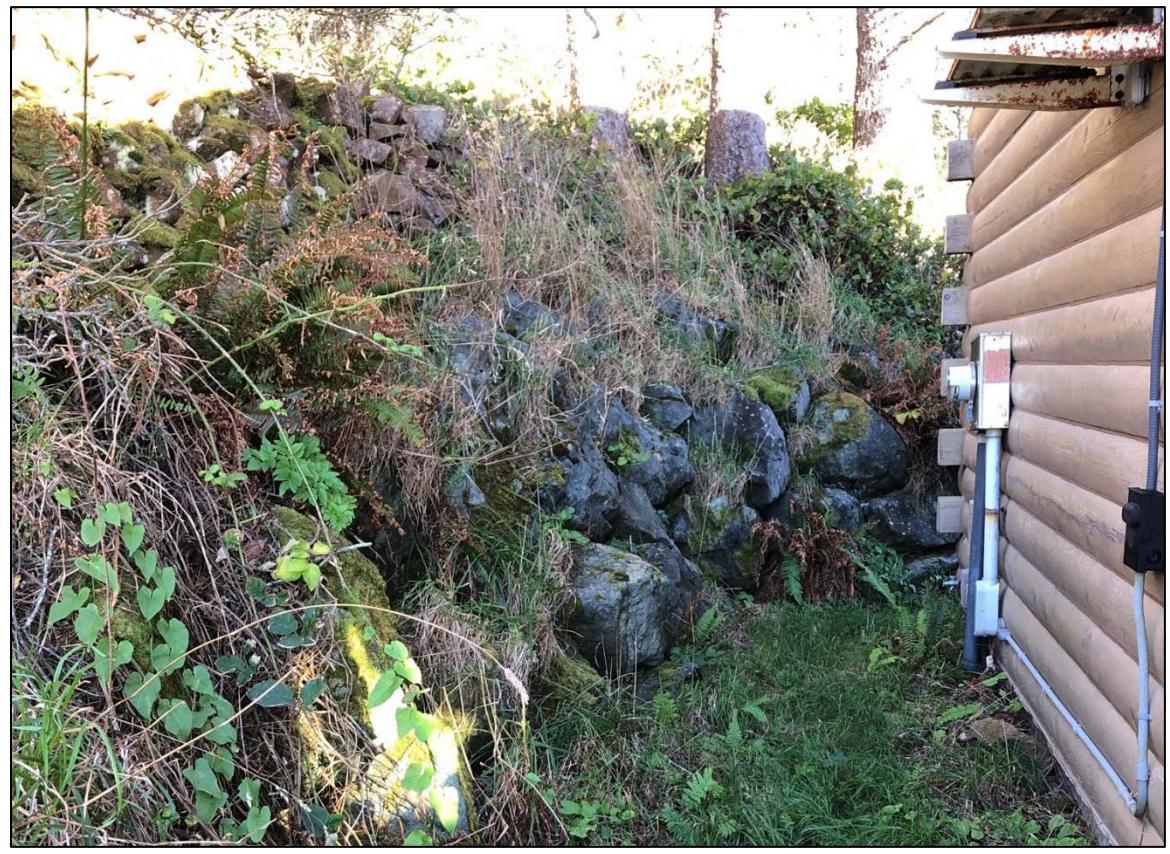
There is an existing rockery retaining wall immediately north of the existing house. While we have not performed a detailed engineering evaluation of its stability, visually it appeared to be in good condition and stable at the time of our site investigation. It should be noted that rockery walls do require periodic maintenance over their life (i.e. restacking of boulders that shift). See Photo 4 below. Based on the layout of the new house, it appears that the eastern portion of the rockery wall will be removed. We assume the exterior wall of the new house will be designed to retain the slope where the rockery wall is removed.

Photo 4: Rockery wall located north of the existing residence, facing east.

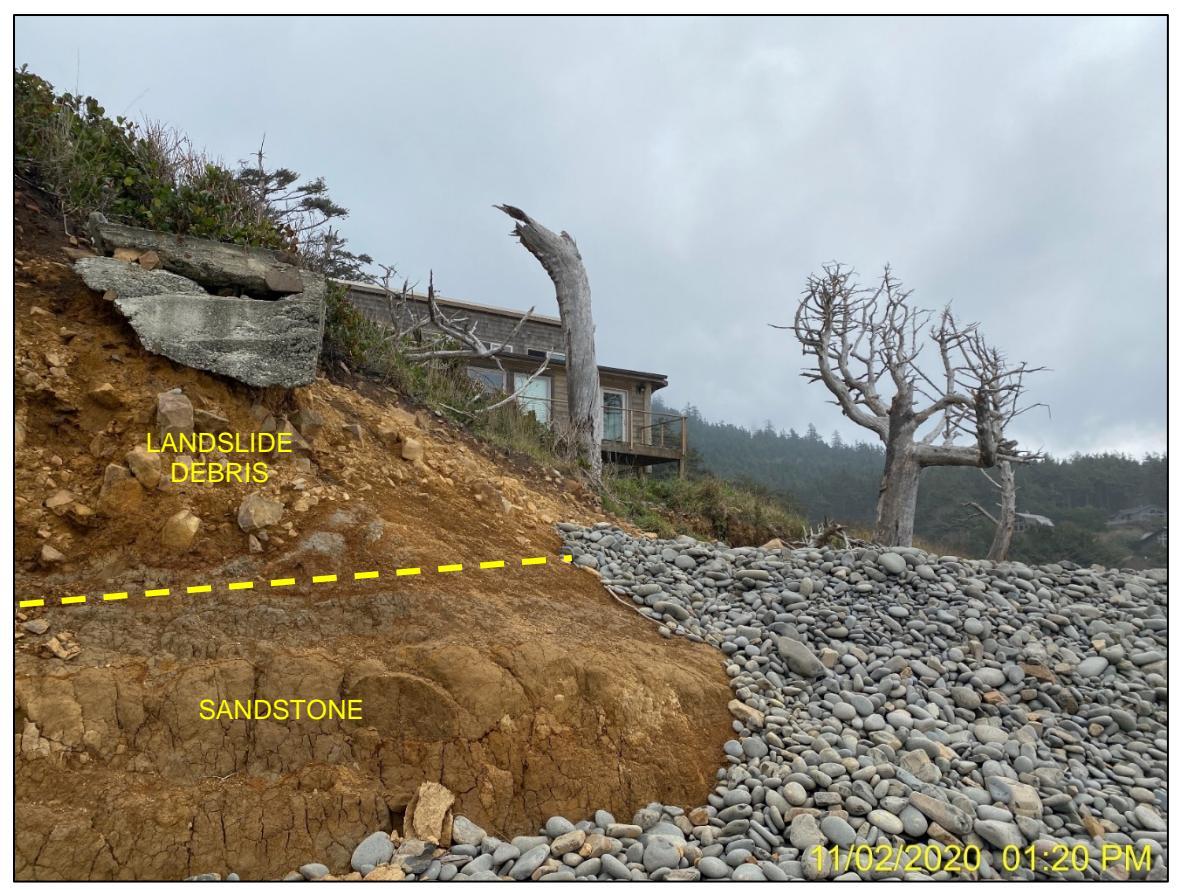
Photo 4: Aggressive erosion observed in exposed landslide deposit overlying intensely weathered sandstone which is mostly protected by the beach cobbles.

As shown in Figure 12 above, the western portion of the site is mapped within a coastal erosion hazard area, ranging from low to high risk of coastal erosion. Much of the exposed bluff along Cove Beach shows signs of active and aggressive coastal erosion. The aggressive, active erosion is mostly limited to the landslide deposit which is generally at or above the elevation of the existing house, while the shoreline at lower elevations appears relatively stable (i.e. more resistive sandstone stratum) and protected by the beach cobbles. Although we do not believe that the

proposed house is at immediate risk from coastal erosion, it could recede back towards the home gradually over time. We envision that it would occur in several sequences that would allow for addressing the issue before it ever reached the house. In addition, the house structure would be protected from erosion if supported on a foundation that bears directly on the more stable sandstone stratum.

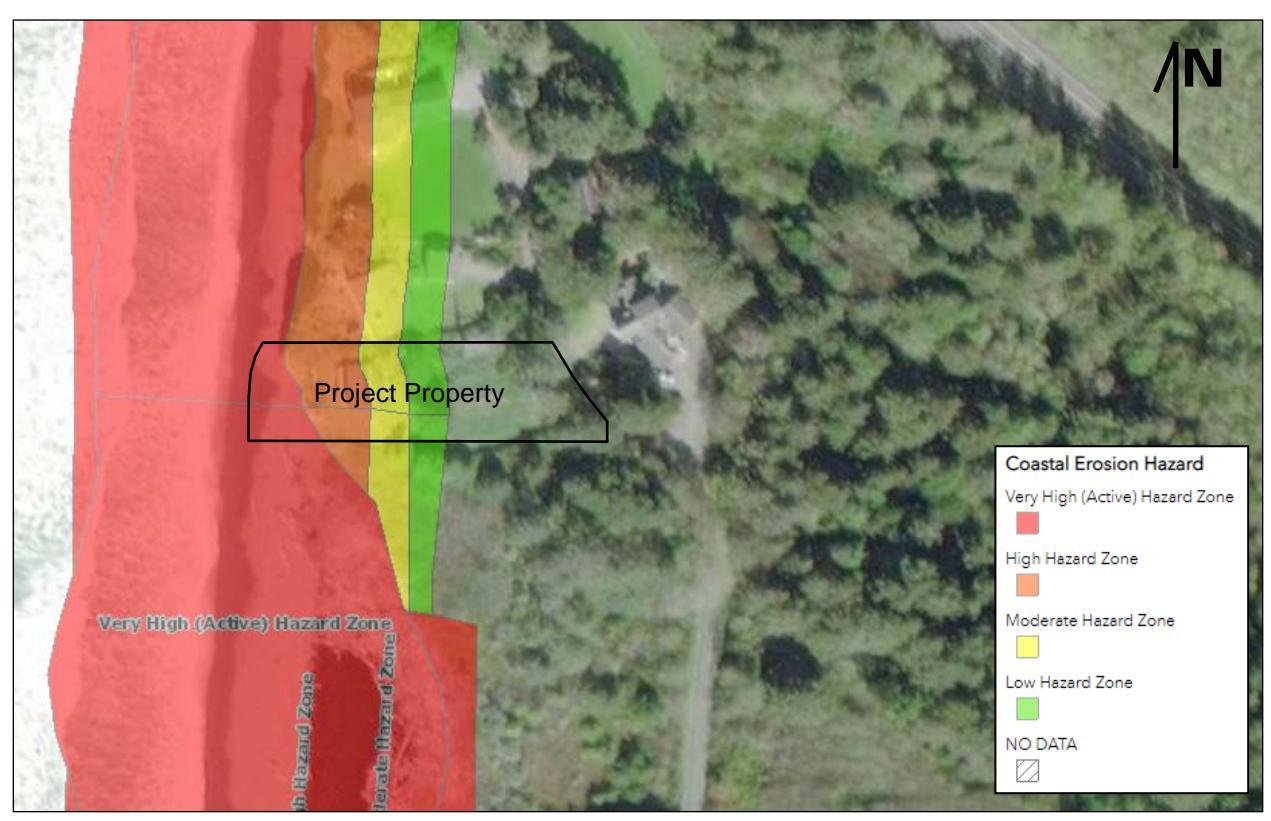
Figure 12: HazVu map showing the coastal erosion hazard zones.
