**SEISMIC RETROFIT
OF UNREINFORCED
MASONRY HERITAGE
CHURCHES IN THE
PHILIPPINES**

Development of a new post-earthquake damage survey procedure and form sheet for masonry churches

Sergio Lagomarsino

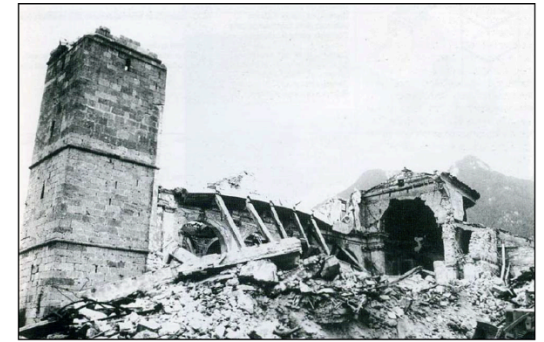
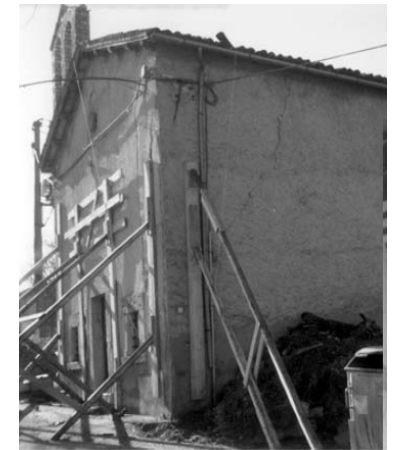
The classification into macroelements and collapse mechanisms has allowed the definition of methods to assess damage and to quickly acquire useful information for handling emergencies (G.U. no. 55, 2006).

S. Stefano di Ceslans Church – Cavazzo (UD)

S. Rocco Church - Sellano (PG)

SS. Faustino e Giovita Church - Botticino Mattina (BS)

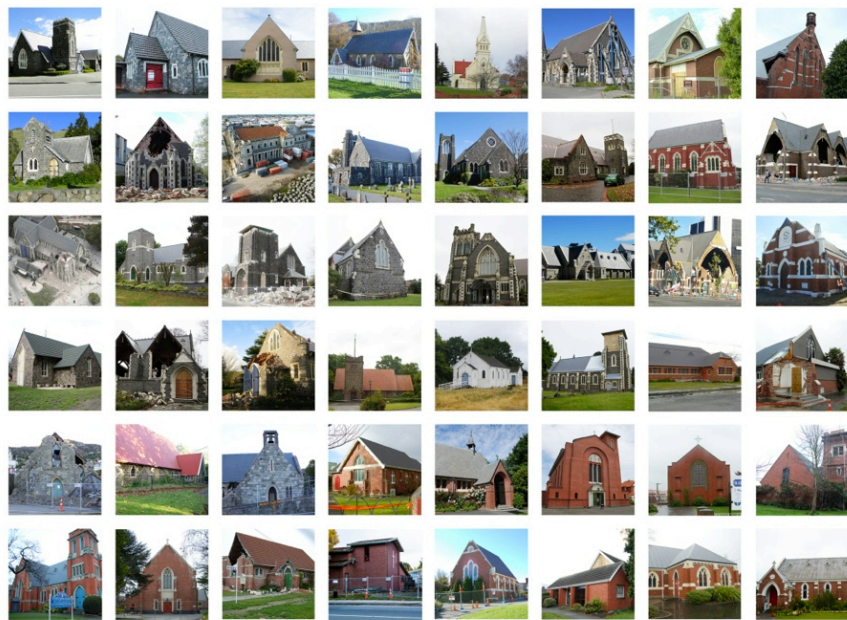
- The macroelements approach is effective having observed the recurrence of collapse mechanisms identified in the form.

Database of the Canterbury churches hit by the 2010-2011 earthquake.

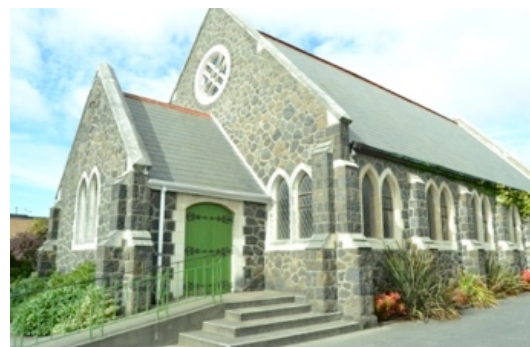
- The resulting damage index usually is not high enough in presence of local peaks of damage;
- Not flexibility and versatility → in considering the presence of macroelements that have been observed in other countries than Italy.

Chapel and narthex for New Zealand churches.

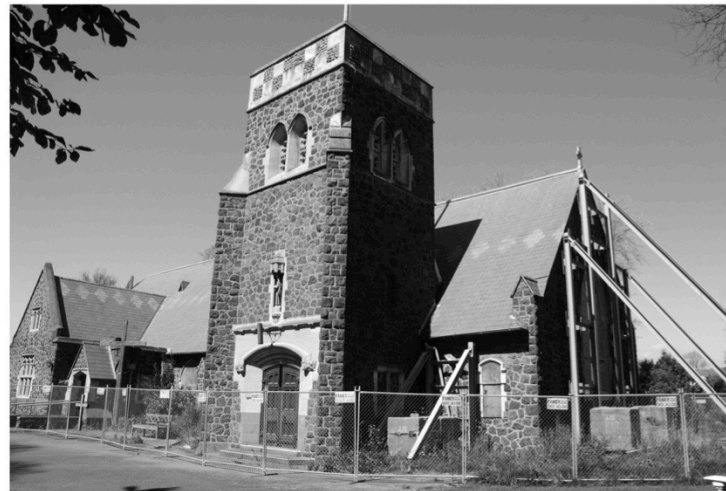
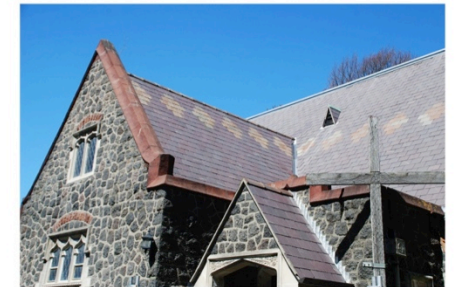
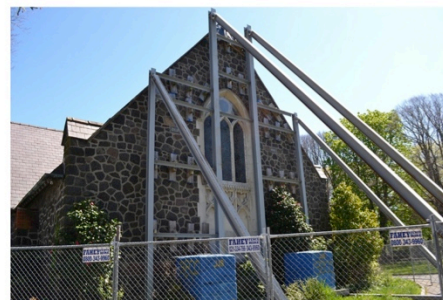
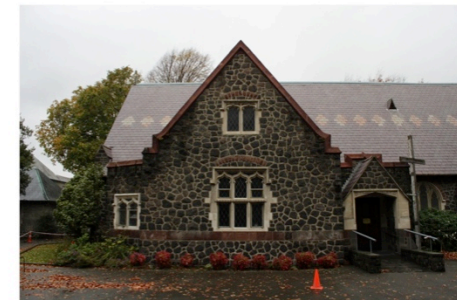
St. Barnaba's Church, Fendalton

Typological analysis and classification of New Zealand churches: these churches show typological and dimensional data different from Italian churches, having generally a more regular plan configuration.

APPLICATION: Damage and vulnerability analysis of urm churches after the Canterbury earthquake sequence 2010-2011

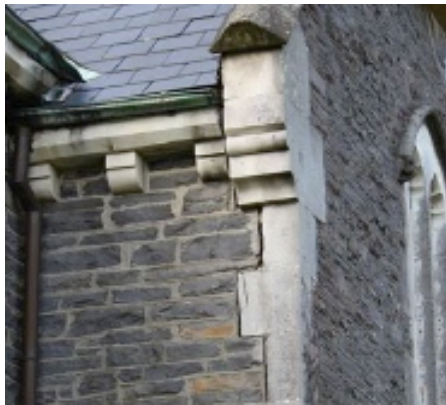
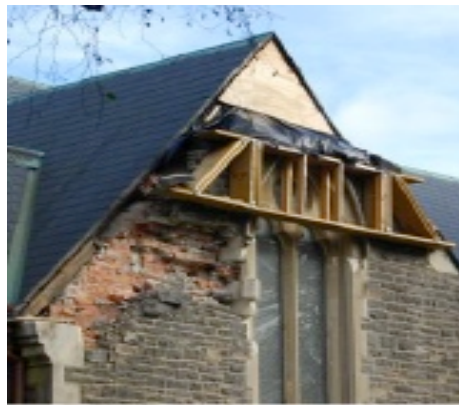
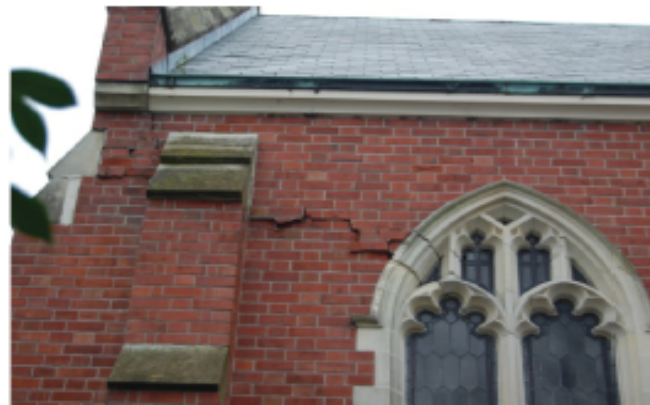
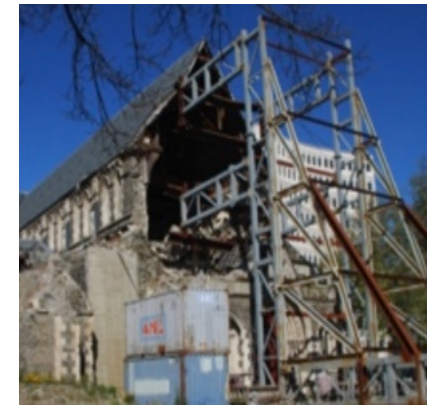
- 3. **The proposed procedure** – New results in terms of transversal index, longitudinal index and peak of damage.

Distinction between transversal and longitudinal index of damage

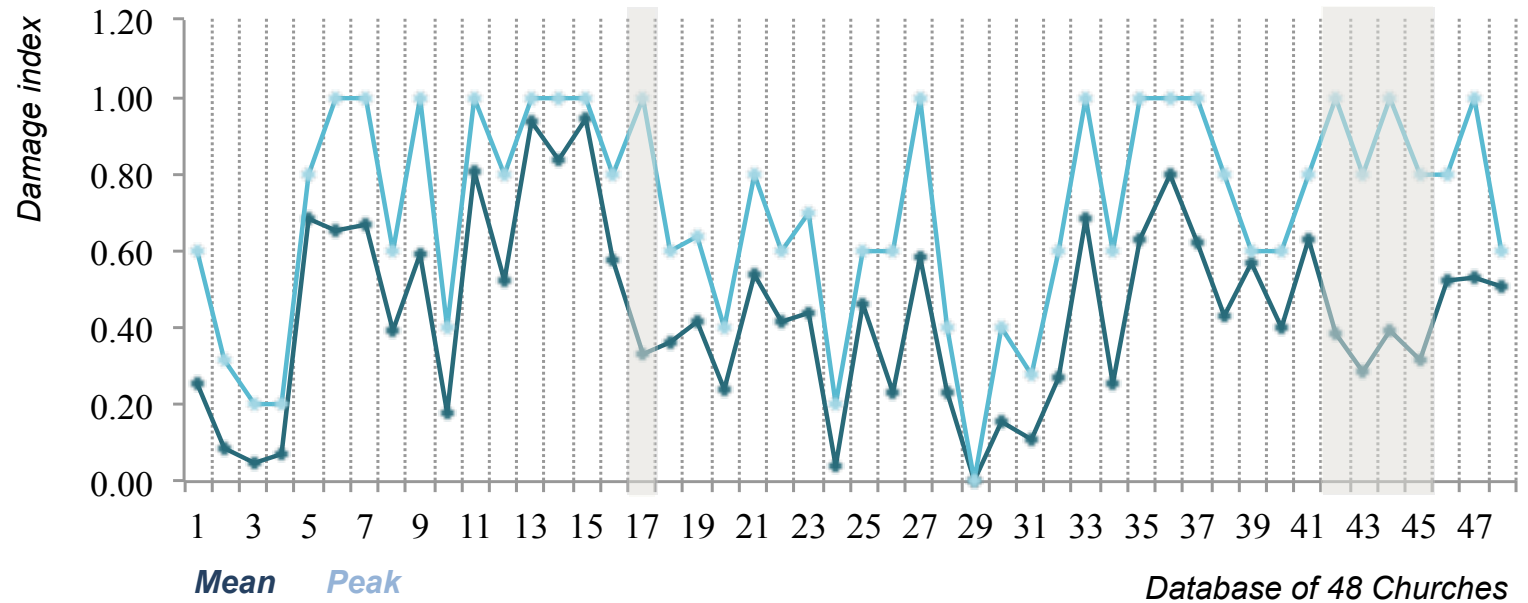
3. **The proposed procedure** – New results in terms of transversal index, longitudinal index and peak of damage.

Distinction between peak of damage and mean damage index.

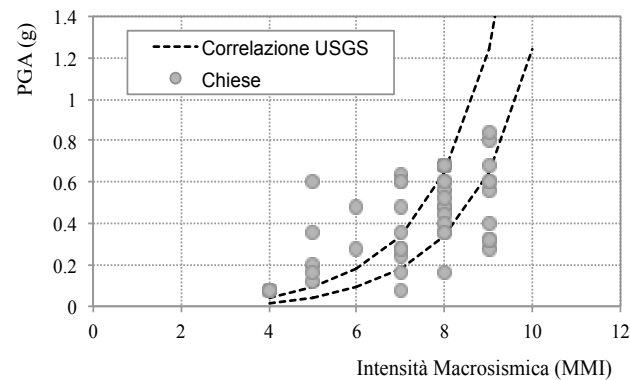
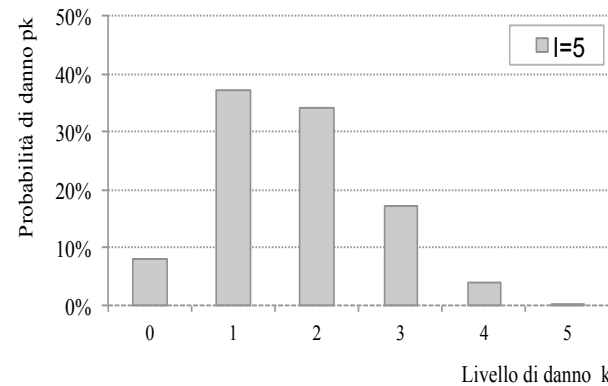
- Damage Probability Matrix (DPM) for different values of macroseismic intensities from 4-9 (MMI), obtained from PGA data taken from shake maps, by using an Intensity-PGA correlation, calibrated in the study area through the data of the US Geological Survey (USGS 2011);

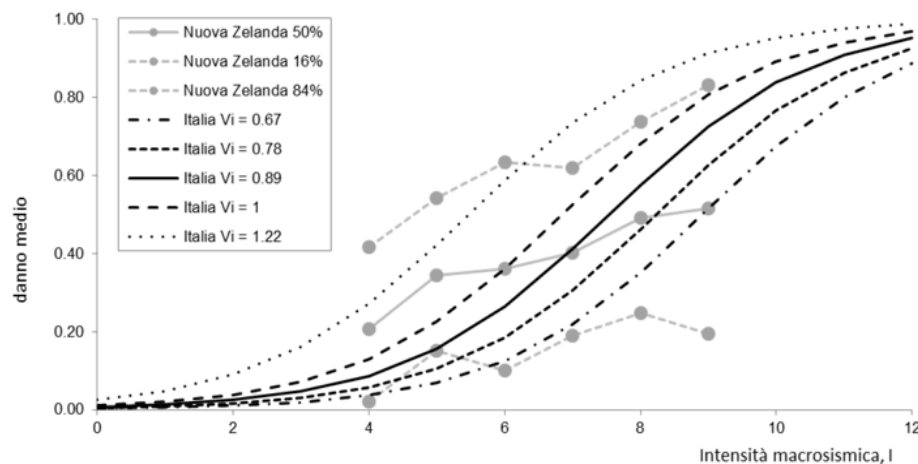
- From the mean damage index and the values corresponding to the 16 and 84 percentiles, the empirical vulnerability curves of New Zealand churches were drawn, which correlate the intensity to damage;

Coherence between New Zealand and Italian curves, both as regards the average values that extremes.
