## **STRUCTURAL RESTORATION OF MASONRY CHURCHES IN PERU**

**Daniel Torrealva**  
**Pontifical Catholic University of Peru**

- **SEISMIC BEHAVIOR OF LATIN AMERICAN CHURCHES**
- **LOCAL SEISMIC CULTURE IN SOUTH AMERICA –  
EVOLUTION OF CONSTRUCTION SYSTEM**
- **METHODOLOGY FOR STRUCTURAL EVALUATION**
- **THE CATHEDRAL OF MOQUEGUA – A COMPATIBLE RING  
BEAM IN A THREE LEAF STONE CHURCH**
- **THE CHURCH OF SECHURA – USING POLYMER GRID TO  
ENHANCE CONTINUITY IN A BRICK MASONRY CHURCH**

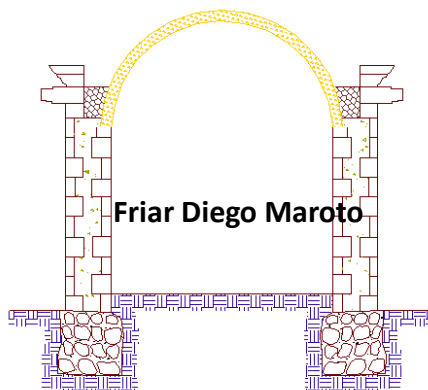
Three consecutive earthquakes in 1687, 1688 and 1690 proved that the use of lighter materials was necessary to avoid the collapse of the vaults and cupolas.

Daños muy leves y fácilmente reparables

Daño severo frente a estos sismos

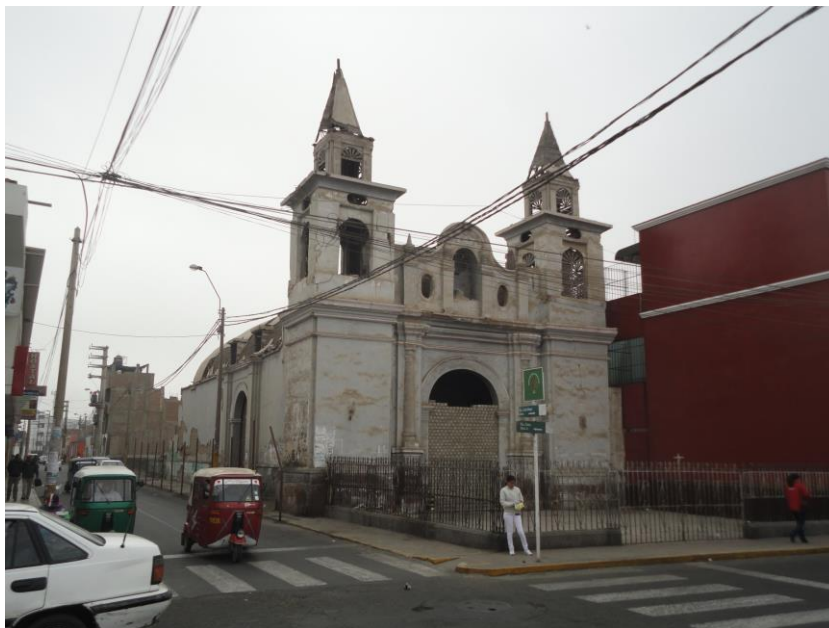
**SAN JOSE CHURCH, ICA**

**TIMBER TOWER WITH  
CANE AND MUD-LIME  
PASTERL**

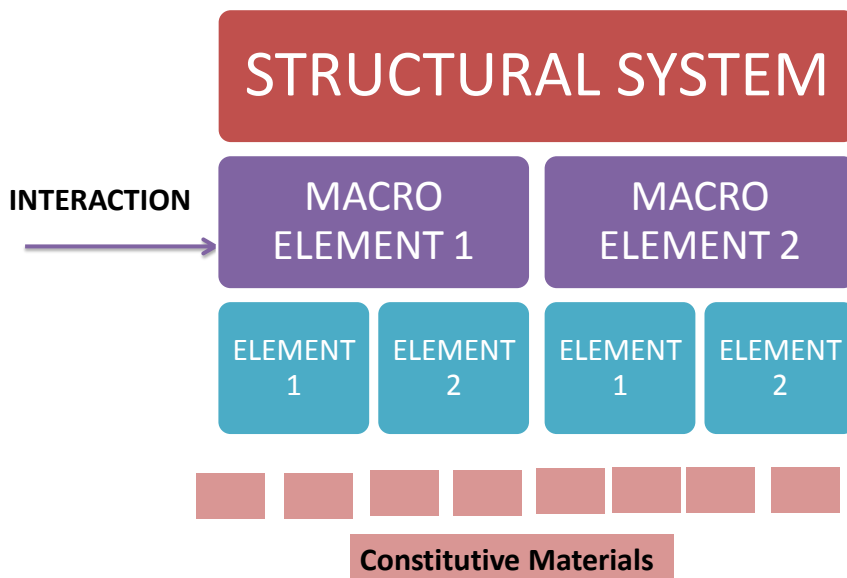
Refers to the ORIGINAL/ACTUAL SYSTEM and how it has performed over the years. Evaluation is qualitative and quantitative.

Qualitative evaluation includes the study of the history of the building.

The quantitative evaluation includes numerical models of the actual structure with actual and future loads.

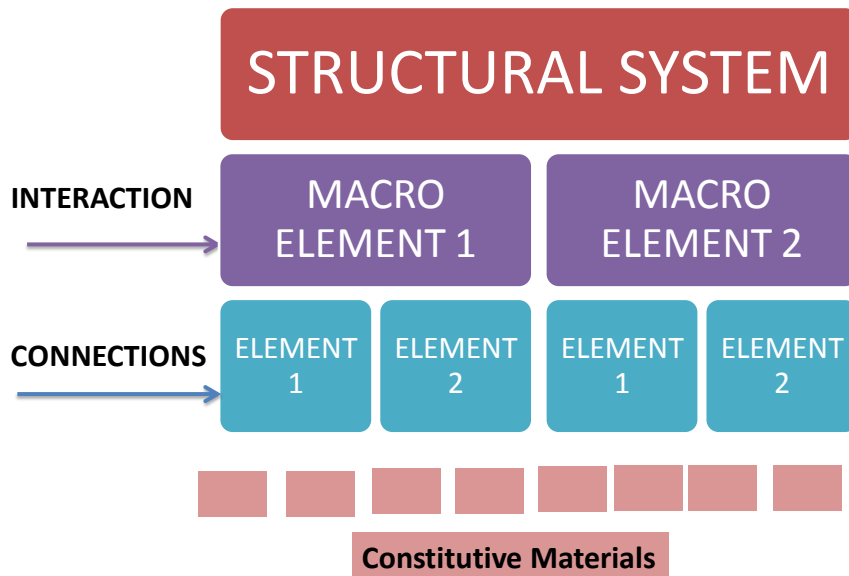
May be positive or negative

Quantitative evaluation is by means of numerical models.

Qualitative evaluation is by inspection and by studying past performance.

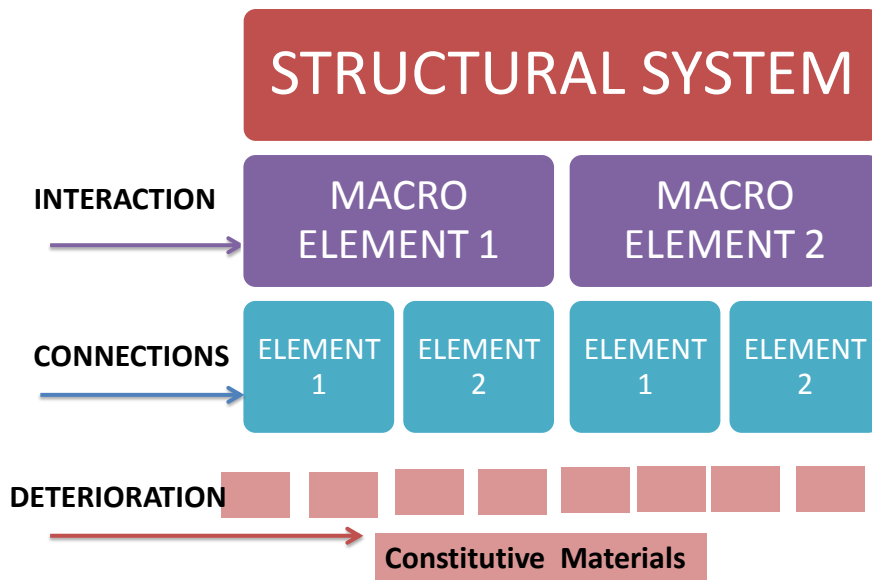
Is directly related with the quality of original materials and how were they built.

Is evaluated qualitatively by inspection

For masonry: Regularity of joints, etc

In timber: the joints and wood carpentry are evaluated.

Quantitative evaluation include in situ testing.
