SEISMIC RETROFIT
OF UNREINFORCED
MASONRY HERITAGE
CHURCHES IN THE
PHILIPPINES

Analysis Methods for Unreinforced Heritage Masonry

prof. eng. Claudio Modena

University of Padova
Department of Civil, Architectural and Environmental Engineering
Padova, Italy

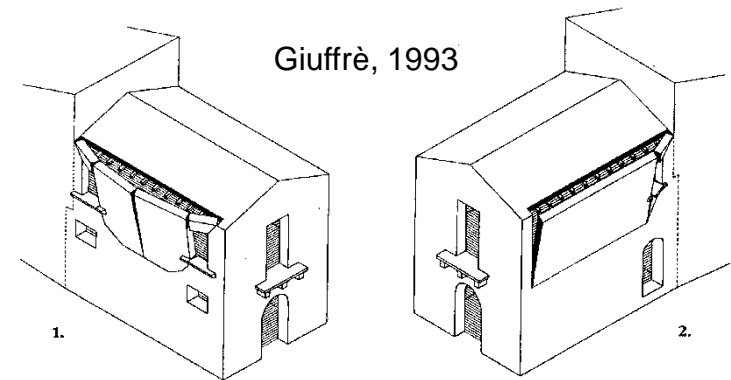
Salò-Garda lake
earthquake (24/11/2004)

The **effective response of an existing masonry building to horizontal actions** can be hardly defined, in the majority of cases, by just considering the global behaviour of the structure

Main causes:

- Lack of connection between walls
- Lack of connection between walls and floors
- Low in plane stiffness of floors
- Masonry composition
- Existing deterioration/damages

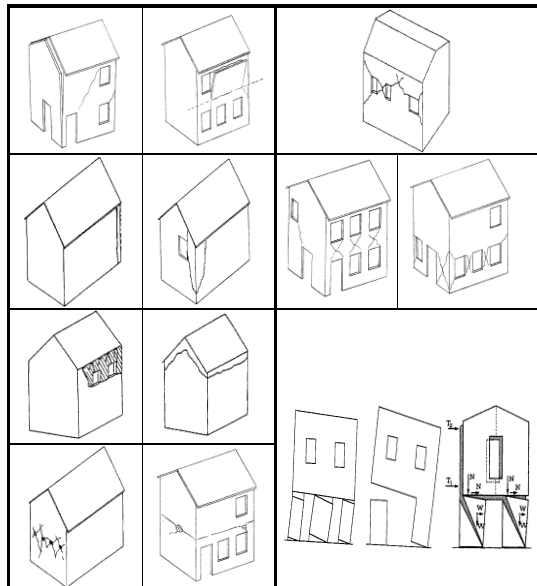
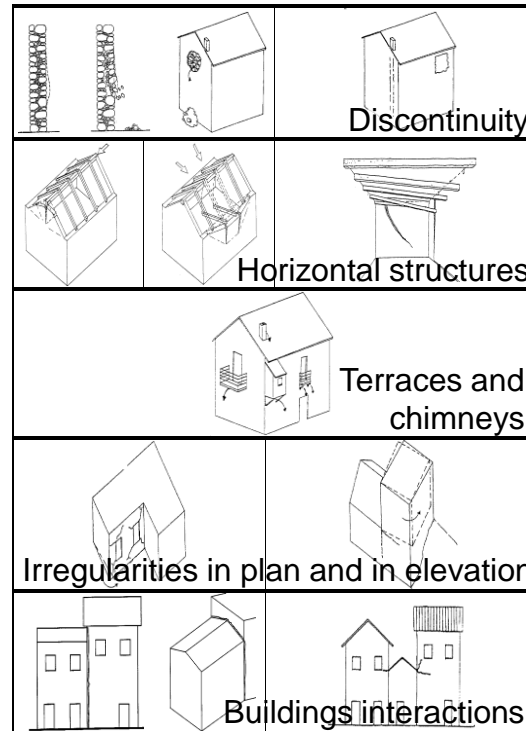
External walls

Out of plane

In plane

Analytical approach procedures considering the modelling of the elementary failure mechanisms with the limit analysis of **local rigid body kinematic mechanisms of structural macroelements** (portions of the buildings with homogeneous constructive characteristics and structural behaviour) found a better match with the observed damage

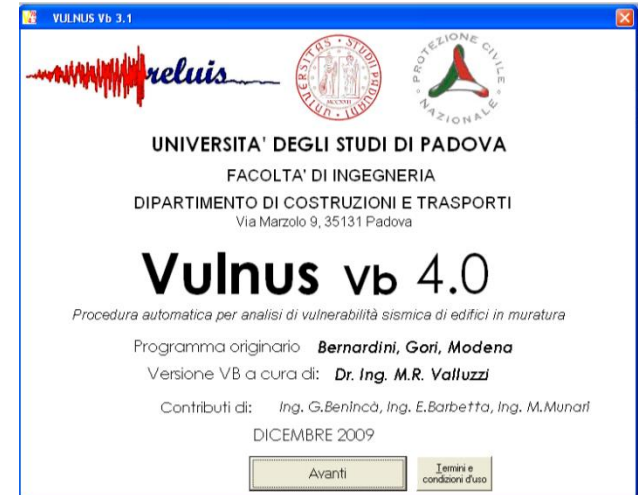
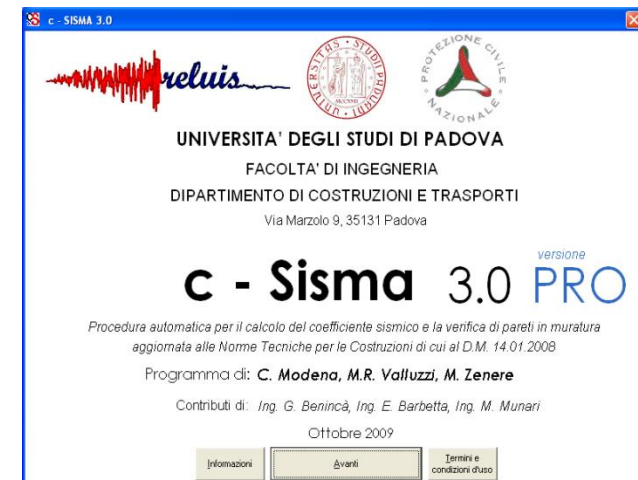
Automatic procedures for the systematic assessment of the existing masonry buildings vulnerability developed by the University of Padova:

Vulnus: global seismic vulnerability analysis (vulnerability assessment and damage probability) of isolated or clustered masonry buildings through different in plane and out of plane mechanisms combinations and qualitative informations.

c-Sisma: local analysis of vulnerability through the application of single kinematic models applied to the more significant macroelements. It also performs the safety analysis according to the Italian regulation

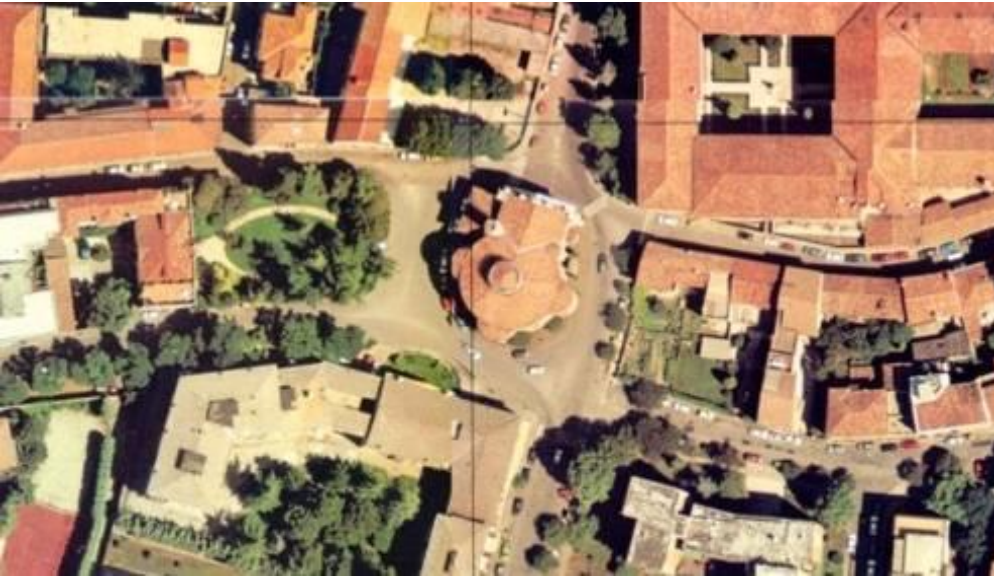
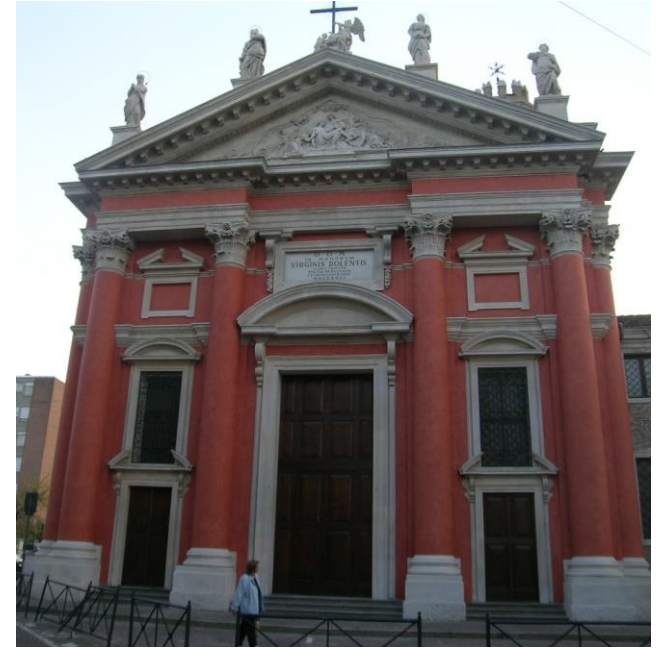
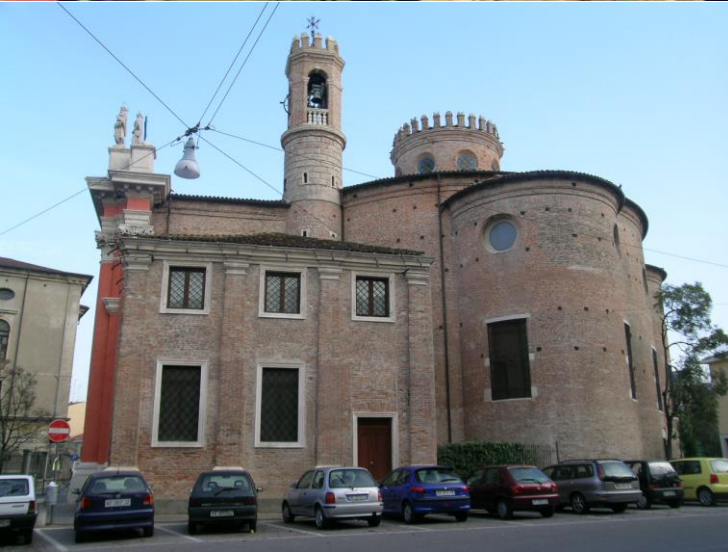
THE CHURCH OF 'MADONNA DEL PIANTO' (Padova)

XVIII Century church by Frigimelica
with central plan and some irregularities
due to following resets done in the first
half of the XX Century

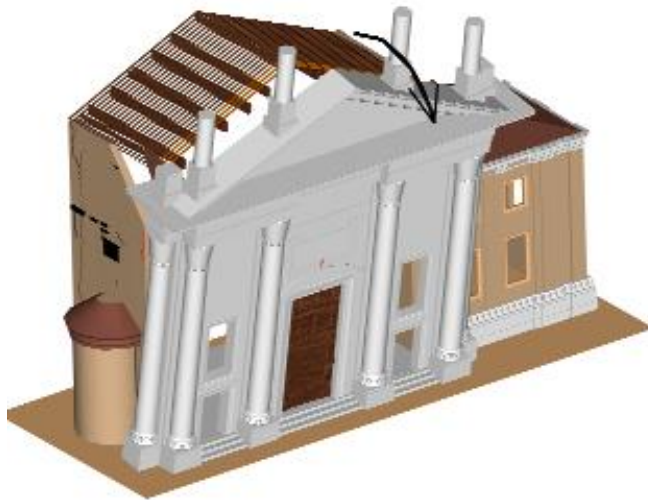
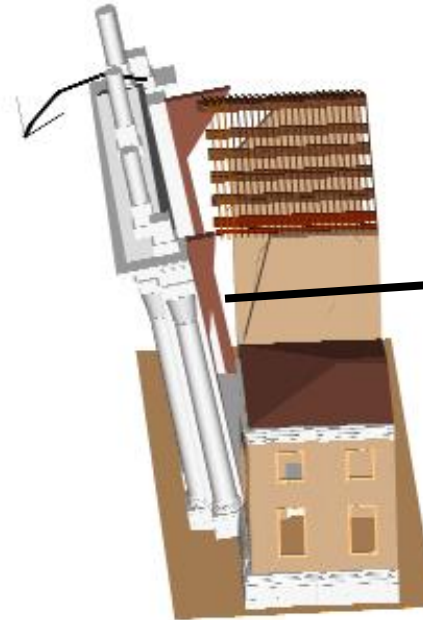
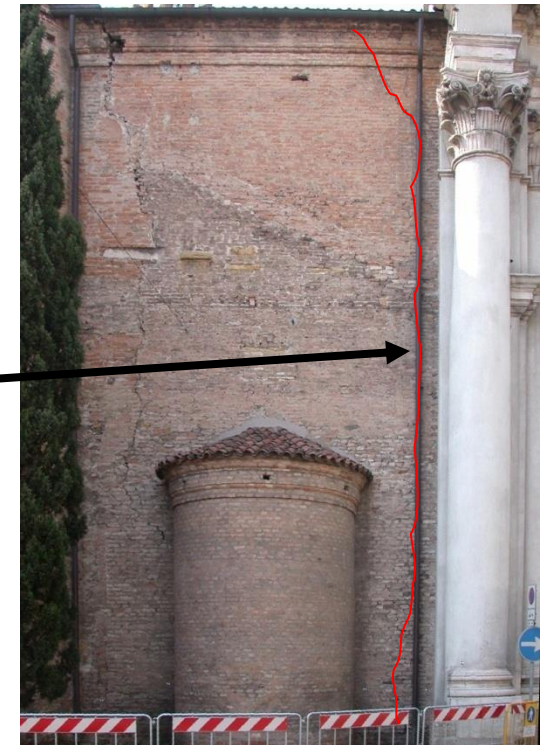
Possible and probable collapse mechanisms for the **façade**

From the analyses carried out, it was pointed out that the most vulnerable element is the **façade**, in case of **overturning with partial involvement of the lateral walls**.

This is also a possible mechanism, due to the presence of corresponding **crack pattern** close by the façade.

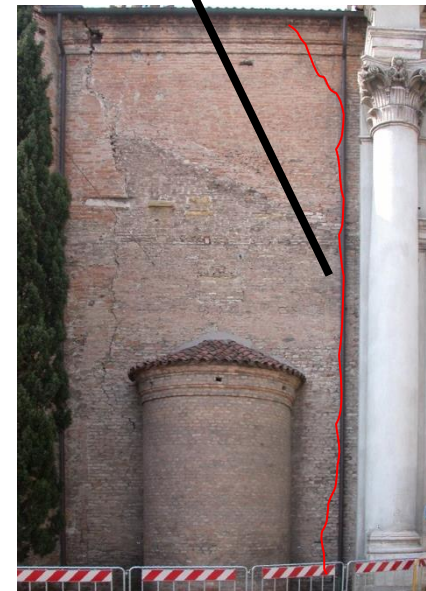
From the analyses carried out, it was pointed out that the most vulnerable element is the **façade**, in case of **overturning with partial involvement of the lateral walls**.

This is also a possible mechanism, due to the presence of corresponding **crack pattern** close by the façade.

$$M_{st} = 52230 \text{ daN m}$$

$$M_{inst} = 3984900 \text{ daN m}$$

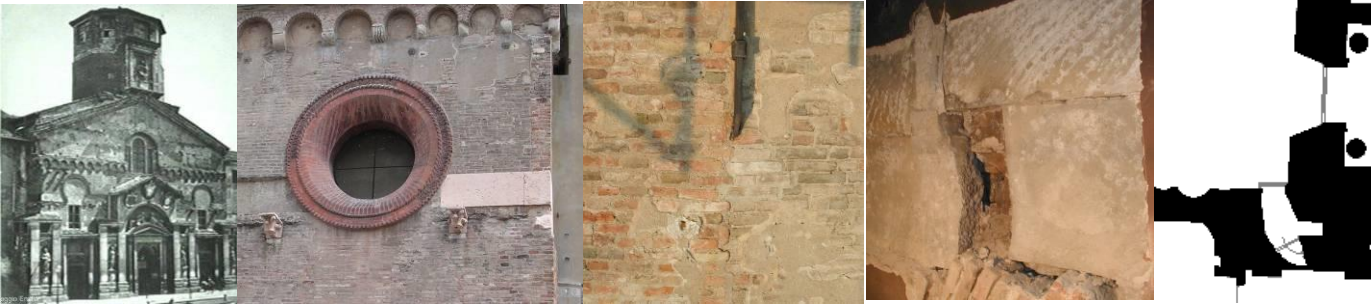
The structures of the Cathedral are generally composed by **clay brickwork masonry**. The diversified constructive phases comported the use of different materials, and some structural elements or parts (e.g. Romanesque pillars, lower façade veneers) are made of **stone**.

The **façade** presents towards the church square a rough and **heterogeneous external aspect**

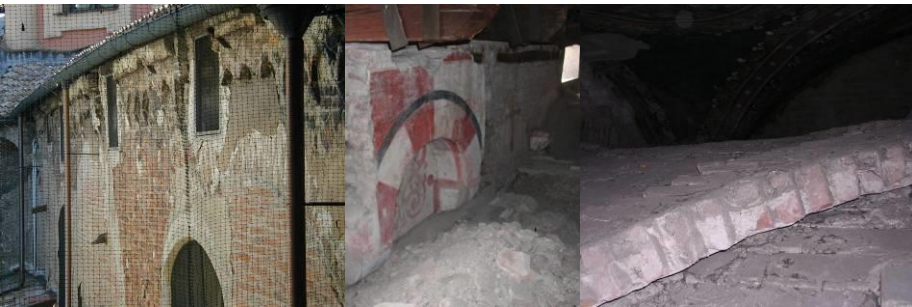
The masonry walls of the **clerestory** present a strongly **composite aspect**, being subject to past interventions comporting remarkable size windows closing

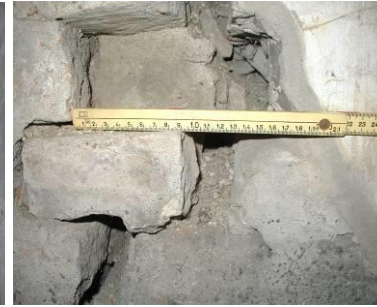
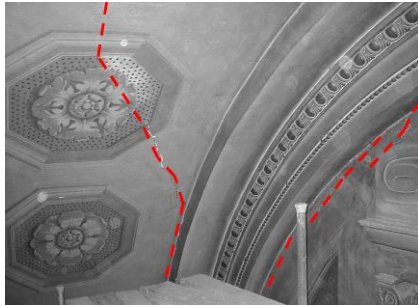
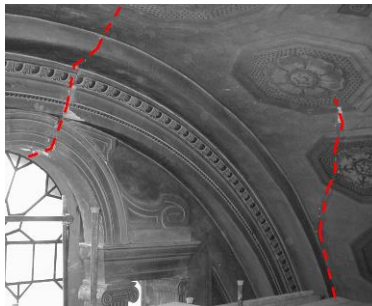
Façade area

The **present damage pattern** shown by the Cathedral is highly indicative of the structural response of the building, and denounces the areas manifesting higher seismic vulnerability

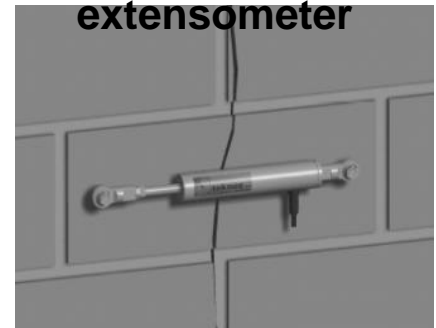
Multi-base extensometer

Electrical extensometer

- Static monitoring:**
- ❑ Relative displacements between the vertical structures;
 - ❑ eventual variations in the openings on the main cracks;
 - ❑ settlements of the foundation soils below the crypt's two main pillars;
 - ❑ air temperature control.

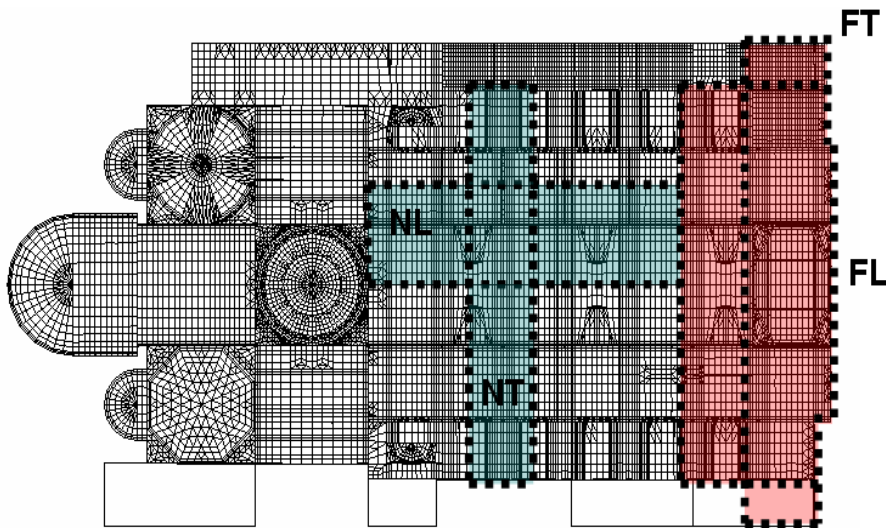
Attention was paid to the **structural unitariness** of the selected parts, in a way to have the possibility to separate them still not losing significance the analysis: the Cathedral's parts considered in the sub-models were selected on the basis of geometrical, historical-constructive and damage pattern preventive evaluations.

Two models for the **façade** longitudinal and transversal response (FL and FT) and two for the **nave** (NL and NT, longitudinal and transversal response) were considered.

MODEL	FL	FT	NL	NT
MASS DENSITY - STRUCTURAL (kg/m ³)	1800	1800	1800	1800
MASS DENSITY – VAULTS' FILLING (kg/m ³)	1500	1500	1500	1500
YOUNG MODULUS (MPa)	2100	2100	2100	2100
POISSON'S COEFF.	0.2	0.2	0.2	0.2
TENSILE STRENGTH (MPa)	0.10	0.10	0.10	0.10
CRACK BANDWIDTH (m)	-	-	0,5	- 0,5
Gf' (J/m ²)			100	100
COMPR. STRENGTH (MPa)	INF.	INF.	INF.	INF.
NUMBER OF NODES	38959	28282	12667	9767
NUMBER OF ELEMENTS	14683	10500	4806	3704

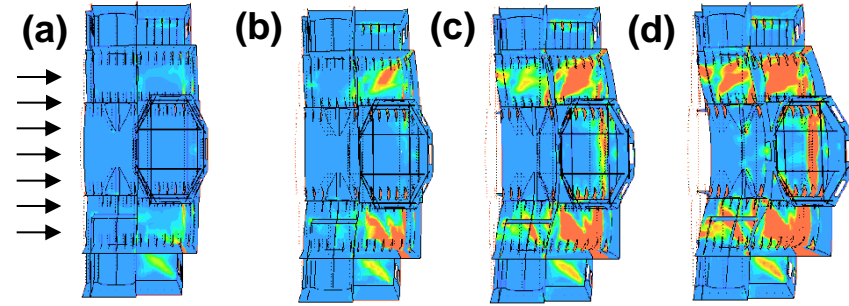
FACADE OUT OF PLANE

Progression of the damage mechanism; deformation is magnified (x100)

The analysis stopped at a value of horizontal acceleration equal to 0.26 g. Defining the parameter **k (structural stiffness)** as:

the final k value, evaluated on the last two load steps, was approximately equal to 13% of the initial k, evaluated on the control point at the top of the dome lantern.

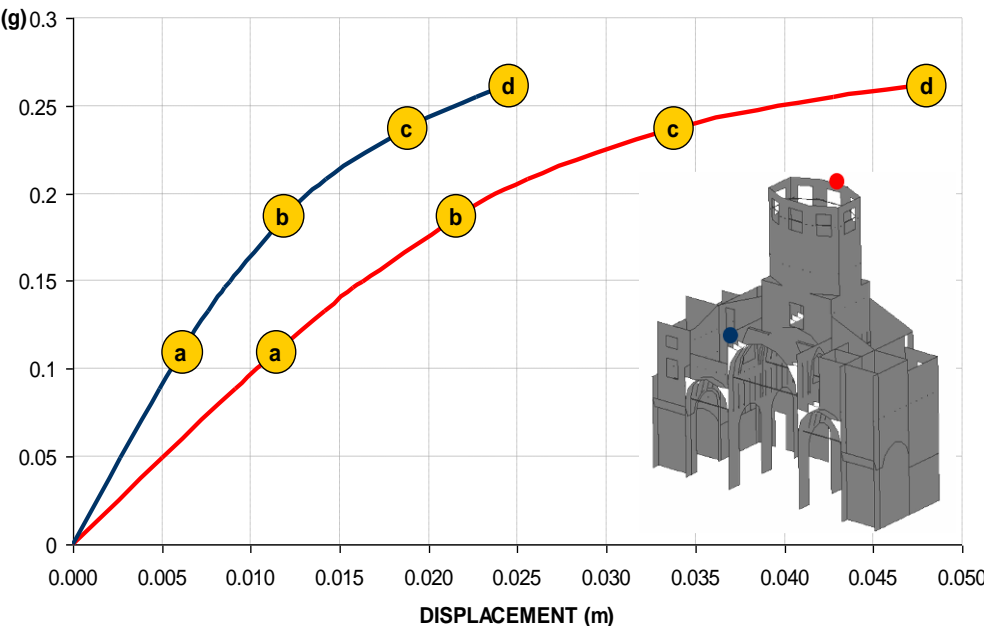
Model FL

The **damage pattern predicted** by the analysis finds a remarkable correspondence with the **effective damage** denoted by the structures, in several positions:

Cracks opening - last step of the analysis (0.26 g)

Principal minimum stresses - last step of the analysis (0.26 g)

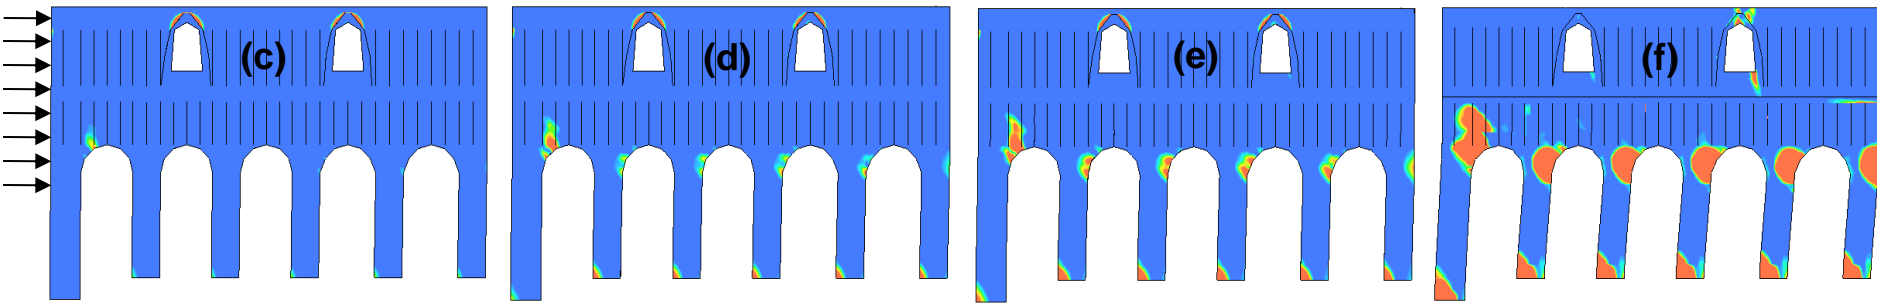
Model NL

LONGITUDINAL RESPONSE - NAVE

The failure mode, following the application of growing horizontal loads, is determined by the overturning of the pillars

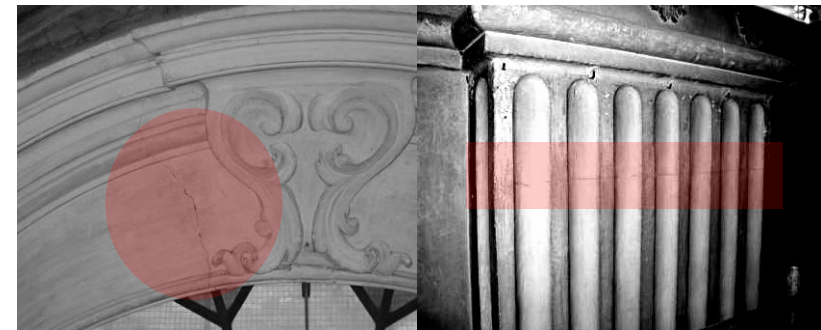
Model FT

Damage identification – model prediction
experimental verification

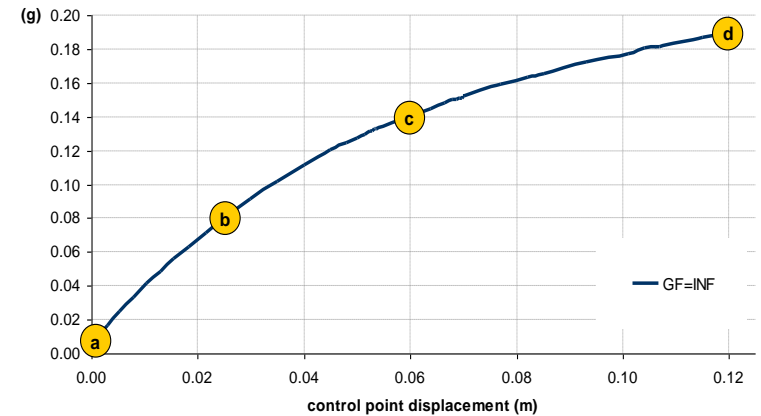
Model NT

TRANSVERSE RESPONSE - NAVE

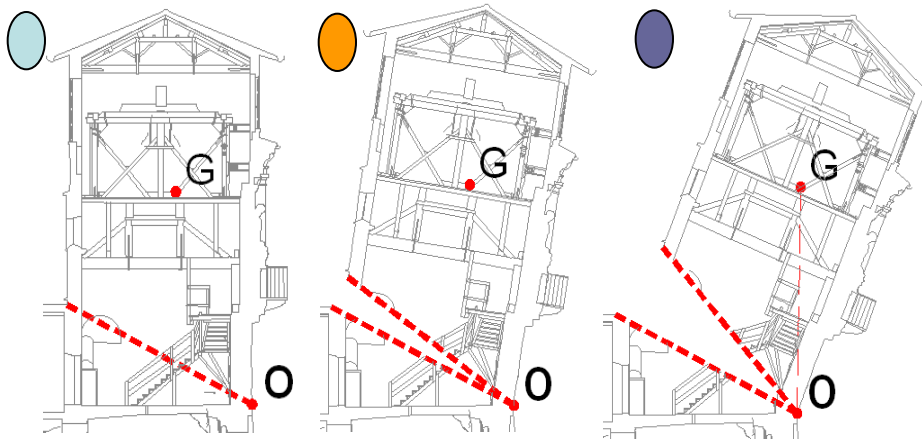
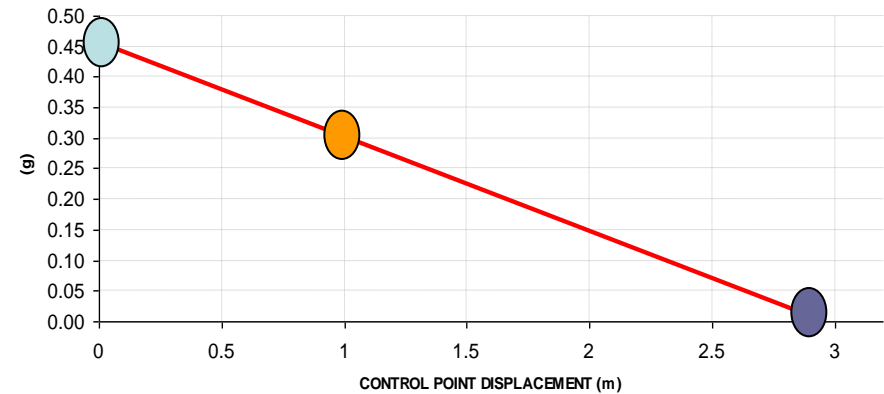
The **possible failures** implemented were selected on the basis of the damage pattern, of the typical seismic vulnerabilities, of the historical analysis and of the comparative evaluation of the numerical simulation results.

Several failure scenarios were evaluated, and corresponding safety factors ($\alpha_0 = c$) and capacity curves were defined. The different α_0 values of the considered mechanisms give then an indication about the range of horizontal acceleration values that possibly will bring the onset of the envisaged failure scenarios.

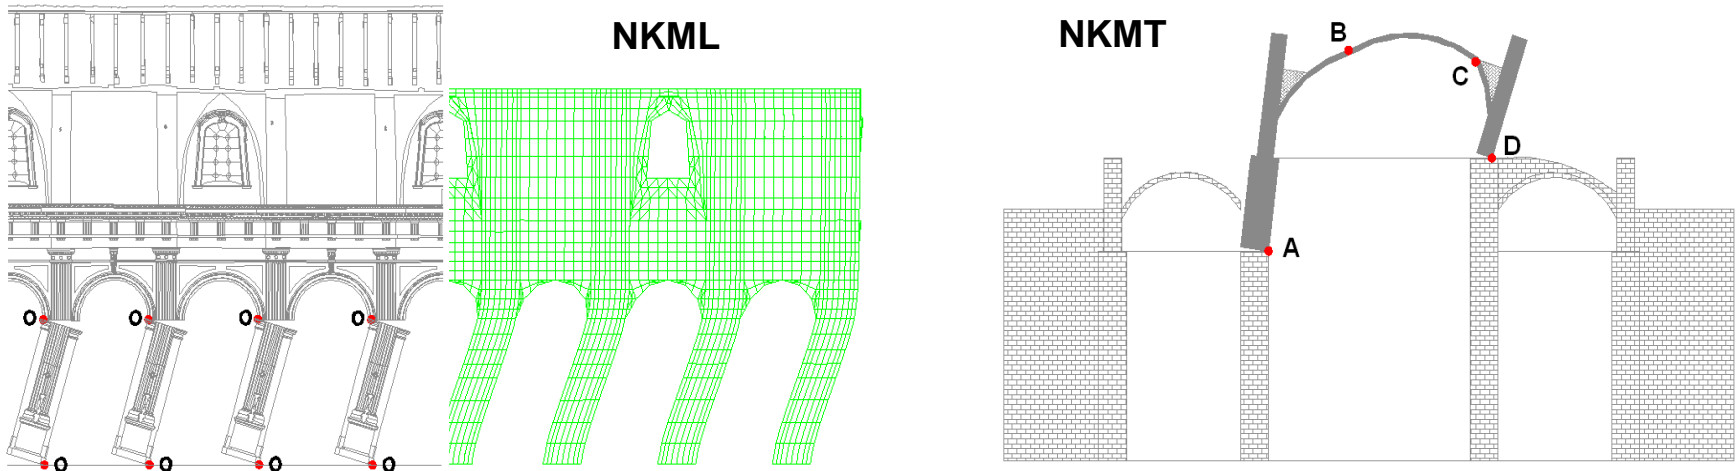
Nave longitudinal and transversal failure mechanisms

a 0 values, nave mechanisms

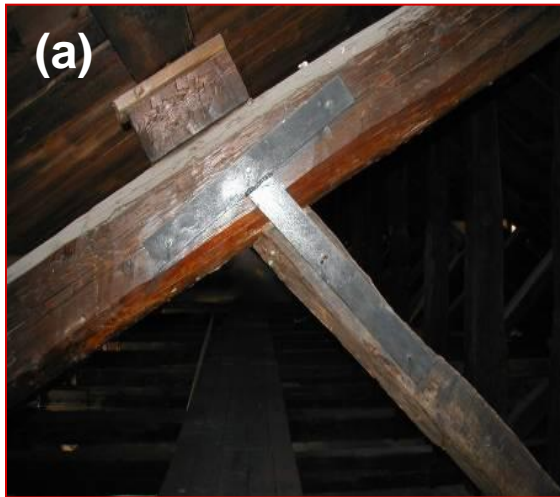
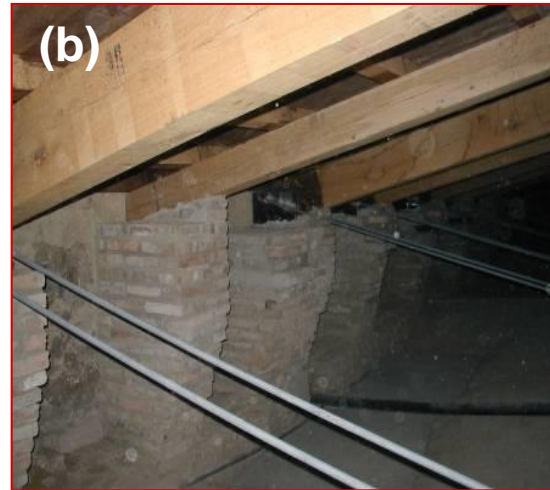
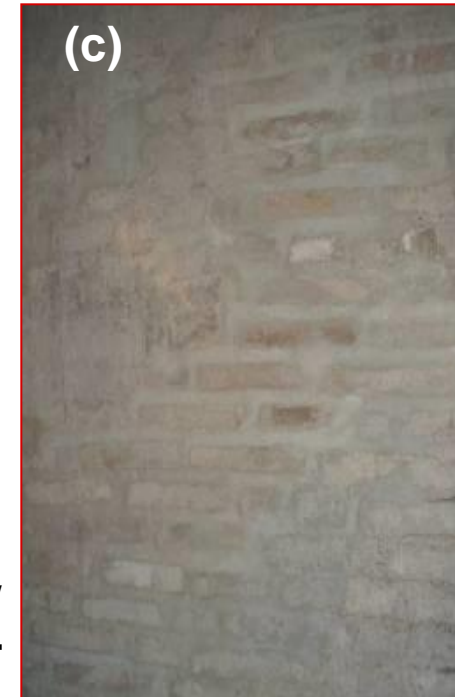
Roof wooden trusses: (a) metallic “T” shaped connection elements; (b) substitution of the old wooden trusses of the left nave with new elements, with stainless steel tie beams. Roof level: (c) a “scuci-cuci” intervention.

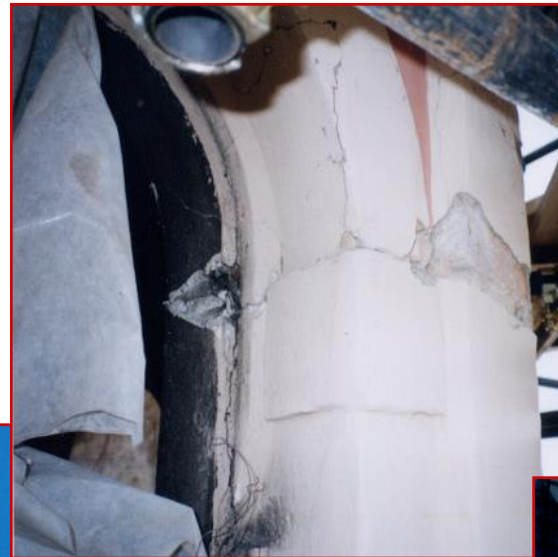
Lateral apses

- ☐ walls of the lateral apses;
- ☐ lantern at the top of the dome;
- ☐ vaults of the central apse;
- ☐ vaults of the main nave;
- ☐ façade area.

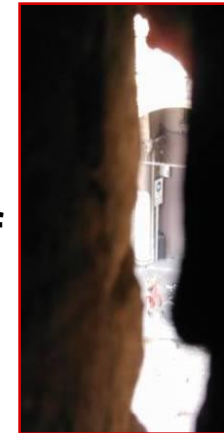
Façade

Results obtained indicate a considerable α_0 value increase; the stainless steel tie beams³ positioning is particularly effective for the overturning mechanism of the façade corner part, presenting high seismic vulnerability in its previous state (not verified according to the national seismic standards).

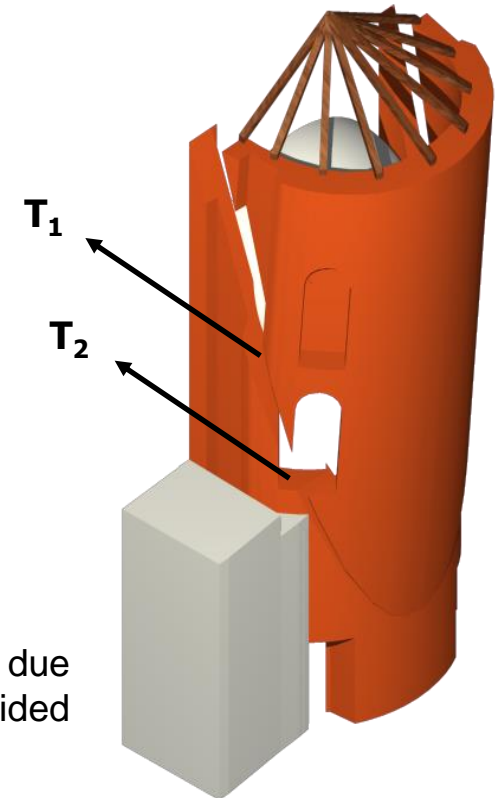
Stabilizing effect due
to the newly provided
seismic devices

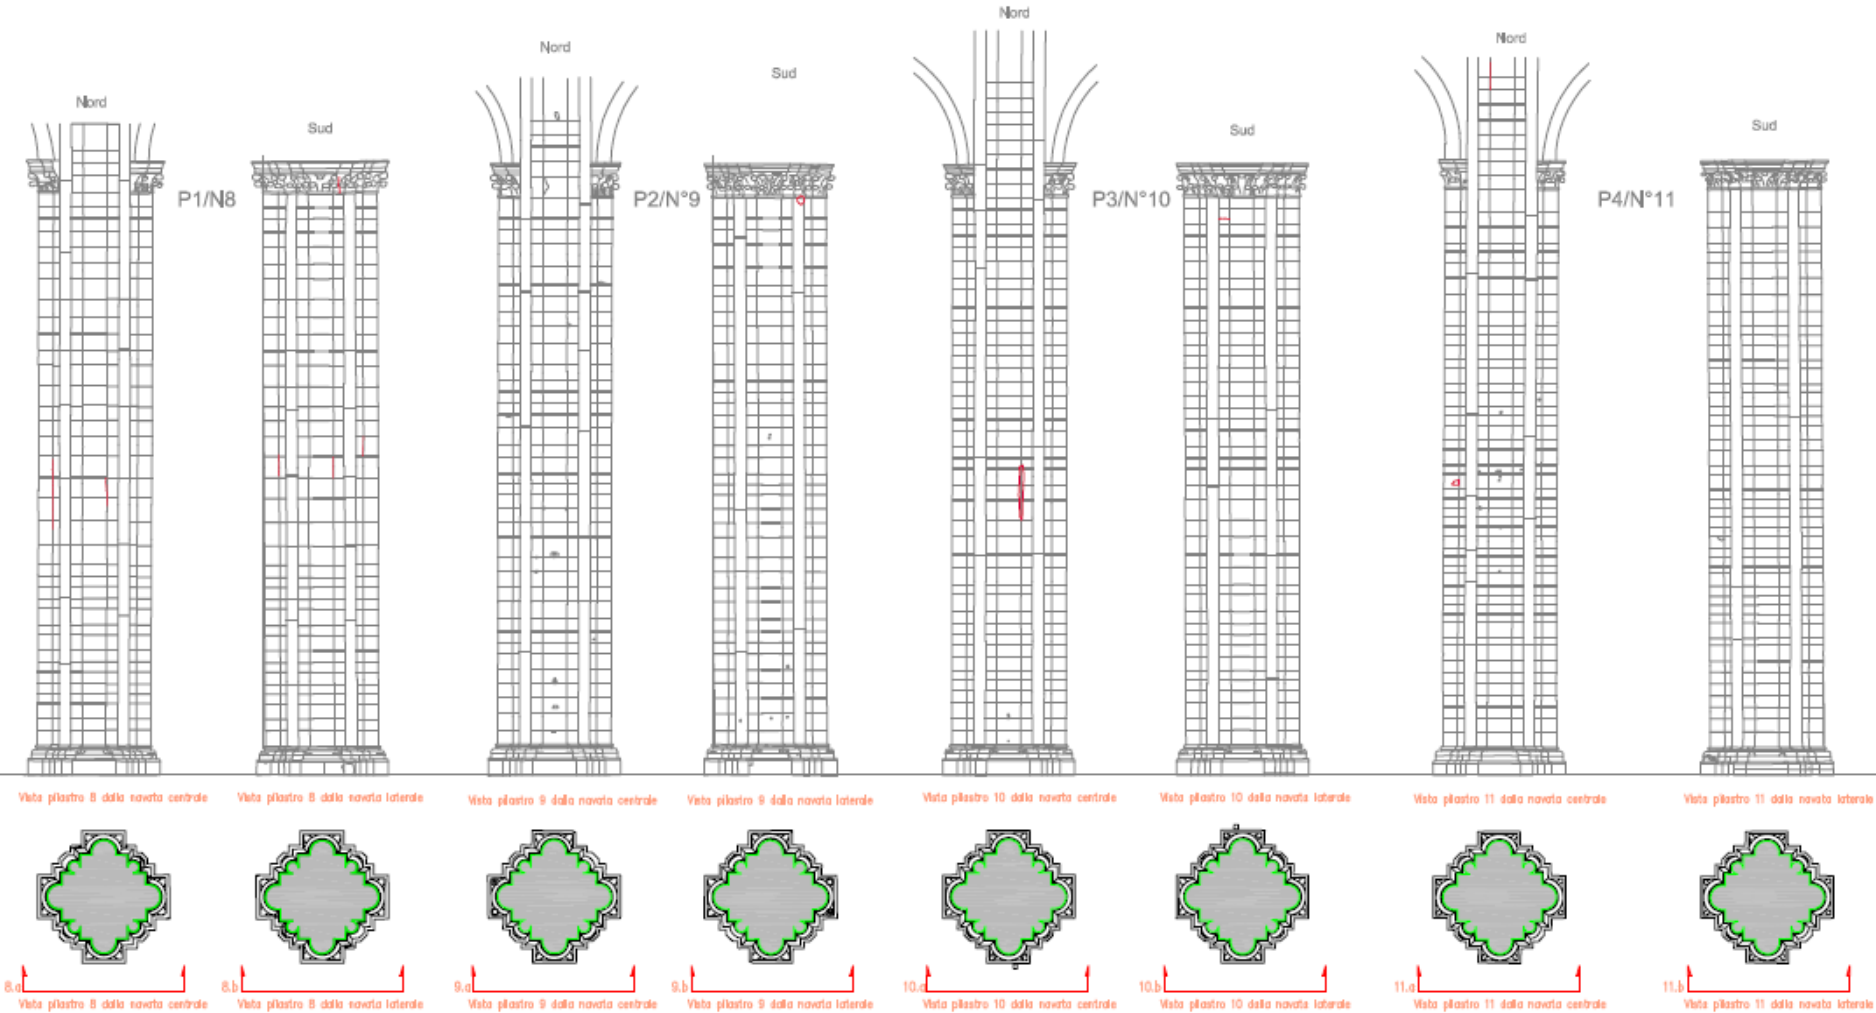
PILLARS CRACK SURVEY

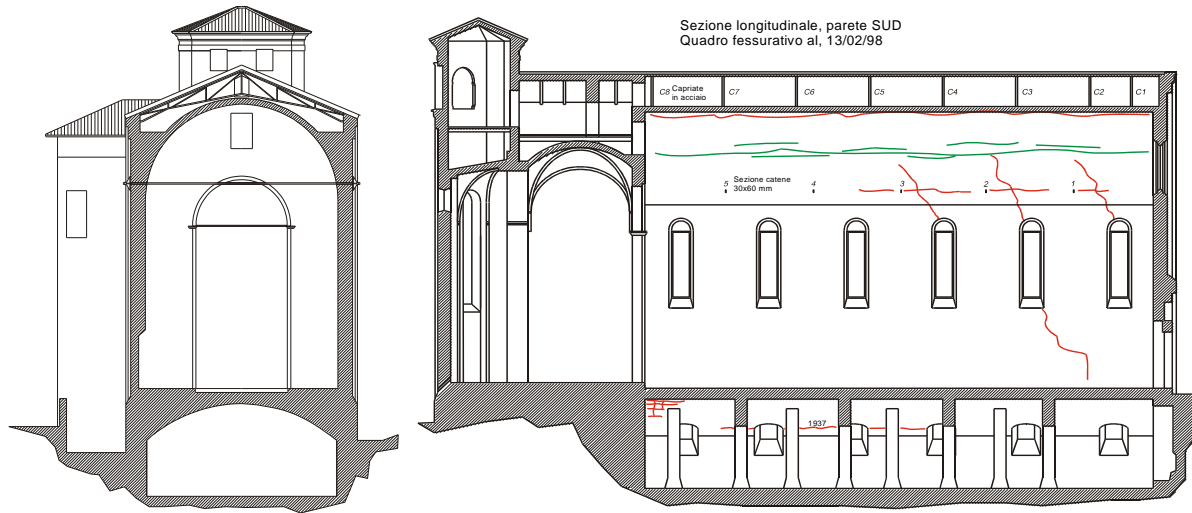
CRACK PATTERN SURVEY

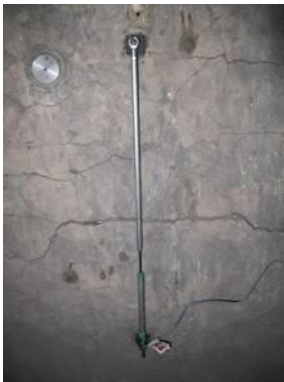
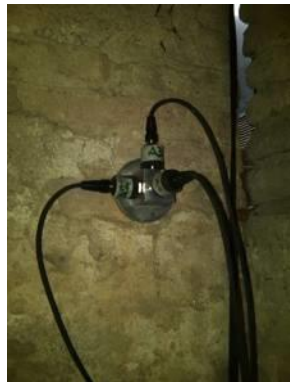
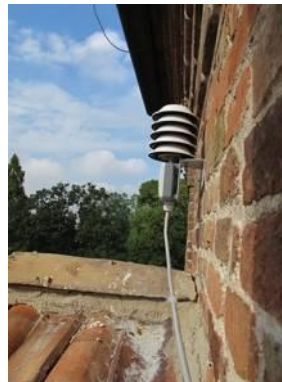
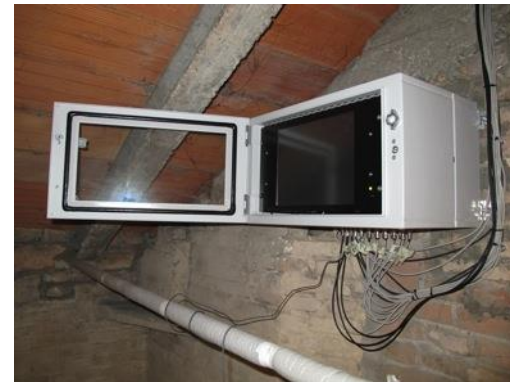
ENVIRONMENTAL MONITORING

2 TEMPERATURE/RELATIVE HUMIDITY SENSORS

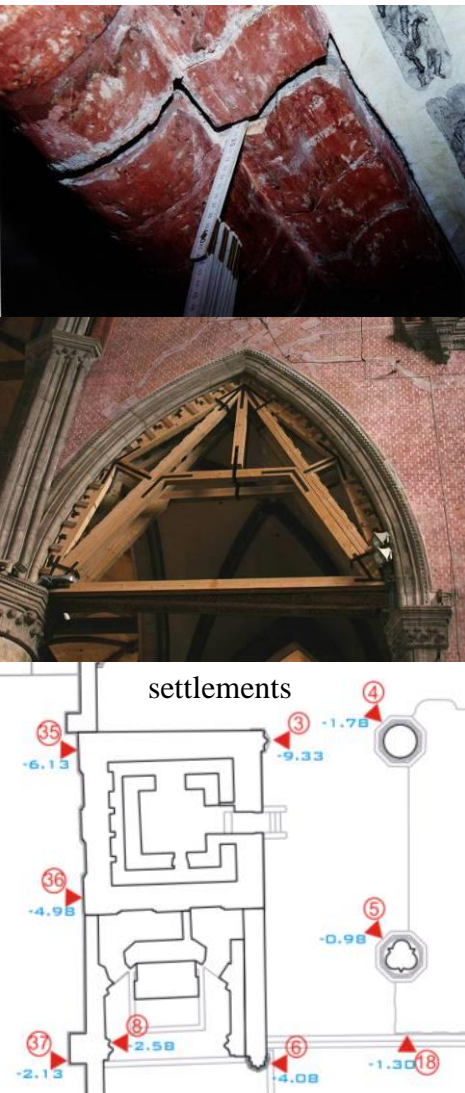
- 61.3 mm South corner

- 93.3 mm West corner

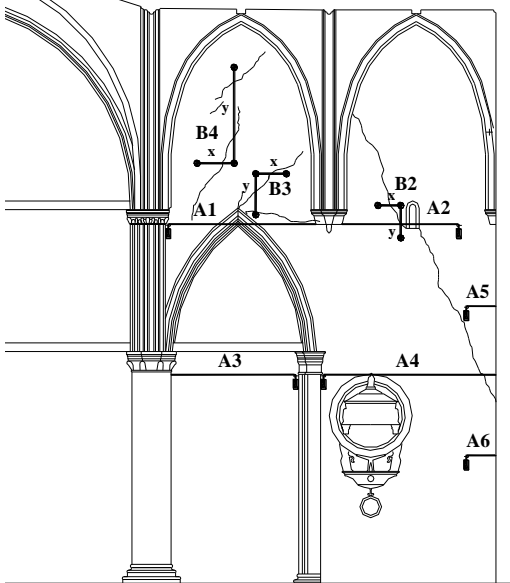
A : long-base extensometers
B : crack-gauges

- **6 long base extensometers** relative displacements between the walls of the bell-tower and the adjacent structures of the basilica;
- **8 crack-gauges** installed on the main cracks of the South-West side of the bell-tower and of the wall above the stone arch.

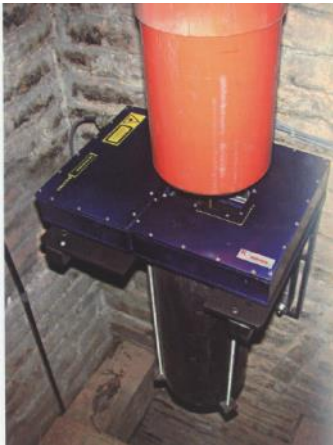
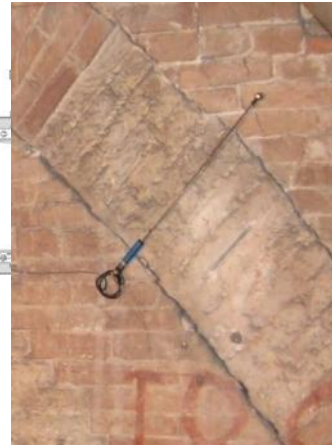
2003 extension of the automatic monitoring system

- Direct Pendulum
- Crack-gauges
- Strain Gauges
- Temperature sensors

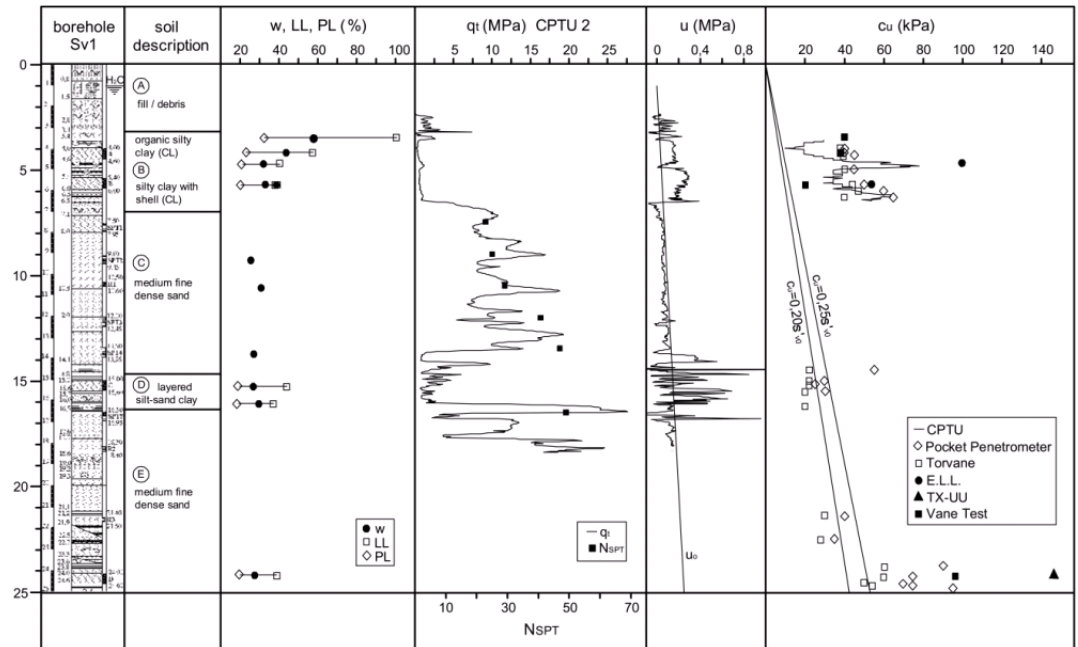
Geotechnical section and foundation geometry

Some **progressive failure** of the soft silty clay layer, squeezed between the piles end and the unit C, must be taken into account.

In addition, a **possible increasing decay** of the **mechanical characteristics** of the **wooden piles** under the foundation block could also be seen as concomitant cause.

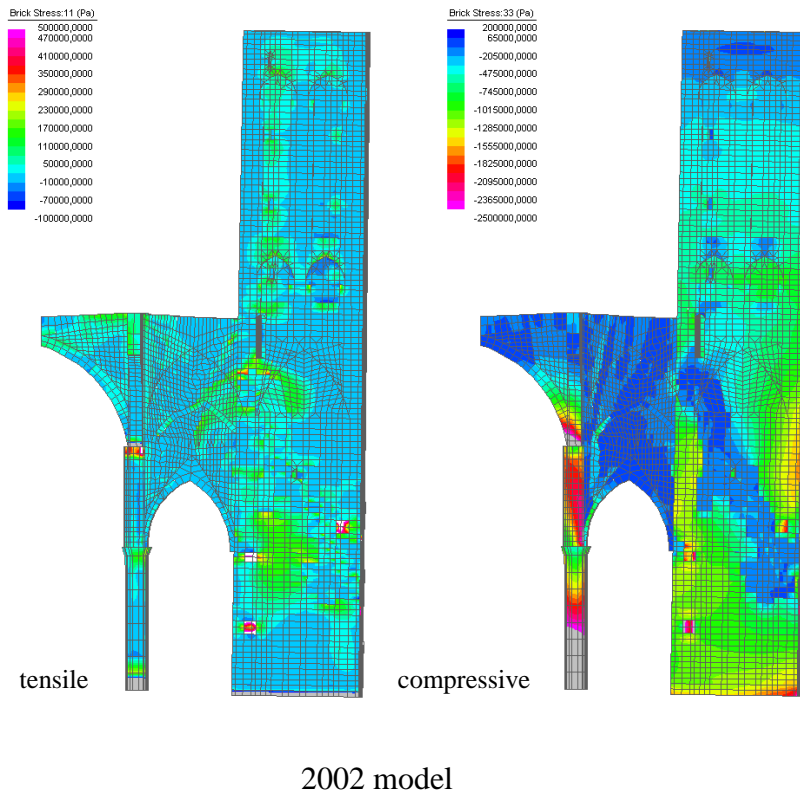
- preferential channels of **compressive stress** localized inside the masonry wall above the propped arch;
- high **tensile stresses** found in the same masonry wall, due to the settlements of the bell-tower → wide crack patterns and loss of shape of the stone arch;
- **high stress** found below the capital of the column → horizontal thrust determined by the movements of the bell-tower;
- **tensile stress** in correspondence of the bell-tower window opening on the transept → presence of the main fissure on the external pipe of the bell-tower.

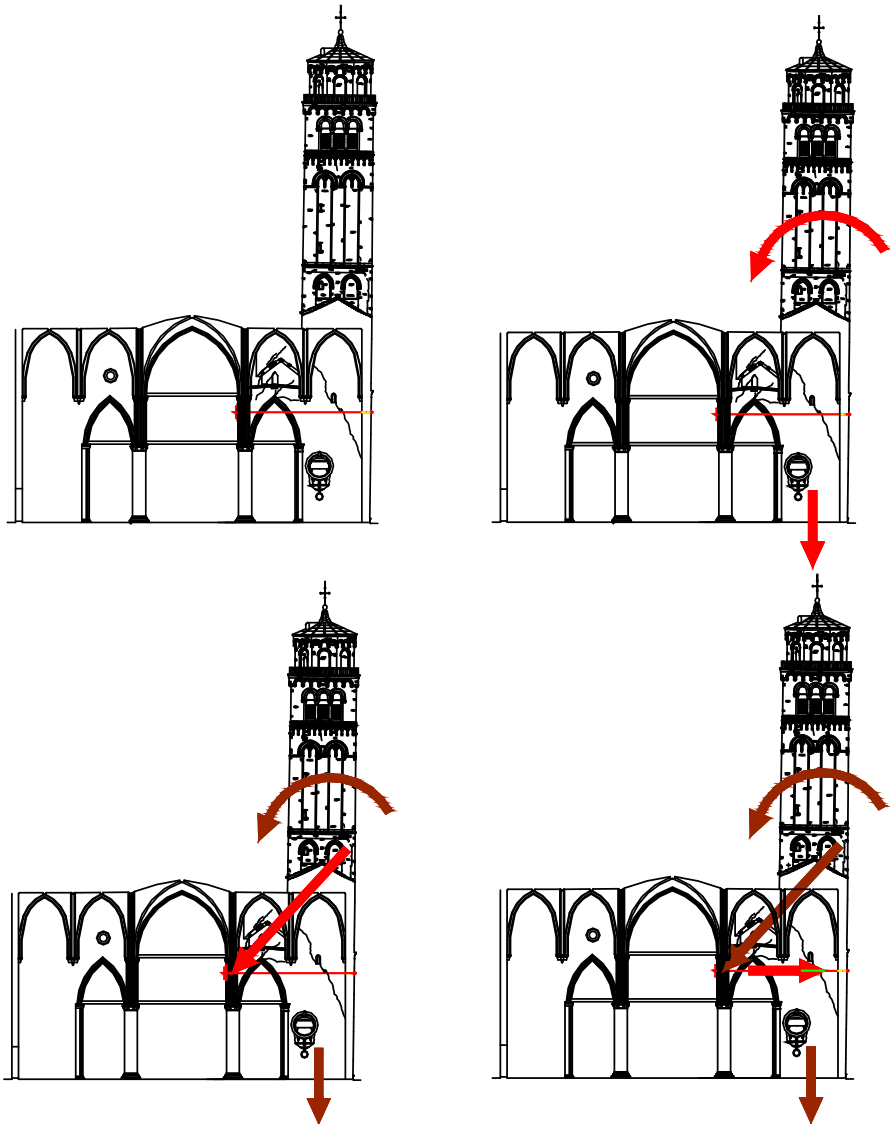
Realization of a provisional intervention for static control

Structural schemes considered for the design of the intervention

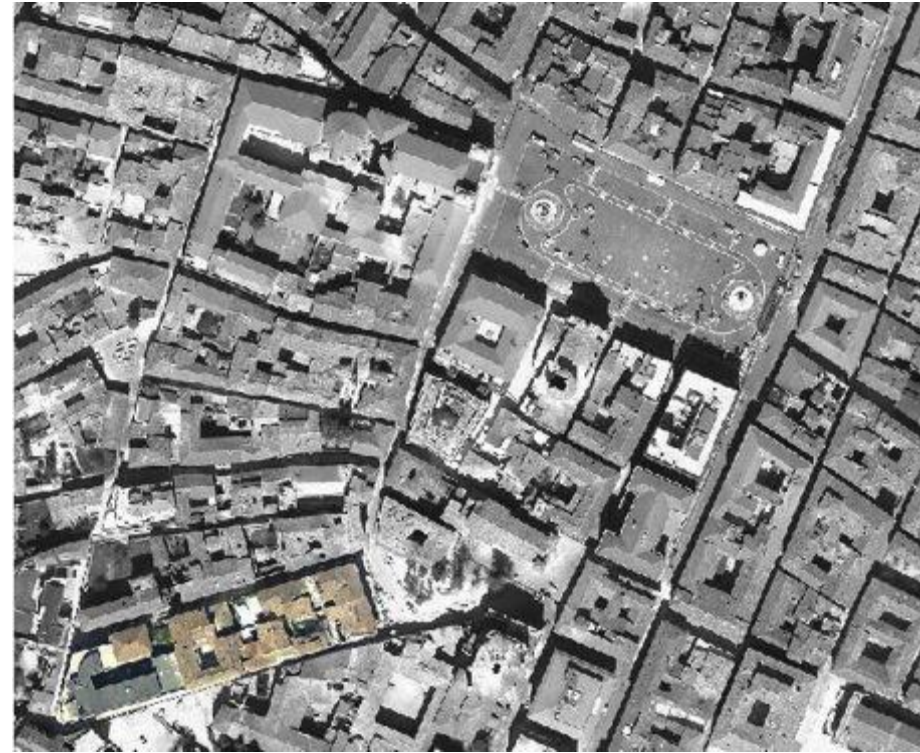
- Carry out a pilot case study of an aggregate building in L'Aquila historic center, to give an operational methodology;
 - The work has been carried out by the “Working group for the evaluation of seismic safety and intervention strategies on masonry buildings in historic centres”.
- Department of Civil Defense
 - ReLUIS consortium
 - Vice-commissioner for cultural heritage

An aggregate building is set of portions that are the result of **an articulated and not unitary genesis**, due to several factors (construction sequence, change in materials, change of needs, change of owners, etc.).

In the analysis of a building that is part of an aggregate building it is necessary to take into account the **possible interactions** due to the close structures, which are interconnected or simply adjacent, with the aim of reducing the fragmentation into single intervention to a minimum.

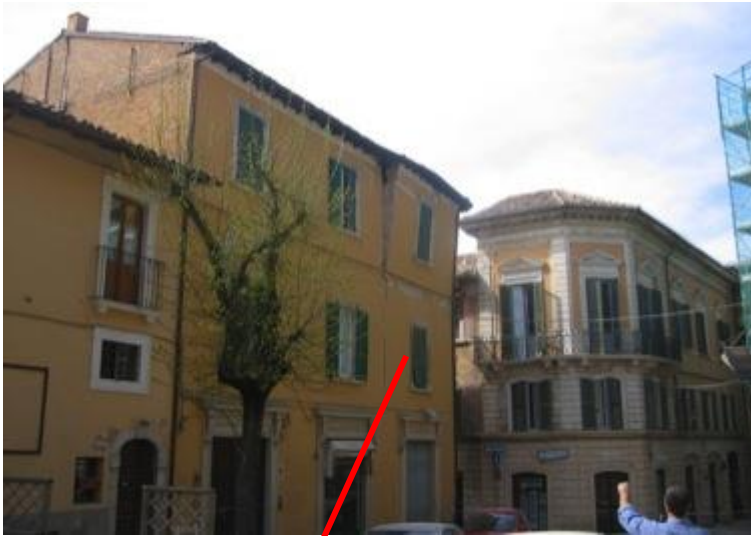
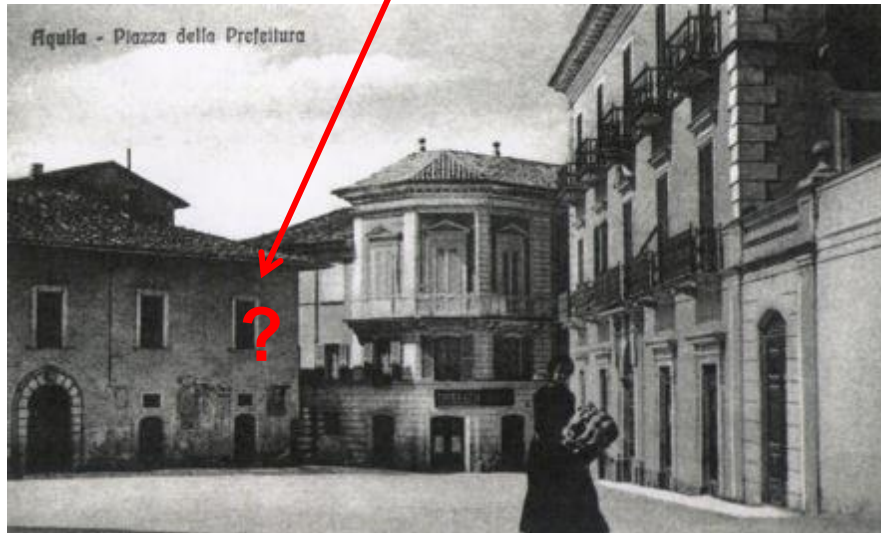
Historic section of **1703**.
The earthquake-induced damages are highlighted

Historic section of **1858**.
