SEISMIC RETROFIT
OF UNREINFORCED
MASONRY HERITAGE
CHURCHES IN THE
PHILIPPINES

Analysis Methods for Unreinforced Heritage Masonry

prof. eng. Claudio Modena

University of Padova
Department of Civil, Architectural and Environmental Engineering
Padova, Italy

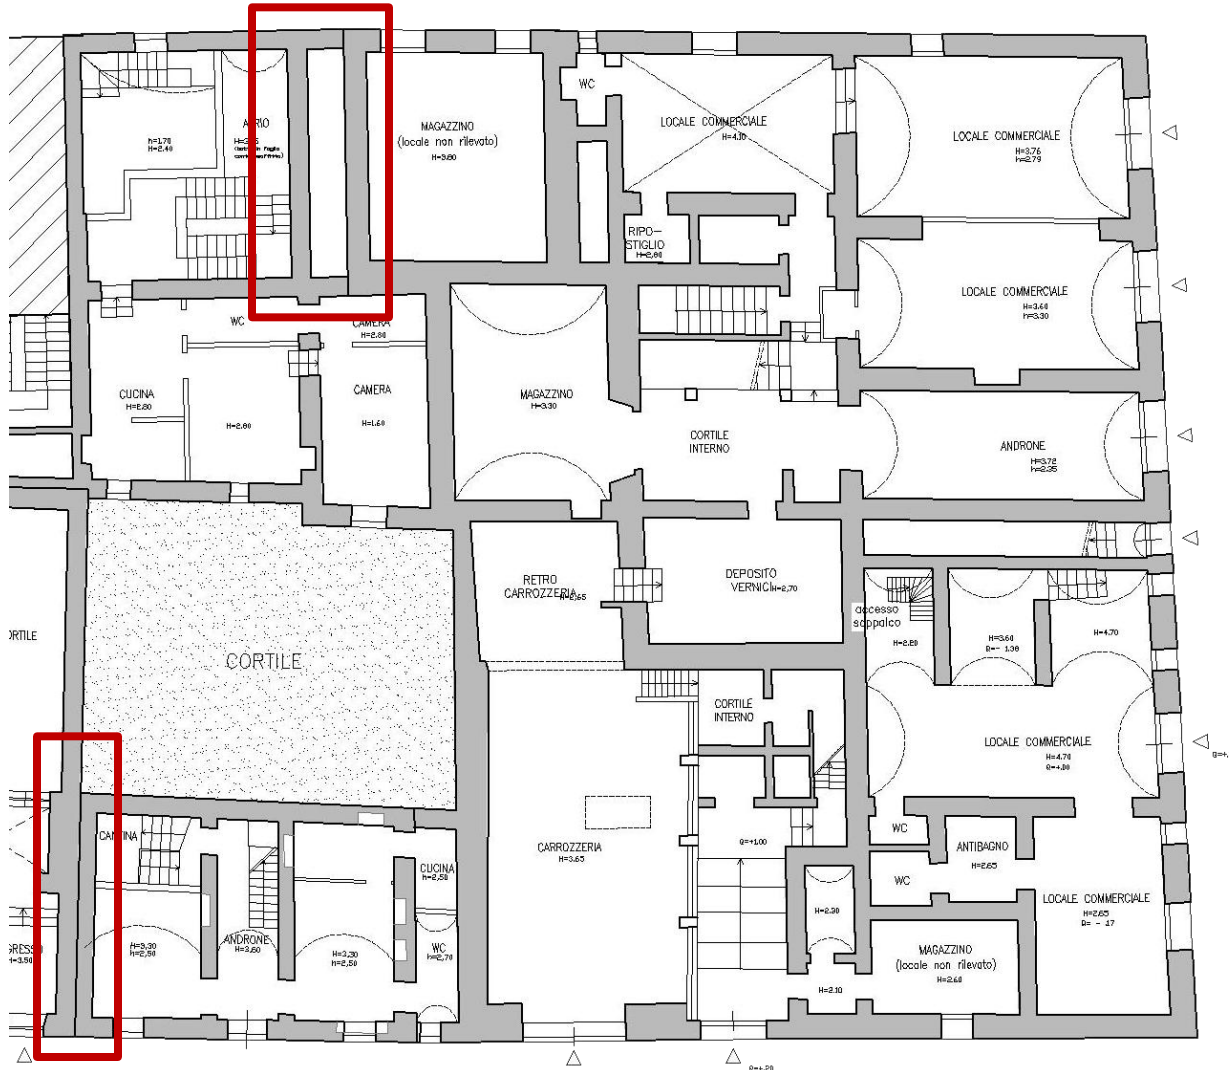
STUDY OF THE BUILDINGS CONNECTIONS

A geometric and structural survey is carried out in order to understand the **structural behaviour** of the buildings, to discover the **local construction role** and to **identify any potential problem or alteration**. It is often possible to find historical seismic protection systems like tie rods, buttresses and contrast arches.

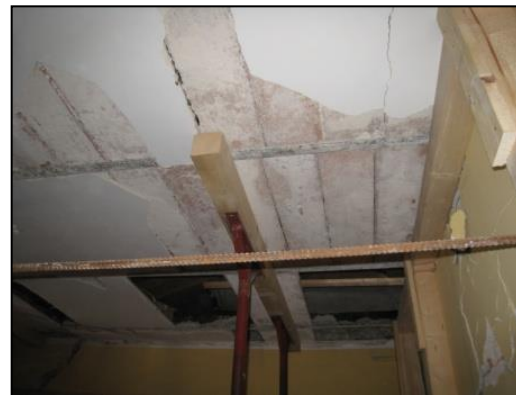
MIXED FLOOR: STEEL BEAMS AND BRICK HALLOW ELEMENTS

- vaults with bricks laid edgewise or vaults with stones
- vaults with bricks laid flatwise
- steel beams and brick small tiles
- steel beams and brick tiles
- steel beams and brick vaults
- concrete and masonry
- wooden diaphragms
- light diaphragms

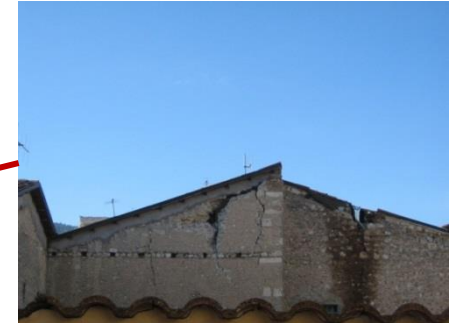
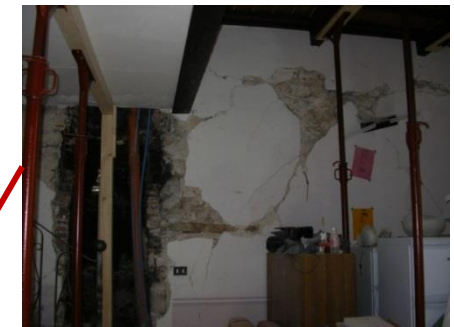
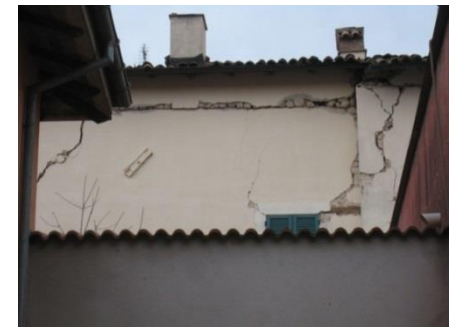
WEAKENING OF MASONRY

R.C TIE BEAM

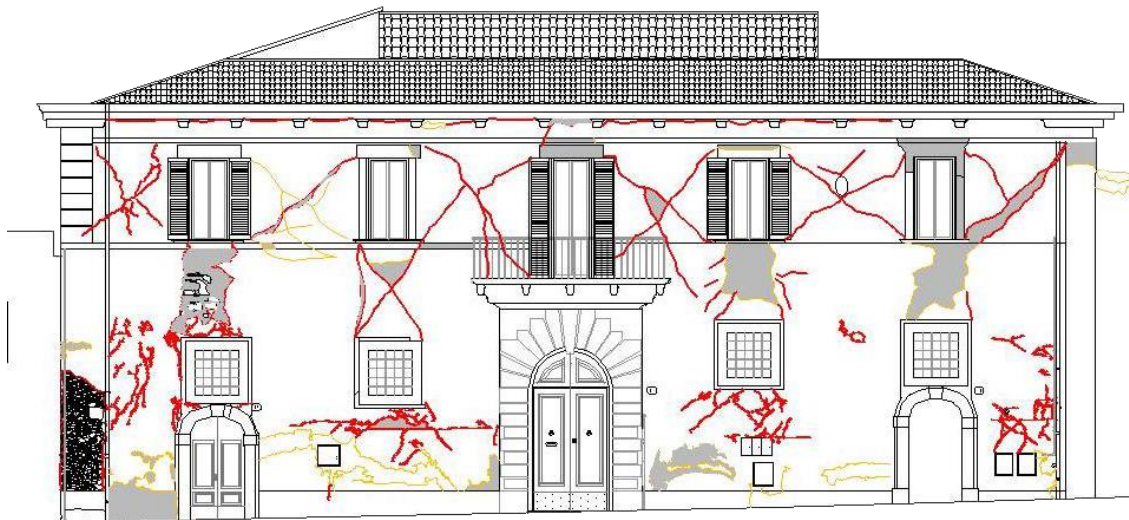
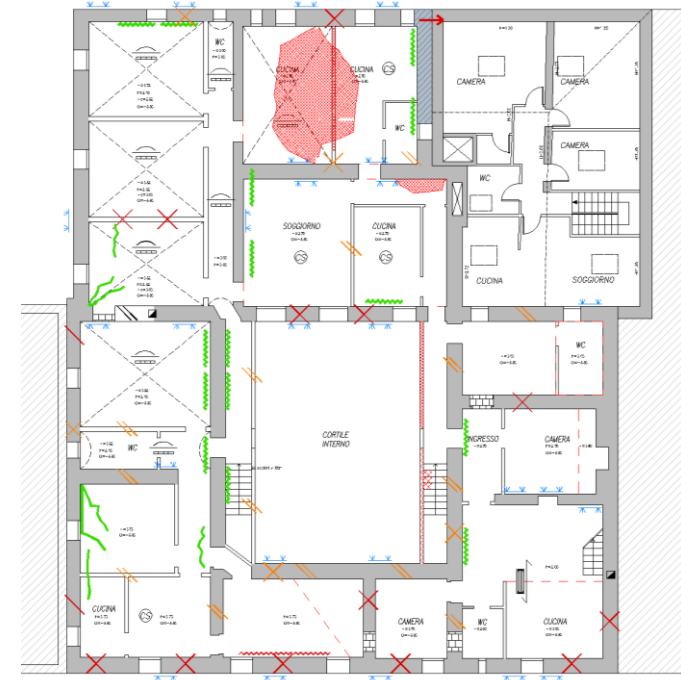
ANALYSIS OF THE CRACK PATTERN

The critical survey of damage is necessary to identify **critical elements**, toward static or dynamic actions, of the structural system, including **deterioration**. The analysis and systematic description of the **cracks** pattern allows to understand the reasons of their existence: Identification of significant **mechanisms of collapse**

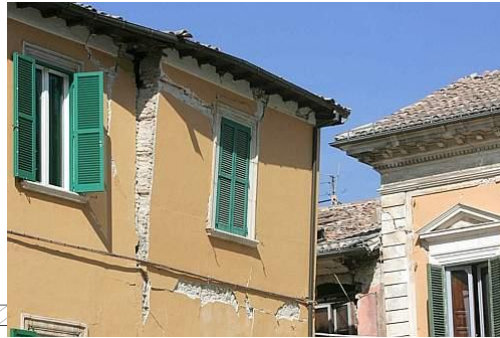
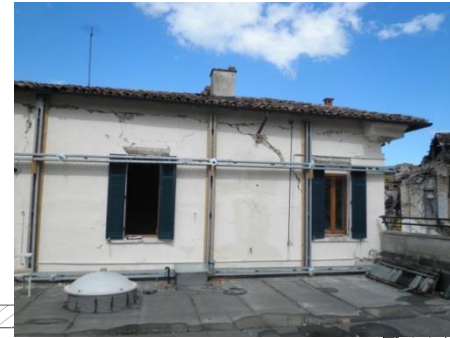
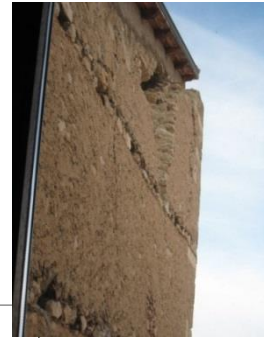
GLOBAL BEHAVIOUR OF THE AGGREGATE

LONGITUDINAL DIRECTION:
IN PLANE FAILURE

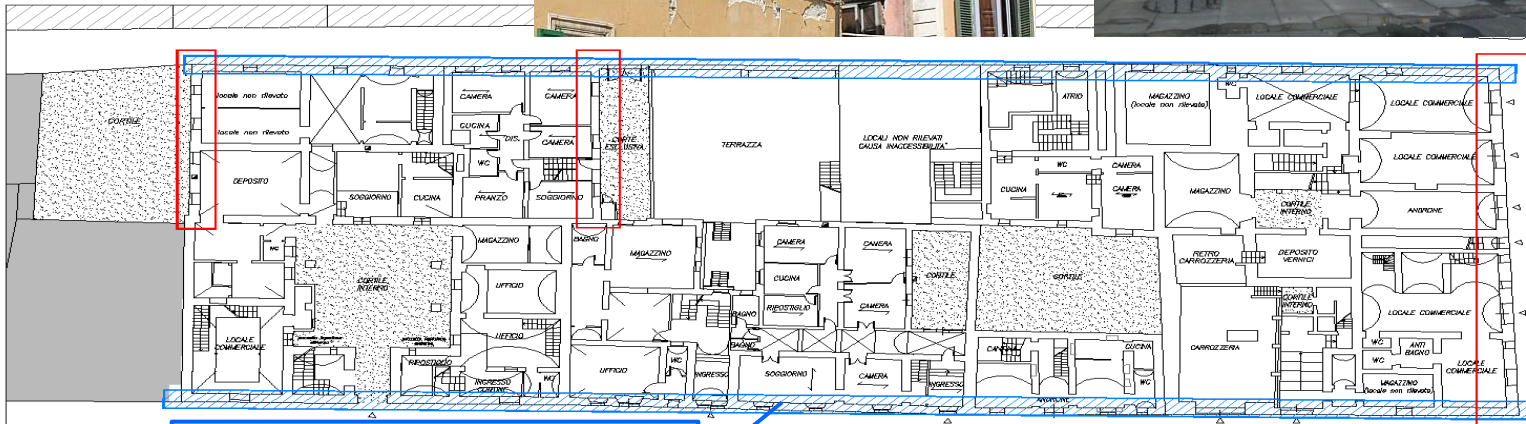
TRANSVERSAL
DIRECTION:
OUT-OF-PLANE
OVERTURNING

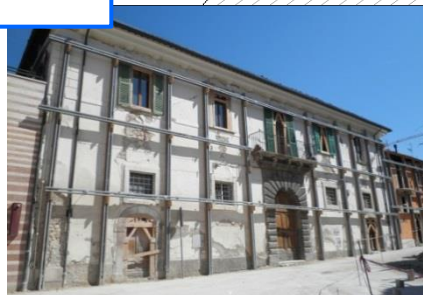
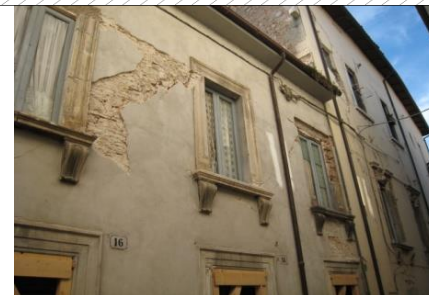
In existing masonry buildings under horizontal (seismic) loads, **local** and **global mechanisms** can develop.

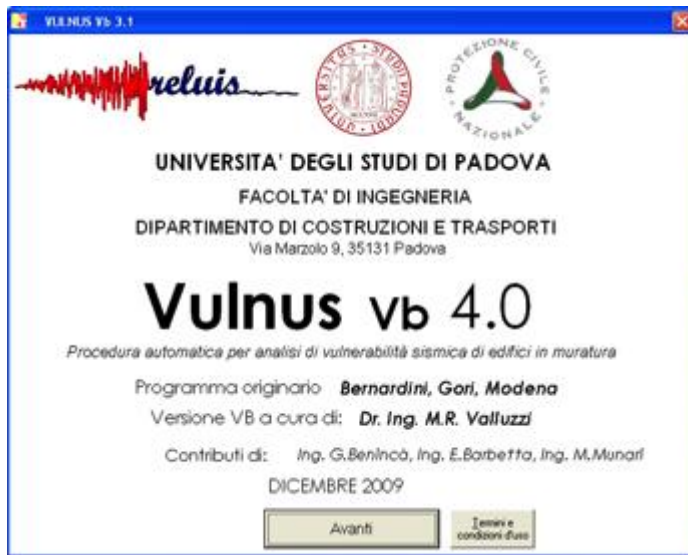
ANALYSIS THROUGH SIMPLIFIED MODELS: VULNUS

1- STUDY OF THE ACTIVATION OF COLLAPSE MECHANISMS IN PLANE AND OUT OF PLANE

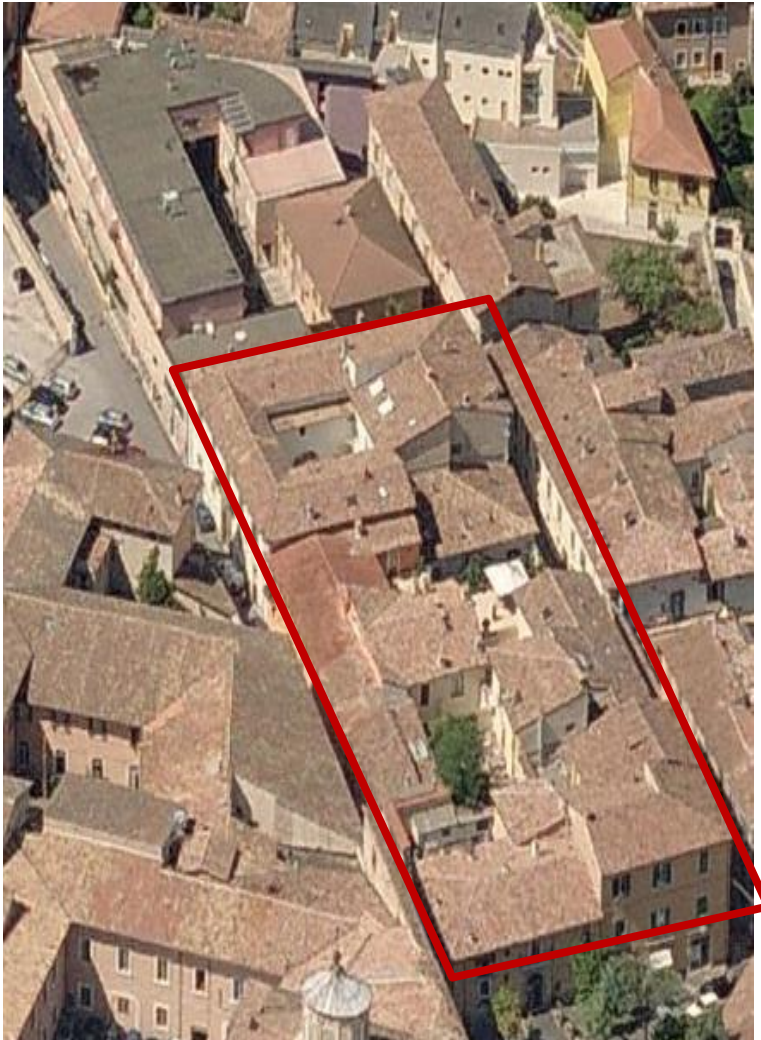
SCHEME OF THE AGGREGATE

1) SUBDIVISION OF THE AGGREGATE INTO 12 STRUCTURAL UNITS (U.S.)

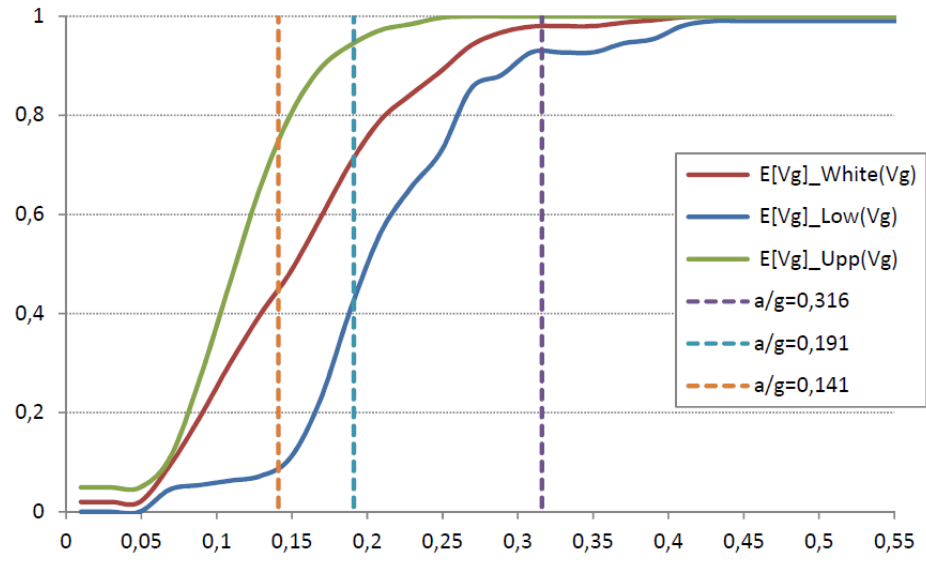
fragility curves obtained by considering all the buildings in the block, which yielded estimated overall vulnerability, and the three considered reference values of PGA/g

Another procedure used by Vulnus to define vulnerability determines the expected values of severe damage $E[Vg]$, depending on the PGA/g ratio of peak ground acceleration and gravity acceleration.

Vulnus provides diagrams (fragility curves) with three curves representing lower, upper and average values, which allow estimation of the expected frequency of serious damage at any value of PGA/g and the relative uncertainty of that value. The area between the upper and lower curves thus represents the range of most probable values of expected frequency of severe damage
