INTERNATIONAL SYMPOSIUM ON SEISMIC RETROFIT OF UNREINFORCED MASONRY CHURCHES OF THE PHILIPPINES

Overview: Seismic Retrofit

Stephen J. Kelley, FAIA, SE, FUSICOMOS

Some (very schematic) Retrofit Ideas for the Churches in Bohol

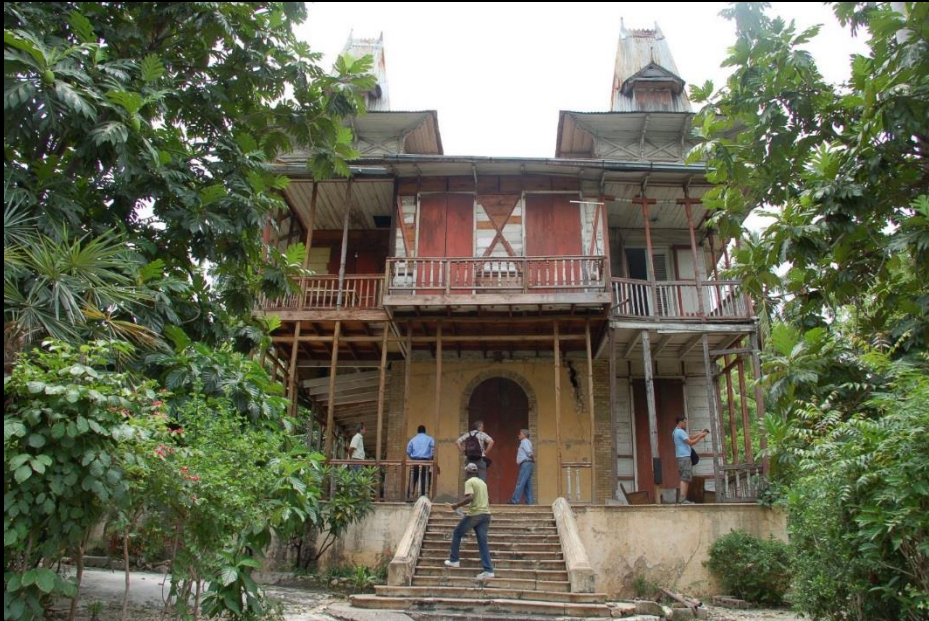
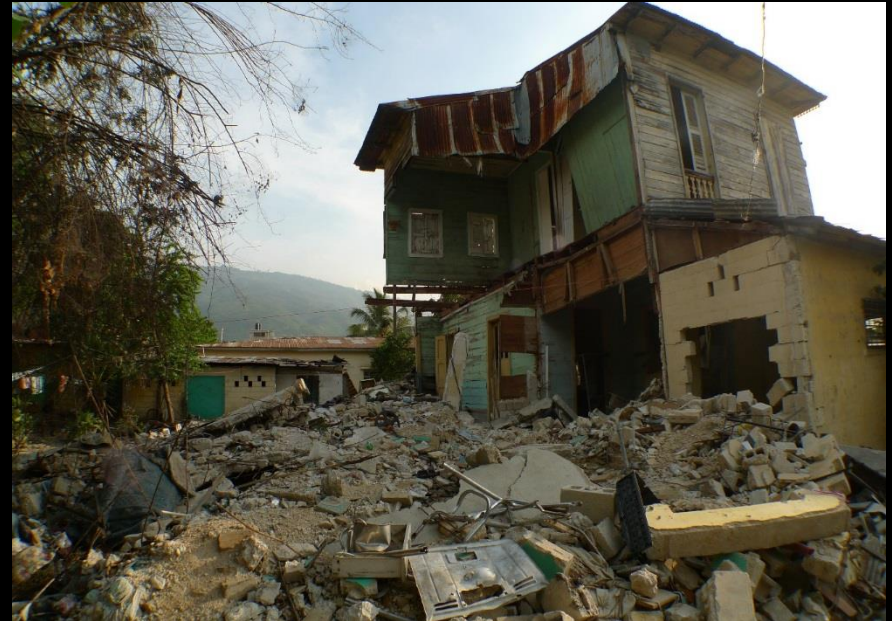
Vulnerabilities – Inappropriate repairs and additions
