Unintended Consequences of Uncontrolled Public Access to a Fragile Shoreline

Gordon Peabody & Jacalyn Gorczynski, July, 2010

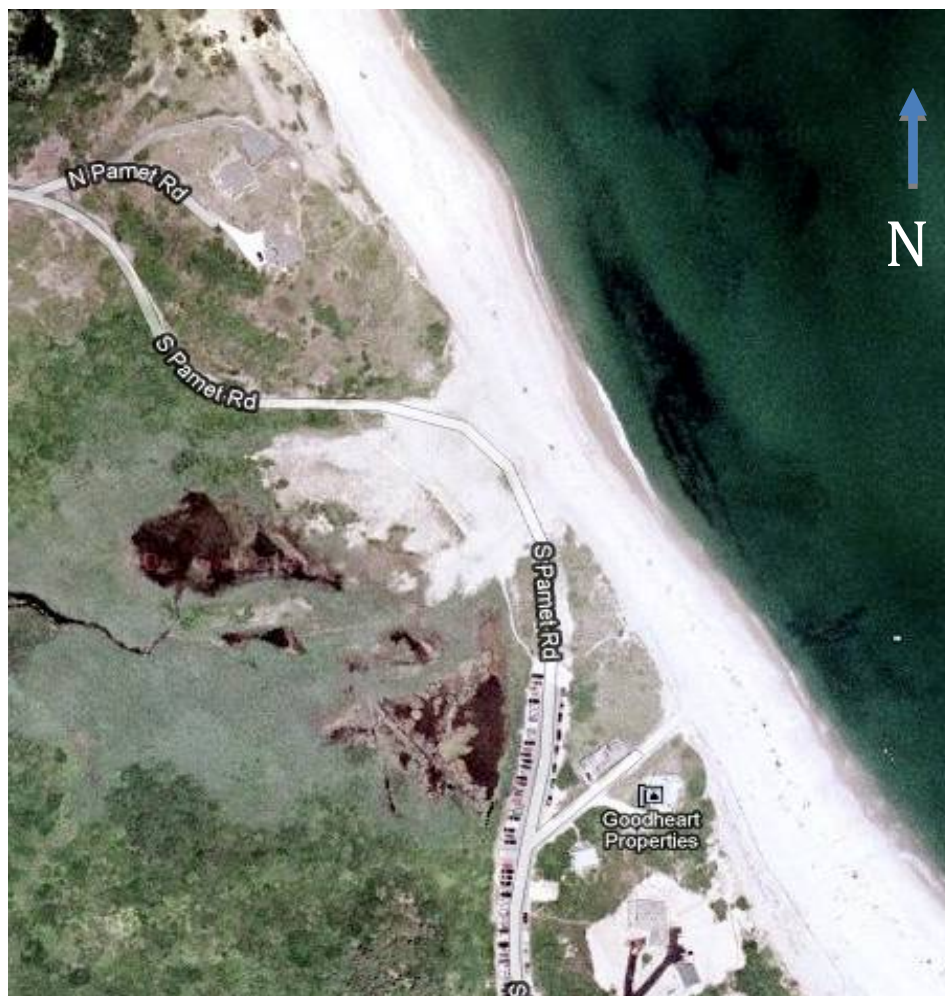
Ballston Beach aerial satellite photograph (Google Maps).

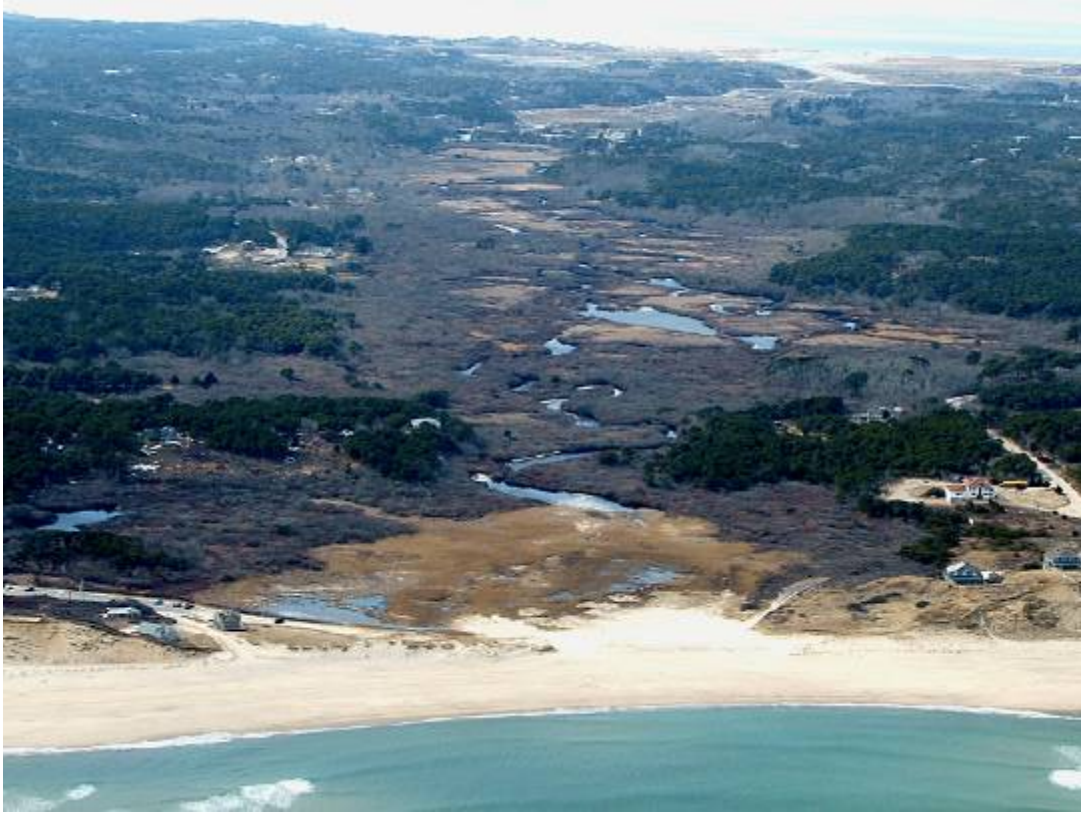
Photograph from above of Pamet River, running east/west from the headwaters behind Ballston Beach (at the bottom of the photograph) to Cape Cod Bay (at the top of the photograph). ("The Perfect Storm, Ballston Beach, Truro." *Changing Coastline: Understanding the Anthropogenic Impact of Climate Change.*)

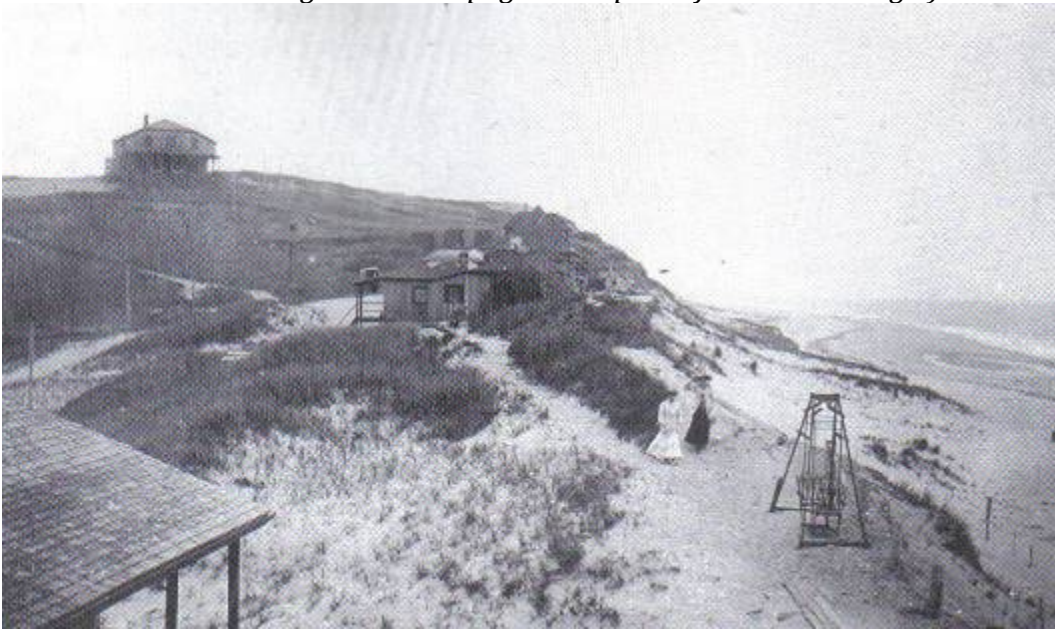
1909 photograph of Ballston resort looking north. Note connected barrier dune. (Brennan, Susan W. and Diana Worthington, *Images of America: Truro*, Arcadia Publishing, Charleston, SC, 2002, pg. 91)

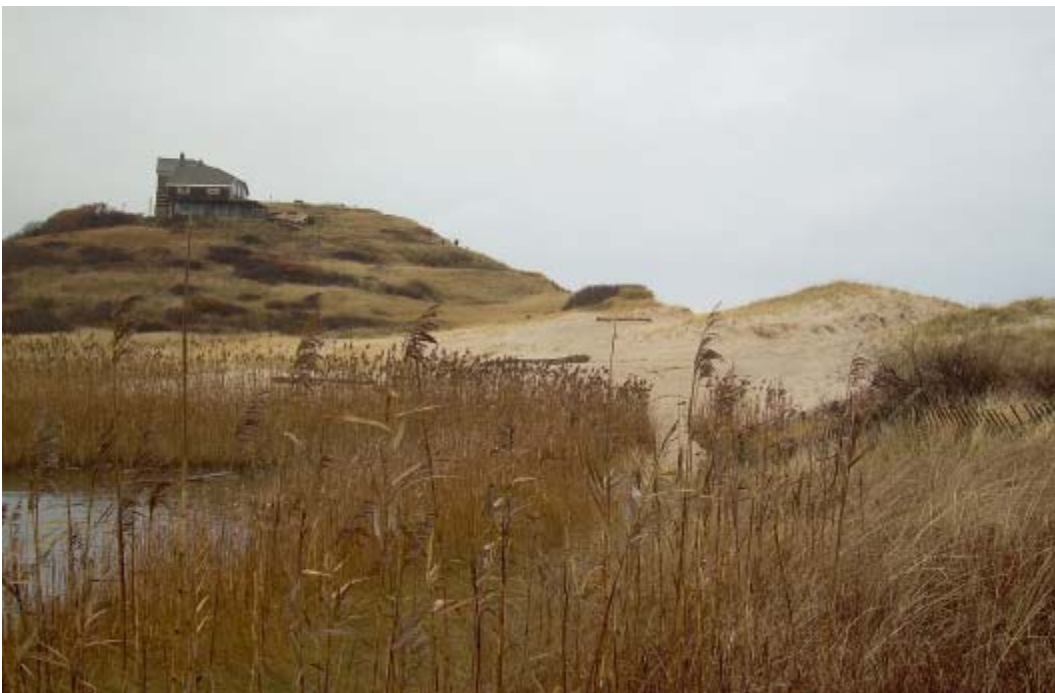
Ballston Beach today from behind what remains of the barrier dune in the previous photograph, again looking north.

These breakthroughs in the barrier dune of Ballston Beach reduce the effectiveness of its protective abilities. While breakthroughs are a normal part of barrier beach migration in coastal systems, the weakening of this barrier dune may have been exacerbated by anthropogenic causes. The thousands of visitors to Ballston Beach each season walk directly over the barrier dune in question and subsequently weaken it. Most native dune grass species die when stepped on and the unprotected geomass becomes vulnerable to wind erosion and subsequent loss of elevation. By establishing pathways having zig zag angles to avoid potential “shotgun blow outs” and by educating visitors with signage as to what is occurring to their beach, these anthropogenic impacts can be reduced. With the use of 4’ high pedestrian control fencing and 24” sand capture fencing, along with the replanting of native plant species on the barrier dune, this system can be returned to its natural functions.

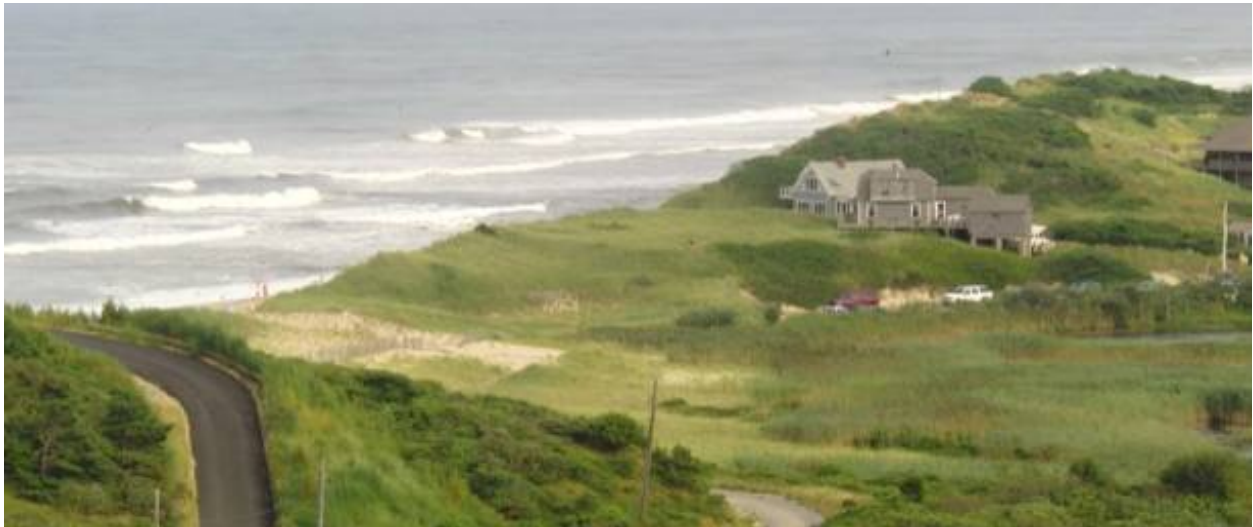
Ballston beach in 2009 looking southeast from atop the coastal bank. ("The Perfect Storm, Ballston Beach, Truro." *Changing Coastline: Understanding the Anthropogenic Impact of Climate Change,*)

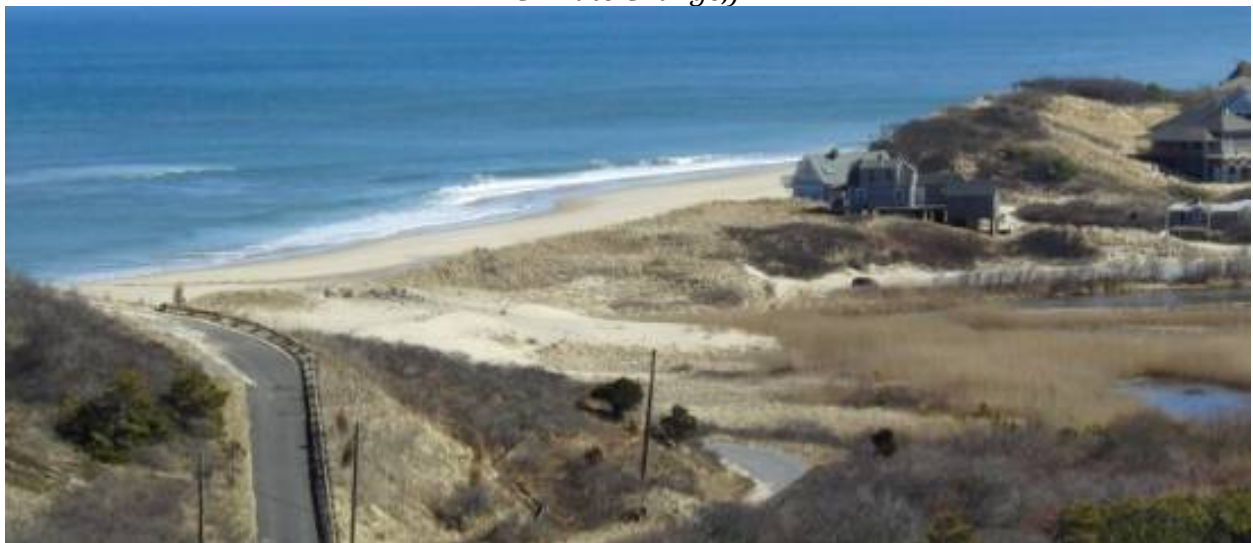
Ballston beach in 2010 after having lost 25 ft of coastal bank over the winter, again looking southeast from the coastal bank. ("The Perfect Storm, Ballston Beach, Truro." *Changing Coastline: Understanding the Anthropogenic Impact of Climate Change,*)

The results of this can be plainly seen on Ballston Beach, which has suffered from one of the highest rates of erosion on Cape Cod over the past several years. Nearly 25 feet of land was lost to the ocean over the past year at Ballston Beach, where the public access area was breached, breaking through the barrier dune and creating a large overwash fan of sand and debris. *Overwash fans are a natural part of the coastal system, as is erosion, but the amount of change caused by these fans and the frequency of overwash occurrences is something that should be looked at more closely.*

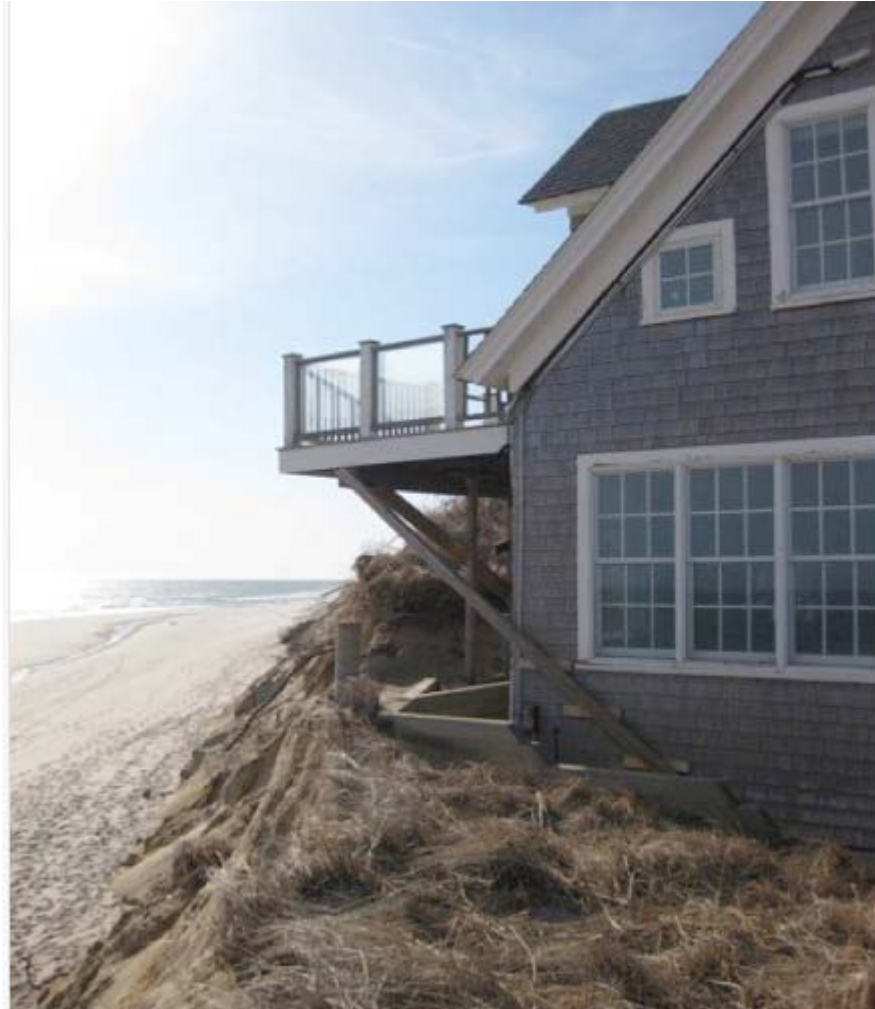
Close up of house on the edge of 25-foot loss (Photo courtesy of Kim Deane).

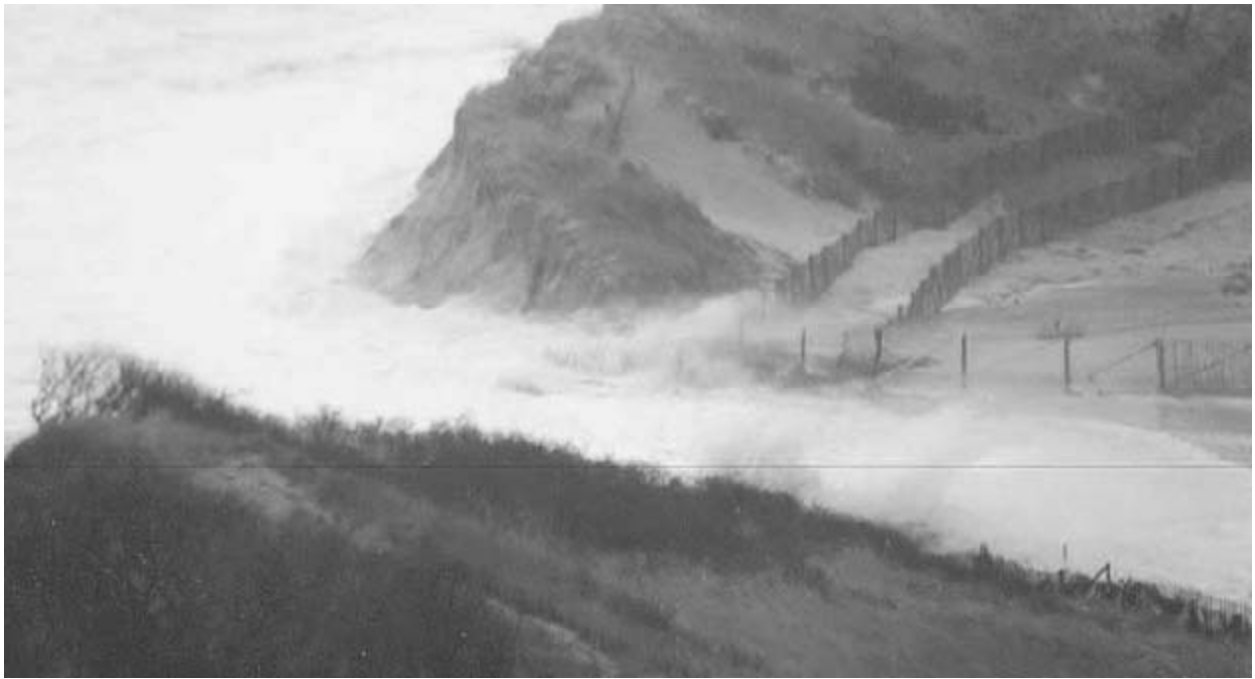
Overwash of Ballston Beach's barrier dune during the "Perfect Storm" of October 31, 1991 looking southeast from atop the coastal bank.
(<http://pubs.usgs.gov/gip/2005/13/pdf/fig13.pdf>)

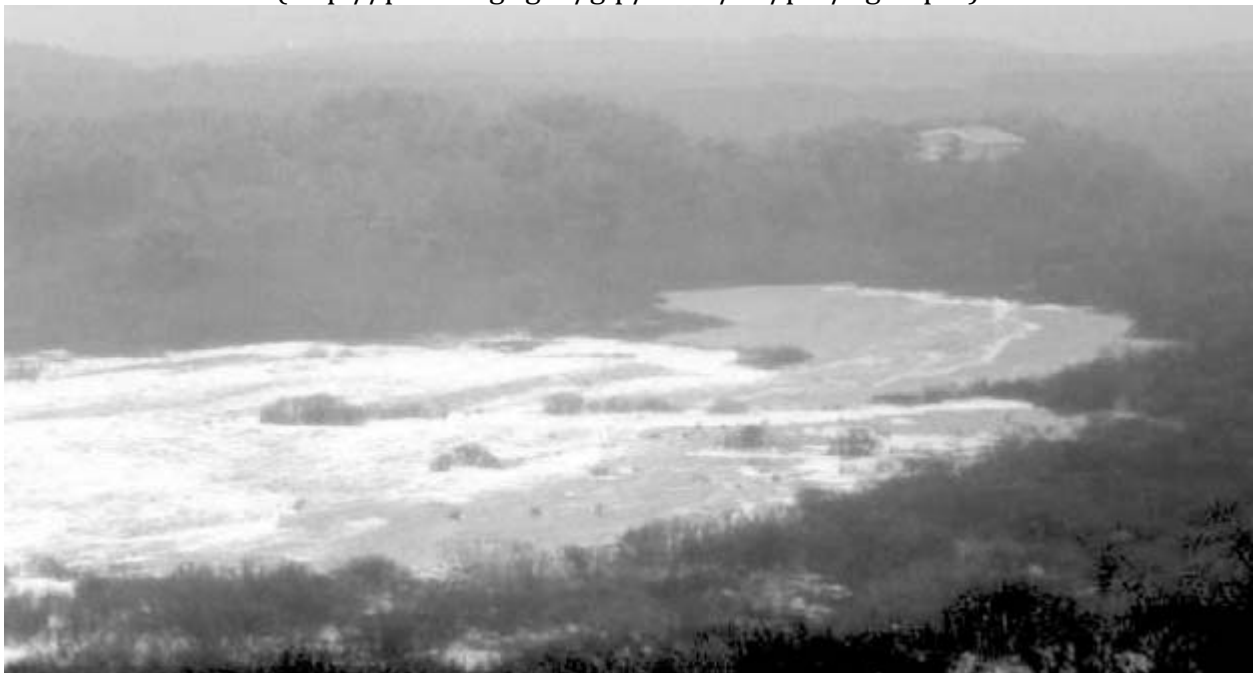
Seawater on the floodplain behind Ballston Beach's barrier dune that maintained a depth of several feet for approximately a week, looking southwest from atop the coastal bank.
(<http://pubs.usgs.gov/gip/2005/13/pdf/fig13.pdf>)

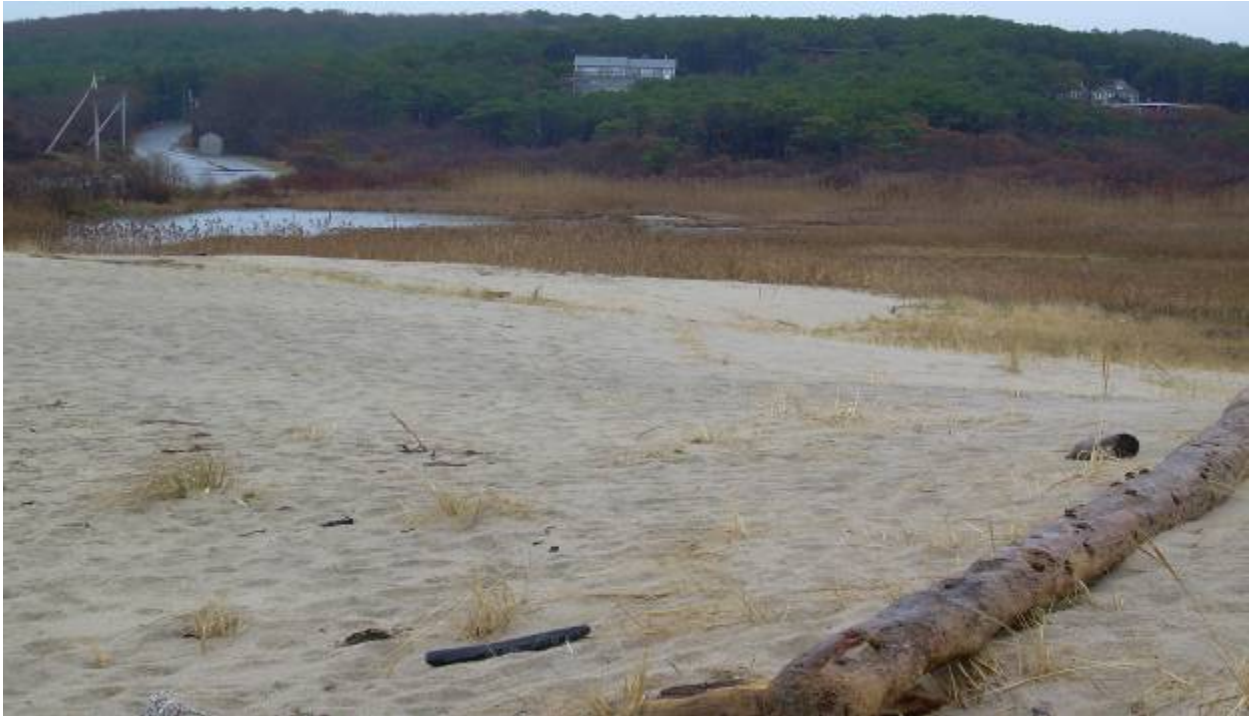
Overwash of 2005 looking west towards the marsh into which sand has been washed.

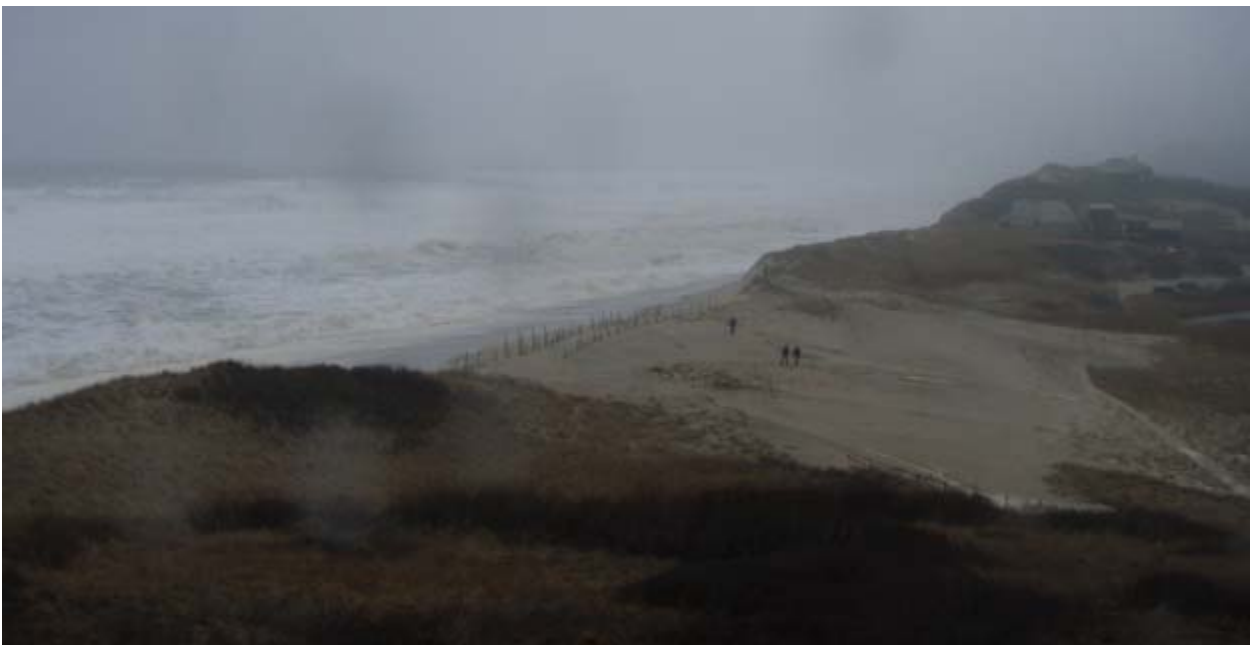
Storm of 2009, that again broke through the barrier dune and created an overwash fan (looking southeast). Ineffective fencing system visible on left edge of overwash area.
