**Recreation Site, Informal Trail, and  
Dispersed Campsite Impact  
Baseline Assessment and Procedures:  
Joe's Valley Bouldering Area, Utah**

**September 2014**

Final Report for the Salt Lake Climbers Alliance  
Bureau of Land Management, Price Field Office  
US Forest Service, Manti-La Sal National Forest, Price Ranger District

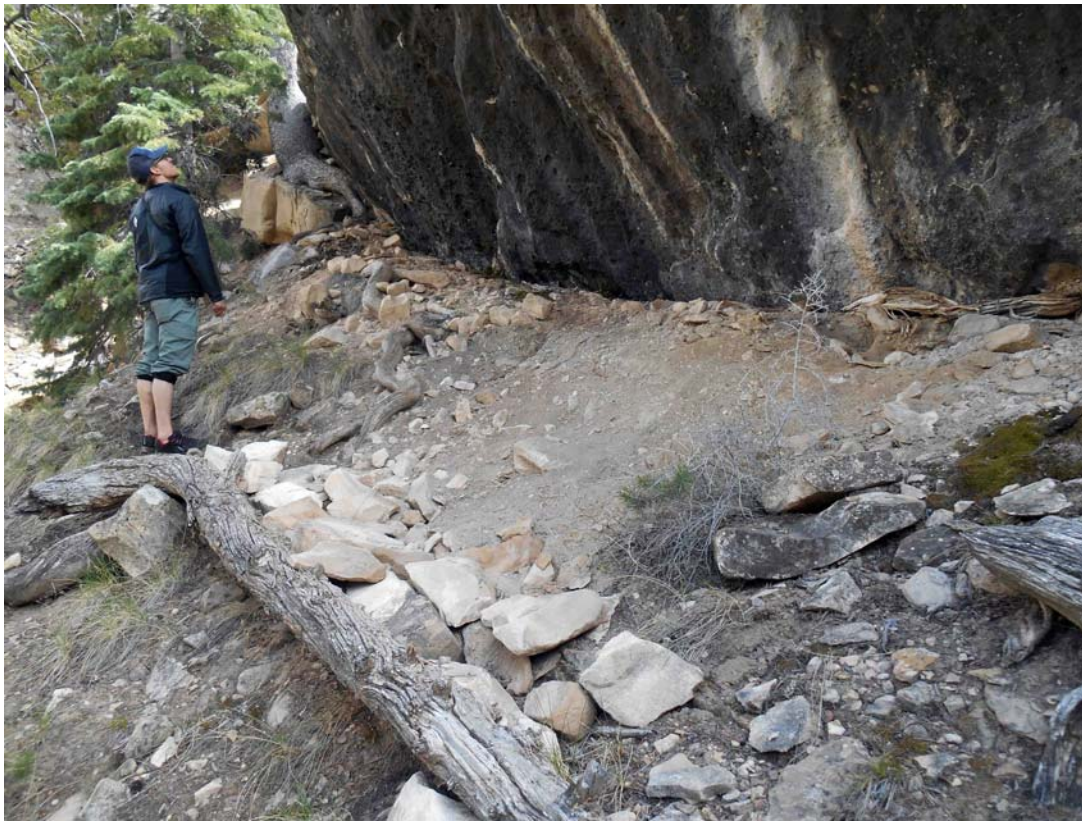
Figure 1. An example of a primitive retaining structure constructed out of a log and rocks at a bouldering site.

This survey identified 188 bouldering sites within Joe's Valley. While many of the bouldering areas are easily accessible from the main roads, other areas require a steep long approach. Bouldering sites in Joe's Valley exhibit similar spatial attributes recognized at other bouldering areas such as primitive approach trails, staging areas, and descent routes. Due to the steepness of the areas, especially in Left Fork and Right Fork, site modifications are a common occurrence. These modifications are the design and building of primitive retaining structures, constructed out of local dead trees, branches, or rocks (see Figure 1). These retaining structures provide a flat area for climbers to establish new lines, provide safe landing zones for placement of crash pads, used as a staging area, and additionally, mitigate potential soil erosion.

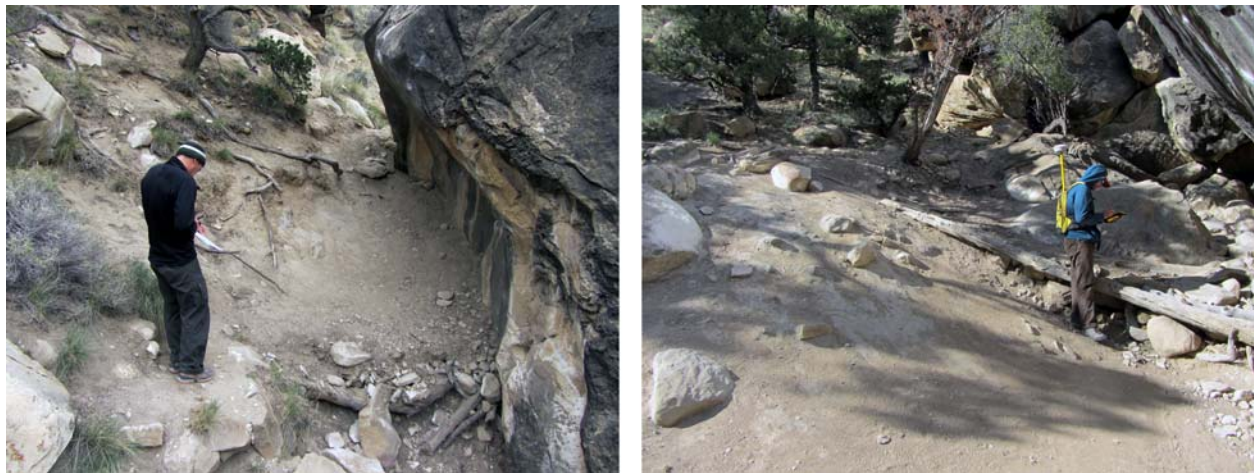
Figure 2. The left image shows localized site impacts beneath the boulder problem while the right image shows an increase in the area size where impacts are occurring.

impacts ranged from small and localized under boulder problems to large and expanding into the surrounding area around the boulder (see Figure 2).

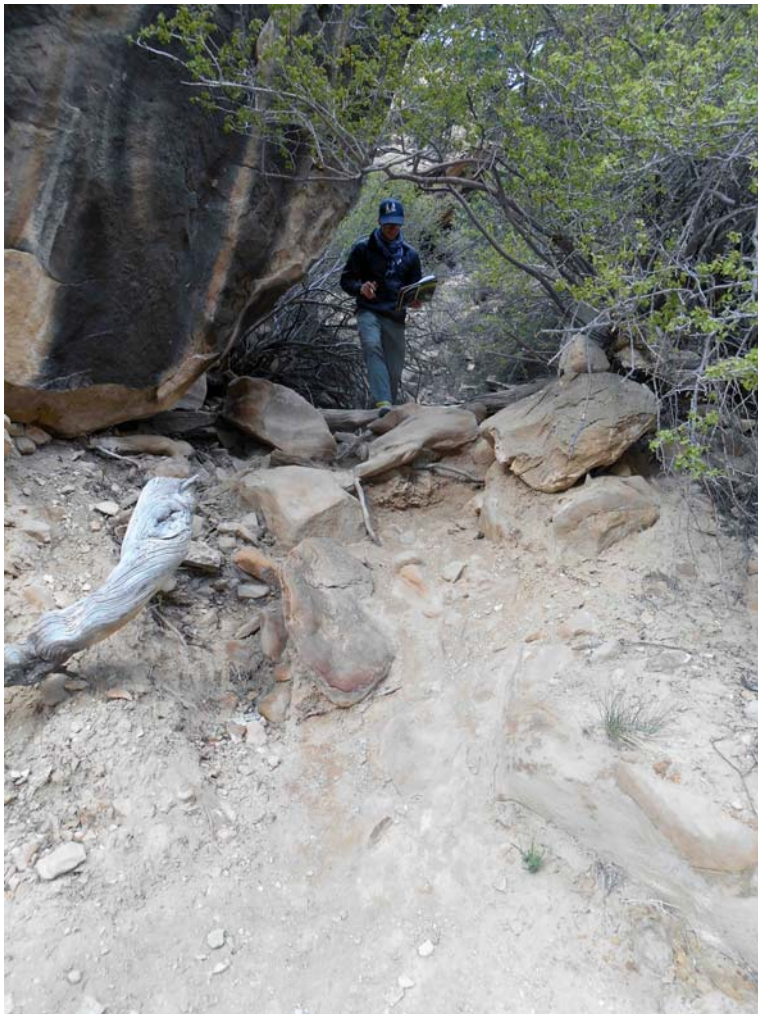
Figure 3. An example of a typical informal trail that is aligned on the fall line. Notice how water is able to channel down the tread causing increased soil erosion.

Specifically, in Left Fork all condition classes were present, with the majority of informal trails (1.4 miles) rated as CC5. Typically, these segments of trails were located on fall line alignments and many identified trails in this condition class began from the main road. These trails are the most problematic segments due to there unsustainable grades which can cause ruts and gullies, trail widening, and braided trails (see Figure 3). The remaining 1.7 miles of informal trails in Left Fork ranged from CC0 (trail not distinguishable, faint access route, drainage or wash route) to CC4 (bare compacted soil widespread, almost total loss of vegetation). Right Fork also had a majority of informal trails (1.3 miles) assigned as CC5 which were similarly located on fall line alignments. The remaining 2.5 miles ranged from CC0 to CC4. New Joes' informal trails were in better condition with the majority of trails (1.6 miles) assigned as CC3. Many trail segments within this condition class were located on old roadbeds which were relatively parallel to the contour of the slope. The additional .9 miles of trail segments in New Joes were identified within the other condition classes, with the exception of CC1 trails.

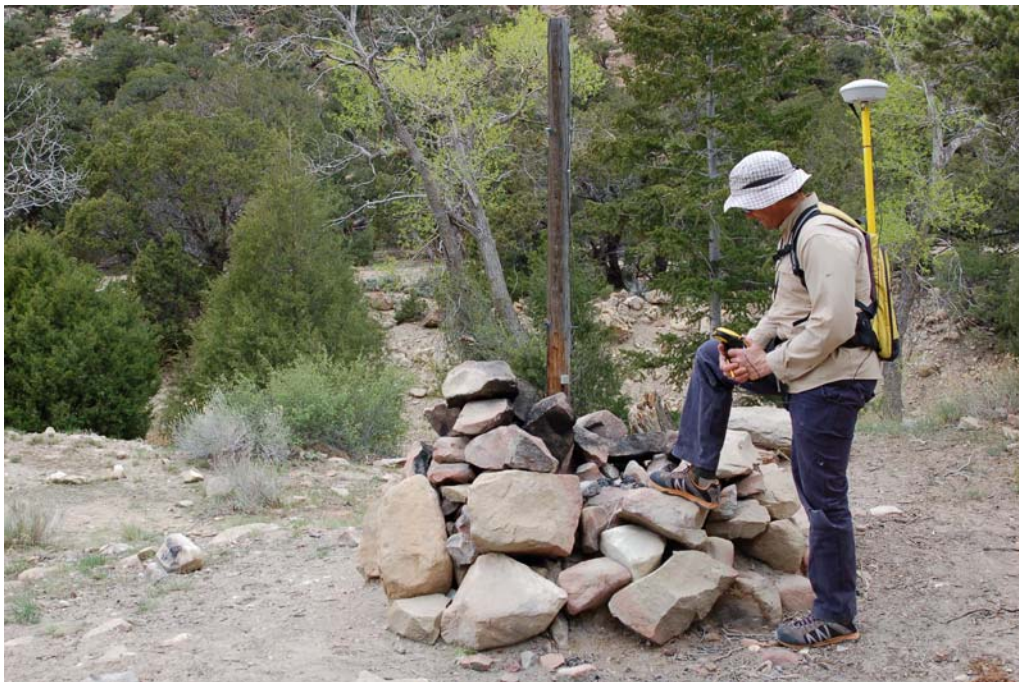
Figure 4. An example of a large fire site with multi-tiered rocks holding in the ash.

Total fire sites at dispersed campsites had a range of 0 to 5 with a mean of 1.3 (see Table 14). Size and impact of fire sites varied. Many fire sites were simple rock rings with little ash, while other fire sites had multi-tiered rocks, were full of ash, and had blackened rocks (see Figure 4). Left Fork had 15 fire sites with 2 campsites having multiple fire sites (2 to 3). Right Fork had 55 fire sites within 39 dispersed campsites, with 9 campsites having 2 to 5 fire sites (the majority at Buoux, Porta Pot, and UMW Camp Areas). New Joes was similar to Right Fork having 55 fire sites within 41 campsites. Twelve of these campsites had multiple fire sites ranging from 2 to 4. The sum of fire sites for all inventoried dispersed campsites was 125.

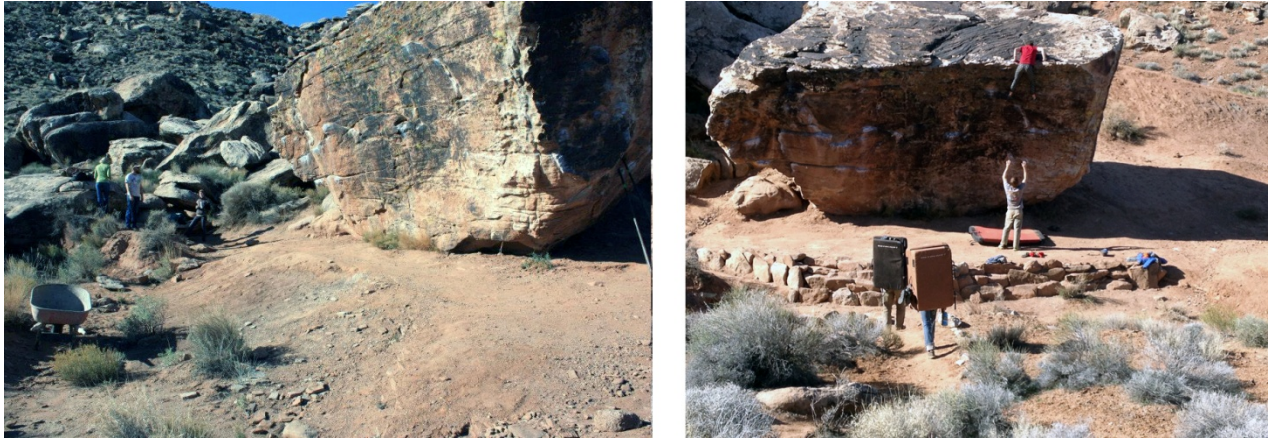
Figure 5. The left image shows the impacted area with soil compaction and some slight erosion occurring. Construction of a rock retaining wall in the right image has leveled the landing area and stabilized potential future erosion (Access Fund).

Provide site maintenance. Since many of the bouldering sites are located on steep slopes, erosion is a common occurrence and can be mitigated by constructing rock retaining walls to level the landing area under the boulder or stabilize eroded areas adjacent to the boulder. This strategy has successfully been used at the base of climbing routes where similar impacts occur and has been implemented at other bouldering areas such as Moe's Valley, Utah (see Figure 5). Another site modification is hardening and leveling the landing under boulders by embedding flat rocks into the impacted zone (see Figure 6). This technique would be beneficial to develop a resistant landing zone that is periodically muddy or slightly sloped. Bouldering sites that are situated on a

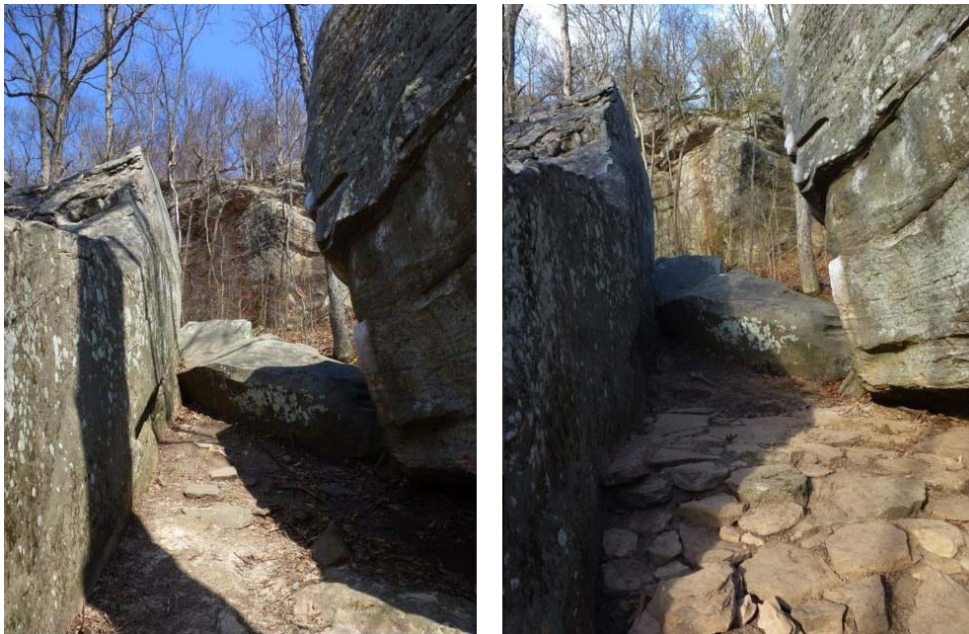
Figure 6. The left image shows the impacted area before site modification. In the right image, the placement of rocks has made the area more resistant to muddiness and trampling related impacts (Access Fund).

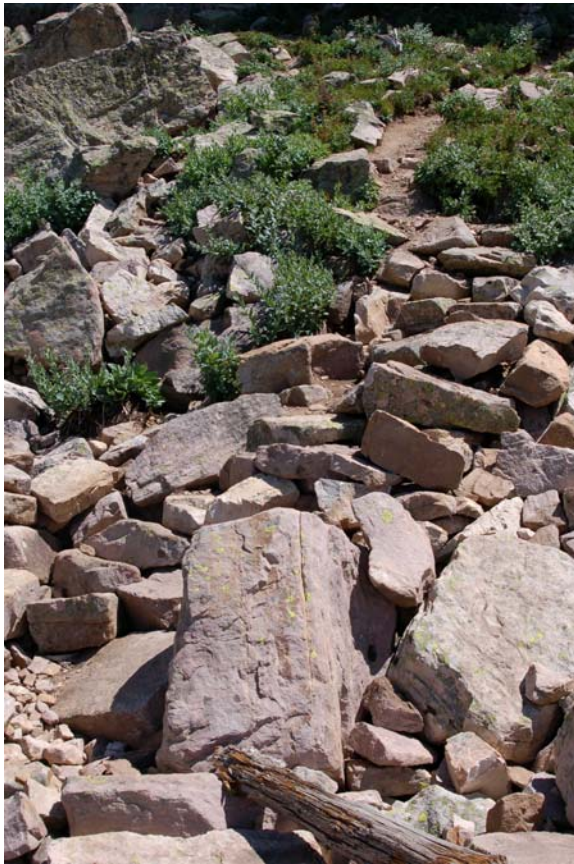
Figure 8. An example of overlapping rock steps that was constructed through a talus field. This type of maintenance structure requires expertise, time, and a good supply of local material.

Maintain informal or formal trails. In circumstances where a new trail alignment is not feasible, sections of informal trails are acceptable, or informal trails are converted to formal trails, managers should address current and future trail impacts through trail maintenance practices. Maintenance includes: defining and reestablishing tread; surface water control such as the installation of waterbars and rolling grade dips; and installation of retaining walls to support tread on steep slopes or hold steep backslope in place. Trail that has a slope of >20% will likely require hardened surfaces or steps. Individual or overlapping steps can be constructed out of on-site material such as rocks or off-site material such as timber and is a common technique implemented at other climbing areas (see Figure 8). These techniques are useful especially on short sections of trail where elevation can be gained in a short distance and realignment is not feasible, yet on extensive steep linear segments, realignment will be a more cost effective long-term solution.

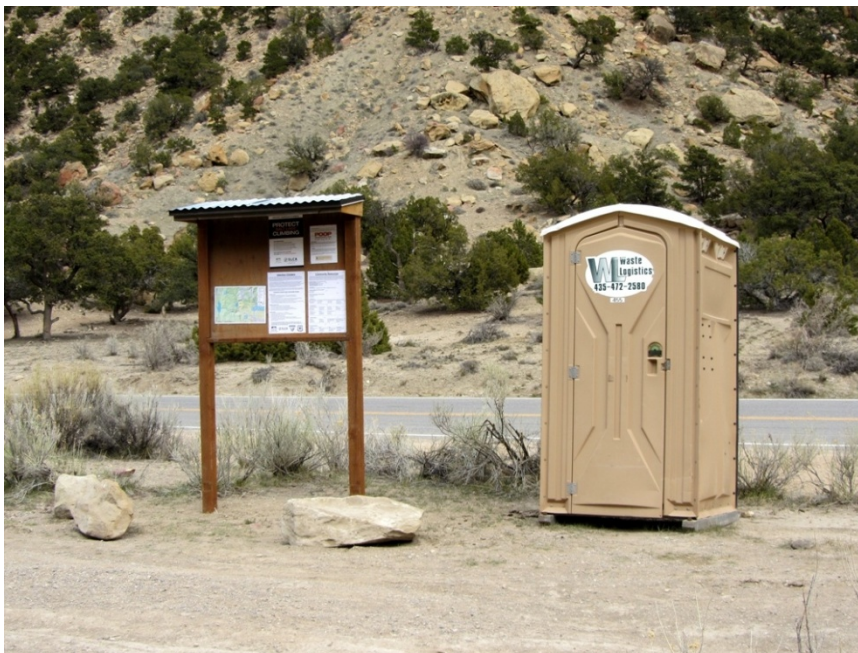
Figure 9. A simple kiosk provides a focal point to disseminate information and educational material while the portable toilet is a temporary solution to manage human waste in heavily-used dispersed campsite areas (Access Fund).

Provide facility development and site design. Simple site design strategies at dispersed campsites can be accomplished such as preventing site expansion or limiting the area for vehicle use by defining the boundary with rocks and logs. While small rocks lined up can define the boundary, additional measures to reduce vehicle encroachment may need to be implemented, such as the placement of large rocks which may require mechanical assistance, or fencing (e.g., buck and rail). Additional site design tactics that can be utilized on current dispersed campsite areas includes identifying campsites with assigned areas and designing and constructing information kiosks that are targeted to specific user groups (see Figure 9).

Facility development may be warranted at dispersed campsite areas with multiple campsites. A noticeable seasonal facility that has been provided for the past few years are portable toilets located in Left Fork (Angler Access Camp) and Right Fork (Mansize Camp) during the spring and fall climbing seasons which has been funded through the Salt Lake Climbers Alliance (see Figure 9). The placement of these facilities has noticeably mitigated human waste issues (no human waste sites were identified at either area). However, human waste sites were still present at other well-used dispersed campsite areas (e.g., Porta Pot Camp and Rock Camp). The presence of these facilities at these locations should continue at a minimum, but for long-term waste management solutions, managers should consider permanently located vault toilets at all three regions of Joe's Valley. Finally, managers could address impacts at dispersed campsites by providing major facility development such as constructing formalized campgrounds. Necessity, location, design, functionality, amenities, user experiences, recreational opportunities, and associated cost and fees should be thoroughly analyzed if managers implement this management strategy.

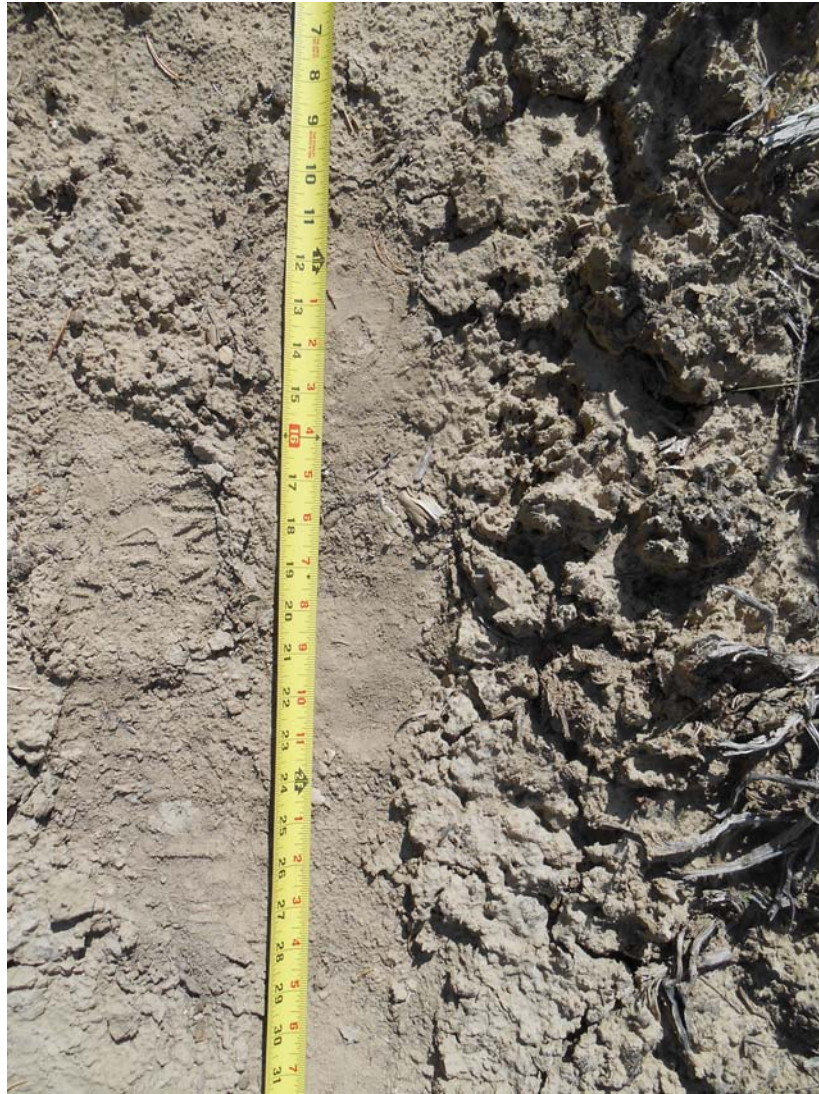
Identified by pronounced change in soil (i.e., compacted compared to non-compacted).

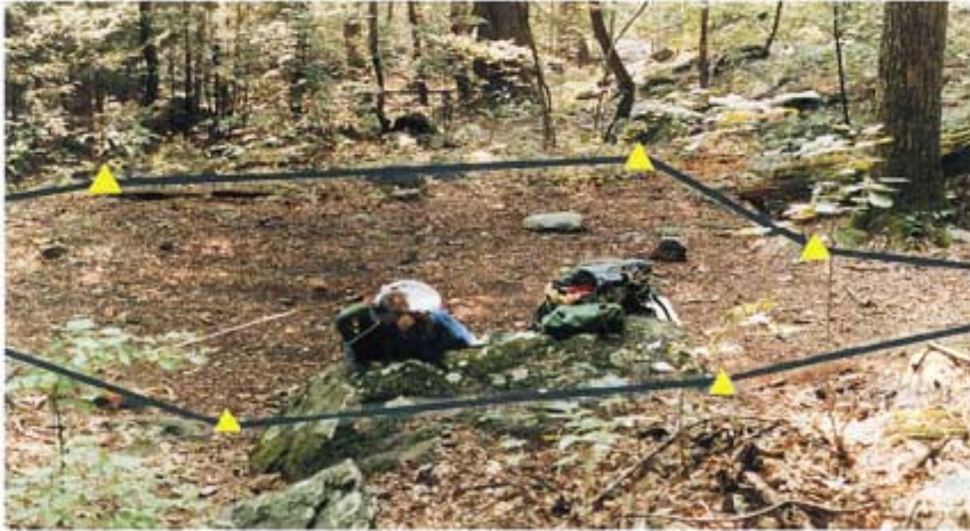
Yellow triangles indicate flagged pin locations which delineate site boundaries.

Site boundaries determined by pronounced changes in vegetation cover.

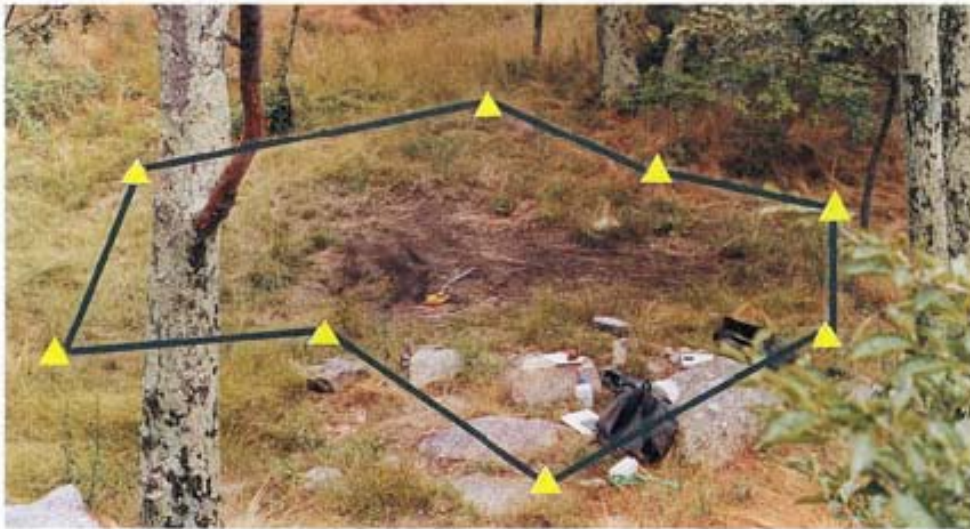
Site boundaries determined by pronounced changes in vegetation height/disturbance.

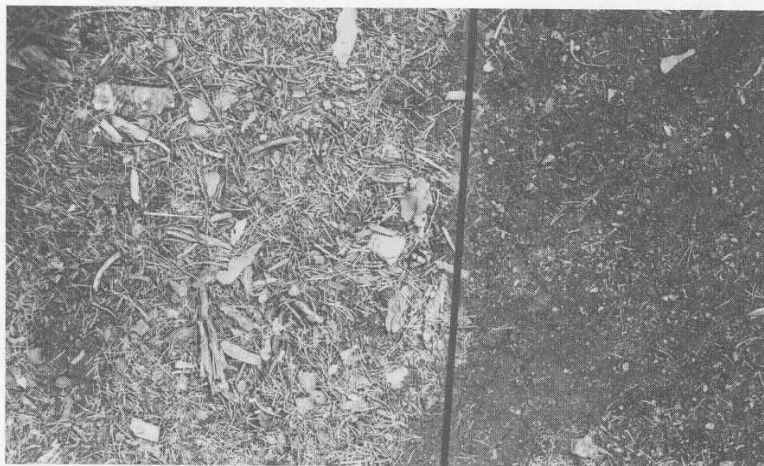
Organic litter on left is pulverized but still covers underlying organic and mineral soil. Dark organic soil on right, which covers lighter colored mineral soil, should be assessed as bare soil.

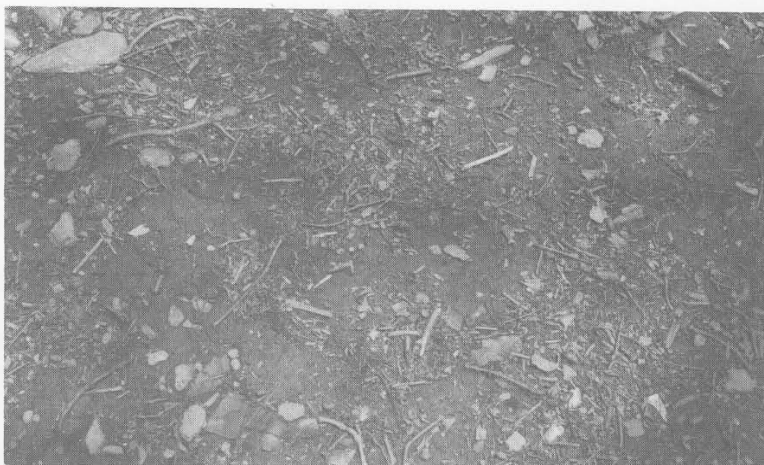
As organic litter is pulverized and eroded from sites the remaining materials often clump together, resulting in a patchwork of organic litter and bare soil which is difficult to evaluate. If patches of organic material are relatively thin and few in number, as illustrated in the photo above, the entire area should be assessed as bare soil. Otherwise, the patches of organic litter should be mentally combined and excluded from assessments.

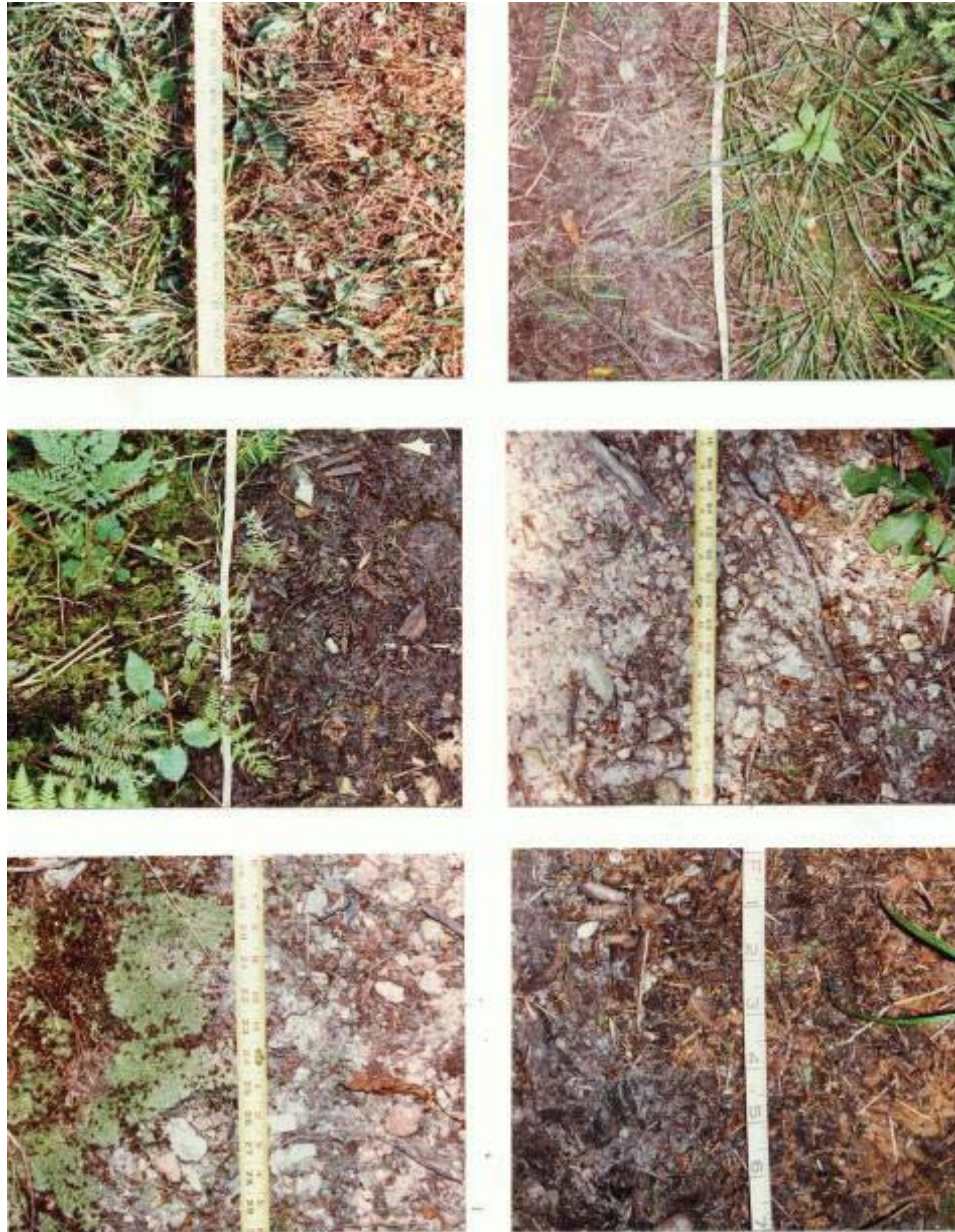
Figure 1. Trail width is defined as the most visually obvious outer boundary of trampling-related disturbance that receives the majority (>95%) of traffic. These boundaries are defined by pronounced changes in ground vegetation height (trampled vs. untrampled), cover, composition, or, when vegetation cover is reduced or absent, by disturbance to organic litter (intact vs. pulverized) or lichen.

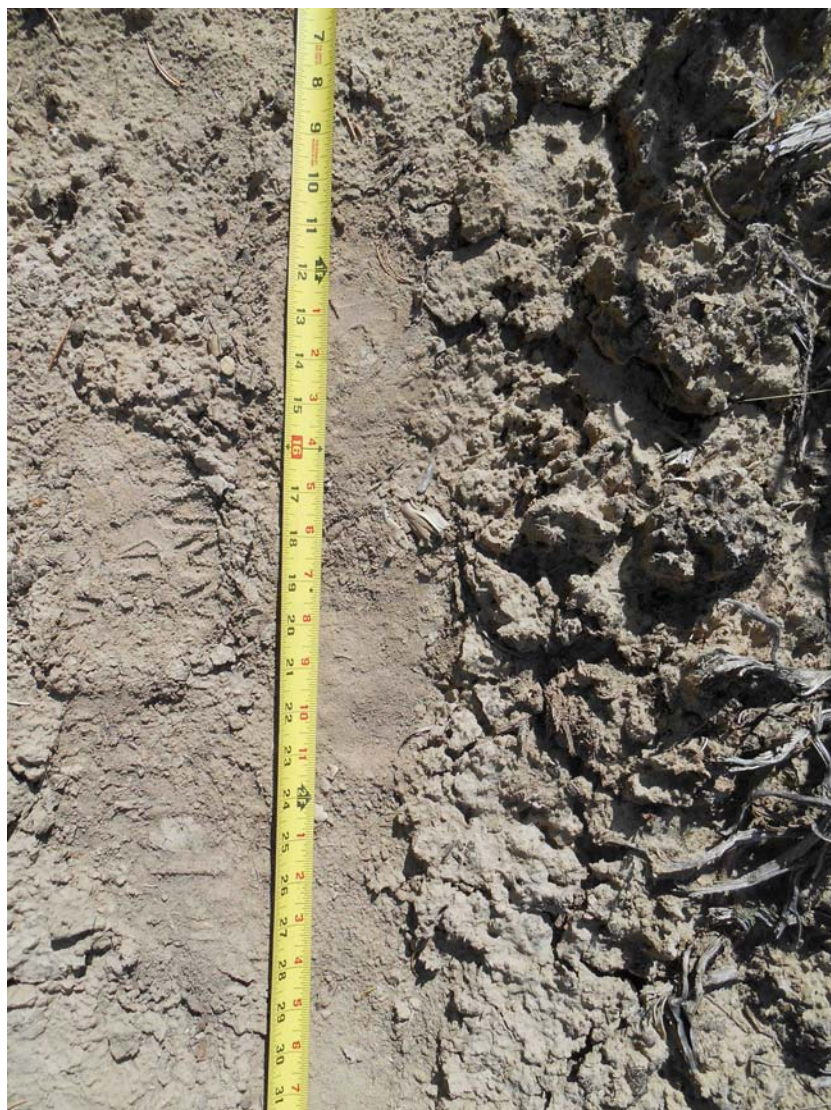
Figure 2. Trail width outer boundary defined by trampling of cryptobiotic soils (Photo by J. Porucznik).

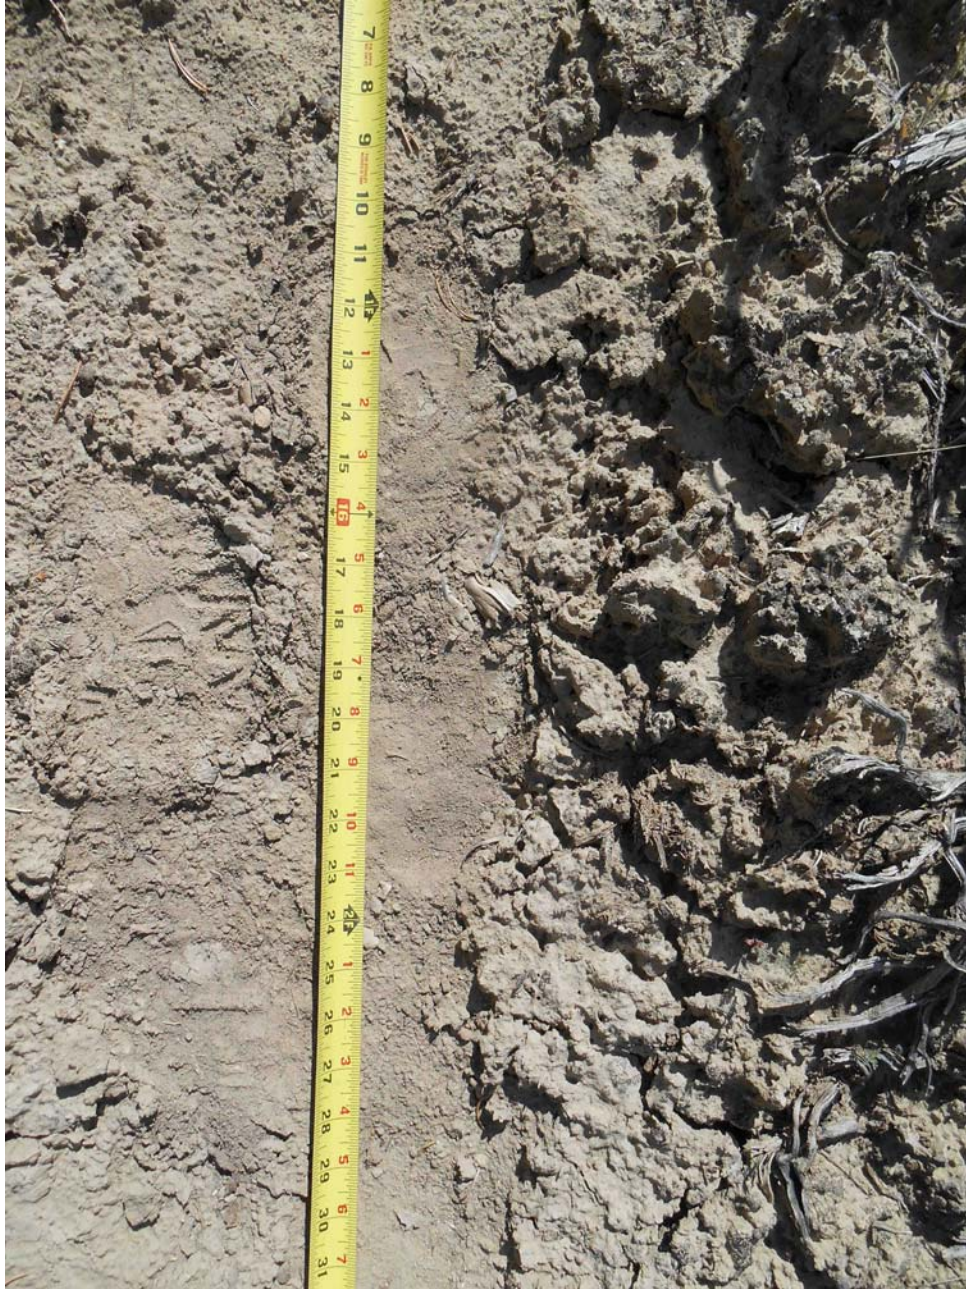
Identified by pronounced change in soil (i.e., compacted compared to non-compacted).

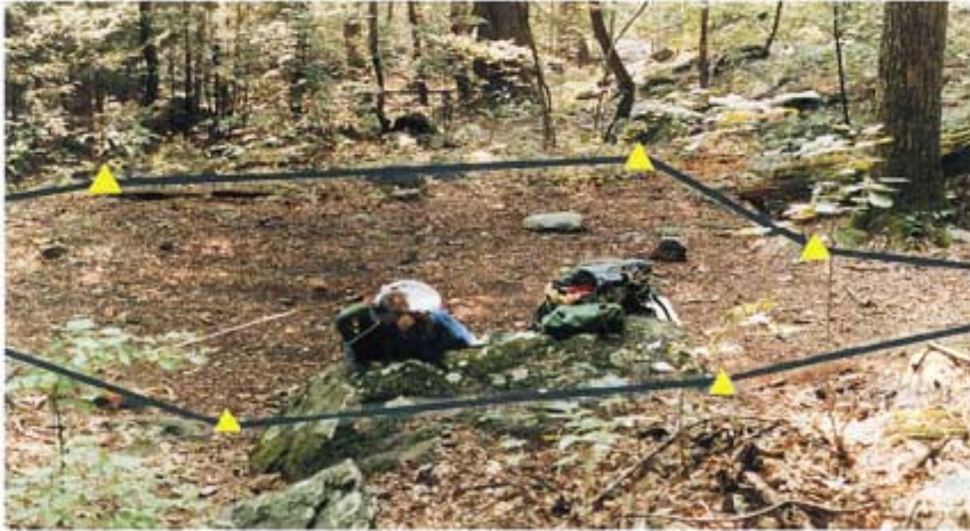
Yellow triangles indicate flagged pin locations which delineate site boundaries.

Site boundaries determined by pronounced changes in vegetation cover.

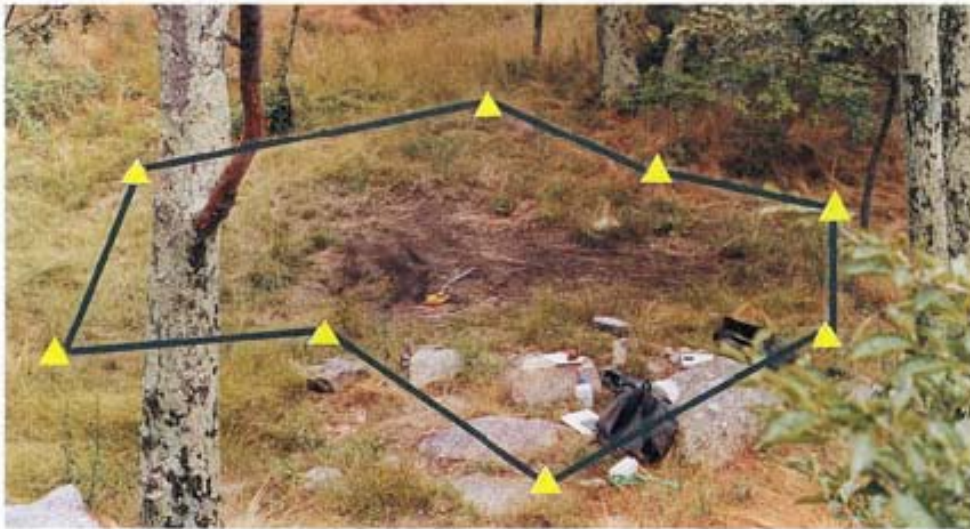
Site boundaries determined by pronounced changes in vegetation height/disturbance.

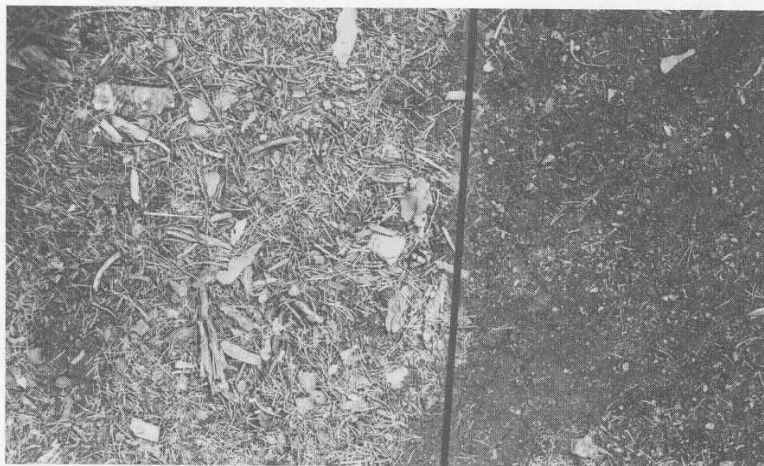
Organic litter on left is pulverized but still covers underlying organic and mineral soil. Dark organic soil on right, which covers lighter colored mineral soil, should be assessed as bare soil.

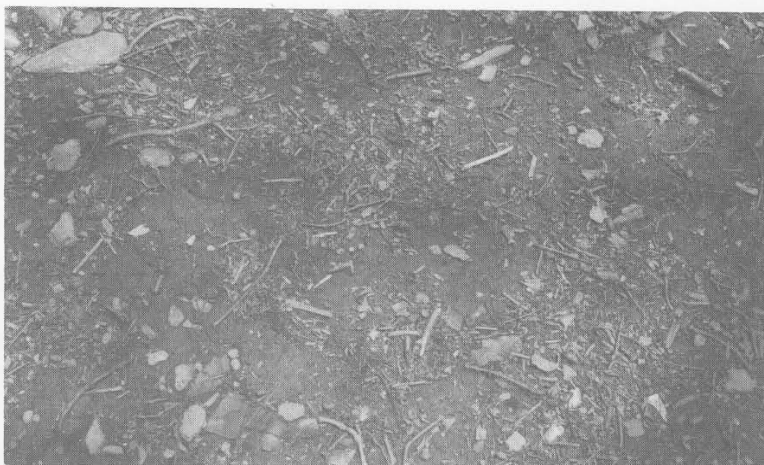
As organic litter is pulverized and eroded from sites the remaining materials often clump together, resulting in a patchwork of organic litter and bare soil which is difficult to evaluate. If patches of organic material are relatively thin and few in number, as illustrated in the photo above, the entire area should be assessed as bare soil. Otherwise, the patches of organic litter should be mentally combined and excluded from assessments.

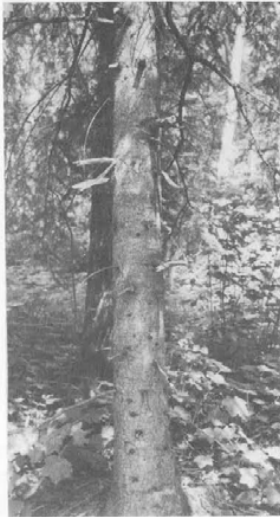
**NONE/SLIGHT**

**NONE/SLIGHT:** No or slight damage such as broken or cut smaller branches, 1 nail, or a few superficial trunk scars.

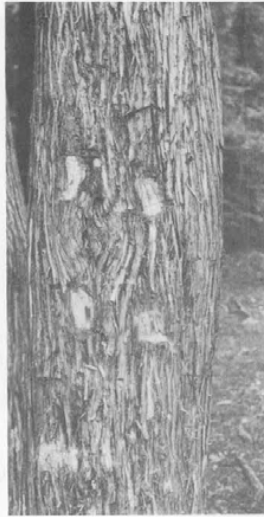
**MODERATE**

**MODERATE:** Numerous small trunk scars and nails or 1 moderate sized scar.

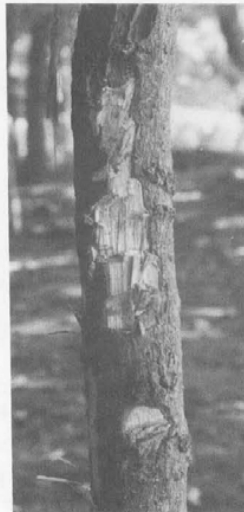
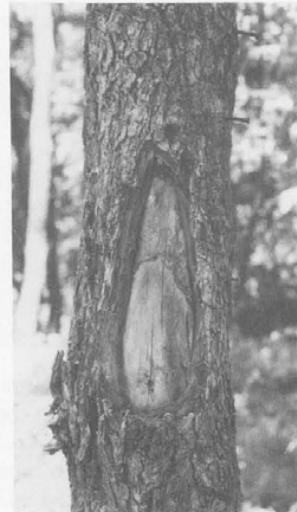
**SEVERE**

**SEVERE:** Trunk scars numerous with many that are large and have penetrated to the inner wood; any complete girdling of tree.

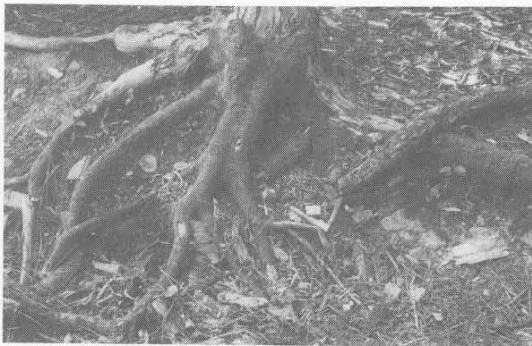
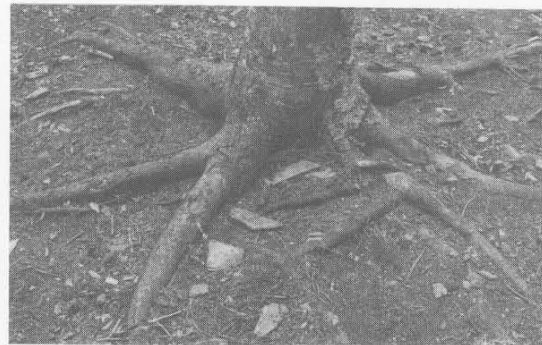
**MODERATE**

**MODERATE:** Top half of many major roots exposed more than 1 foot from base of tree.
