# **Red Hill Bulk Fuel Storage Facility Update**

**Board Meeting  
September 24, 2018**

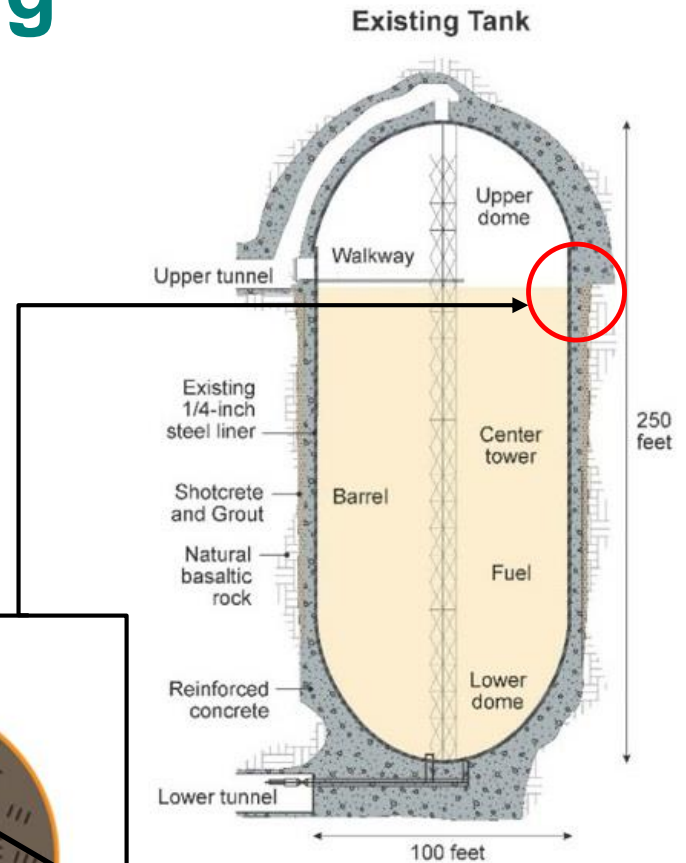
Fuel side of liner

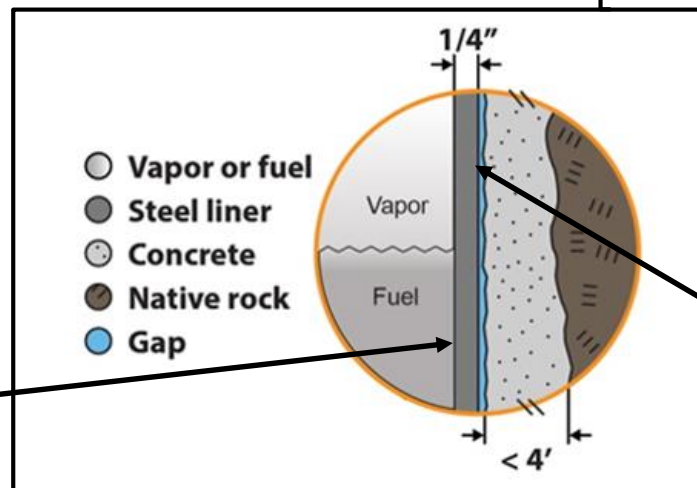
Back side of liner

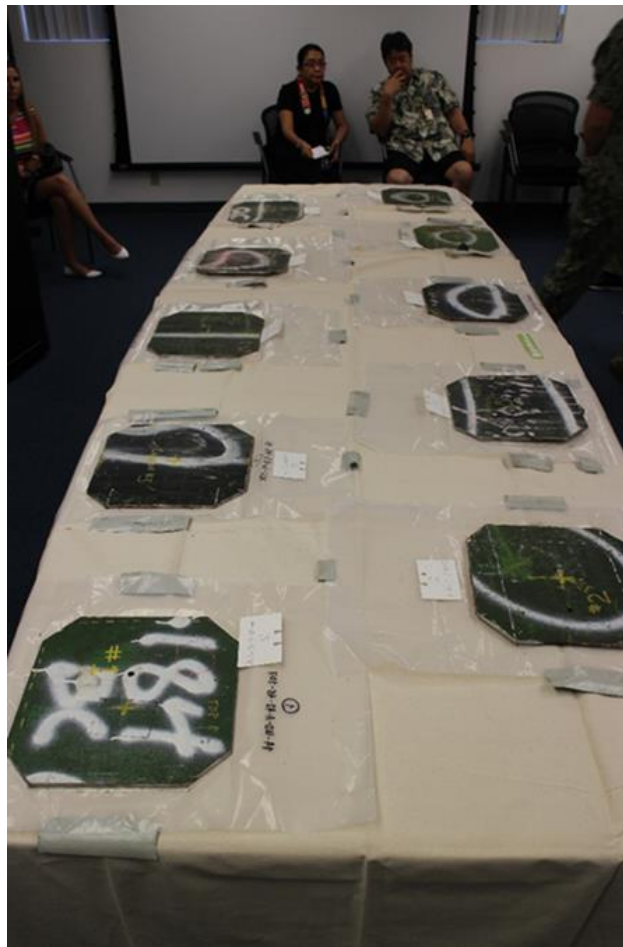
Coupons with  
Fuel Side Up

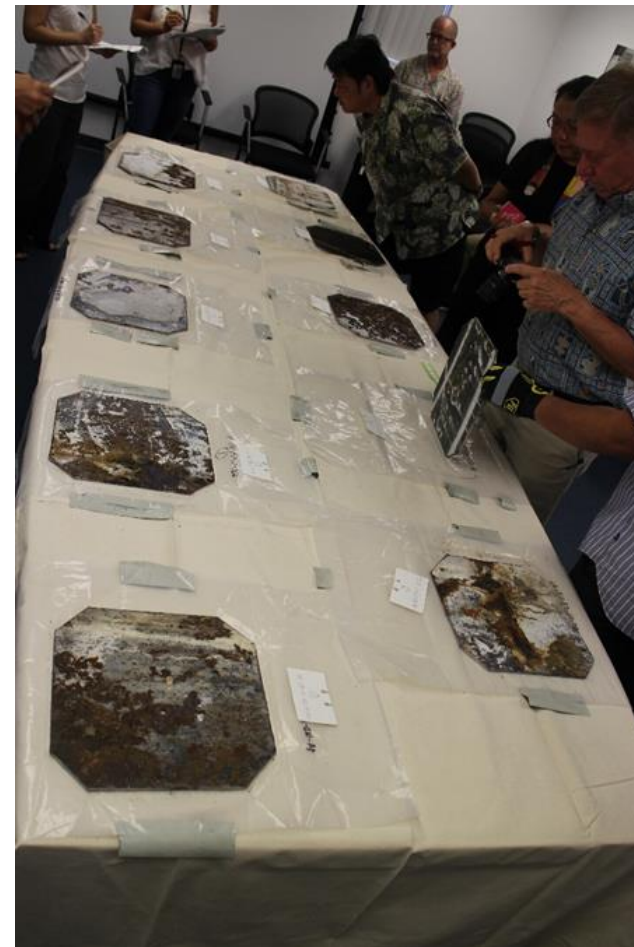
Coupons with  
Back Side Up

- Presence of backside corrosion
  - Half of the coupons exhibited considerably more corrosion than others [Coupons # 1 (UD), 2 (ER), 3 (ER), 7 (BA) and A1(BA)].
  - Potential for through-wall pitting, and associated fuel leaks, is a concern.
- Staining on Backside of Steel
  - Deposits on the backside of some coupons suggest hydrocarbon-staining. [Coupon # 2 (ER), 3 (ER), 7 (BA), 10 (LD) and A1 (BA)]
  - Chemical analysis by independent lab will determine nature of staining.

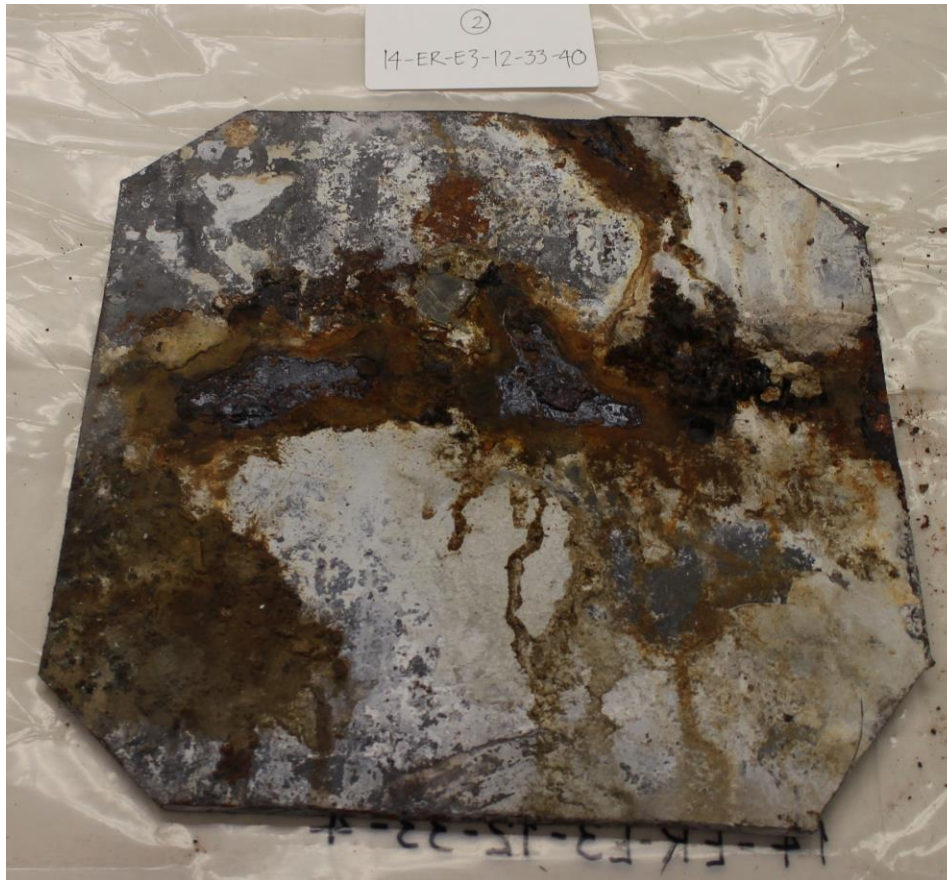
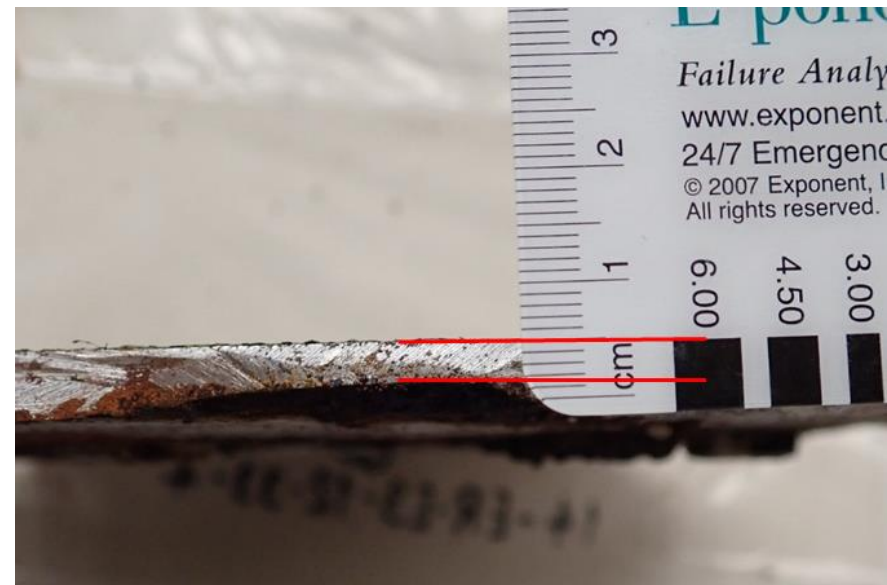
## (Coupon #2) Expansion ring – back side

### NDE Prediction:

- Remaining thickness: 0.150" to 0.157"

### June 25<sup>th</sup> Observations:

- Apparent remaining thickness:  
3mm = 0.118"

- Current NDE Technique Appears to Underestimate Remaining Wall Thickness
  - Corrosion pit depths measured on the cut specimen edges suggest that NDE techniques were not able to locate and measure the thinnest wall of the coupon.
- Work continues under Red Hill Administrative Order on Consent (AOC) to understand tank condition and reach decision on tank upgrade alternative (TUA) selection.

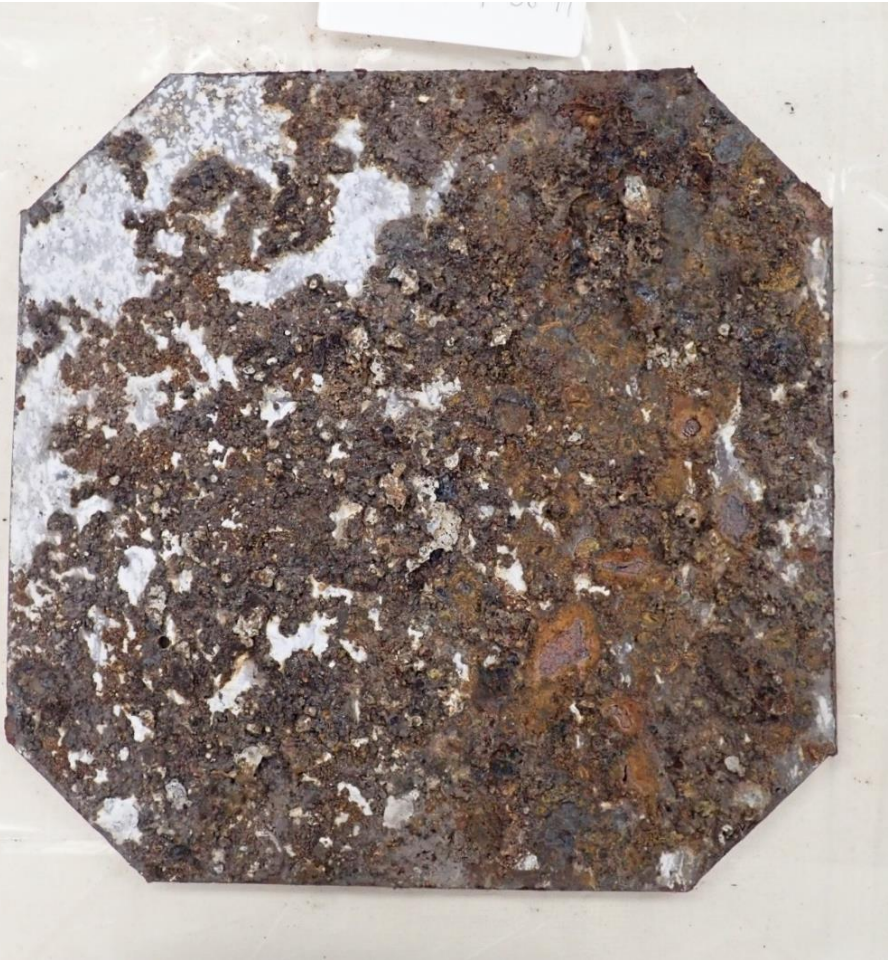
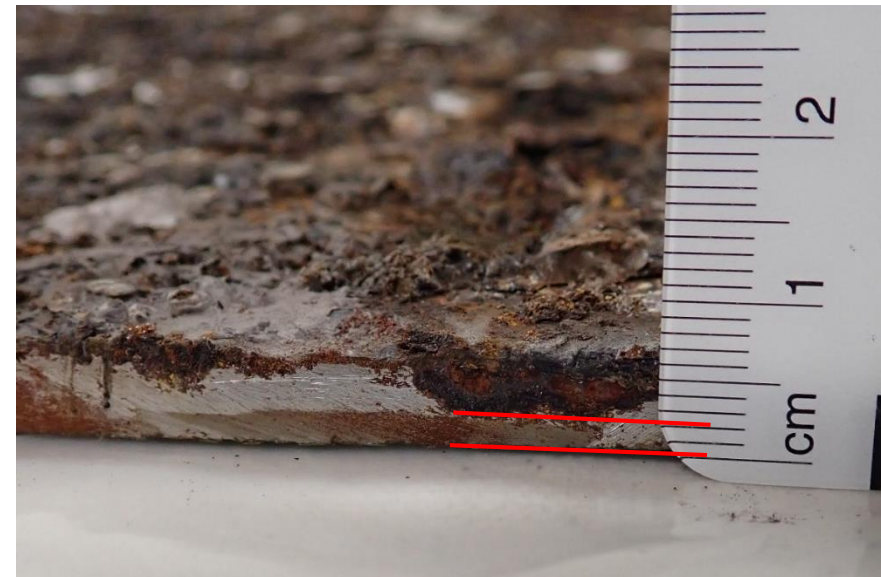
## (Coupon #7) Barrel – back side

### NDE Predictions:

- Minimum remaining thickness:  
0.135" to 0.187"

### June 25<sup>th</sup> Observations:

- Apparent remaining thickness:  
2mm = 0.079"

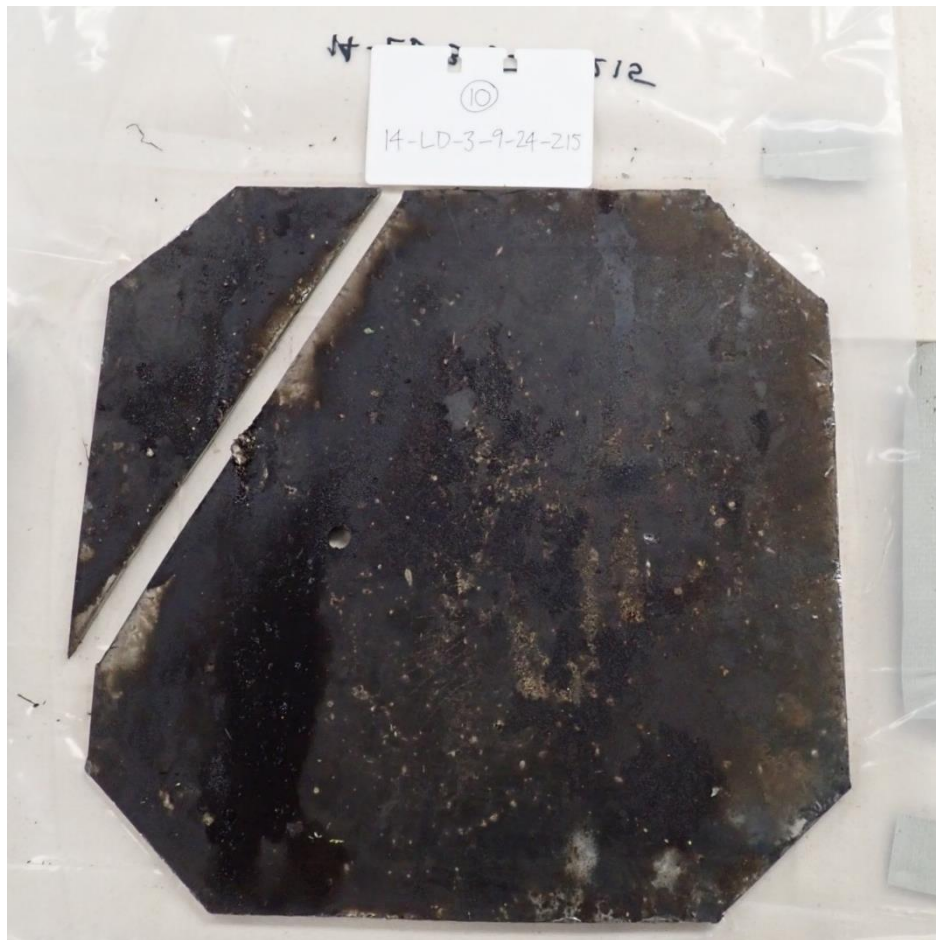
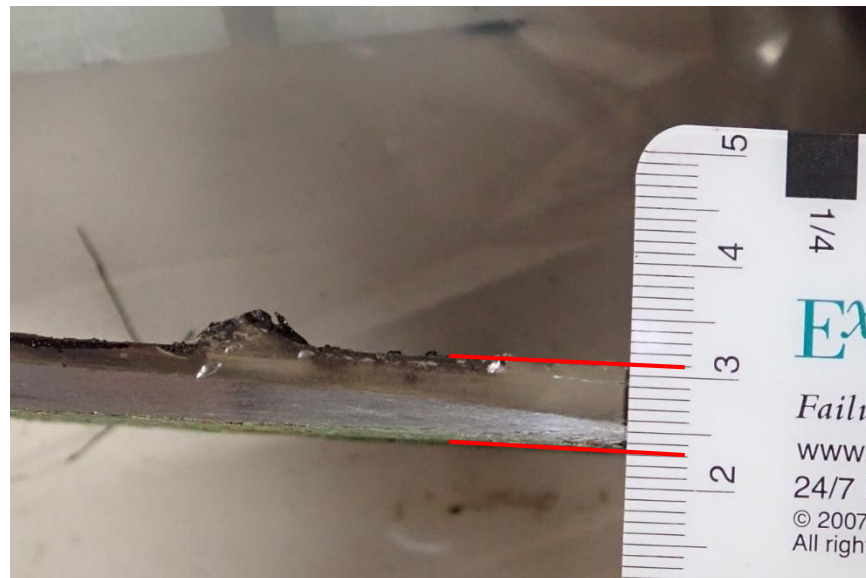
## (Coupon #10) Lower dome – back side

### NDE Predictions:

- Remaining thickness expected to exceed 0.200"

### June 25<sup>th</sup> Observations:

- Apparent remaining thickness: 6.3mm = 0.25" (full original thickness)

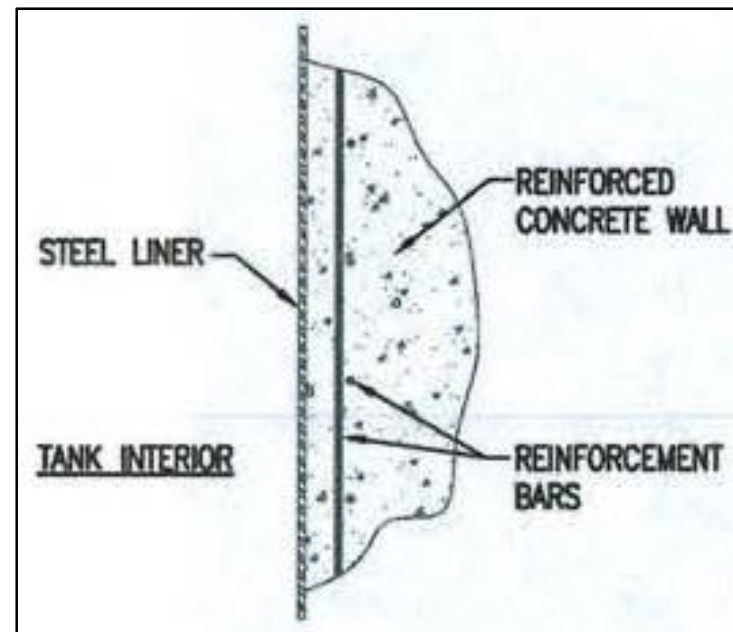
### Single wall

- Existing 1940 single ¼ inch wall separating fuel and environment
- Cannot inspect or maintain back side of the wall
- Back side of wall subject to potential groundwater contact and corrosion

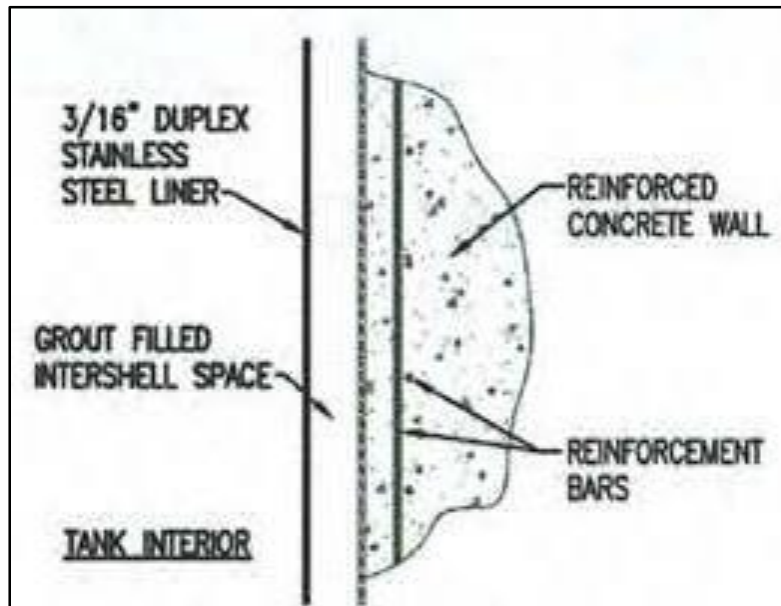
### Composite Wall

- Two walls with 3 inch space filled with cement

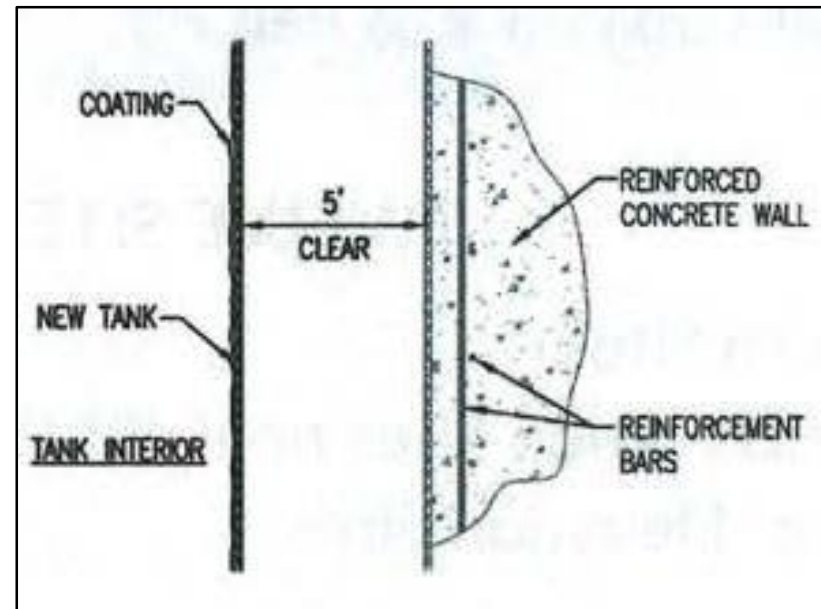
### Interstitial Double Wall

- Two walls with 5 ft. space in between to collect leaked fuel, inspect and maintain inner wall.

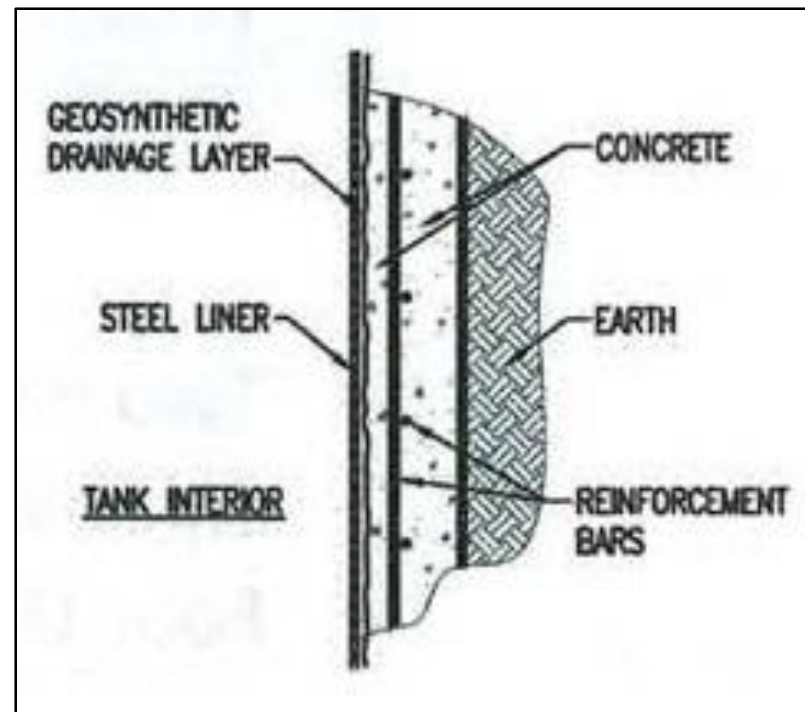
### “Cut and Cover” Double Wall

- New steel liner, geosynthetic drainage layer and concrete design
- Steel liner is one wall, concrete is the second wall
- No interstitial space to inspect between new steel liner and concrete
- Back side of wall in contact with environment
