Preserving
Our
Lifeline:
A Report
on the
State
of the
Bow River

October 1994

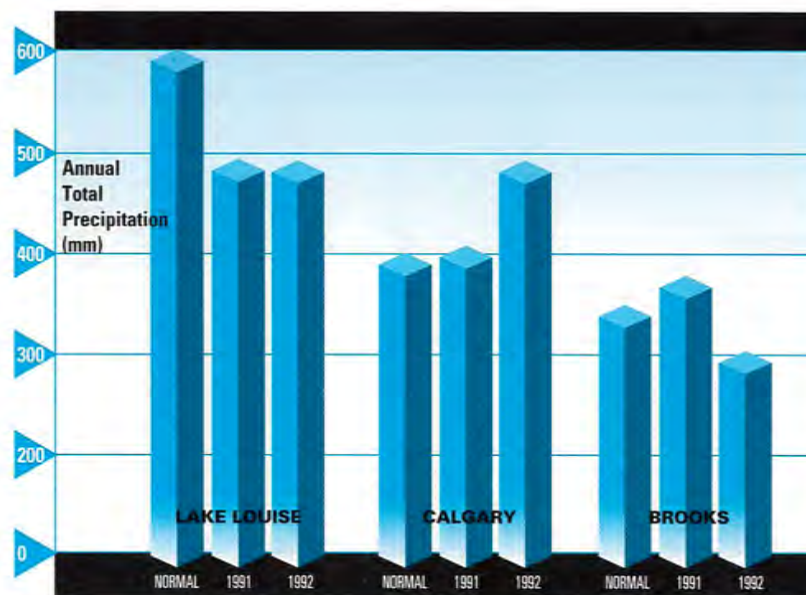
Figure 6. Precipitation in the Bow River Basin

In 1991 and 1992, precipitation in the mountains (Figure 6) was relatively light (about 83 percent of normal). Heavier than normal rainfall in the Calgary area in 1992 and the Brooks area in 1991 produced above-average soil moisture conditions.

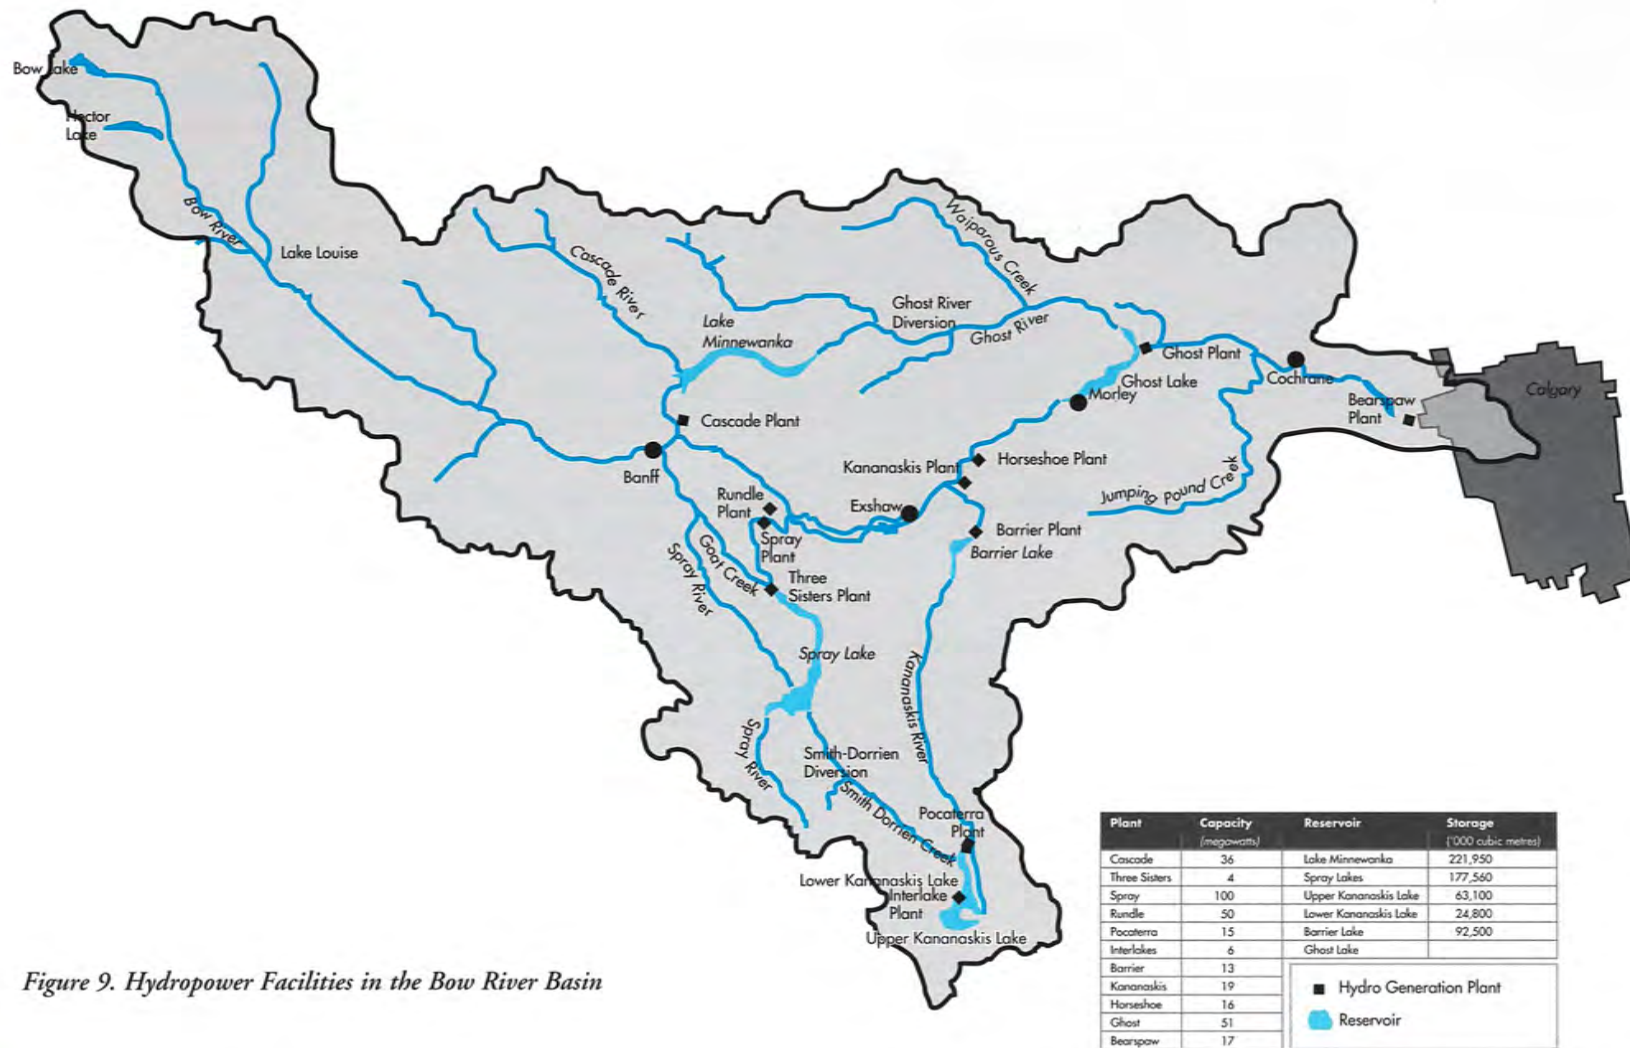
Figure 9. Hydropower Facilities in the Bow River Basin

The hydropower facilities in the Bow River Basin generate 3.5 percent of TransAlta Utilities' total generating capacity. While this is a small amount, it is very significant to TransAlta's operations because, compared to coal-fired thermal power, hydropower can provide quick response to varying demands for power.

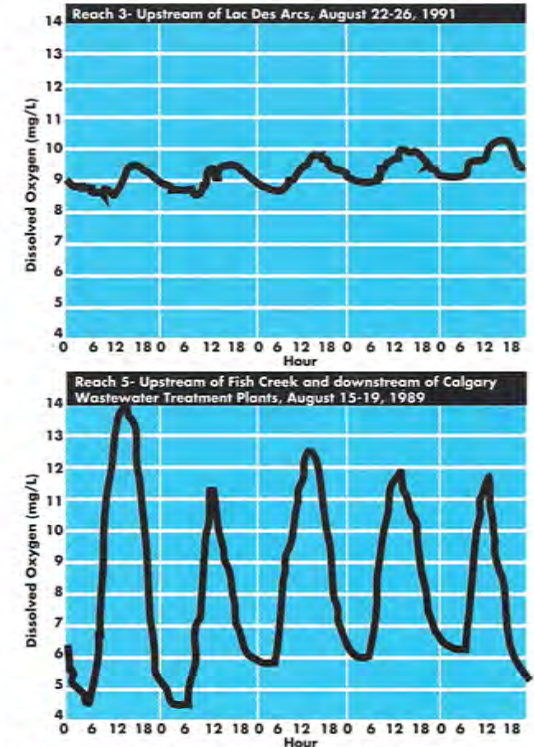
Figure 13. Dissolved Oxygen Levels Upstream and Downstream of Calgary

In the Bow River, benthic algae and macrophytes (weed-like aquatic plants) cause daily fluctuations in the amount of oxygen dissolved in the water. Aquatic plants are useful to fish and other aquatic organisms because they provide food and cover, but they may also reduce levels of dissolved oxygen. Dissolved oxygen must be at adequate levels for fish and other aquatic organisms to survive, and therefore is a good indicator of river health.

The provincial government has studied aquatic plant growth in and below Calgary since 1981. The studies indicate that biomass has been reduced by about two-thirds at sites most impacted by the Calgary wastewater treatment plants since phosphorus began to be removed from the wastewater efflu-

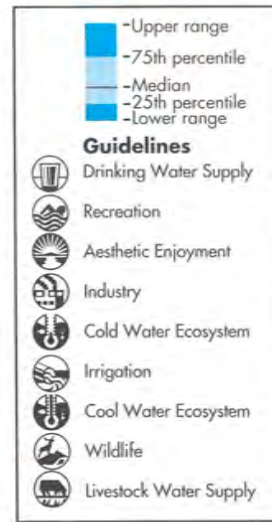
Figure 20.
Reach 1 Water Quality Variables, 1985 to 1992

The time-series data on key water quality variables (Figure 20) indicate very consistent levels over the years shown. The levels are also very low compared to the guideline levels.

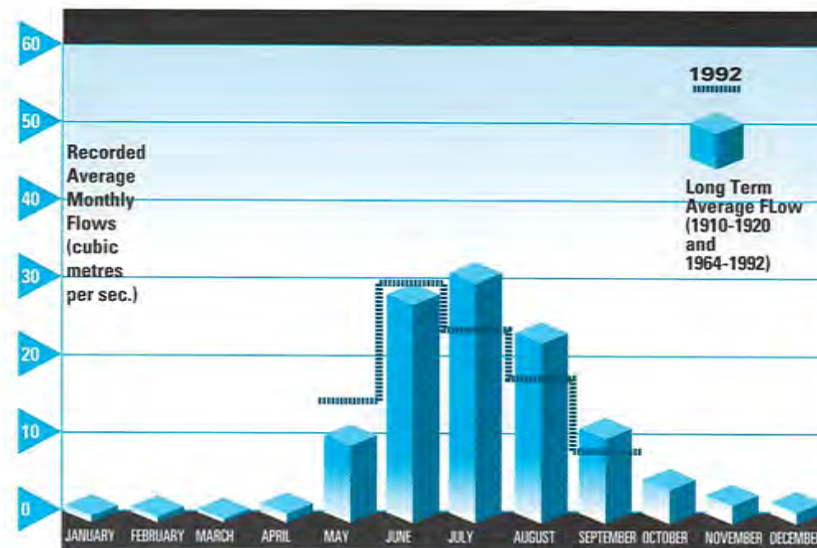
Figure 22. *Monthly Flows at Lake Louise, 1992*

Figure 22 shows the volume of water passing through Reach 1 each month in 1992, and compares them with average flows over the long term. Compared to the long-term average, 1992 May flows were higher, June flows were similar, July and August flows were lower, and September flows were similar.

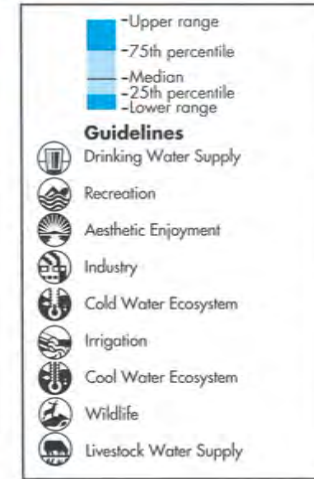
Figure 27. Water Quality Variables, 1985 to 1992

The time-series data for Reach 2 (Figure 27) show consistent levels of nitrate and nitrite over the years at levels far below guideline levels.

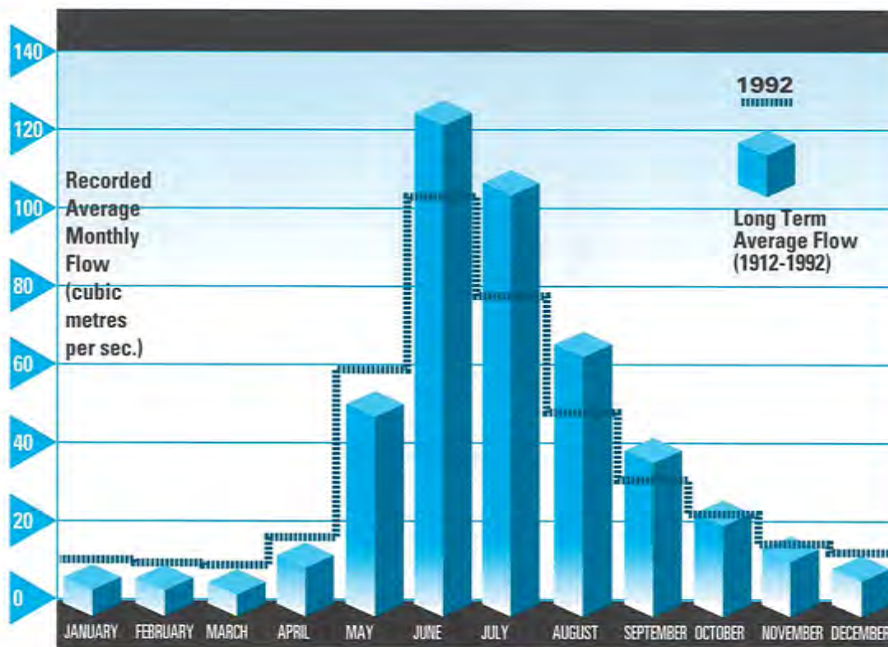
Figure 29. Monthly Flows at Banff, 1992

Figure 29 shows the monthly flows in 1992, and compares them with average flows over the long term. Monthly recorded flows were below average throughout the year with the exception of February to May. Figure 28. 1992 Annual Flow Compared with Long-term Average Flow at Banff

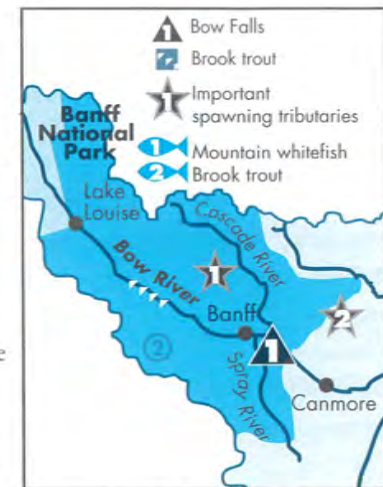
Figure 31. Fish and Fish Habitat in Reach 2

Mountain whitefish is the most widespread of the sportfish in Reach 2, but brook trout are also common (Figure 31). Brown trout are more abundant than brook trout downstream of Bow Falls. There are relatively few cutthroat, bull and rainbow trout in Reach 2.

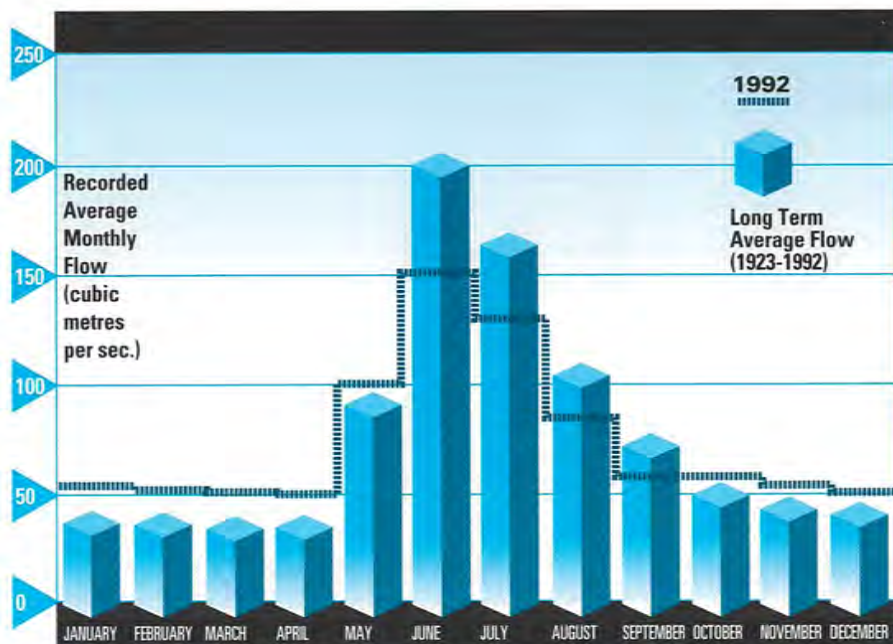
Figure 36. Monthly Flows at Seebe, 1992

long term. The measuring station is located upstream of the Ghost River discharge into the Bow River. The 1992 monthly recorded flows were above average for January to May (caused by releases for hydropower) and below average during the summer months of June to September.

Figure 36 shows monthly flows in 1992 and compares them with average flows over the

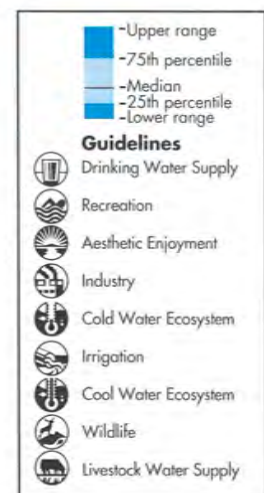
Figure 42. Reach 4 Water Quality Variables, 1985 to 1992

The time-series data for Reach 4 (Figure 42) are also limited. Fecal coliform levels have been somewhat erratic, but well within the guideline levels for irrigation and recreation. There are no apparent trends or concerns with respect to the guidelines in the other variables shown in Figure 41.

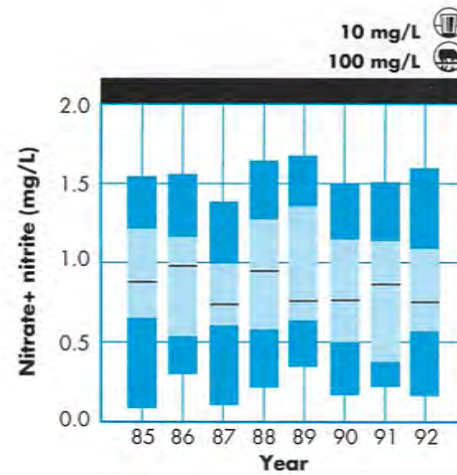
Figure 61. Reach 7 Water Quality Variables, 1985 to 1992

The time series data for Reach 7 (Figure 61) show that filterable residues have remained steady and well below the guideline limits for irrigation and livestock watering. Fecal coliform levels have been increasing since the late 1980s and are generally at the guideline limits for irrigation and recreation. Phosphorous levels

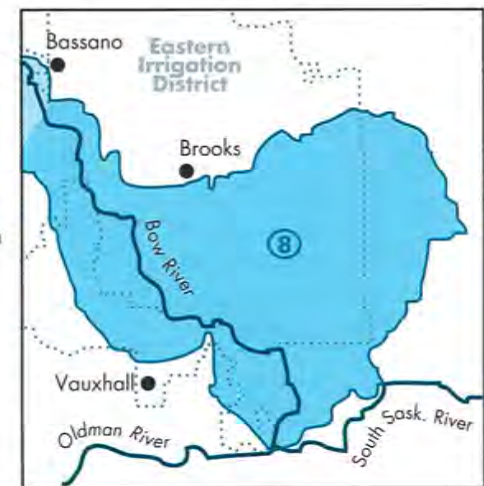
Figure 67. Reach 8 Map

In Reach 8, the river flows from Bassano Dam cutting a fairly deep valley cross mostly undulating prairie lying within rural municipalities. The river ends where it joins the Oldman River and forms the South Saskatchewan River (Figure 67). This is the longest reach of the river at 185 kilometres. The South Saskatchewan River flows eastward through Medicine Hat into Saskatchewan, where it eventually drains via the Saskatchewan-Nelson River system into Hudson Bay.

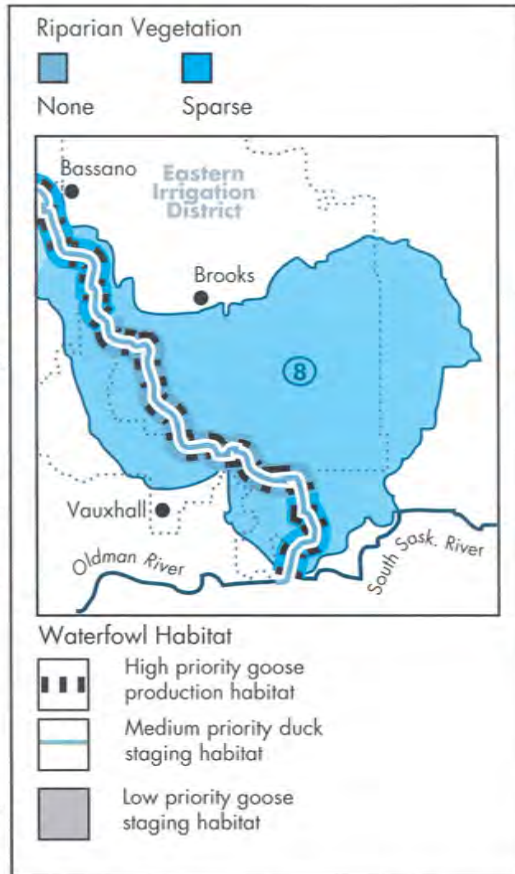
Figure 73. Waterfowl, Wetland Habitat and Riparian Vegetation in Reach 8

In this reach, tree cover diminishes to scattered clumps of balsam poplar and plains cottonwood (Figure 73). Grasses and shrubs dominate the valley. Cattle grazing and beaver activity have not caused any changes in riparian vegetation since the 1880s.

Wetland habitats along the reach are limited because of the steep banks of the Bow River valley (Figure 73). Also, withdrawals of significant amounts of water in the summer at Bassano Dam probably restrict downstream brood production. The water is too shallow to provide protection from predators and feeding habitat for diving ducks. Within the irrigation district, approximately 40 000 acres of wetland habitat is maintained by irrigation withdrawals.
