## Hotel / Resort Restoration

### Restoring & Waterproofing Planters

This project highlight was the restoration of the fourth floor pool deck planters, which are located directly over the ballrooms at the Fort Lauderdale Marriott North, in Fort Lauderdale, Florida.

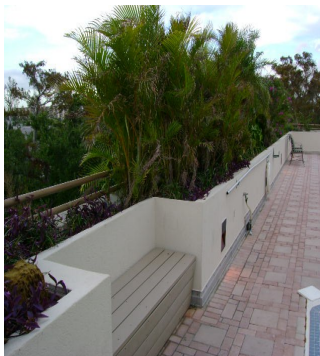
Typical view of pool deck planters on the 4th floor

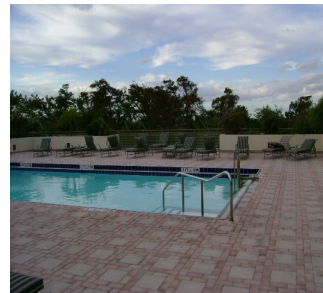
Typical view of pool deck planters on the 4th floor
