# The Triangle Papers

EPA Headquarters, Federal Triangle, Washington, DC

Volume 1, Issue 1  
April, 2005

## *The Systems Connection: - Chemical Water Treatment*

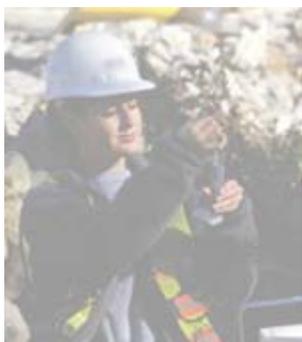
Testing needs to be performed by skilled personnel, capable of assessing problems and recommending immediate solutions

To be effective, all testing must be done on a consistent basis by qualified technicians.

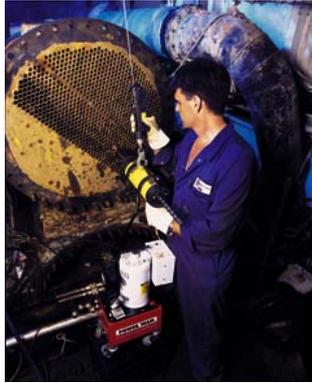
Corrosion can destroy the steel end bells or heads of the chiller condensers. In severe cases the results of corrosion can be holes in the condenser heads creating leaks.

Chillers need to be opened up to have their tubes inspected, and to have their tubes brushed. Excessive tube wear can cause expensive tube replacement, or even tube breaches.

The steel tube sheet within the condenser can also be severely corroded. In extreme cases the steel can become so pitted around the copper condenser tubes that water can leak into the refrigerant system. This is a major and costly repair that requires the chiller to be out of service for long periods of time.

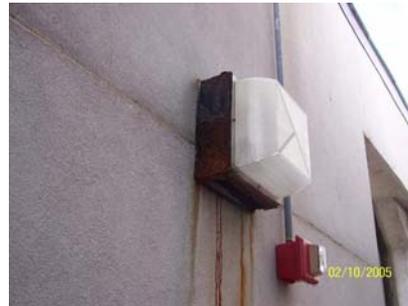
North-South cooling tower, showing tower overspray creating rust and corrosion.

The metal structures are damaged by rust and corrosion. In advanced stages the structural members of the tower are weakened. The bottom of the basin can rust through creating leaks with loss of water and chemicals. Constant exposure to chemicals can also cause roof damage.

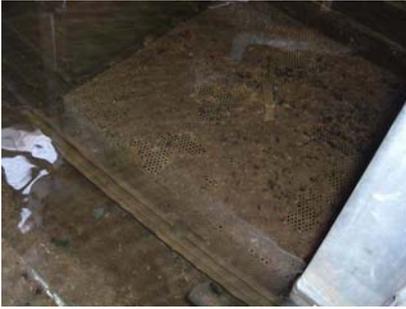
Loose debris created by particles of rust, corrosion or calcium deposits will collect in the Cooling Tower basin. The debris will migrate to the intake screen and clog the screen. This will restrict water flow to the chillers.

East-West cooling tower, showing sump strainer covered in debris and scale.

Loose debris in the system will clog pump strainers. Pump impellers can also become worn. Both conditions will reduce water flow in the systems.

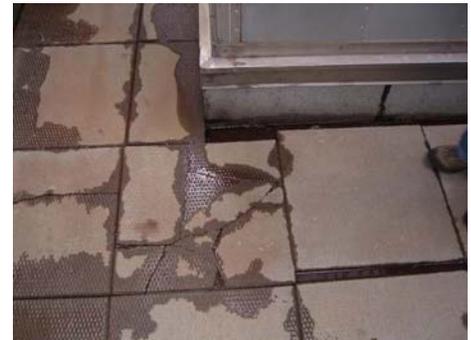
In the case of condenser water, one of the main causes can be from excess bleed due to faulty or improperly set controls. A known major cause in the East-West condenser water loop is overflow of the tower basin due to faulty or misadjusted make up water controls. This has already resulted in using an overabundance of chemicals at higher than necessary costs.

*The truth is* that spillage of chemicals on the roof may cause premature failure of sections of the roofing systems.

Overflow of cooling tower water onto East-West roof..
