# FLAG Performance Extra Antifouling £69.95 for 2.5ltr

A pretty effective, low biocide antifouling that's suitable for a wide variety of craft and locations.

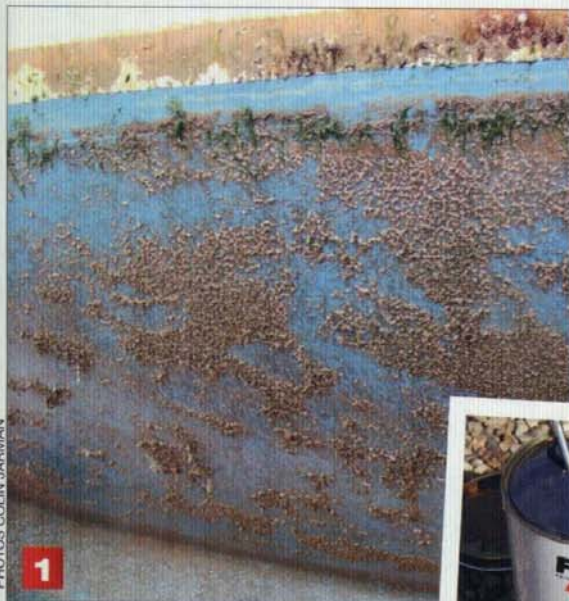
**1. Patches, like this, of muddy slime dotted the hull, but washed off instantly. 2. The mud cleared to leave clean, intact paint with just a line of barnacles along the foot of the keel. 3. Spraying off and even the waterline begins to show considerable improvement.**

could be wiped off with just a finger. I must emphasise, and the photos show, that this was patchy coverage not continuous and it sprayed off in a trice with a pressure spray to show a clean layer of intact paint beneath.
