**FLAG CRUISER ANTIFOULING £39.95 per 2.5lt**  
 Rating ★★★★★

When the Flag Cruiser Antifouling was applied to *Moonshadow* at the beginning of the 2003 season, I wrote that I was impressed by its covering qualities and the ease with which it went on with a small paint roller.

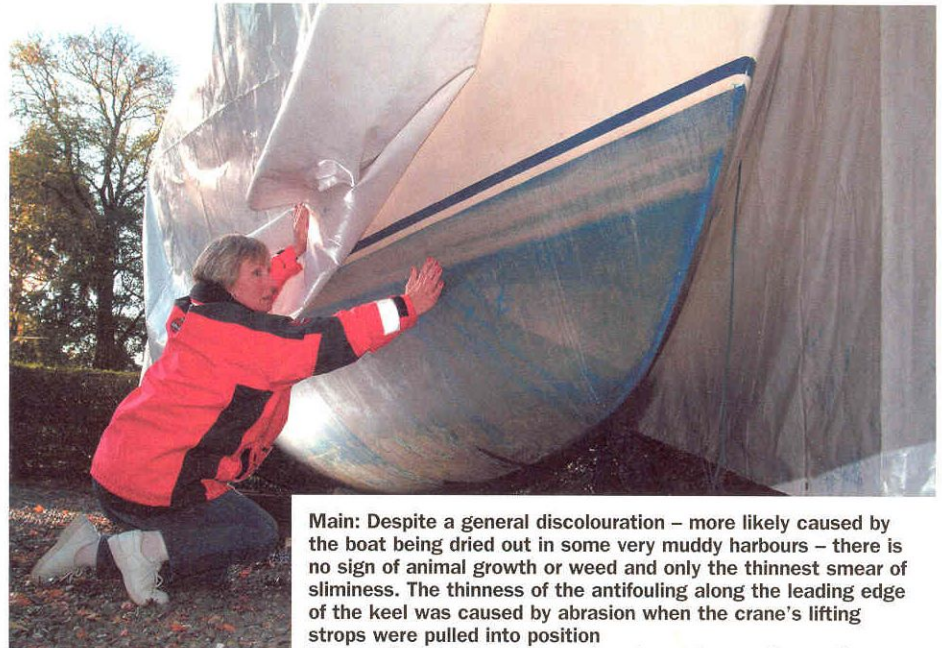
**Main:** Despite a general discolouration – more likely caused by the boat being dried out in some very muddy harbours – there is no sign of animal growth or weed and only the thinnest smear of sliminess. The thinness of the antifouling along the leading edge of the keel was caused by abrasion when the crane's lifting strops were pulled into position  
**Below left/right:** Apart from minor barnacle growth near the rudder stock, the rudder area was pretty clean

Well, yes, it did. At the end of the season there was absolutely no sign of weed growth and only a very slight veil of slime that was so thin it could easily be put down to staining or discolouration from dirty mud. There was the start of barnacle growth beneath and around the bottom of the rudder, but it's only fair to say that this area takes a great deal of abrasion when the boat takes the ground in thick mud and would need a 'hard' rather than this 'eroding' type of antifouling to cope.

I found this Flag Cruiser self-polishing, eroding antifouling to be perhaps a little more prone to wear than some others. Certainly where the strops encompassed the hull when the boat was lifted out, there is now a distinct lack of coating. I feel certain that the slight barnacle growth

around the bottom of the rudder is a direct result of the boat's regular grounding and settling into mud. This has, quite naturally, worn away the coating.  
**Philip Dunn**  
 Contact C W Wastnag ☎ 01621 785173  
 Email sales@flagfinishes.co.uk  
 Website www.flagfinishes.co.uk
