Designing the Lake to Lake Trail

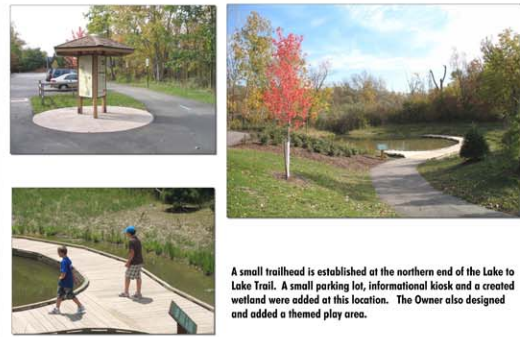
Providing a Trailhead

A small trailhead is established at the northern end of the Lake to Lake Trail. A small parking lot, informational kiosk and a covered picnic table were added at this location. The Owner also designed and added a themed play area.

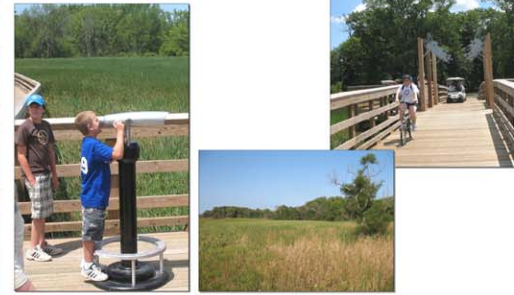
Viewing Lake Abram

Lake Abram is surrounded by wetlands and not easily accessible. It was decided early on to try to obtain a glimpse of this natural water body from the trail. An overlook was carefully located and elevated to provide this view. The addition of telescopes makes the lake appear nearby.

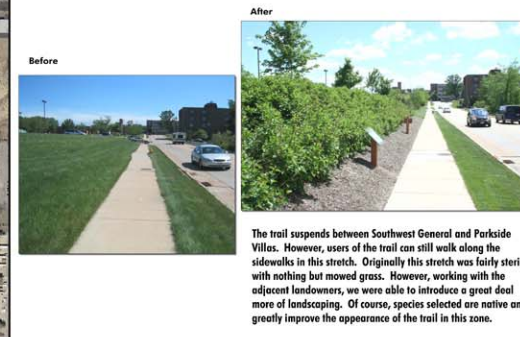
Landscaping along Hepburn Road

The trail suspends between Southwest General and Parkside Villas. However, users of the trail can still walk along the sidewalks in this stretch. Originally this stretch was fairly sterile with nothing but mowed grass. However, working with the adjacent landowners, we were able to introduce a great deal more of landscaping. Of course, species selected are native and greatly improve the appearance of the trail in this zone.

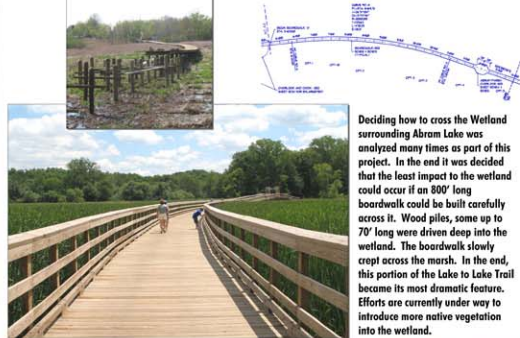
Crossing a Category 3 Wetland

Deciding how to cross the Wetland surrounding Abram Lake was analyzed many times as part of this project. In the end it was decided that the least impact to the wetland could occur if an 800' long boardwalk could be built carefully across it. Wood piles, some up to 70' long were driven deep into the wetland. The boardwalk slowly crept across the marsh. In the end, this portion of the Lake to Lake Trail became its most dramatic feature. Efforts are currently under way to introduce more native vegetation into the wetland.

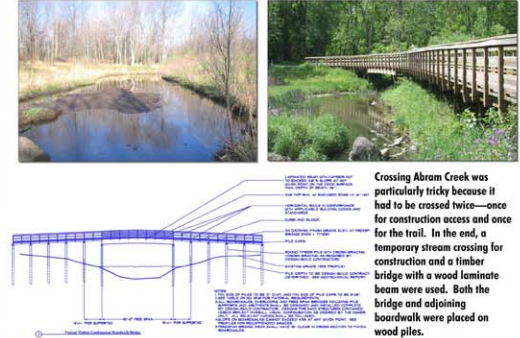
Crossing Abram Creek was particularly tricky because it had to be crossed twice—once for construction access and once for the trail. In the end, a temporary stream crossing for construction and a timber bridge with a wood laminate beam were used. Both the bridge and adjoining boardwalk were placed on wood piles.

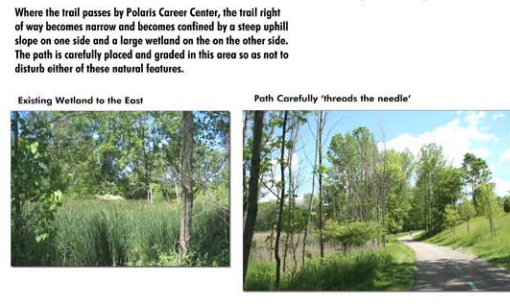
Threading the Needle Between Wetlands & Private Property

Where the trail passes by Polaris Career Center, the trail right of way becomes narrow and becomes confined by a steep uphill slope on one side and a large wetland on the other side. The path is carefully placed and graded in this area so as not to disturb either of these natural features.

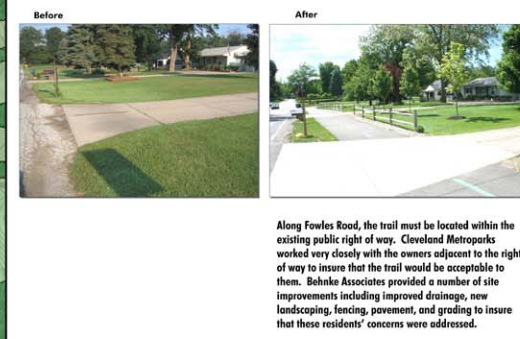
Traveling Along Fowles Road

Along Fowles Road, the trail must be located within the existing public right of way. Cleveland Metroparks worked very closely with the owners adjacent to the right of way to insure that the trail would be acceptable to them. Behne Associates provided a number of site improvements including improved drainage, new landscaping, fencing, pavement, and grading to insure that these residents' concerns were addressed.

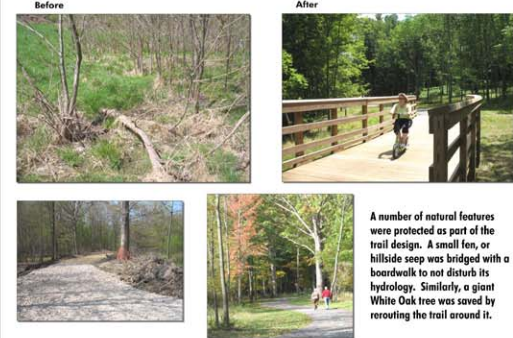
Protecting Natural Features

A number of natural features were protected as part of the trail design. A small fen, or hillside seep was bridged with a boardwalk to not disturb its hydrology. Similarly, a giant White Oak tree was saved by routing the trail around it.

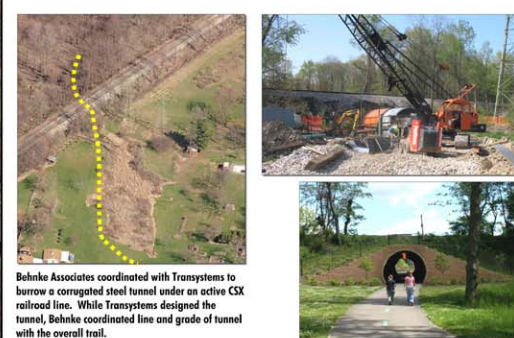
Crossing Under CSX Railroad

Behne Associates coordinated with Transystems to borrow a corrugated steel tunnel under an active CSX railroad line. While Transystems designed the tunnel, Behne coordinated line and grade of tunnel with the overall trail.

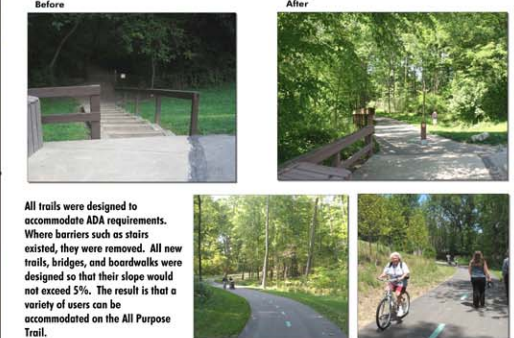
Improving ADA Accessibility

All trails were designed to accommodate ADA requirements. Where barriers such as stairs existed, they were removed. All new trails, bridges, and boardwalks were designed so that their slope would not exceed 5%. The result is that a variety of users can be accommodated on the All Purpose Trail.
