# Hidden Asbestos

Tech-Bits is a publication of ASTI Environmental, PO Box 2160, Brighton MI 48116-2160. For a free subscription call 800-395-ASTI or visit [www.asti-env.com](http://www.asti-env.com)

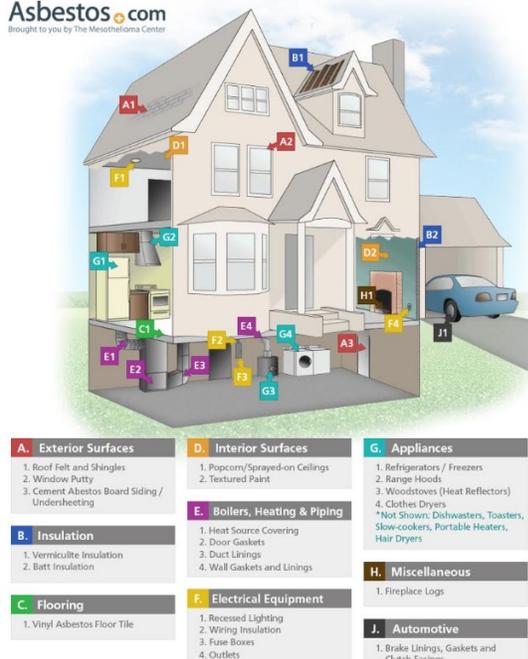
Figure 1: Graphic of common asbestos-containing materials courtesy of Asbestos.com

You might not be aware of some of the common uses of asbestos, but our inspections always include decorative plaster, sprayed-on ceilings, suspended ceiling tiles, drywall, mudding compound, mastic, roof tar, window caulking, cement piping used in air handling systems, and biocide flooring. We sample the usual suspects and typically find chrysotile, but have found asbestos in unusual materials. As a general rule, if we observe a material with a unique look or peculiar finish we will collect samples.

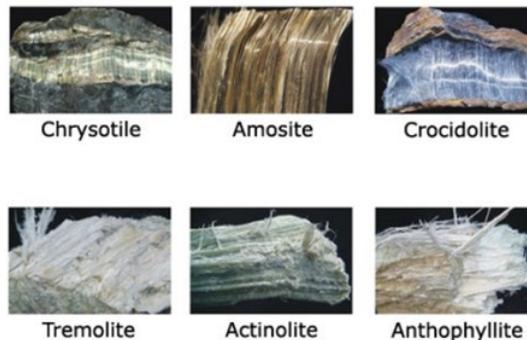
Figure 2: The six asbestos varieties <http://www.linsch.co.uk/asbestos.php>

**Chrysotile (White Asbestos)** is the most common and is often contaminated with trace amounts of tremolite. Chrysotile fibers are fine in texture and possess high flexibility and excellent heat resistant properties. It is ideal for use within cement, drywall, adhesives, roofing materials, and flooring.

**Amosite (Brown Asbestos)** is mined mainly in Africa. Amosite is a very strong and heat-resistant type of asbestos. It is commonly used in cement sheets, plumbing, and electrical insulation.

**Crocidolite (Blue Asbestos)** has very fine and brittle fibers. It is commonly used in ceiling tiles, spray-on coatings, cement products, reinforced plastics, plumbing gaskets, and steam engine insulation.

Three rare asbestos varieties are **actinolite, anthophyllite, and tremolite**. These rare types of asbestos were not intentionally mined, but are found as trace asbes-

tos varieties in other types of asbestos. All six asbestos varieties are considered hazardous to human beings.

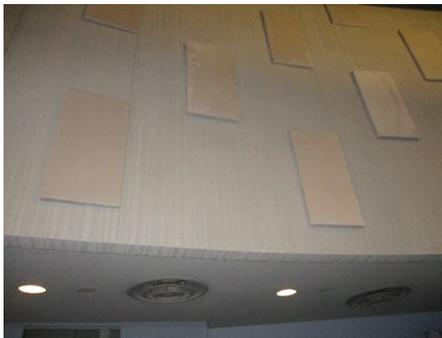
Another uncommon source of asbestos was found in a material used as sound proofing panels on walls of an auditorium (Figure 3). The sound proofing material

Figure 3: Sound proofing panels found on the walls of an auditorium.

compound, which are common sources of asbestos. The drywall and mud joint compound did not contain asbestos, but the sound proofing panels did.

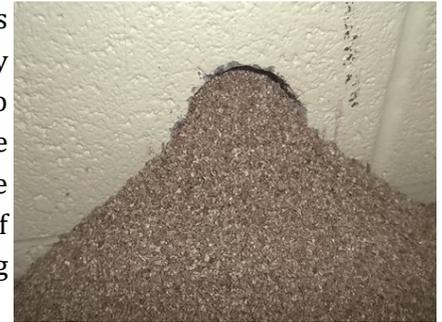
Asbestos can also be found in wall cavities that are not typically included in the initial inspection. For example, during a demolition project, the contractor punched a hole in the exterior concrete block wall of a school and loose insulation spilled out (Figure 4). Demolition was halted, the loose insulation was analyzed, and vermiculite/tremolite asbestos was identified. An asbestos abatement company was engaged to remove the loose insulation before the demolition of the school building resumed.

Figure 4: Loose insulation spilling out of a hole in an exterior concrete block wall.
