Animas River Water Quality at Rotary Park, Durango, Colorado
Gold King Mine Release Monitoring

March, 2016

Prepared By:
Scott Roberts, Aquatic Ecologist
Mountain Studies Institute
1309 E. Third Avenue #106
Durango, Colorado 81301

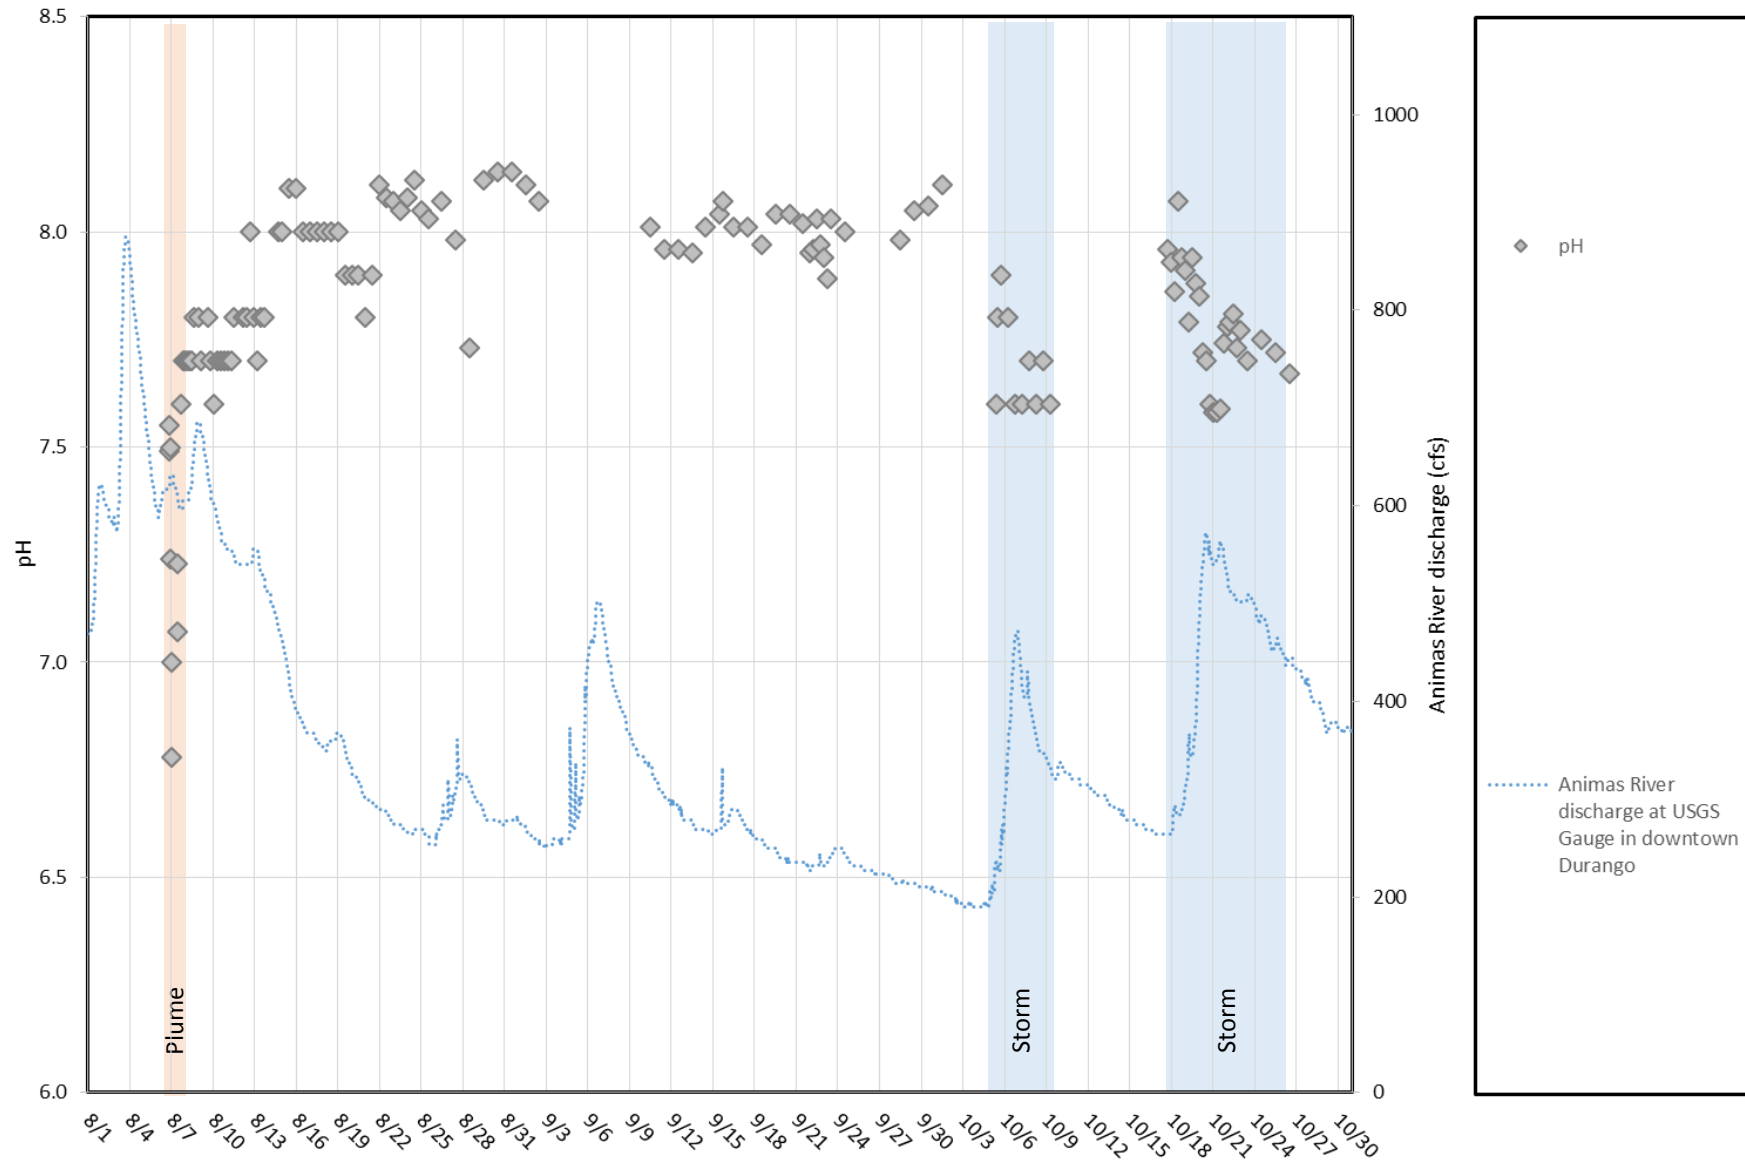
Figure 3

pH

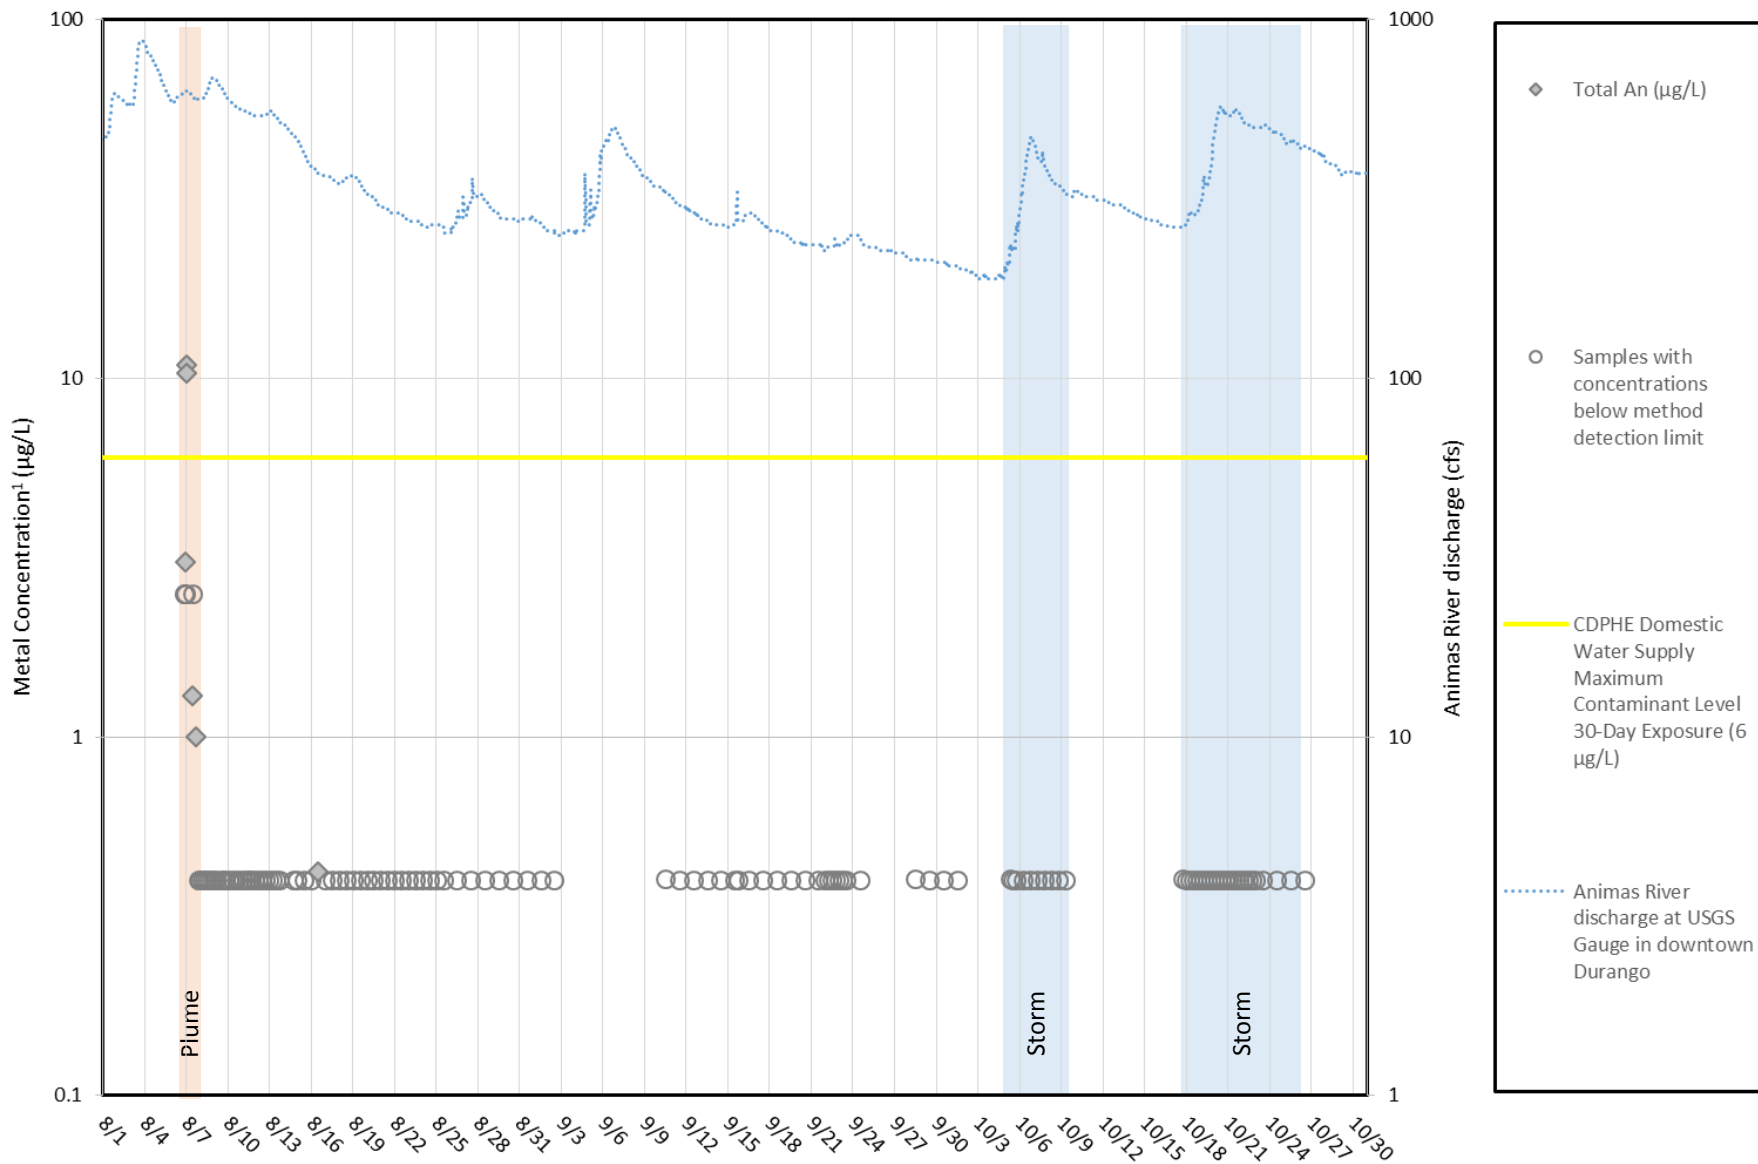
Figure 6

¹ EPA analytical methods 200.7 and 200.8. Method detection limit was 2.5 µg/L (8/6-8/7 10AM) and 0.4 µg/L (8/7 12PM - 10/26).

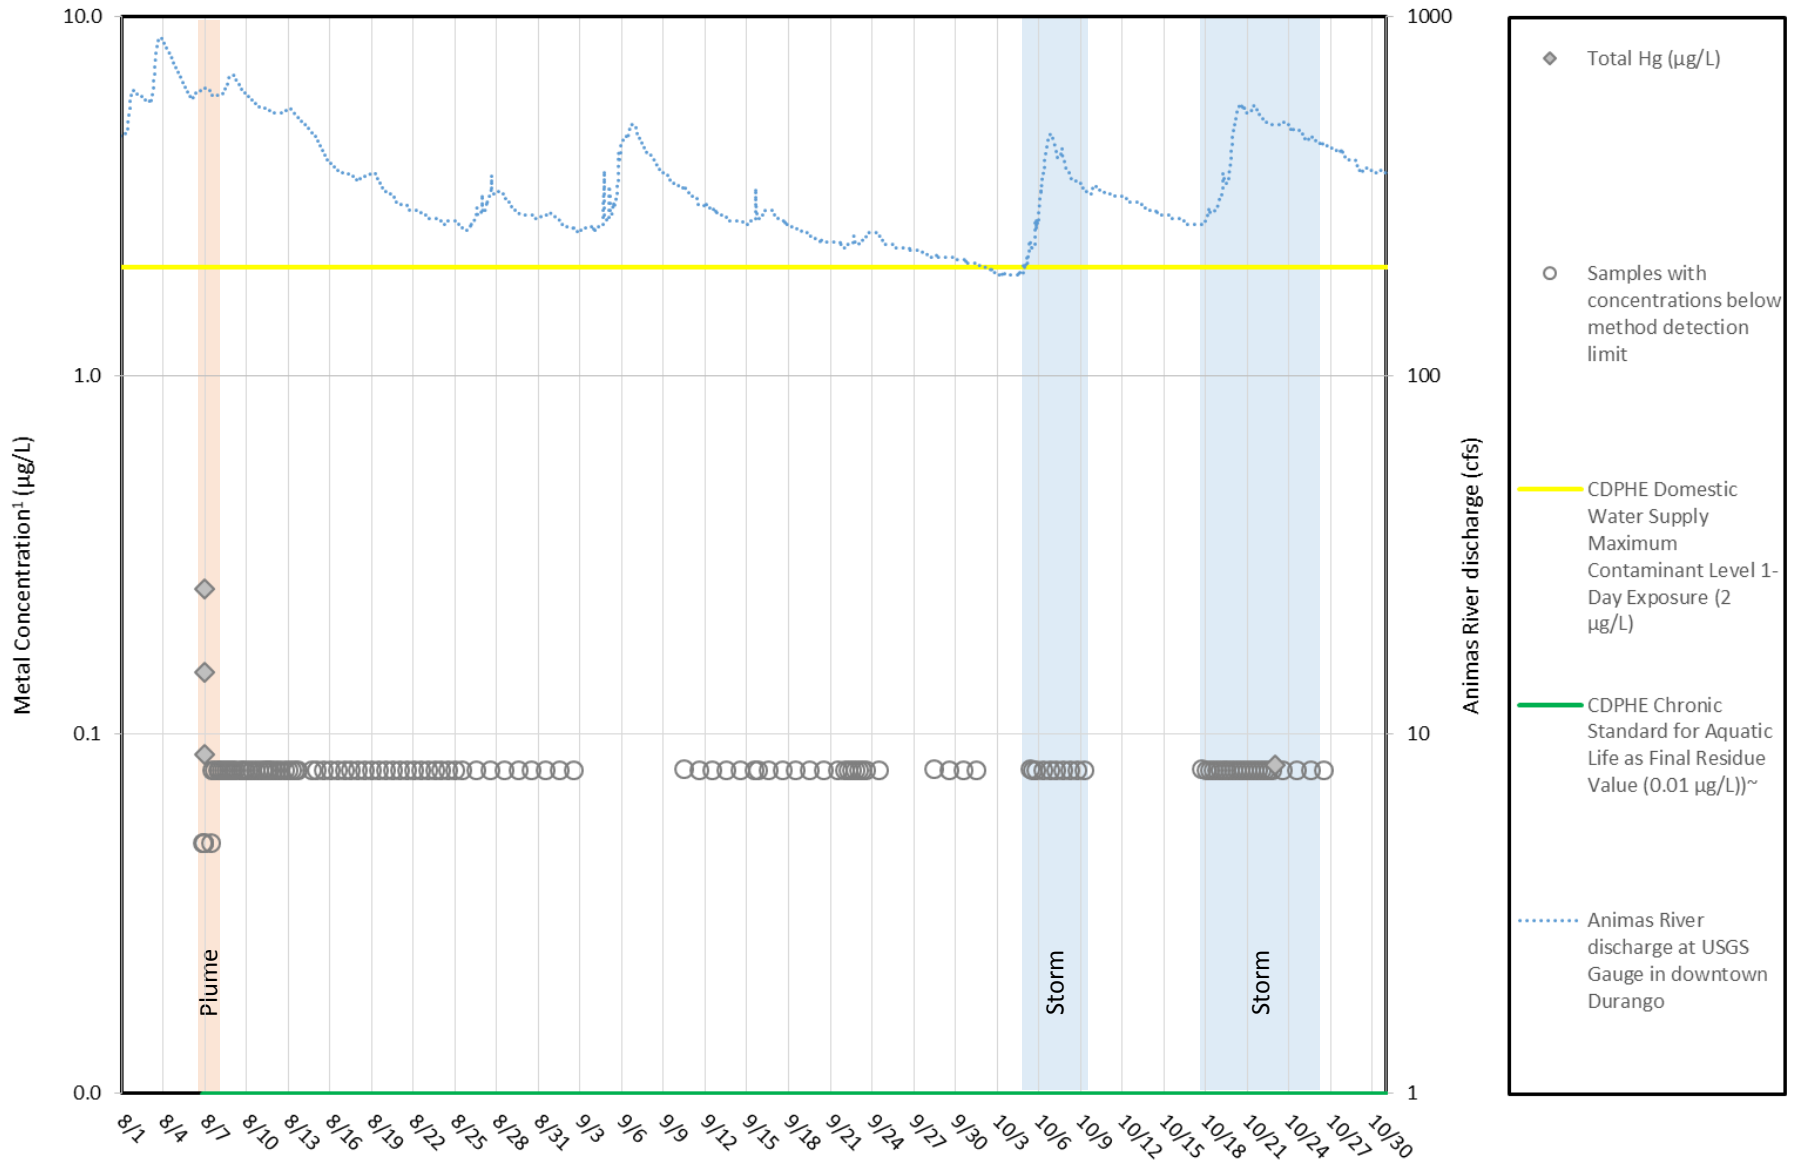
¹ EPA analytical method 245.1. Method detection limit was 0.05 µg/L (8/6 - 8/7 10AM) and 0.08 µg/L (8/7 12PM - 10/26).

~CDPHE standards based on Colorado surface water quality classifications and Reg. 31 and 34. The mercury chronic standard for aquatic life is based on the final residue value (FRV) of 0.01 µg/L, which is the maximum allowed concentration of total mercury in the water that will present bioaccumulation of methylmercury in edible fish tissue. Since our method detection limit was higher than the mercury chronic standard for aquatic life (0.01 µg/L), comparing observed total mercury concentrations to this standard is problematic.

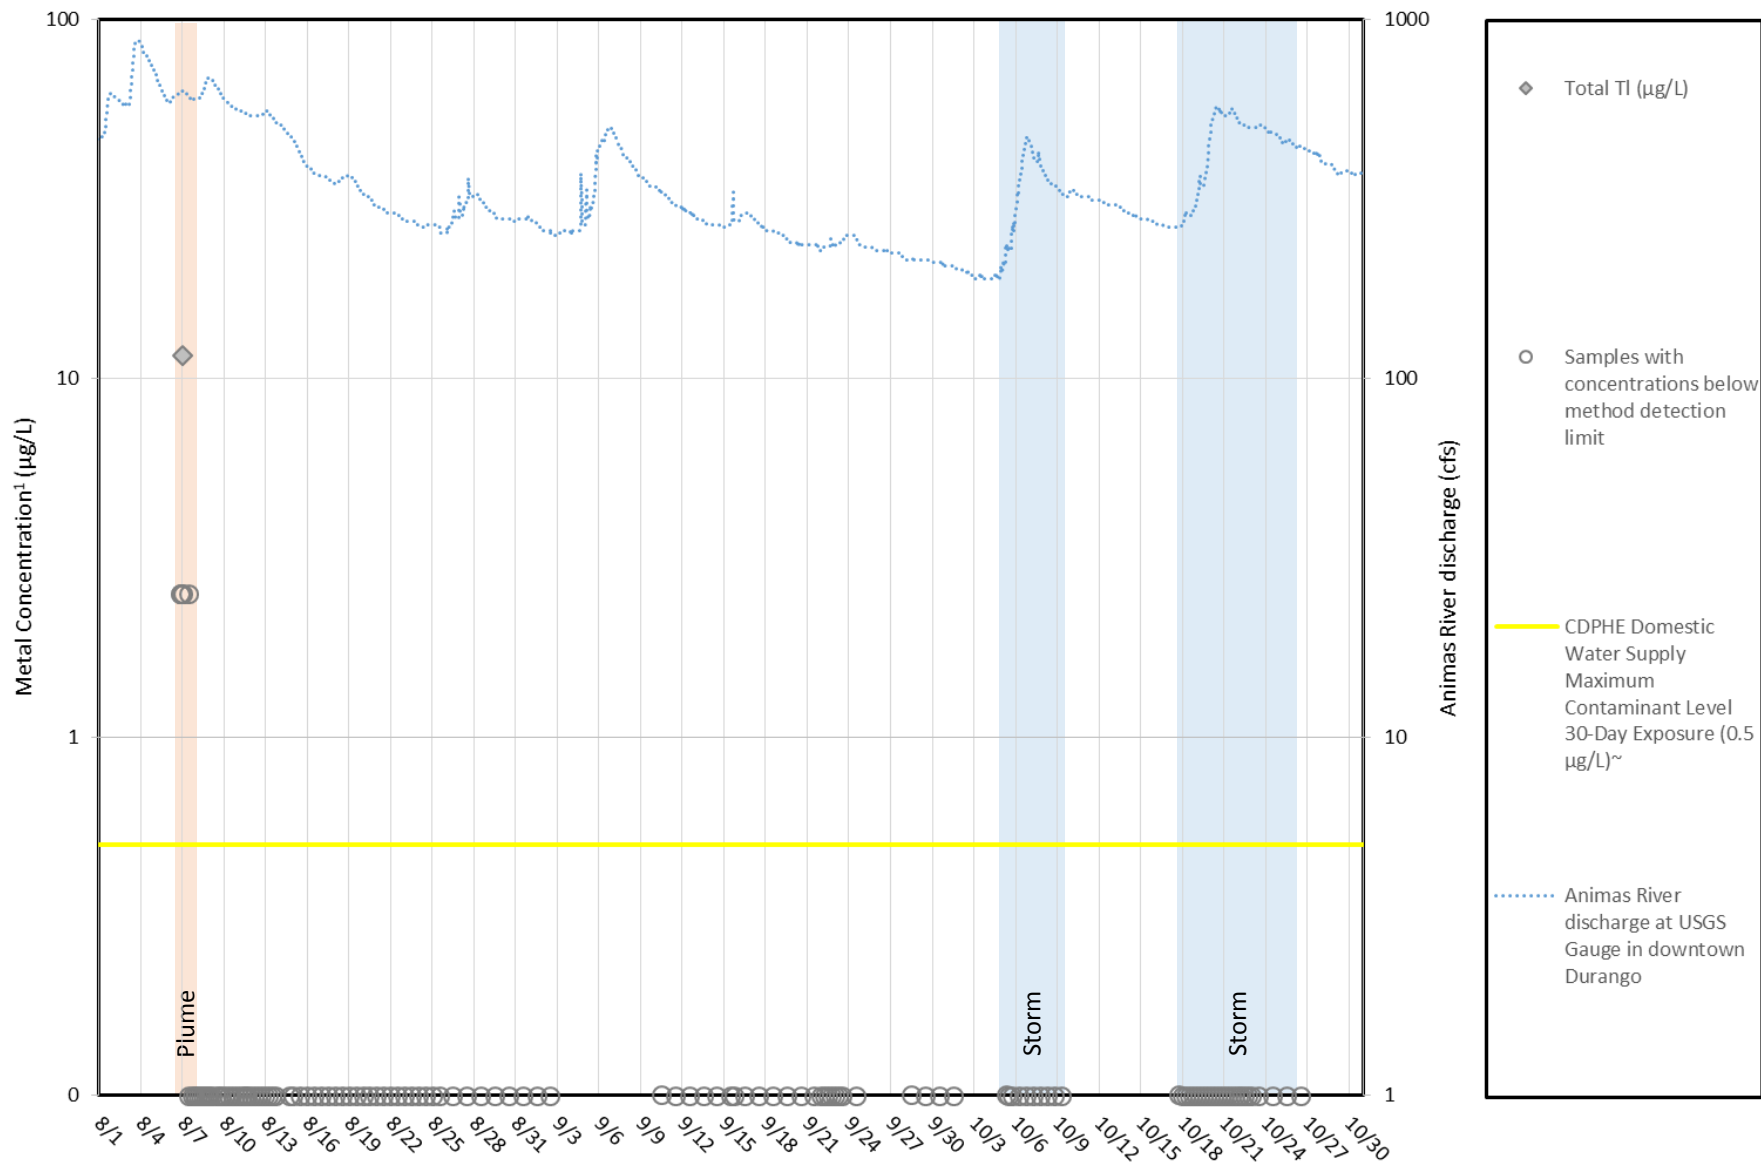
Thallium (Tl), Total

¹ EPA analytical methods 200.7 and 200.8. Method detection limit was 2.5 µg/L (8/6 - 8/7 10AM) and 0.1 µg/L (8/7 12PM - 10/26).
 ~CDPHE standards based on Colorado surface water quality classifications and Reg. 31 and 34.

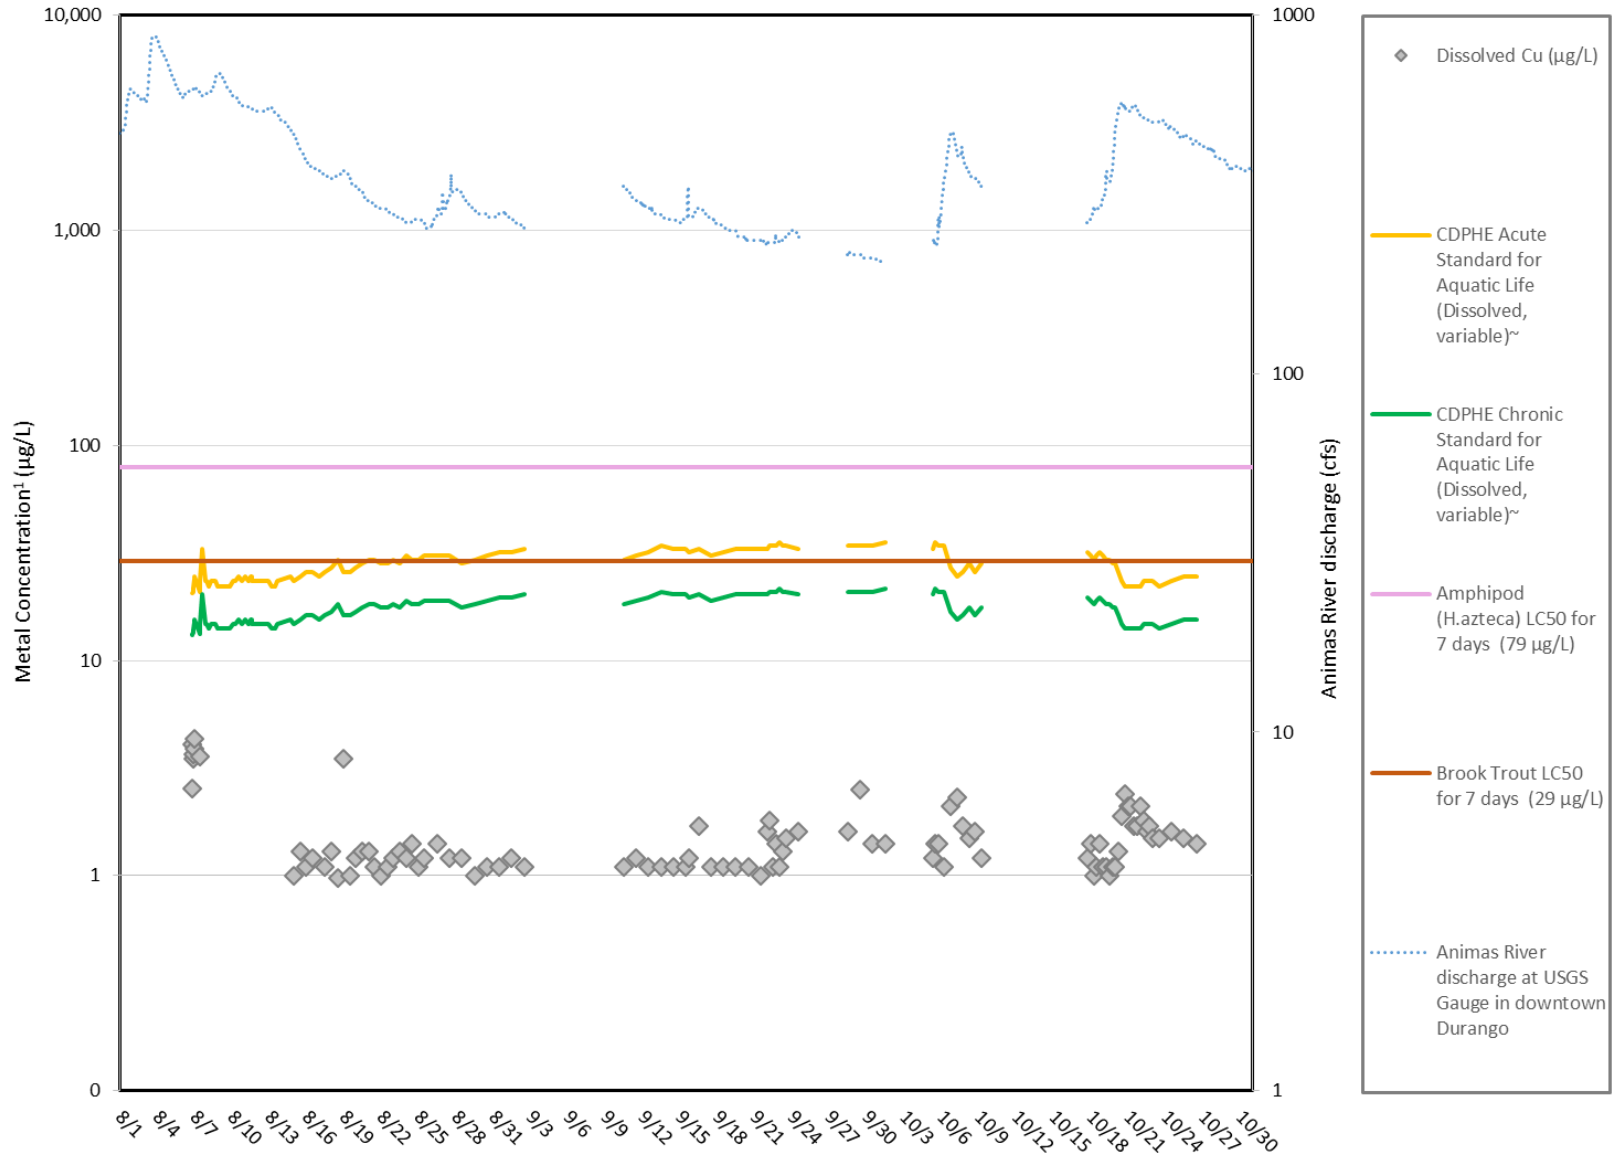
*LC50 is the lethal concentration that causes 50% mortality of test organisms in laboratory bioassays. The LC50s depicted here are not directly comparable because tests were conducted at varying water hardnesses and for different durations. Sources include: Besser and Leib 2007; Brinkman and Johnston 2012; Nehring 1976; Warnick and Bell 1969.
¹ EPA analytical methods 200.7 and 200.8. Method detection limit was 2.5 µg/L (8/6 - 8/7 10AM) and 0.5 µg/L (8/7 12PM - 10/26).
 ~CDPHE standards based on Colorado surface water quality classifications and Reg. 31 and 34. Standard varies with water hardness.

In addition to water quality standards, results from bioassays (toxicity experiments) can be used to judge potential impacts to aquatic life from elevated metal concentrations. Bioassays are typically used to determine the lethal concentration that causes 50% mortality of test organisms in the laboratory (LC50). We found that dissolved copper and zinc concentrations from the Animas River at Rotary Park did not surpass LC50s for Brook Trout, Colorado Cutthroat Trout, Mottled Sculpin, Amphipods, or several macroinvertebrate species (Appendix C). However, laboratory conditions are often different from real world conditions. For example, because the toxicity to aquatic life of copper and zinc depends on the hardness of the water, it is important to note the differences in water hardness between experimental conditions in the laboratory and natural conditions in a river. In Appendix C, we present dissolved copper and zinc detected at Rotary Park in context to results from toxicity experiments for several aquatic species. The toxicity thresholds presented in Appendix C were derived from bioassays using water hardness ranging from 42.3 to 144 mg/L (Besser and Leib 2007; Brinkman and Johnston 2012; Nehring 1976; Warnick and Bell 1969). The water hardness measured at Rotary Park from August to October of 2015 ranged from 157 to 280 mg/L. Since the toxicity of dissolved copper and zinc decreases with water hardness, it can be assumed that if anything, these toxicity thresholds are lower than they would be if bioassays would have been conducted using a water hardness more similar to the higher values observed in the Animas River at Rotary Park.

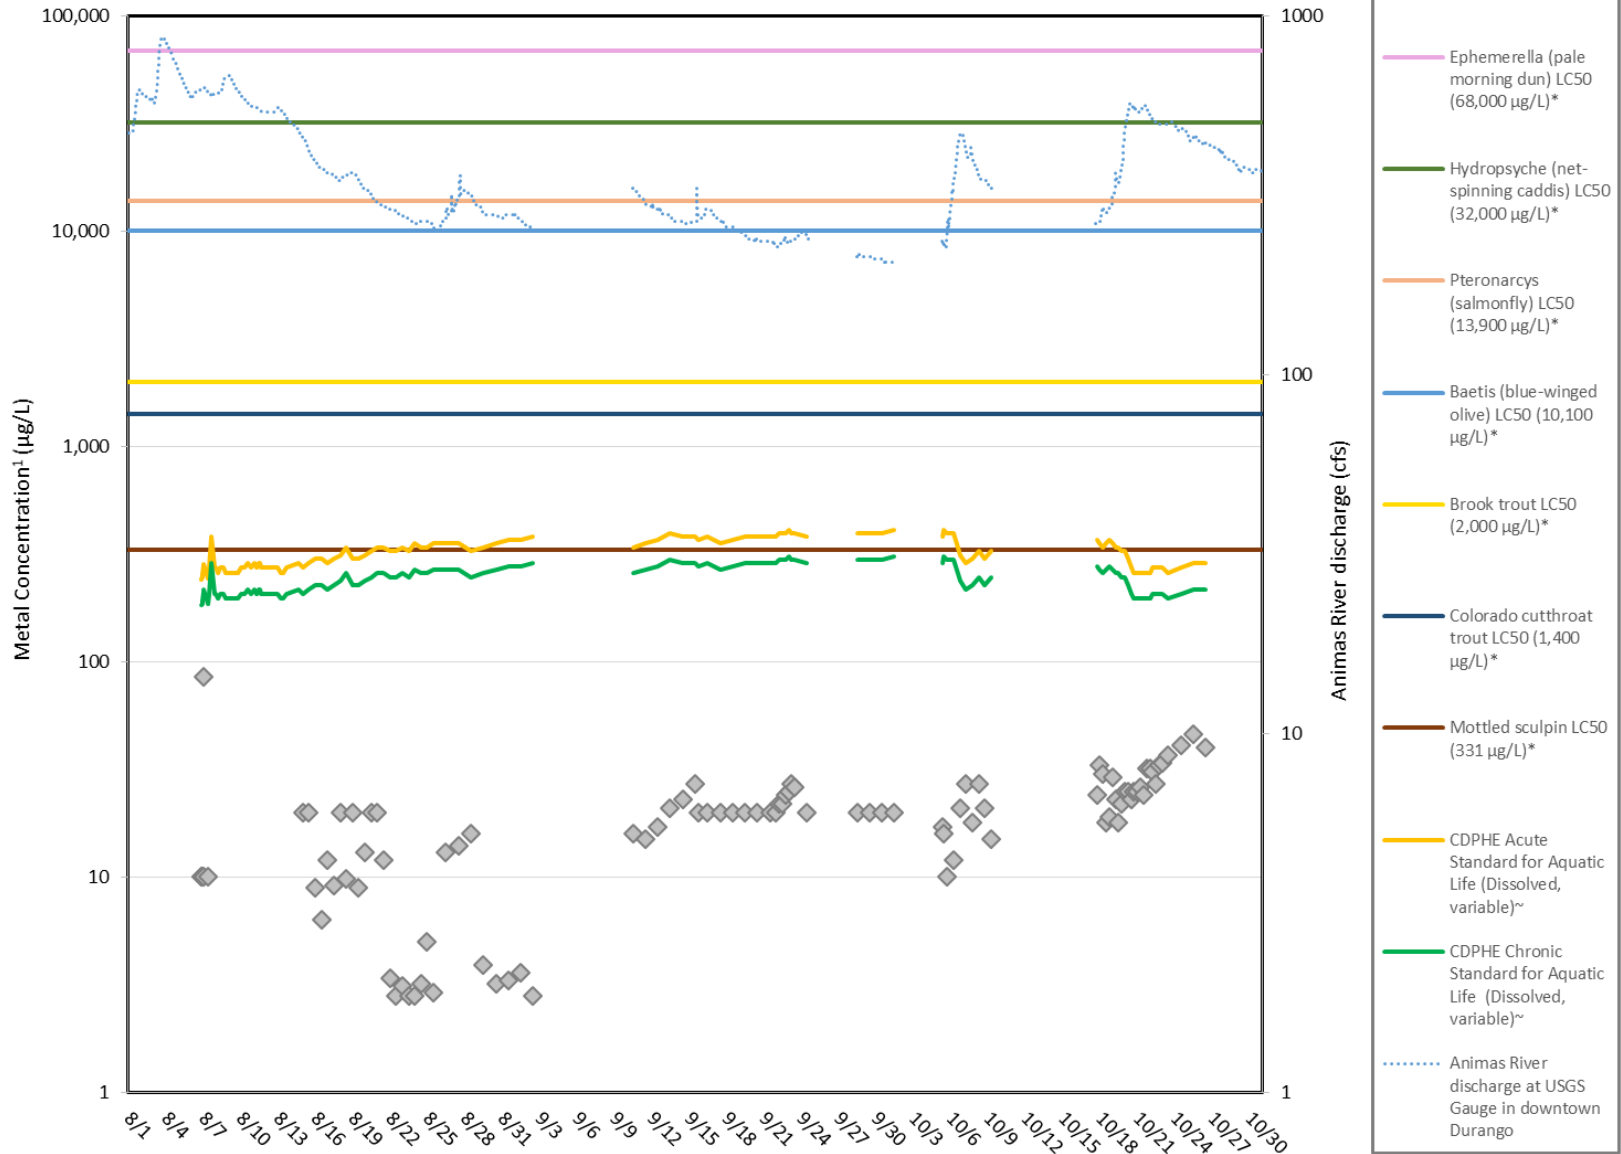
*LC50 is the lethal concentration that causes 50% mortality of test organisms in laboratory bioassays. The LC50s depicted here are not directly comparable because tests were conducted at varying water hardnesses and for different durations. Sources include: Besser and Leib 2007; Brinkman and Johnston 2012; Nehring 1976; Warnick and Bell 1969.

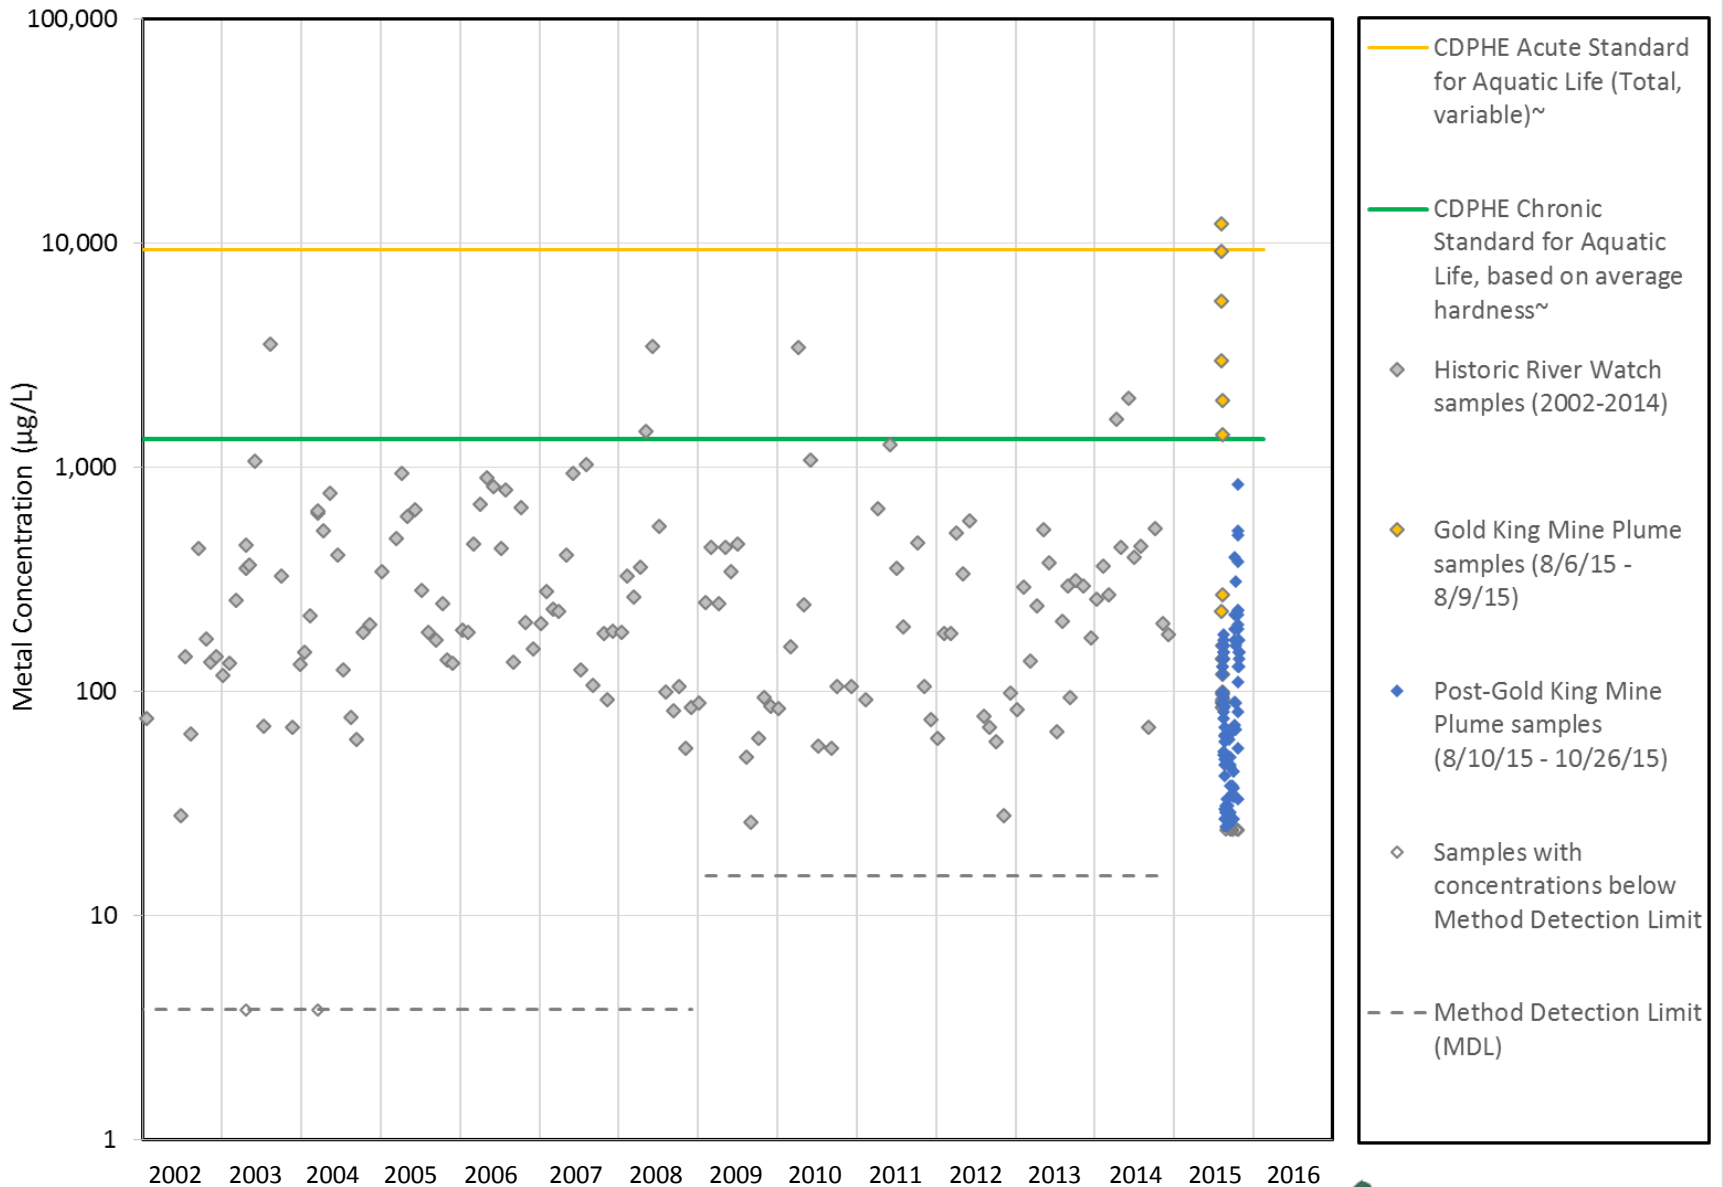
~Colorado Department of Public Health and the Environment (CDPHE) standards based on Colorado surface water quality classifications and Reg. 31 and 34. Standards vary with water hardness and are plotted here using an average water hardness of the Animas River at this location, 208 mg/L.
Note: 2002 - 2014 data is River Watch data from the Animas River at the fish hatchery in Durango, CO. 2015 data is Mountain Studies Institute data from the Animas River at Rotary Park in Durango, CO

Concentrations of total recoverable aluminum, copper, iron, lead, and zinc were clearly higher at the peak of the Gold King Mine plume than in any other sample since at least 2001 (Appendix D). However, the historic River Watch data indicated that concentrations of total recoverable arsenic and selenium observed during the plume were not unprecedented; higher concentrations were documented in the 2001-2014 time period.

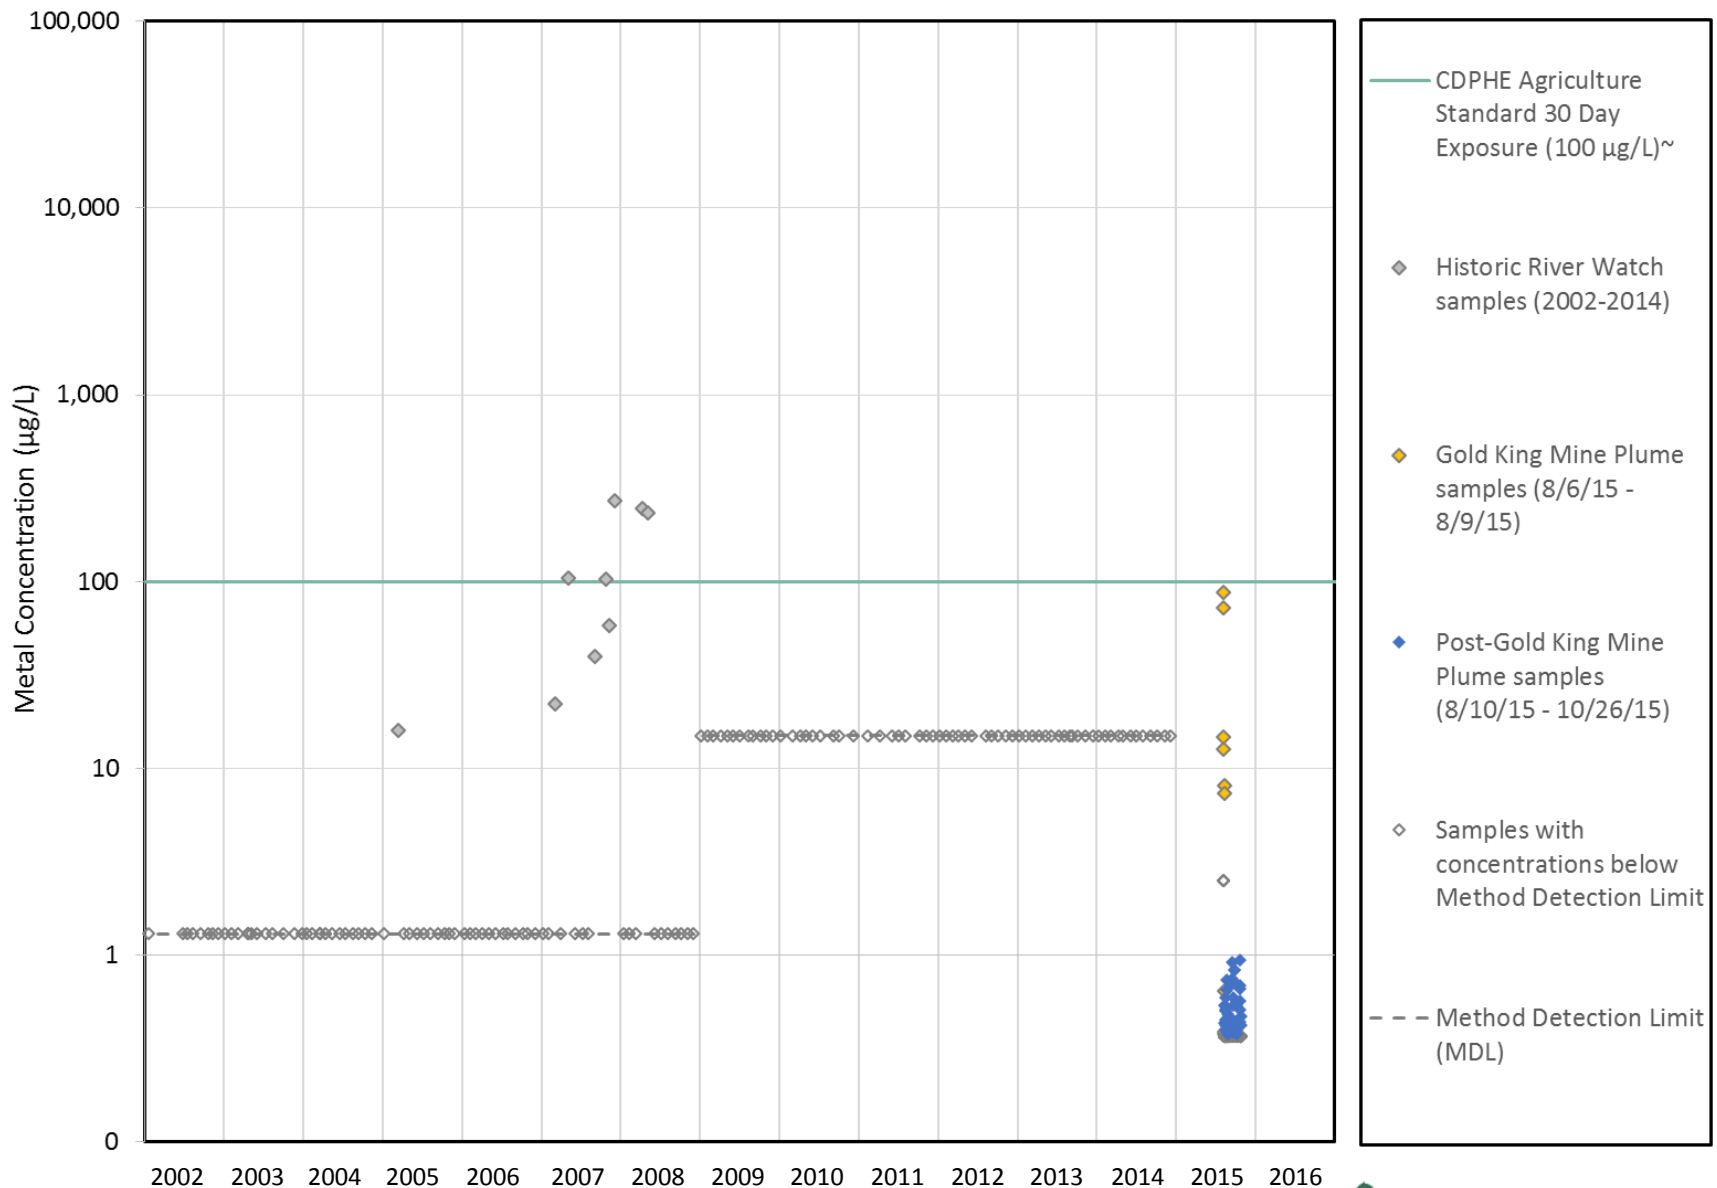
~Colorado Department of Public Health and the Environment (CDPHE) standards based on Colorado surface water quality classifications and Reg. 31 and 34. Note: 2002 - 2014 data is River Watch data from the Animas River at the fish hatchery in Durango, CO. 2015 data is Mountain Studies Institute data from the Animas River at Rotary Park in Durango, CO
