Upper Pine River Watershed

State of the Watershed Report 2008

Edited By Win Wright, Certified Professional Hydrologist

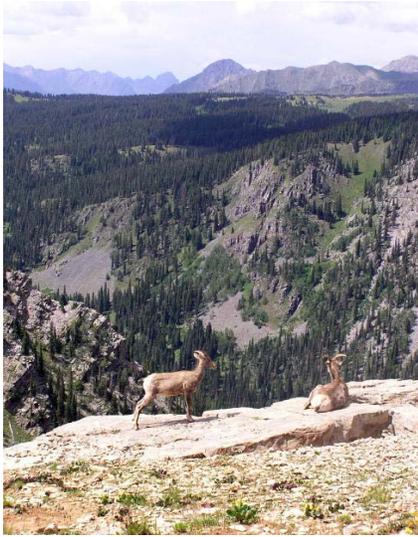
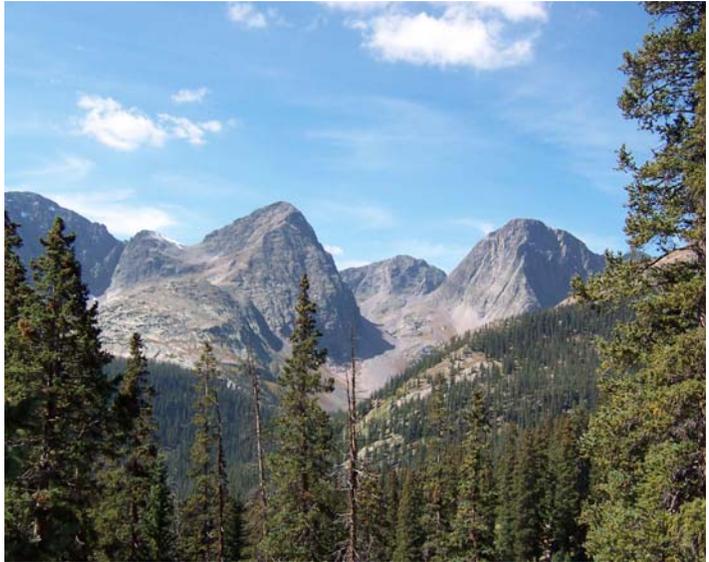
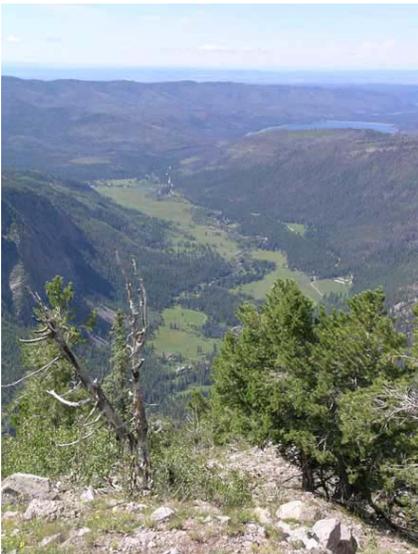
Figure 1. Streams and hydrologic units of the upper Pine River watershed.

The upper Pine River watershed (**Figure 1**) exemplifies a classic mountain setting of high-altitude streams, lakes, and alpine views. The watershed includes two main streams--Vallecito Creek and Los Pinos River, which converge at Vallecito Reservoir (pronounced *Vai. ya. sito*), a man-made reservoir constructed in 1942 for storage and distribution of irrigation water to farmlands in the lower Pine River watershed. Water-quality data have been collected since the 1970's by the U.S. Geological Survey (USGS) and Bureau of Reclamation (BOR). In the 1990's the BOR conducted a study of ground-water quality in the Vallecito Valley. In 1997, the USGS conducted a detailed study of the water quality of Vallecito Reservoir.

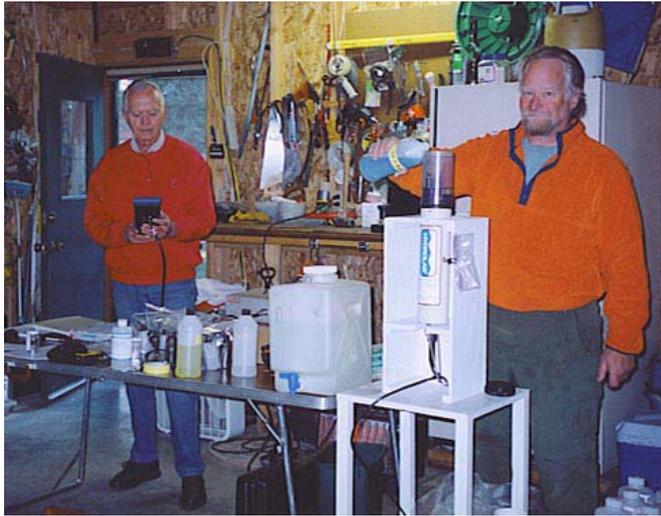
Meet early to calibrate the water-quality sonde, which is checked for the accuracy of pH, specific conductance, temperature, and dissolved oxygen readings.

With grant funds, a lake-water sampler (Kemmerer sampler) and water-quality data sonde (Hydrolab™) were purchased. Training was provided by the USGS in the proper methods for calibration of the sonde and collection of water samples for laboratory analyses.

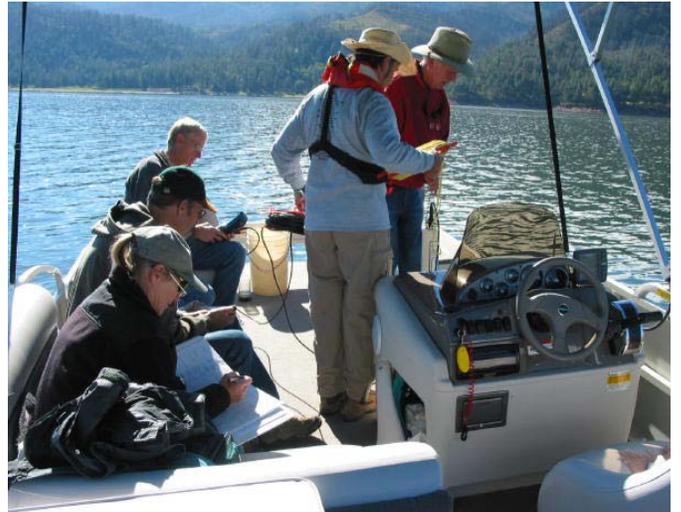
The sonde is lowered into the lake 5 or 10 feet at a time, and water properties are sent to the data unit, where readings are recorded by a notetaker. On this day, we had the luxury of a pontoon boat. Most sampling days are spent in a small outboard motor boat.

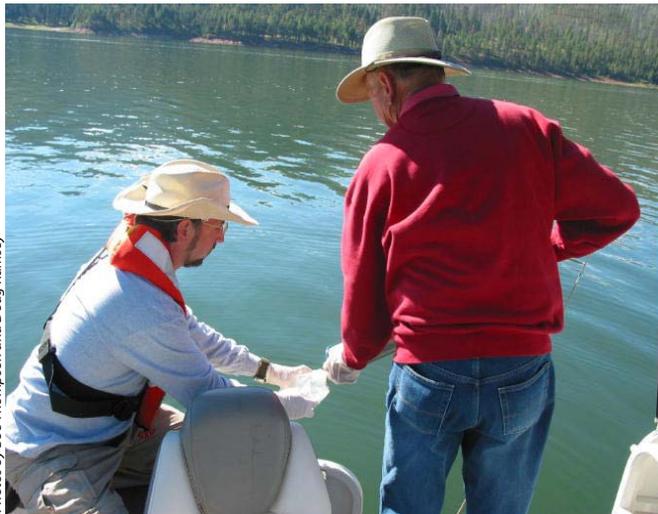
Water samples are collected at the bottom and top of the lake using a point-sampler on a rope with a weighted "messenger" to trigger open the sampler. Samples are poured into one-liter cube bottles. A sample number with a suffix of "L" indicates the lower sample, and a "U" indicates the upper sample.

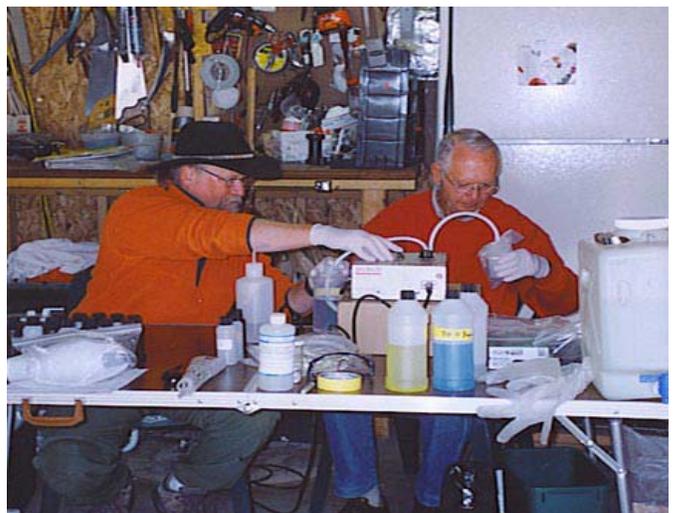
Water samples collected from the lake are filtered and preserved afterwards. Laboratory request forms are filled out, and samples are delivered to the laboratory by express shipping.

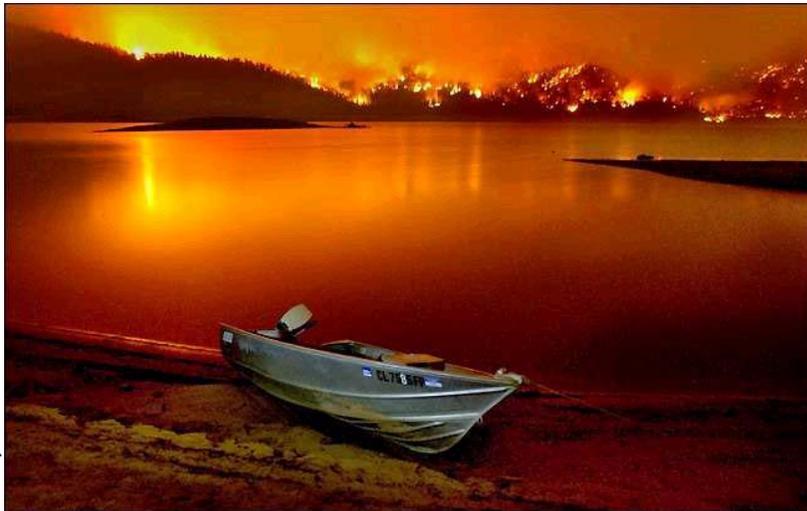
Figure 3. Drought, wildfires, and low reservoir storage levels.

lake at its lowest was only 38 ft deep at the center (the lake is typically 95-105 feet deep) **(Figure 3)**.

Forests of the upper Pine River watershed were heavily impacted by the wildfires. Surface plant cover was lost to the fires, which increased erosion and caused debris flows. Nature is very resilient, though, and the forest conditions are rapidly recovering.

In June and July 2002, the Missionary Ridge wildfire burned 70,485 acres in the forested and developed lands northeast of Durango, Colorado, and about 8,000 acres in the upper Pine River watershed. In August 2003, the Bear Creek wildfire burned about 1,500 acres in the upper Vallecito Creek watershed.

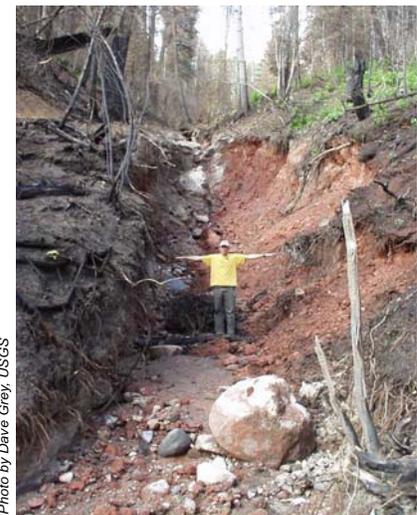
Scour in Root Creek from rain on burned forest, July 22-23, 2002.

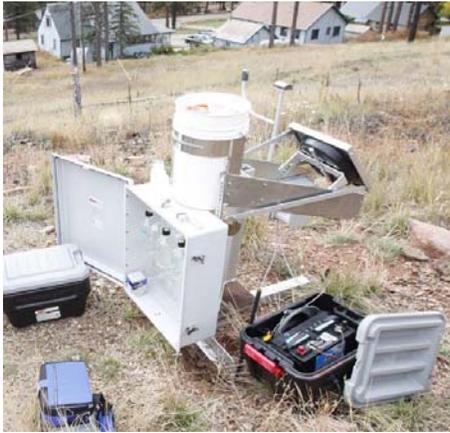
Automatic precipitation sampler near Vallecito Reservoir

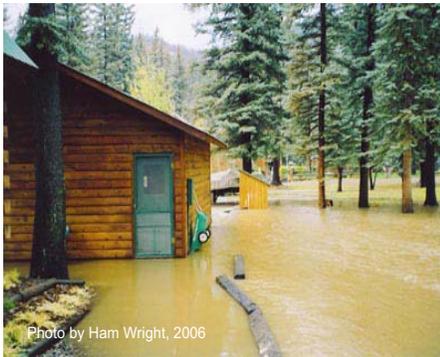
High-flow event in Vallecito Creek, October 6-7, 2006

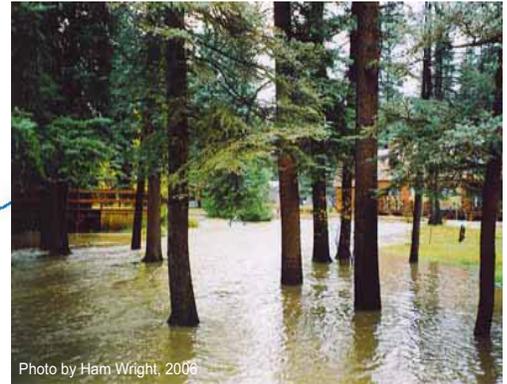
High-flow event in Vallecito Creek, October 6-7, 2006

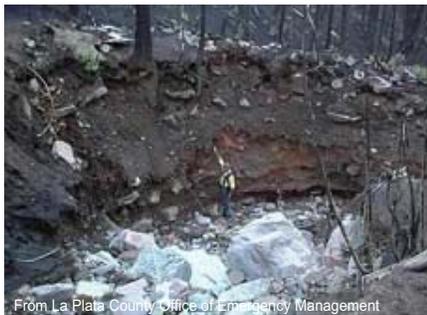
Flood and scouring event, September 2002

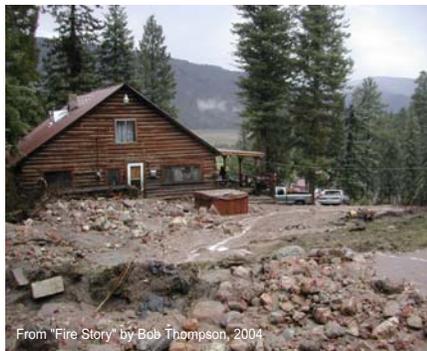
Debris flow damages house, September 2003

A number of side creeks have flooded during past history. Flooding in the mountain drainages creates alluvial fans that form due to deposition of gravels, rocks, and flood debris. After the wildfire, several debris flow events caused flooding and damage to houses located near the side creeks (**Figure 9**).

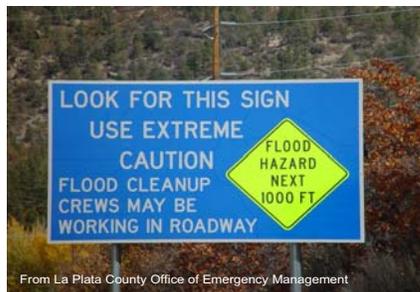
La Plata County flood hazard warning sign
