Bringing Back History at Baldwin Wallace

University partners with American International to restore key structures across campus

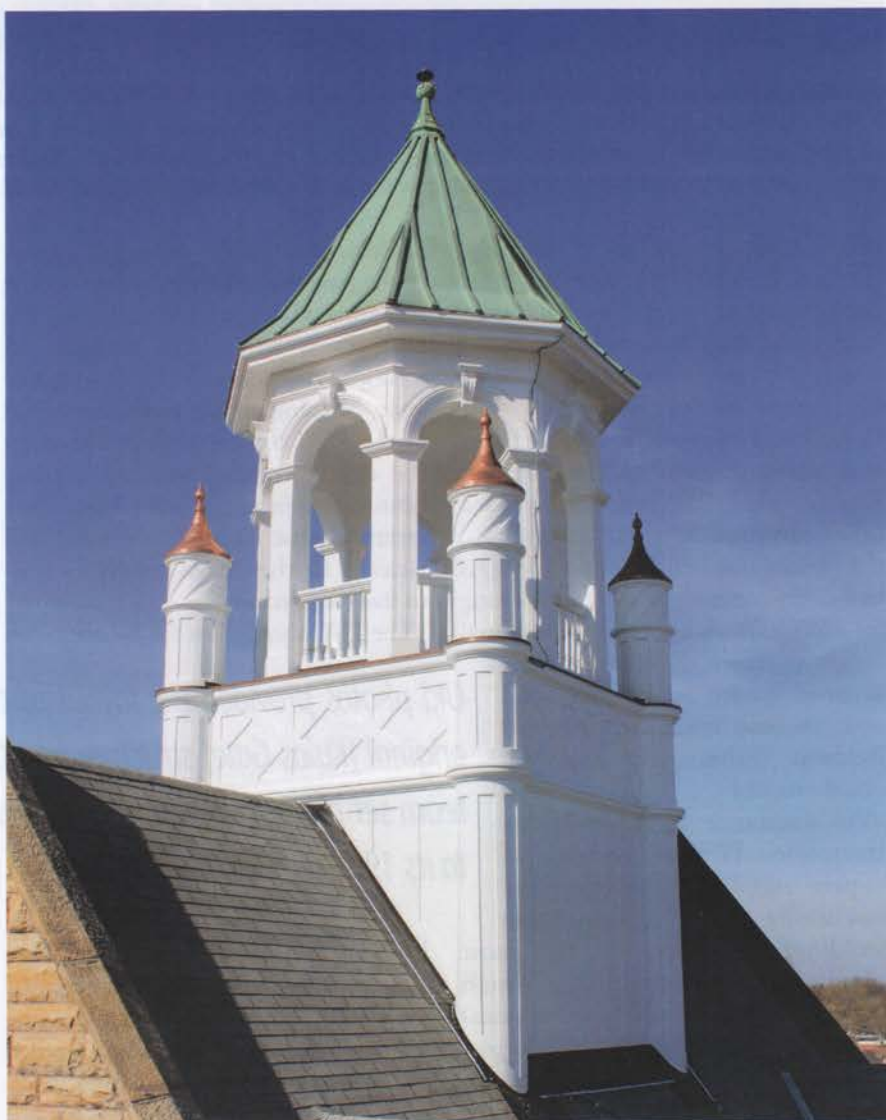
BUILT TO LAST Restoration of Marting Hall's iconic cupola entailed rebuilding intricate moldings and spires with PVC, which should last for decades with little maintenance required.

prises. Most notably, metal sheathed the cupola, with five layers of sheet comprising some of the moldings. Solder and long nails held the metal cladding in place. Initial plans called for repainting of sheetmetal sections, but a closer look revealed rust and water damage to the interior. Removing the flat sheetmetal yielded other surprises. In prior restorations, the spires' barber-shop-pole designs had been covered by workers looking for a quick fix. American International sought to return the spires to their original ornate appearance, and with an okay from Kerbusch and Baldwin Wallace, the company could proceed.

Via assistance from American International's small network of expert suppliers, the company essentially rebuilt the intricate moldings and spires, in fact most of the cupola, with PVC. Tough and long lasting, PVC was an ideal solution. The trick was measuring, calculating, designing and fabricating the PVC into sections that mimicked the original look.

To rebuild the spires, Perry and American International had to locate two-foot-diameter Schedule 40 (about ¾ inches thick) PVC pipe – no easy task – then figure out how to cut and shape the pipe to intersect longitudinally with the square corners of the

cupola. That meant cutting a quarter of the pipe lengthwise as well as adding stiffening plates on the inside of the pipe. Pains were taken to hide cut locations and deliver a seamless appearance. Shaping, fitting and adhering all of the PVC sections and moldings for the cupola entailed intricate cutting, heating and fastening procedures. Perry estimates that each piece created and fastened for the cupola involved a four- to five-step process.

little maintenance, and bottom sections of the cupola have been designed for simple removal for future roofing work. The cupola work also entailed removal of louvers that had been added during prior restorations as well as reframing and patching of those sections, along with the addition of copper flashing. Also, crews re-sheeted the existing roof with rubber EPDM and increased roof pitch to assist in water runoff. Weep holes were added to let water drain from cupola interior sections. At a secret location in the

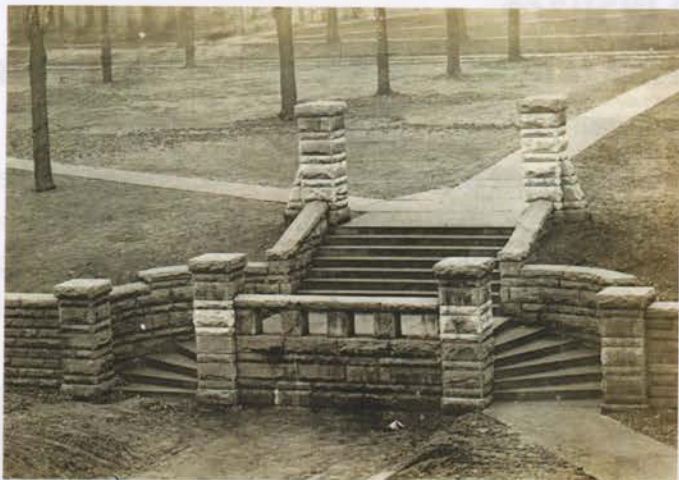
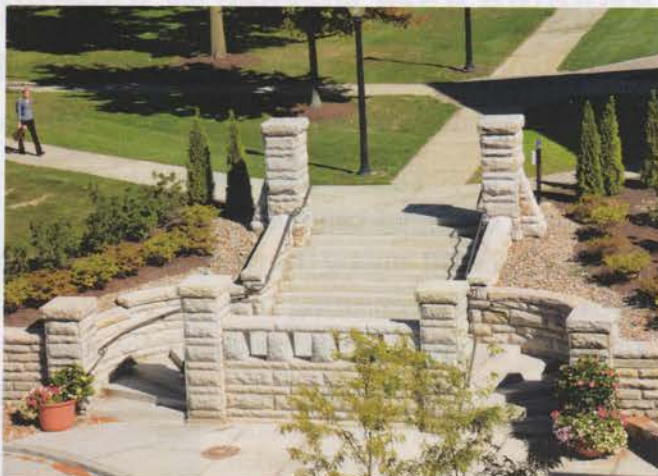
RISING TO THE CHALLENGE Kulas Gate (left), a stairway that was built in 1890 near Kulas Hall with ornate stonework and symmetrical winding steps as well as intricate retaining walls, had worn over the years. In 2013, a painstaking restoration (right) included finishing of stonework to match the original design, with new stones hand-chiseled and hand-finished.

American International has also wrapped up restoration of Kulas Gate, a stairway near Kulas Hall. The stairway, built in 1890, with ornate stonework and symmetrical winding steps as well as intricate retaining walls, had worn over the years. Previous renovations had dismantled original elements and covered up others. Old photos provided Baldwin Wallace and American

International with the layout of the original structure – two stairways at the base curving into a central landing and single staircase to the top, framed by sandstone wall structures – and the team set about to return the structure to its 19th-century glory.

A 1980 reconstruction had covered the old stairway and added practicality but certainly not beauty. The current restoration aimed to accomplish both. Crews began by disassembling the visible sections of the original stairway and numbering the stones for later reconstruction. During demolition, other original sections of the stairway, long buried or hidden, were unearthed. During previous repairs and renovations, original stone had been removed and replaced with concrete, and elevations had been altered.

American International and work crews set about excavating and then pouring footers as well as adding drainage lines and catch basins. Doing so, along with dishing of the stair structure, would provide a stable base and allow proper water runoff.

A wall on the central landing had a major issue, according to Perry. For safety's sake, the wall's height had to increase. One possible solution, a rail, would detract from the stairway's appearance and from efforts to restore the structure to its original state. An alternative plan forwarded by American International and accepted by Baldwin Wallace raised the entire wall by various means, including placement of a 6.5-inch-thick concrete slab at the bottom of the wall, and the addition of 13-inch-high stone to each of the four stairway columns to maintain proportion.

Other height and proportion issues had to be addressed. Various work over the years had altered the landing height as well as the rise and run of stair treads. The construction team took action, which included moving and adding stone blocks, to create a workable, proportionate solution.

The painstaking restoration included finishing of stonework to match the original design, with new stones hand-

chiseled and hand-finished. The detail in the finishing work speaks to the capability of an able subcontractor and the American International team. Restoration also included new handrails that blend seamlessly into the stone walls. Here, too, the university has placed a time capsule.

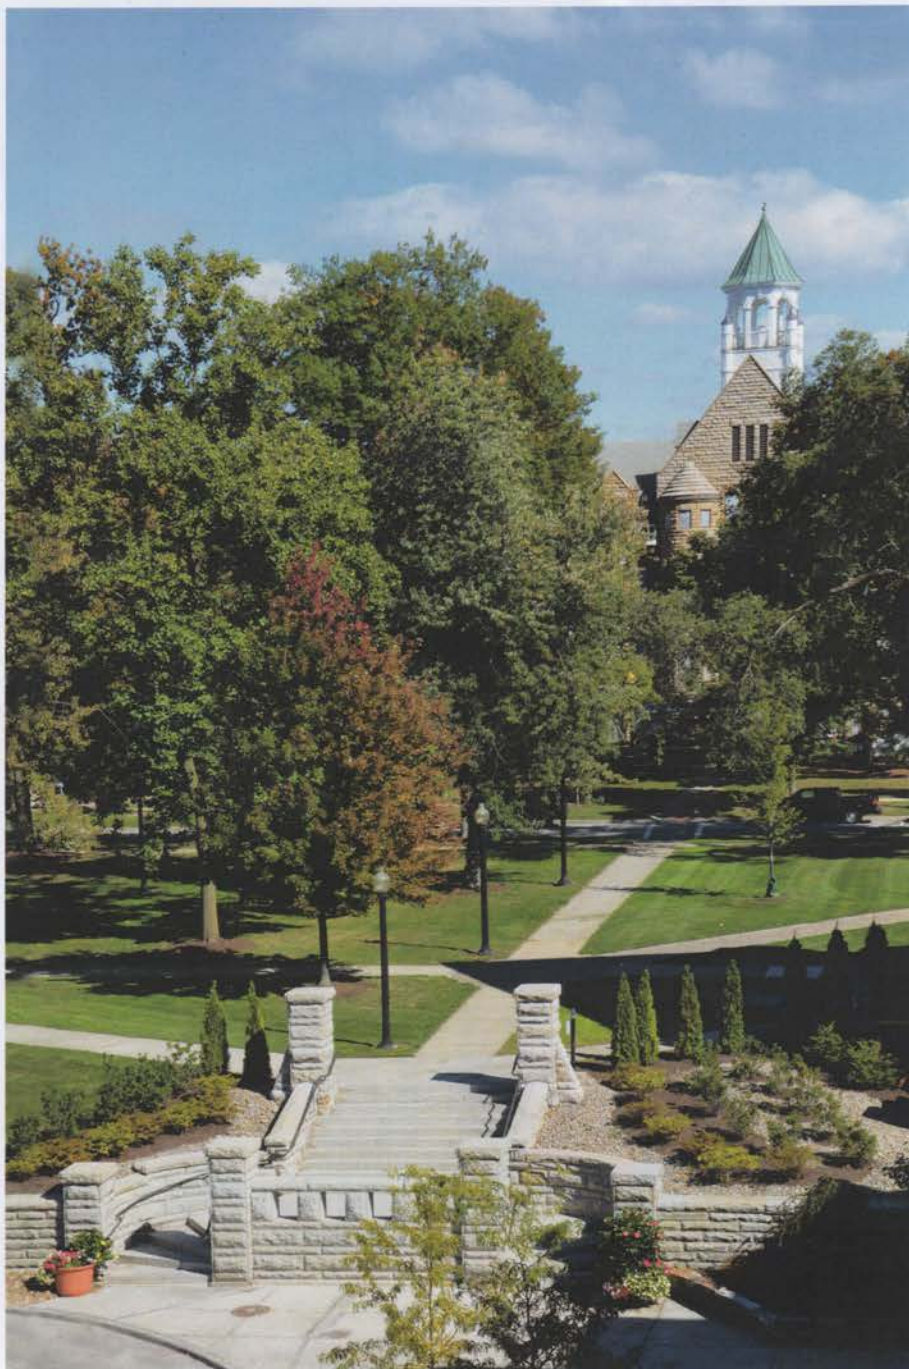
PRESERVING THE PAST American International has worked on projects across Baldwin Wallace University's campus, most recently completing the restoration of Marting Hall's exterior, including its iconic cupola, as well as "Kulas Gate," a historic stone stairway near Kulas Hall.
