SAFETY ALERT

Technical Bulletin 07012020

Subject: High-Pressure Gauges sold between 2012 and 2018

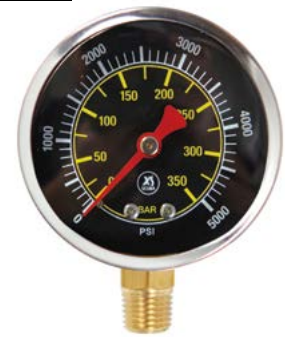
Fig. 1B

This is the current gauge, 2019 – present. Notice the **YELLOW** scale. It is **NOT** the subject of this bulletin.

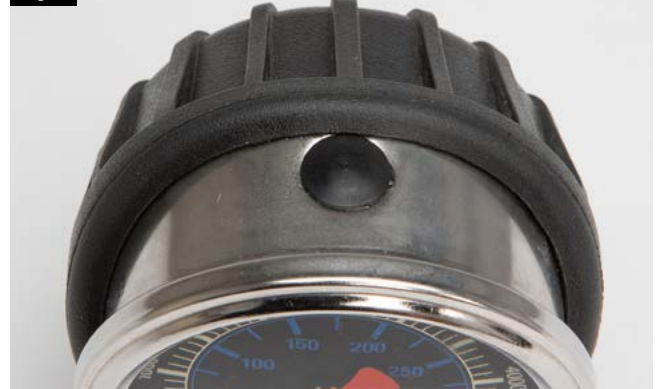
Fig. 2

The Problem: In the rare event of an internal leak, the black over-pressure (OP) relief plug (Fig. 2), located on top, should vent, allowing excess pressure to escape. It does not in all cases.

We are finding that as these over-pressure plugs age; they are becoming harder. While originally supple and pliable, some that have been in the field for many years have become hard. In some cases, we found that the plug had become too hard to properly relieve excess pressure should there be an internal leak. This can result in the glass lens shattering outward.

1. Replace the over-pressure relief plug.

Have the new, blue replacement OP plug available. Relieve any pressure in the gauge so that it reads zero. Peel back the black, rubber protective boot to expose the OP plug on top. While keeping the gauge vertical so as not to spill the oil inside, remove the black OP plug. You may be able to pull it out with fingernails or you may have to use a thin, blunt instrument like a small screw-driver or similar (Fig. 5). Press fit the new blue plug, barb side first into the hole (Fig. 6).

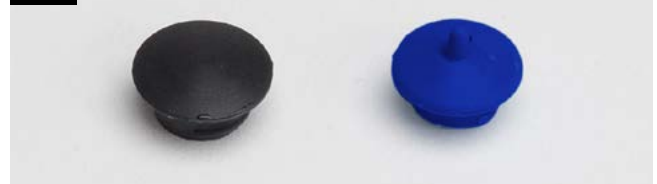
Fig. 3

The Solution: XS Scuba has a replacement OP plug available, which will not harden with age. To visually distinguish the two, the upgraded replacement plug is blue, while the old plug was black (Fig. 3).

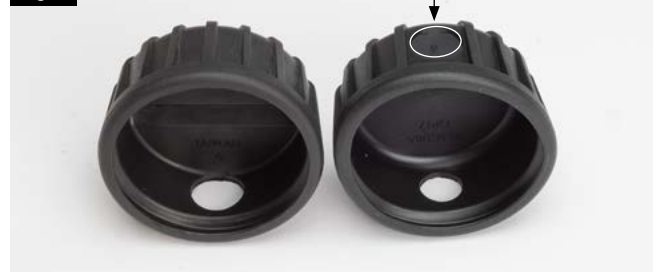
Fig. 4

In addition, if your High-Pressure Gauge has an older style, protective rubber boot that does not have a relief hole on top, XS Scuba will provide an updated boot for you. The relief hole allows the OP plug to release without interference (Fig. 4).

2. Upgrade the rubber protective boot (if necessary).

If the gauge's rubber protective boot does not have a 1-inch relief hole on top, centered over the OP plug, remove the boot and replace with the upgraded model (Fig. 4).

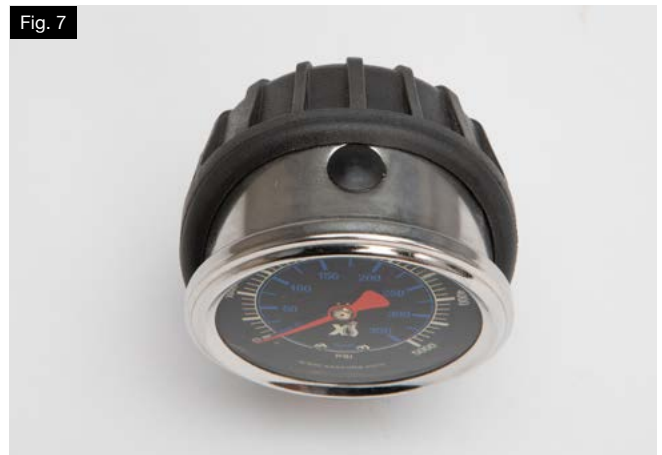
Email a simple picture, taken with your phone, of each suspect HP gauge in your possession. Peel back the rubber protective boot, exposing the OP Plug. Shoot the gauge from the front, at a sharp downward angle (Fig. 7). The image should show the front face card, the black OP plug, and the top of the rubber protective boot.
