JOINT LEGISLATIVE AND EXECUTIVE TASK FORCE CAPITOL BUILDING REHABILITATION AND RESTORATION

Section 1: Introduction

LEVEL I RECONNAISSANCE & LEVEL II FEASIBILITY STUDY 2013-2014

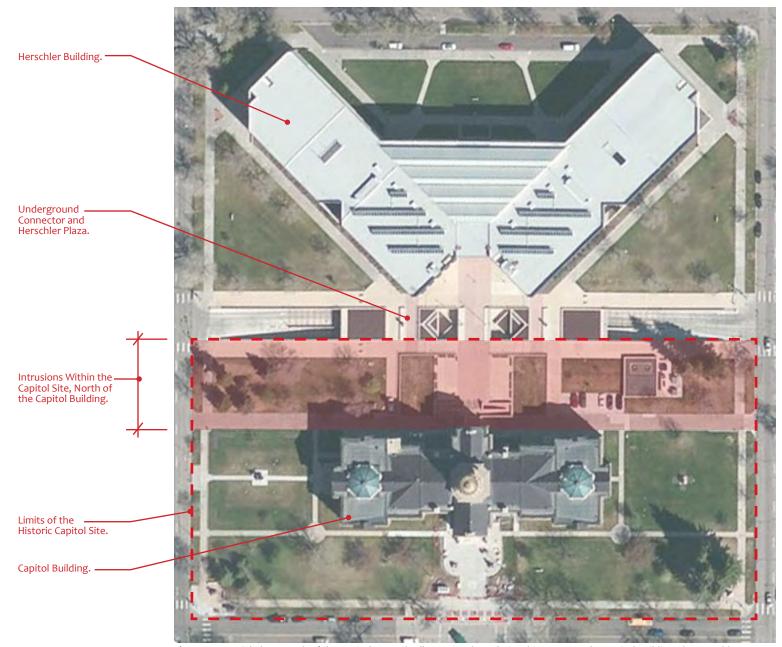
Figure 1.2: Aerial Photograph of the Capitol Grounds, Illustrating the Relationship Between the Capitol Building, the Herschler Building and the Underground Connector.

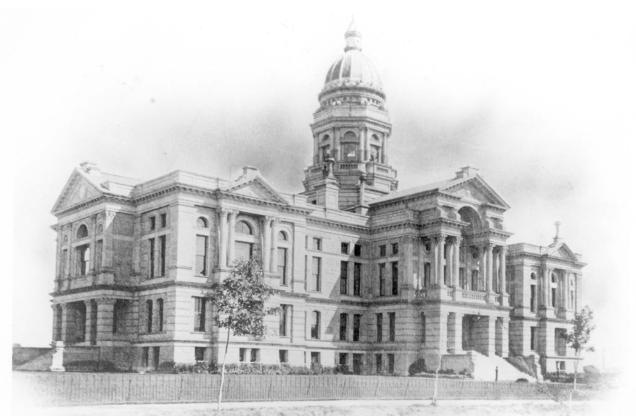
Figure 3.6: Historic Photograph of the Recently-Completed [Phase II] Capitol Building From the Southwest, ca. 1890.

The most significant contribution to developing an in-depth understanding of the building was the information relating to the details of the 1917 Phase of the building, a major and very extensive intervention that transformed both the exterior and the interior of the Capitol [Figures 3.6 - 3.7; See also Section 4: Historic Analysis, pp 4.82 – 4.91].

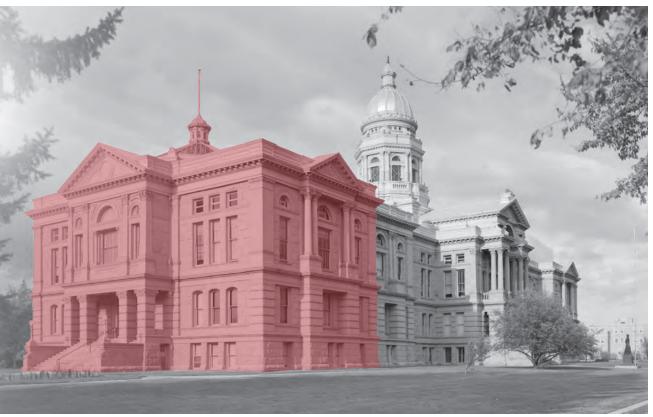
Figure 3.7: Similar View of the Capitol Building From the Southwest, ca. 1979. The highlighted area delineates the Phase III [1917] west wing. The Phase III additions had a significant impact on both the exterior and interior of the Capitol. Details can be found in Section 4.

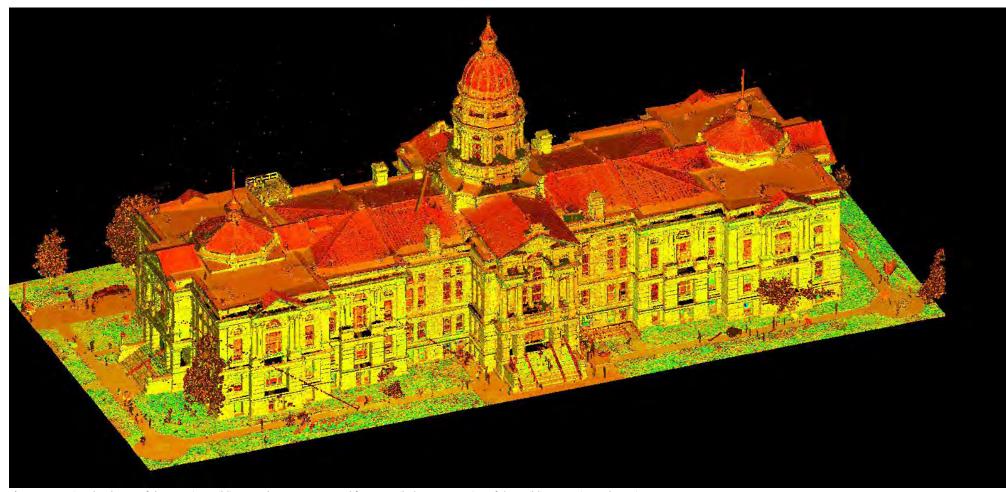
Figure 3.8: Point Cloud Data of the Exterior Building Envelope, as Generated from Detailed Laser Scanning of the Building Exterior and Interior.

For this reason, the Design Team proposed the preparation of an "asfound" conditions set of documents. This set was prepared using laser scanning and modeling the building three-dimensionally [Figure 3.8].

The 3-D model became the basis to create plans, sections and elevations, as well as layers of information on the historic evolution of the building from 1888 to the present day. It was also used as a tool by all disciplines that are participating in the project.

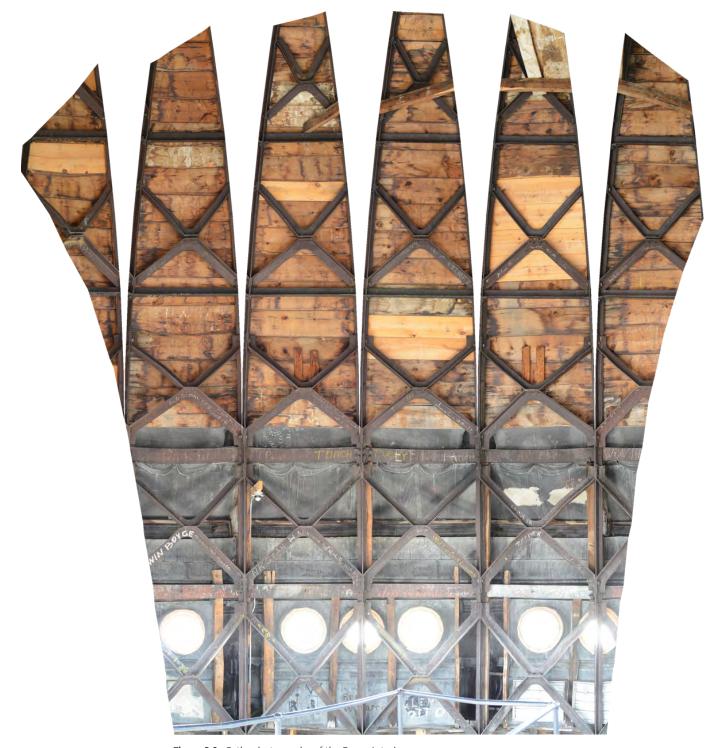
Figure 3.9: Orthophotography of the Dome Interior.
