# STAYING ABOVE WATER

## Property Owner's Guide

Greater Portland Landmarks

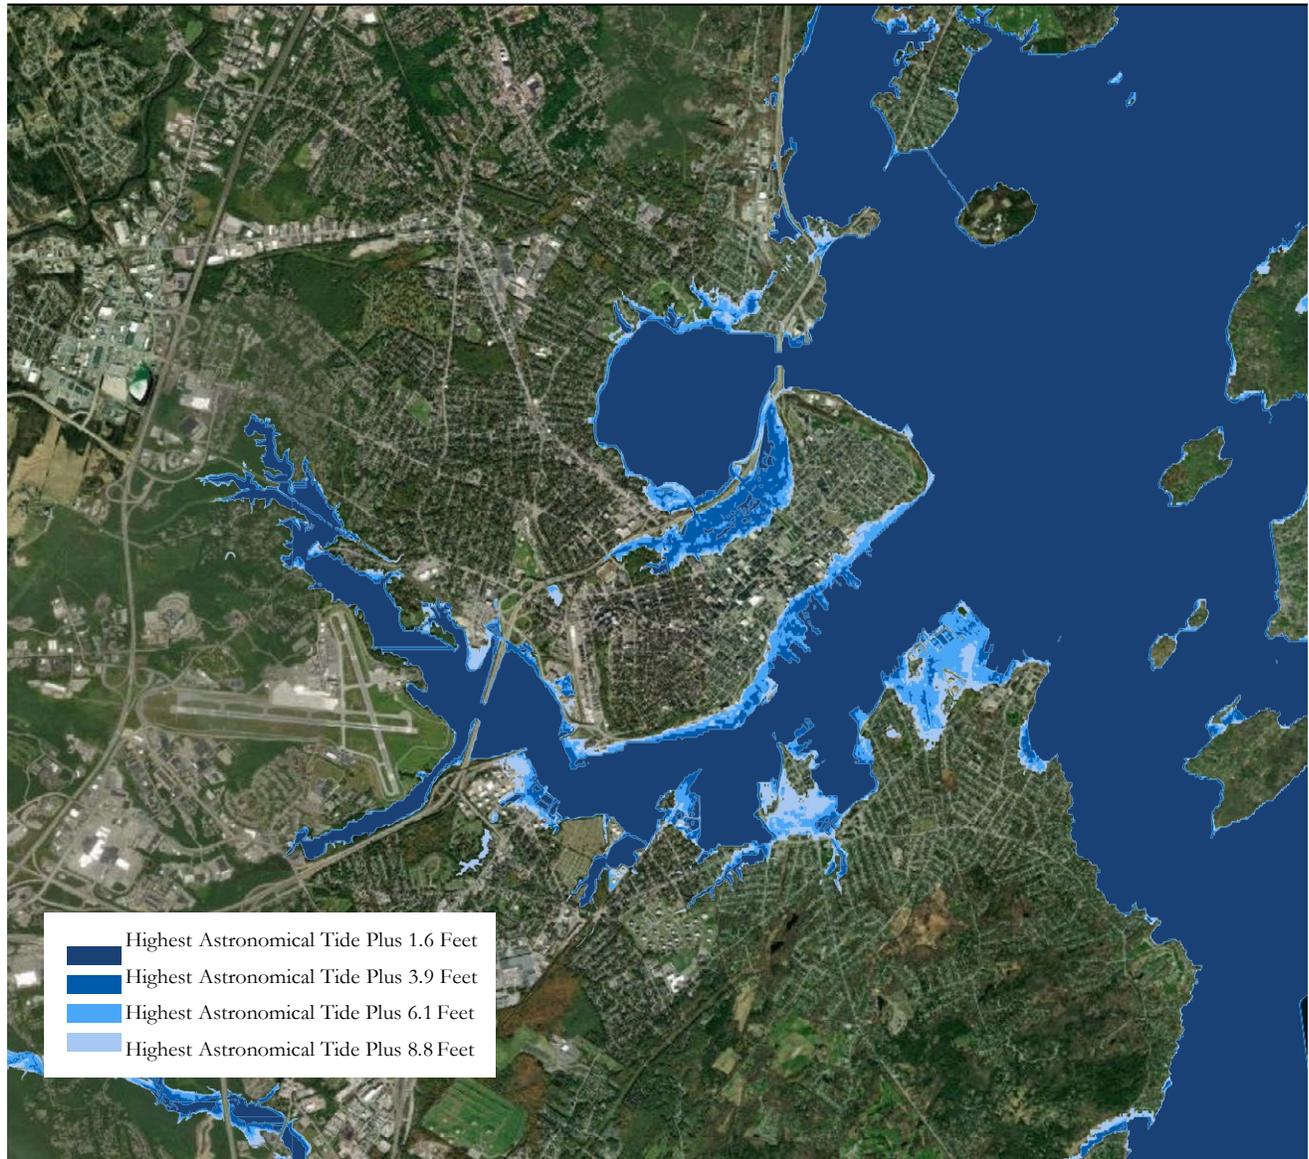
# Sea Level Rise and Storm Surge Scenarios in Greater Portland

The Scientific and Technical Subcommittee of the Maine Climate Council recommends committing to manage 1.5 feet of sea level rise (darkest blue) by 2050 and 3.9 feet by 2100. They recommend preparing to manage 3 feet of sea level rise by 2050 and 8.8 feet of sea level rise by 2100 (lightest blue).  
(*Scientific Assessment of Climate Change and its Effects in Maine, August 2020*)

Sea Level Rise scenarios by P. A. Slovinsky, S. Rickerich, and C. H. Halsted of the Maine Geological Survey

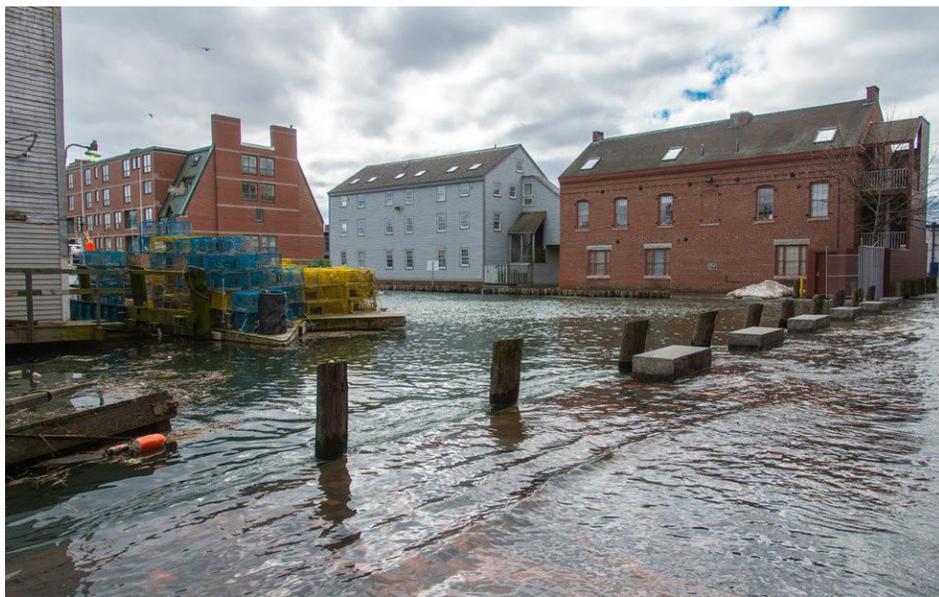
Flooding at Custom House Wharf during high tide, 2018 (Photo by Corey Templeton)

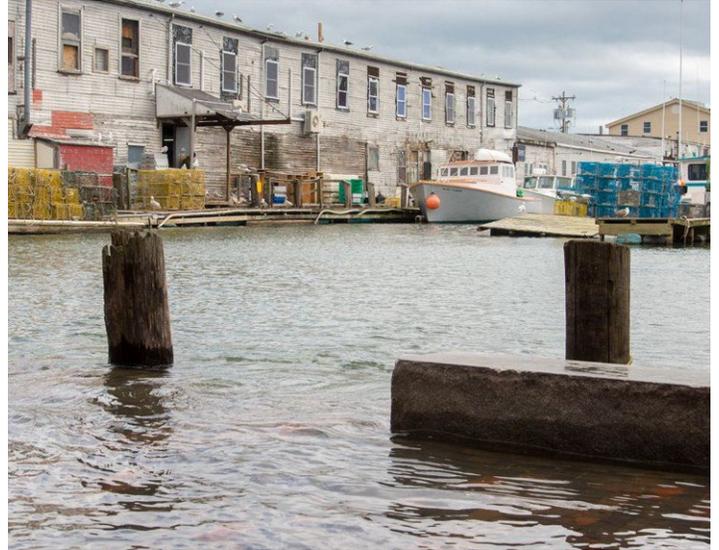
Flooding at Custom House Wharf during high tide, 2018 (Photo by Corey Templeton)

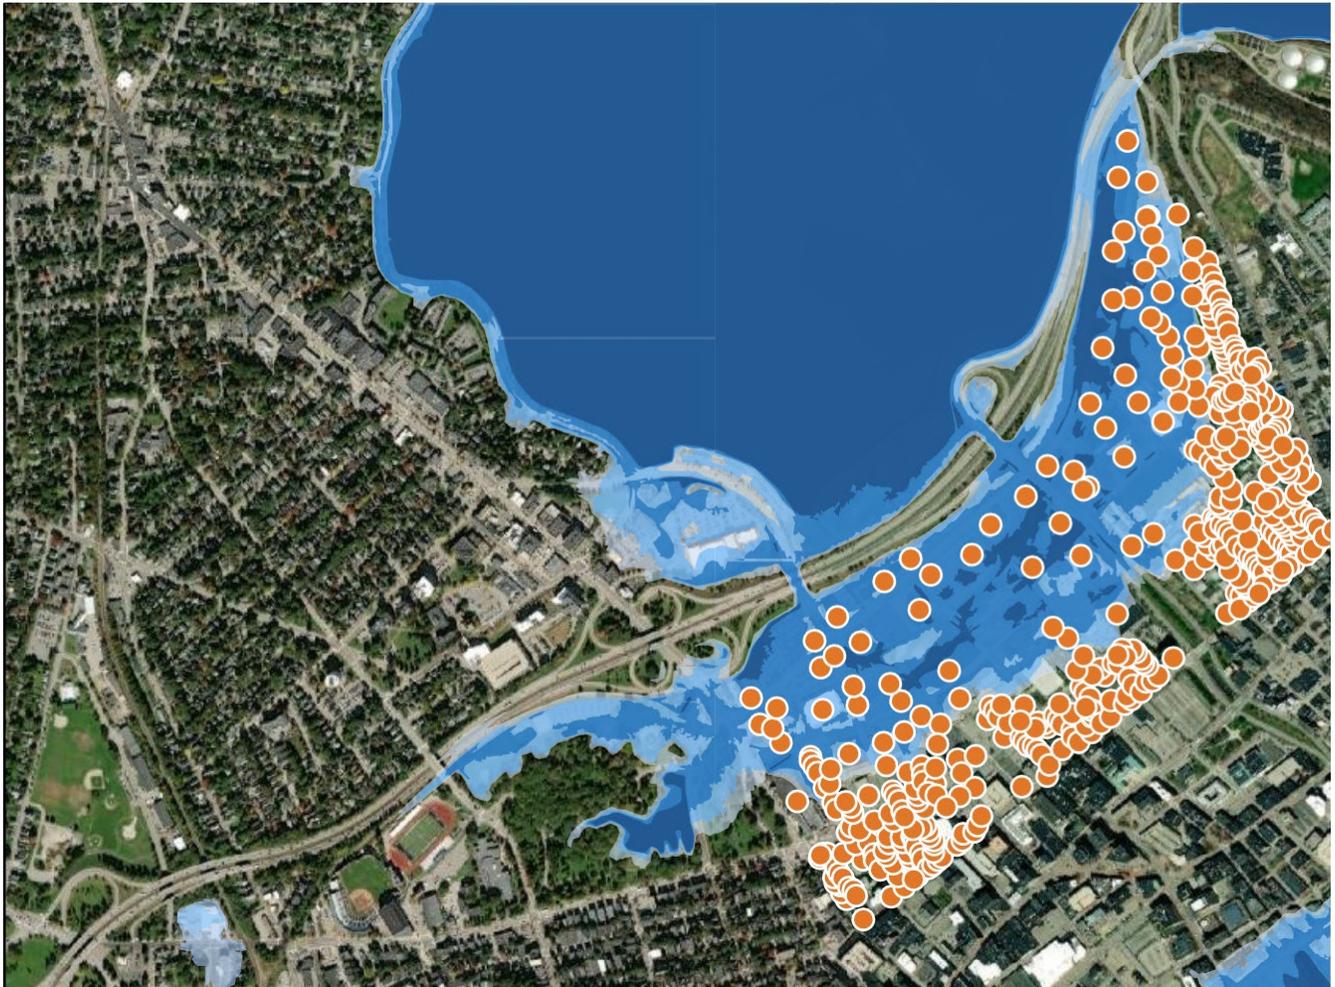
- Highest Astronomical Tide Plus 1.6 Feet
- Highest Astronomical Tide Plus 3.9 Feet
- Highest Astronomical Tide Plus 6.1 Feet
- Highest Astronomical Tide Plus 8.8 Feet

Each orange dot represents a surveyed historic resource in Bayside at risk due to increased flooding and sea level rise caused by climate change.

As the population and economy of East and West Bayside continues to grow, so too does the threat of climate change. Flooding now occurs regularly during heavy rainfall and high tides along Marginal Way and Somerset Street, and is only projected to get worse. Most affected are the buildings constructed on land filled in during the 19th and 20th centuries. Due to sea level rise, Back Cove is slowly creeping back to reclaim those areas of the neighborhood that did not exist 225 years ago.

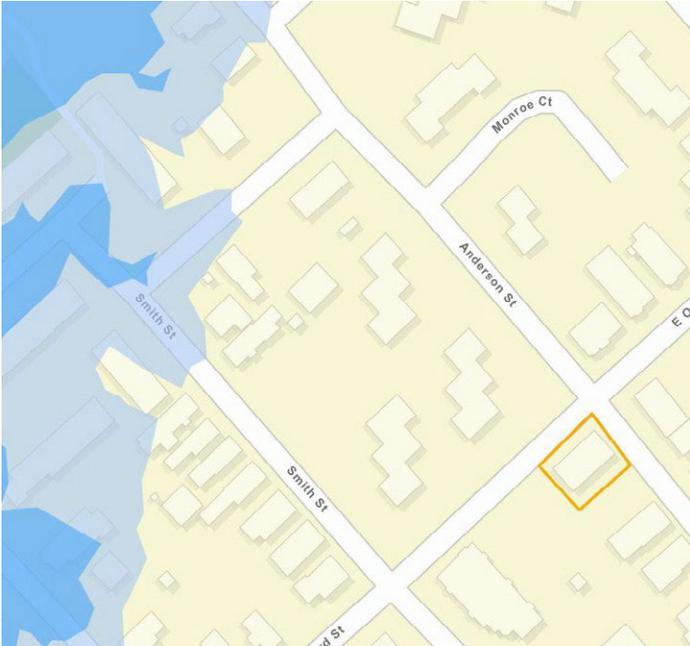
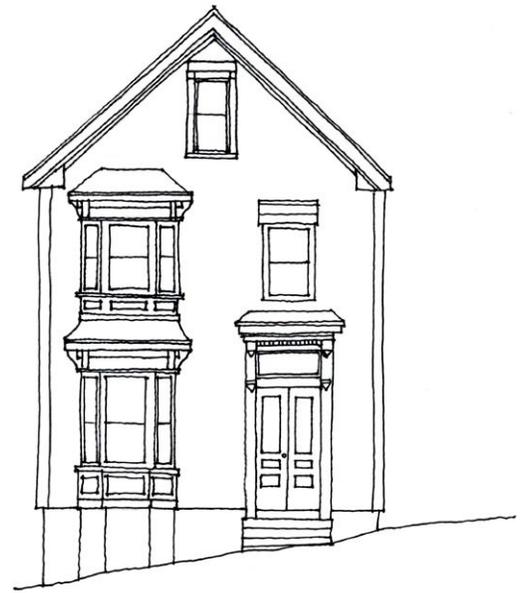
## 32 Anderson Street

This multi-family residence rests on a high foundation in an elevated area in Bayside. Although not identified as at risk to flooding from rain and storm surges, storm water runoff from uphill sites and parking lots to the rear of the dwelling could impact the masonry foundation and at-grade openings. There are few trees to shade the southwest-facing yard. The lot could be improved to encourage site drainage away from the building's foundation.

- Install solar panels on the south slope of the roof, set back from the edge of the gable end
- Elevate critical mechanical systems on the interior
- Resize gutters to handle increasing precipitation loads and drain away from foundation.
- Install rain barrels or integrate gutter runoff into landscaping strategies
- Slope grade and landscaping away the foundation on the uphill side of the house to help drainage
- Install hardware around openings at grade level to accommodate retractable flood shields during storm events
- Reduce impermeable paving, particularly uphill of the dwelling

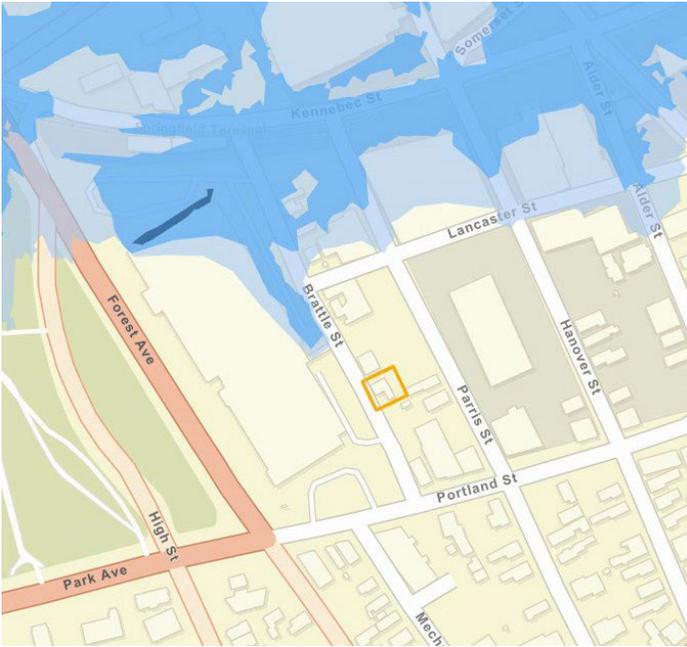
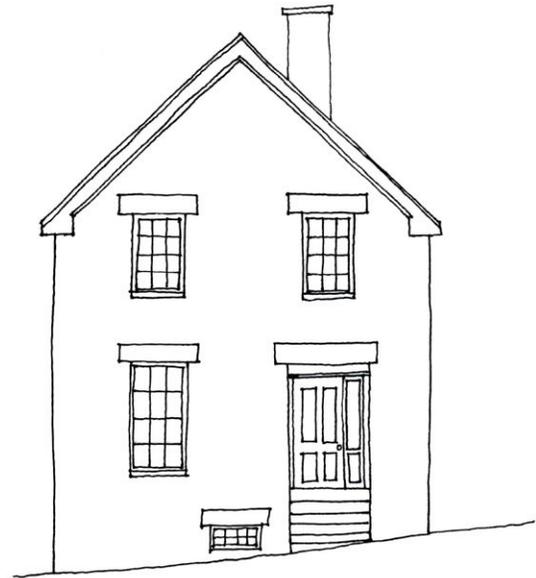
## 17 Brattle Street

This single-family residence rests on a high foundation in an elevated area in Bayside. Although not identified as at risk to flooding from rain and storm surges, storm water runoff from nearby paved streets and parking lots uphill and across the street from the dwelling could impact the masonry foundation and at-grade openings. A large deciduous tree shades the south-facing side yard. The lot could be improved to encourage site drainage away from the building's foundation.

- Install solar panels on the ell roof or main roof, set back from the edge of the gable end
- Elevate critical mechanical systems on the interior
- Integrate rainwater runoff strategies into landscaping
- Maintain masonry, particularly chimneys to reduce damage from loose falling bricks and water infiltration
- Install hardware around openings at street level to accommodate retractable flood shields during storm events
- Slope grade and landscaping away from the foundation on the uphill side of the house to improve site drainage

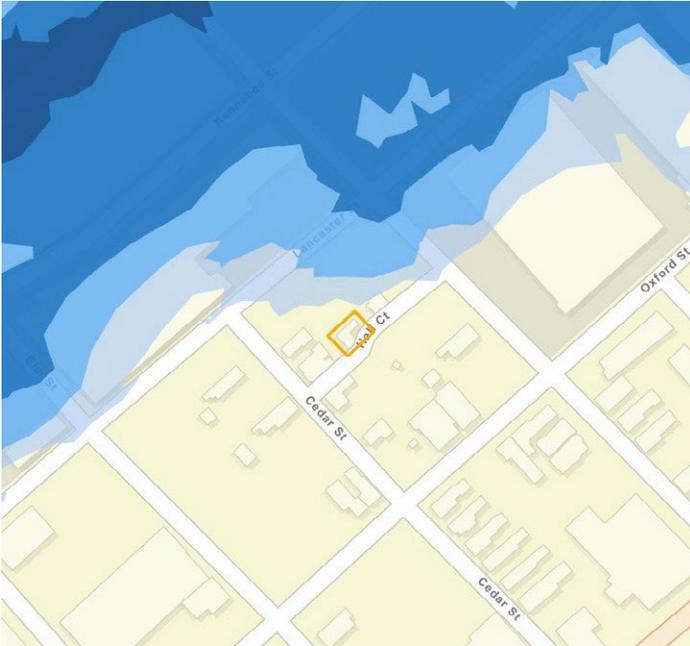
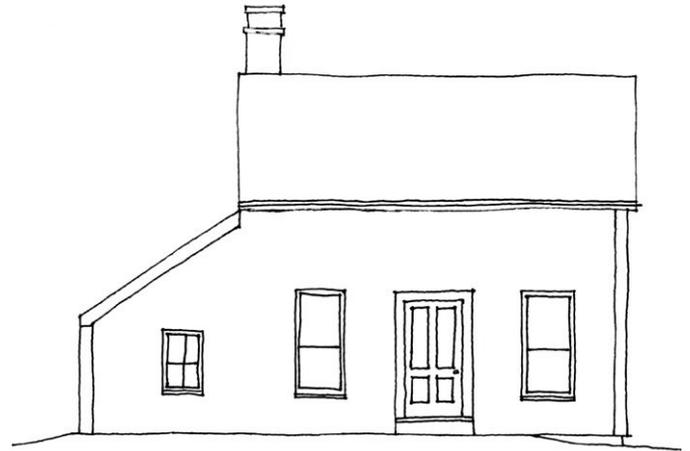
### *3 Hall Court*

This historic single-family residence (c.1820) is built very close to grade and located at the edge of a low-lying area of Bayside identified as at risk to flooding from rain and storm surges. The area around the house features many paved surface parking lots where runoff during storm events negatively impacts adjacent properties and the city's storm water system. With the building sill located close to grade, even minimum levels of flooding or storm water runoff would submerge or wet the building's wood framing, siding, and trim. The front entrance is also very close to grade and susceptible to flood waters.

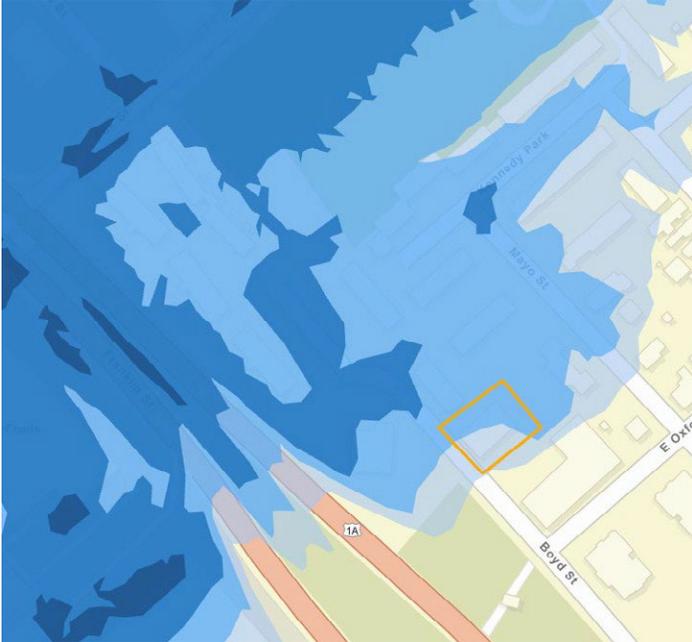
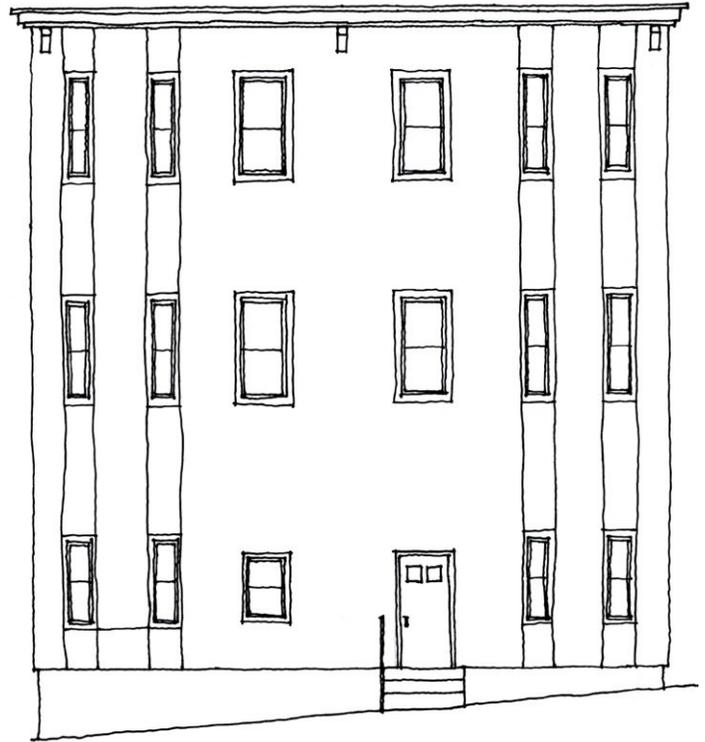
## 47-49 Boyd Street

This multi-family residence rests on a foundation that reflects the topographical change on Boyd Street at the edge of a low-lying area identified as at risk to flooding from rain and storm surges. The area around the dwelling features many paved surface parking lots where runoff during storm events impacts adjacent properties and the city's storm water system. There are limited large trees to shade the yard or building. The relatively flat lot could be improved to encourage site drainage away from the building's foundation, particularly on the uphill side of the dwelling.

- Install a cool roof on flat or low-slope roofs to reduce interior temperature and reduce heat island effects
- Elevate critical mechanical systems on the interior and exterior
- Install solar panels on the roof in consultation with a structural engineer or at the rear of the site
- Size gutters to handle increasing precipitation loads
- Install rain barrels or integrate rainwater runoff strategies into landscaping
- Slope grade and landscaping away the foundation on the uphill side of the house to help drainage
- Add trees where possible to help lower temperature by providing shade.

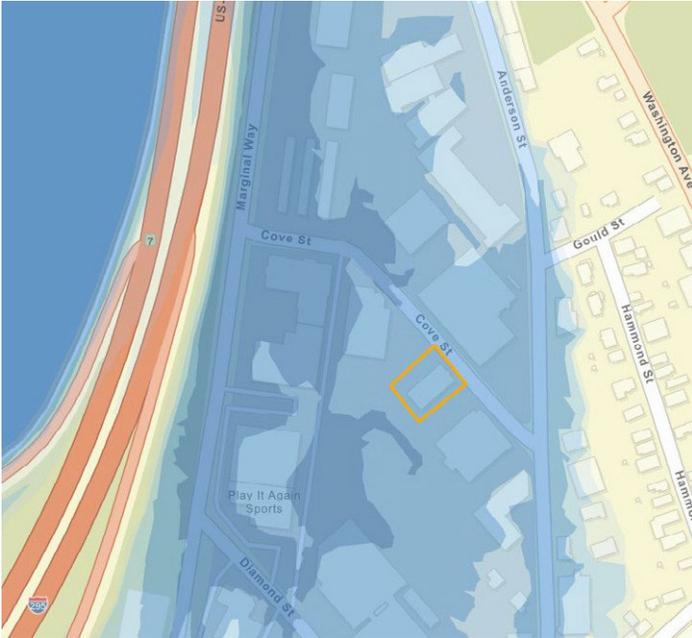
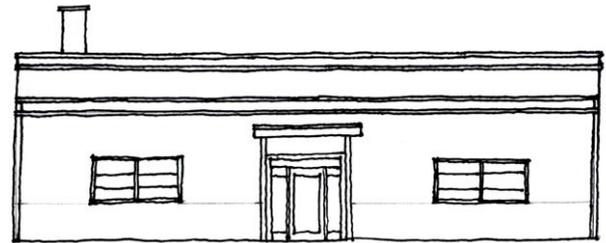
## 66 Cove Street

This industrial brick building (c.1953) is typical of many of its small-scale neighbors, built in an section of Bayside that was once part of Back Cove until it was filled in the first half of the 20th century. The area currently experiences nuisance flooding during extreme storm and high tide events. The at-grade entrance is vulnerable to street flooding. Likewise, mechanicals systems on the exterior, and possibly the interior, are at risk from street flooding. Impermeable paving in the parking area surrounding the building does not allow storm water to penetrate into the ground and raises the temperature more than a vegetated surface would do.

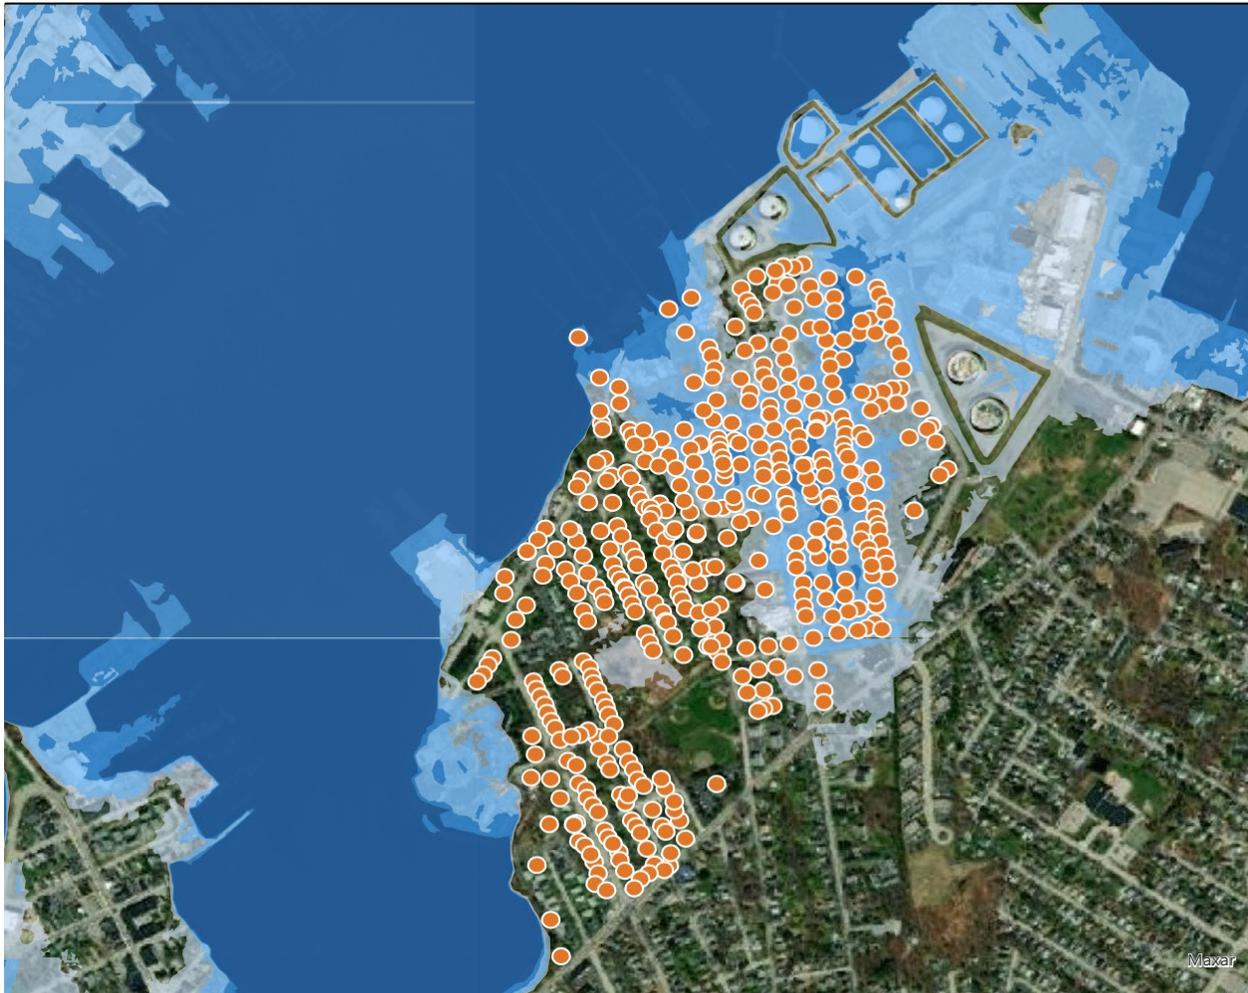
- Highest Astronomical Tide Plus 1.6 Feet
- Highest Astronomical Tide Plus 3.9 Feet
- Highest Astronomical Tide Plus 6.1 Feet
- Highest Astronomical Tide Plus 8.8 Feet

Each orange dot represents a surveyed historic resource in Ferry Village at risk due to increased flooding and sea level rise caused by climate change.

The low-lying character of the shoreline, as well as the fill and subsequent development in areas once part of the harbor, has left Ferry Village vulnerable to the effects of sea level rise. Further risk is posed by a stream that once bisected the neighborhood and is now buried, its former path apparent in flood maps that project flooding in properties far from the shoreline. Historic images depict flooding as far into the neighborhood as High Street, and anecdotal evidence of water in basements in the area of the former stream during extreme rain events corroborates the threat to properties deep into the Ferry Village neighborhood.

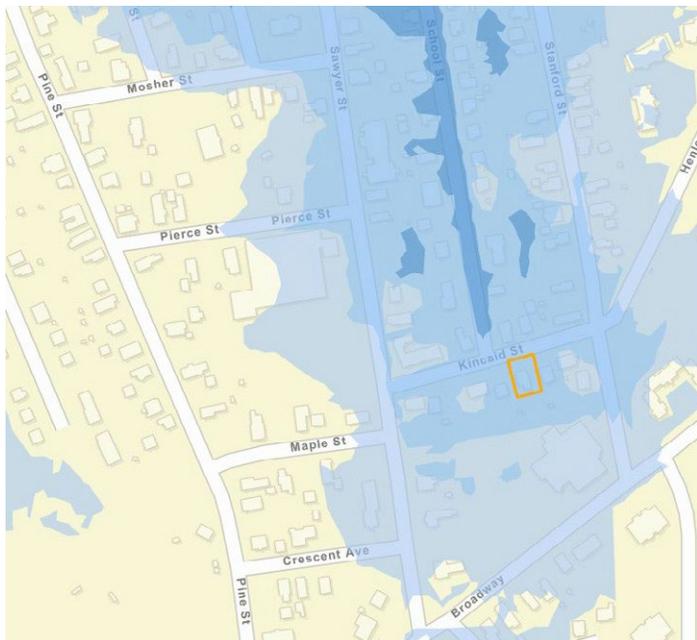
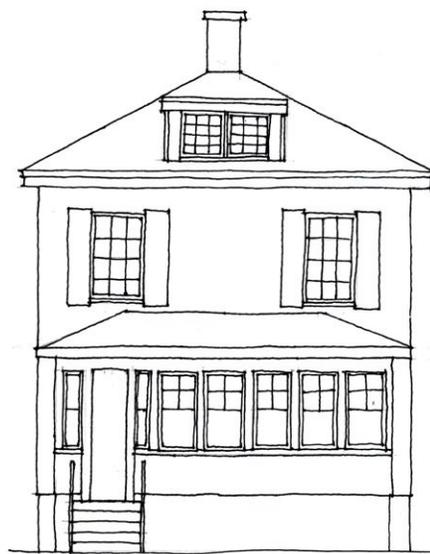
## 16 Kincaid Street c.1900, Craftsman

This single family residence rests on a high foundation at the edge of a low-lying area in Ferry Village identified as at risk to flooding from rain and storm surges. Buildings in this area were anecdotally noted during the study to have wet basements during some major rain events. Large trees shade the south-facing rear yard. The relatively flat lot could be improved to encourage site drainage away from the building's foundation.

- Elevate critical mechanical systems on the interior
- Integrate rainwater run off strategies into landscaping
- Maintain masonry, particularly chimneys, to reduce damage from loose falling bricks and foundations to prevent water infiltration
- Slope grade and landscaping away the foundation to help drainage
- Reduce impermeable paving in the driveway
- Add trees where possible to help lower temperature by providing shade
- Install solar panels on the rear roof slope

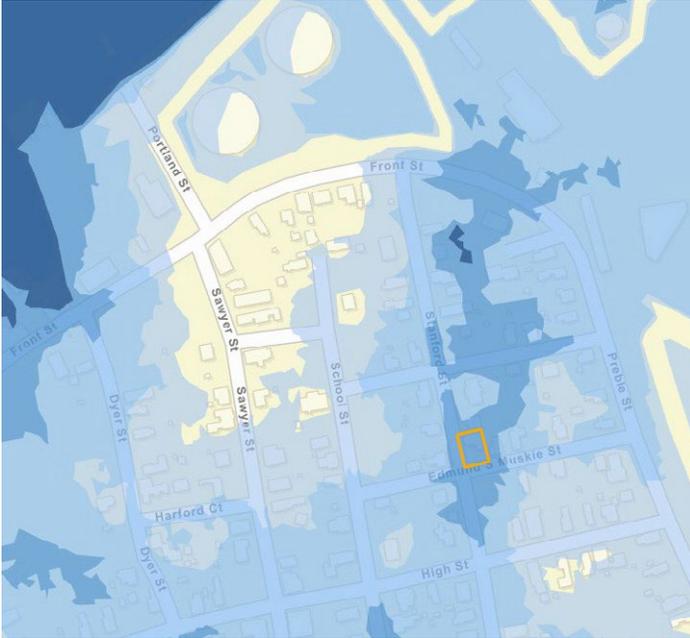
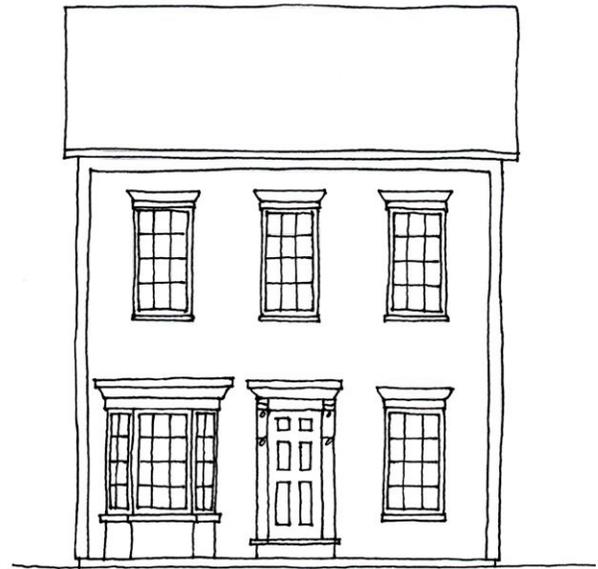
Benjamin W. Pickett House

This historic single family residence (c.1865) is built very close to grade and located in a low-lying area of Ferry Village identified as at risk to flooding from rain and storm surges. With the building sill located close to grade, even minimum levels of flooding would submerge the building's wood framing, siding, and trim. The front entrance is also very close to grade and susceptible to damage from flood waters. Elevated levels of ground water could impact the basement, damaging critical mechanical systems.

- Elevate critical mechanical systems on the interior
- Size gutters to handle increasing precipitation loads
- Install rain barrels or integrate rainwater runoff strategies into landscaping
- Slope grade and landscaping away from the foundation to help drainage
- Install solar panels on the ell roof, garage, or at the rear of the site
- While a last resort, elevating the entire structure to raise the wood sills and entry above projected flood levels is an option. It would be prudent to raise the surrounding site where possible to mask the visual impact of the structure's elevation.

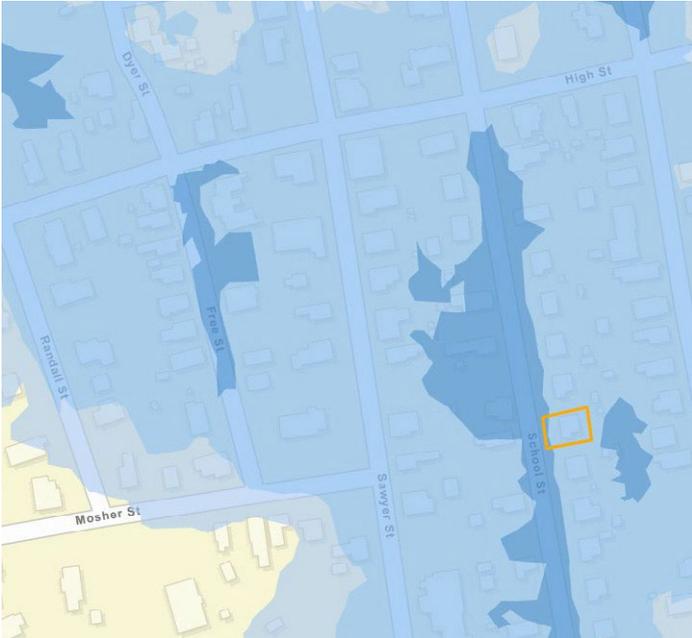
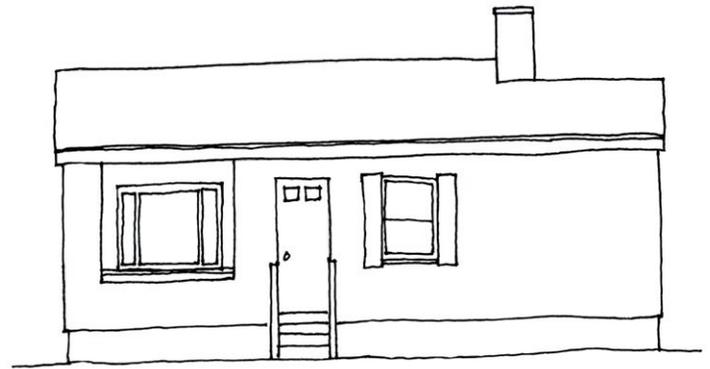
## 154 School Street

This single-family residence is slightly elevated above street level, in a low-lying area of Ferry Village identified as at risk to flooding from rain and storm surges. Buildings in this area were anecdotally noted during the study to have wet basements during some major rain events. Basement windows on the side elevations are at or near grade and are potentially vulnerable to flooding. Elevated levels of ground water could also impact the basement, damaging critical mechanical systems.

- Install solar panels on the roof or site
- Elevate critical mechanical systems on the interior
- Integrate rainwater run off strategies into landscaping
- Maintain masonry, particularly chimneys to reduce damage from loose falling bricks
- Slope grade and landscaping away the foundation to help drainage
- Reduce impermeable paving in the driveway
- Add trees where possible to help lower temperature by providing shade
- Install hardware around basement windows to accommodate retractable flood shields during storm events

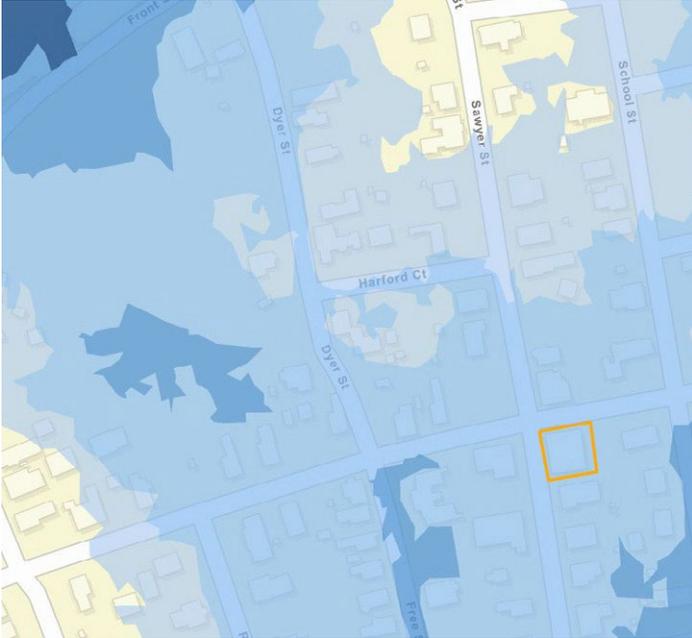
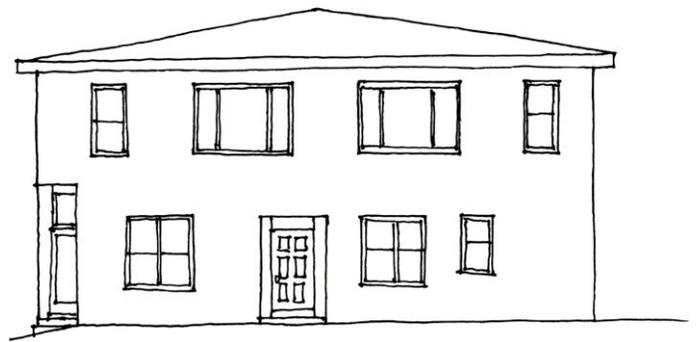
## *124 Sawyer Street* c.1900, vernacular

This mixed-use building at the corner of two major streets is located close to the sidewalk on two sides of the building and surrounded by paved parking on the two remaining sides. This low lying area of Ferry Village has flooded during historic storm events. Entries at or near grade are vulnerable to street flooding. Impermeable paving in the parking area does not allow storm water to penetrate into the ground and raises the temperature more than a vegetated surface would do.
