OPENING THE FIRST FLOOR

1941 2-Story Home
Chopped up spaces, poor traffic and sight lines
Small kitchen, no room for seating
No true mudroom
Un-needed full bath

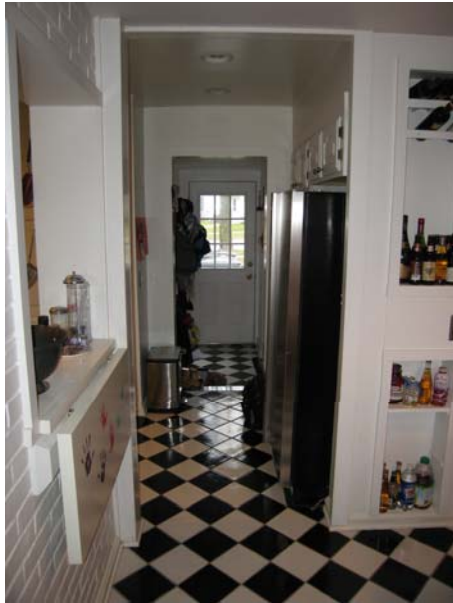
A

Original entrance,
cuts through kitchen

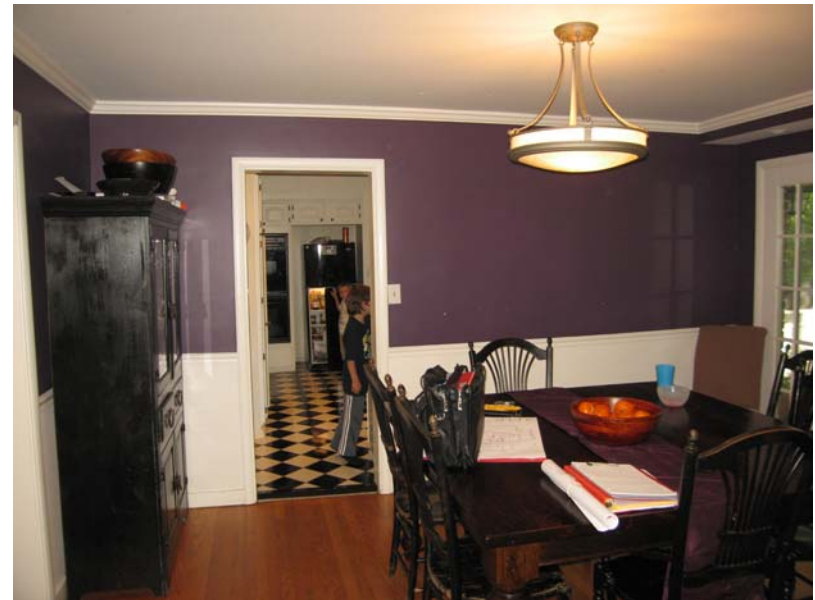
D

Existing wall between dining and kitchen, which blocked views
and communication between the spaces

The wall between the dining room and the kitchen presented a unique set of complications. It was the central support structure for the second floor. It also housed several drain lines, two supply pipes, two major heating runs, and assorted electrical. All of it had to go.

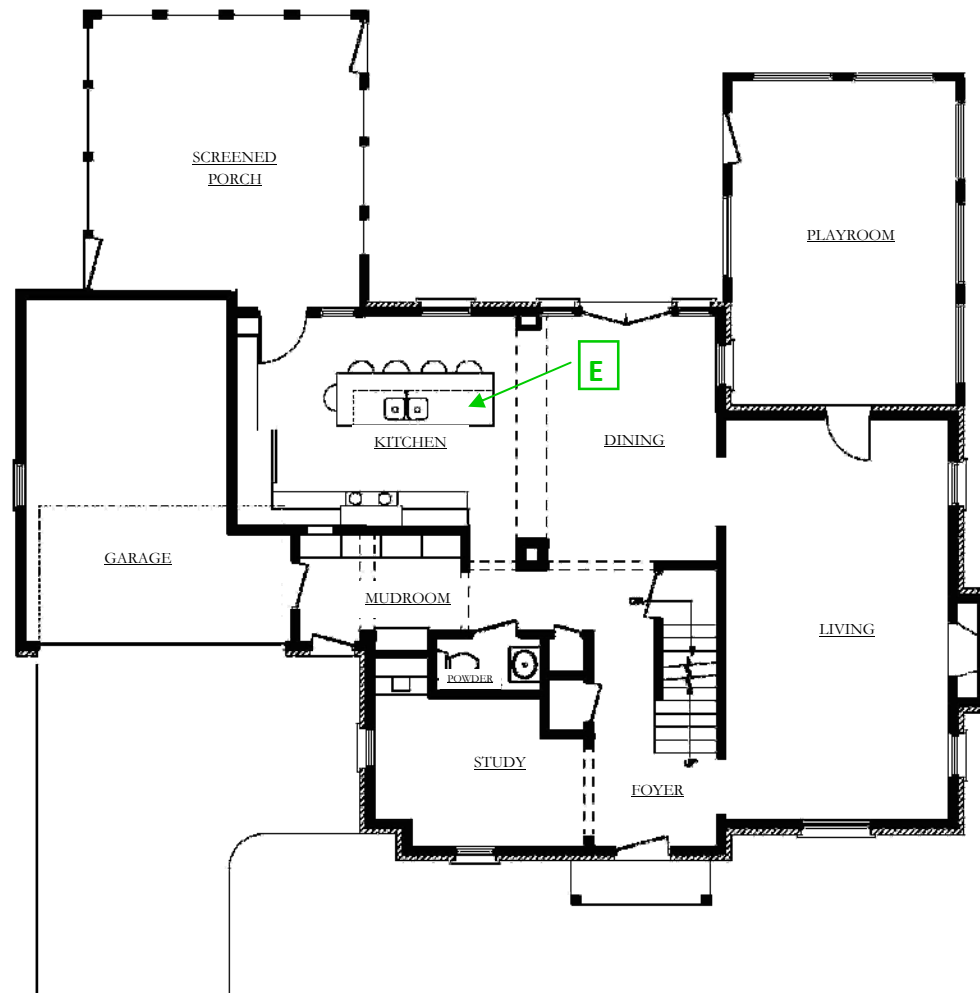
AFTER: FLOOR PLAN

1941 2-Story Home

Open plan between kitchen and dining

Better utilization and arrangement of kitchen

Full mudroom with space for entire family

New powder room

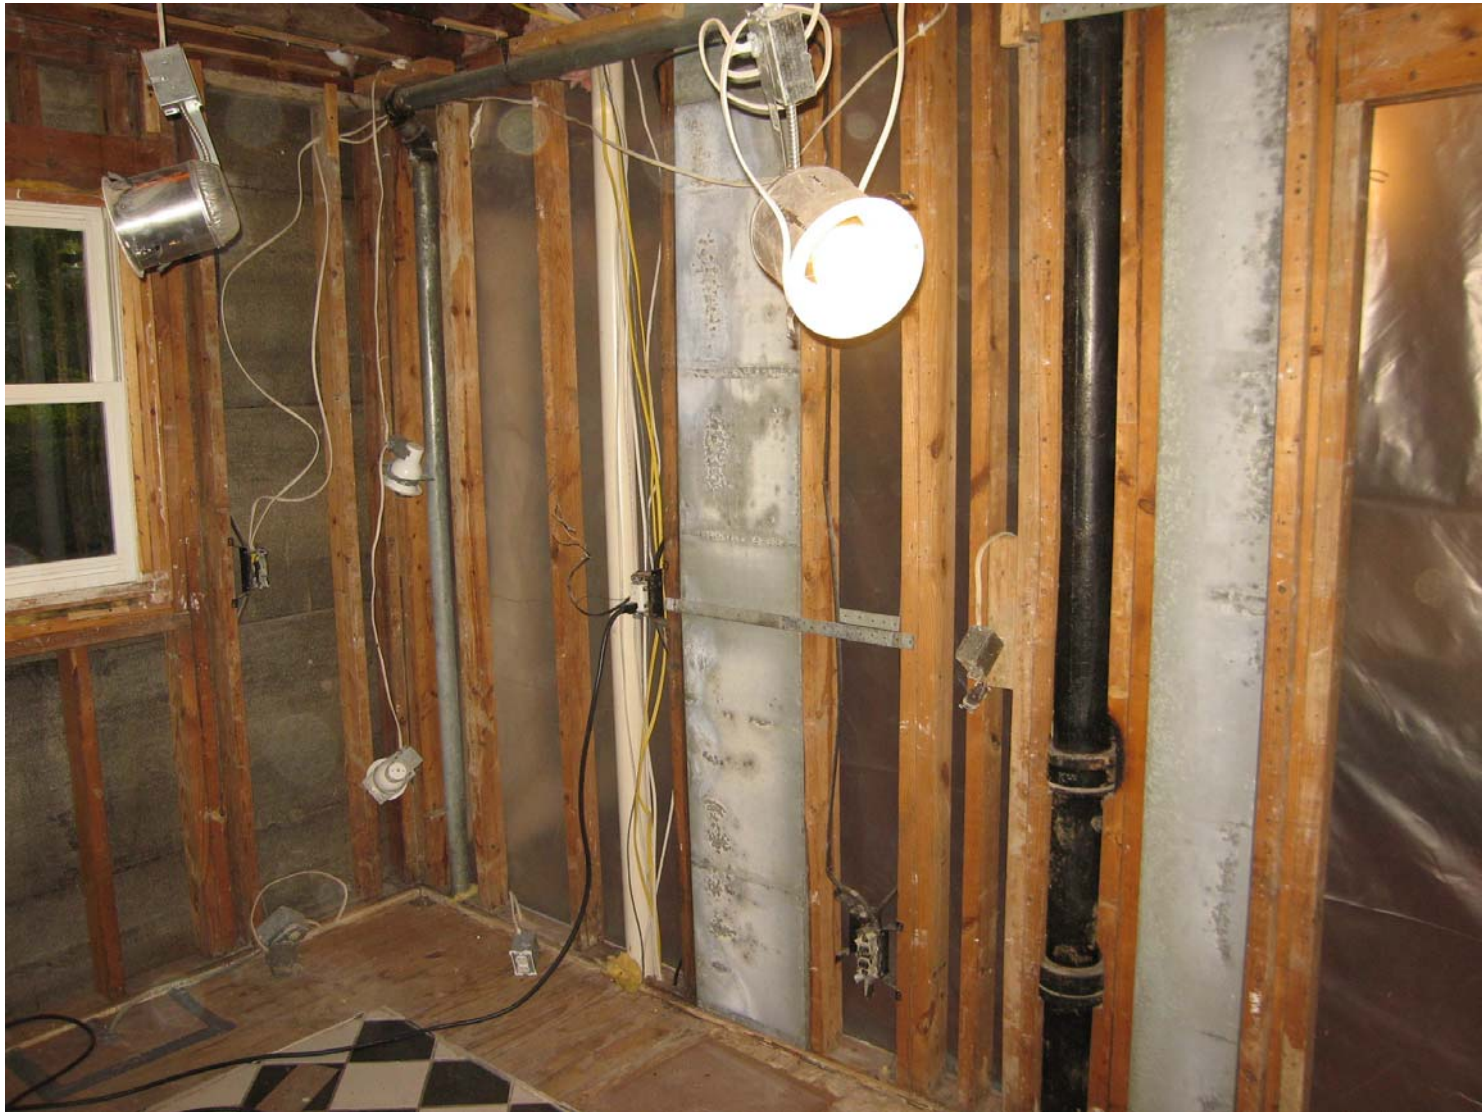
CHALLENGE #1 – THE CENTER WALL

We took the straightforward approach structurally. We installed three large LVLs across the span, building in posts at each end. This formed one side of the soffit.

Plumbing was run next. New PVC drain lines were installed and run toward the exterior wall, to be hidden in a chase. Supply lines went toward the interior to a second chase.

This second chase also housed the new supply ductwork. It was then run parallel to the plumbing to re-connect with the second

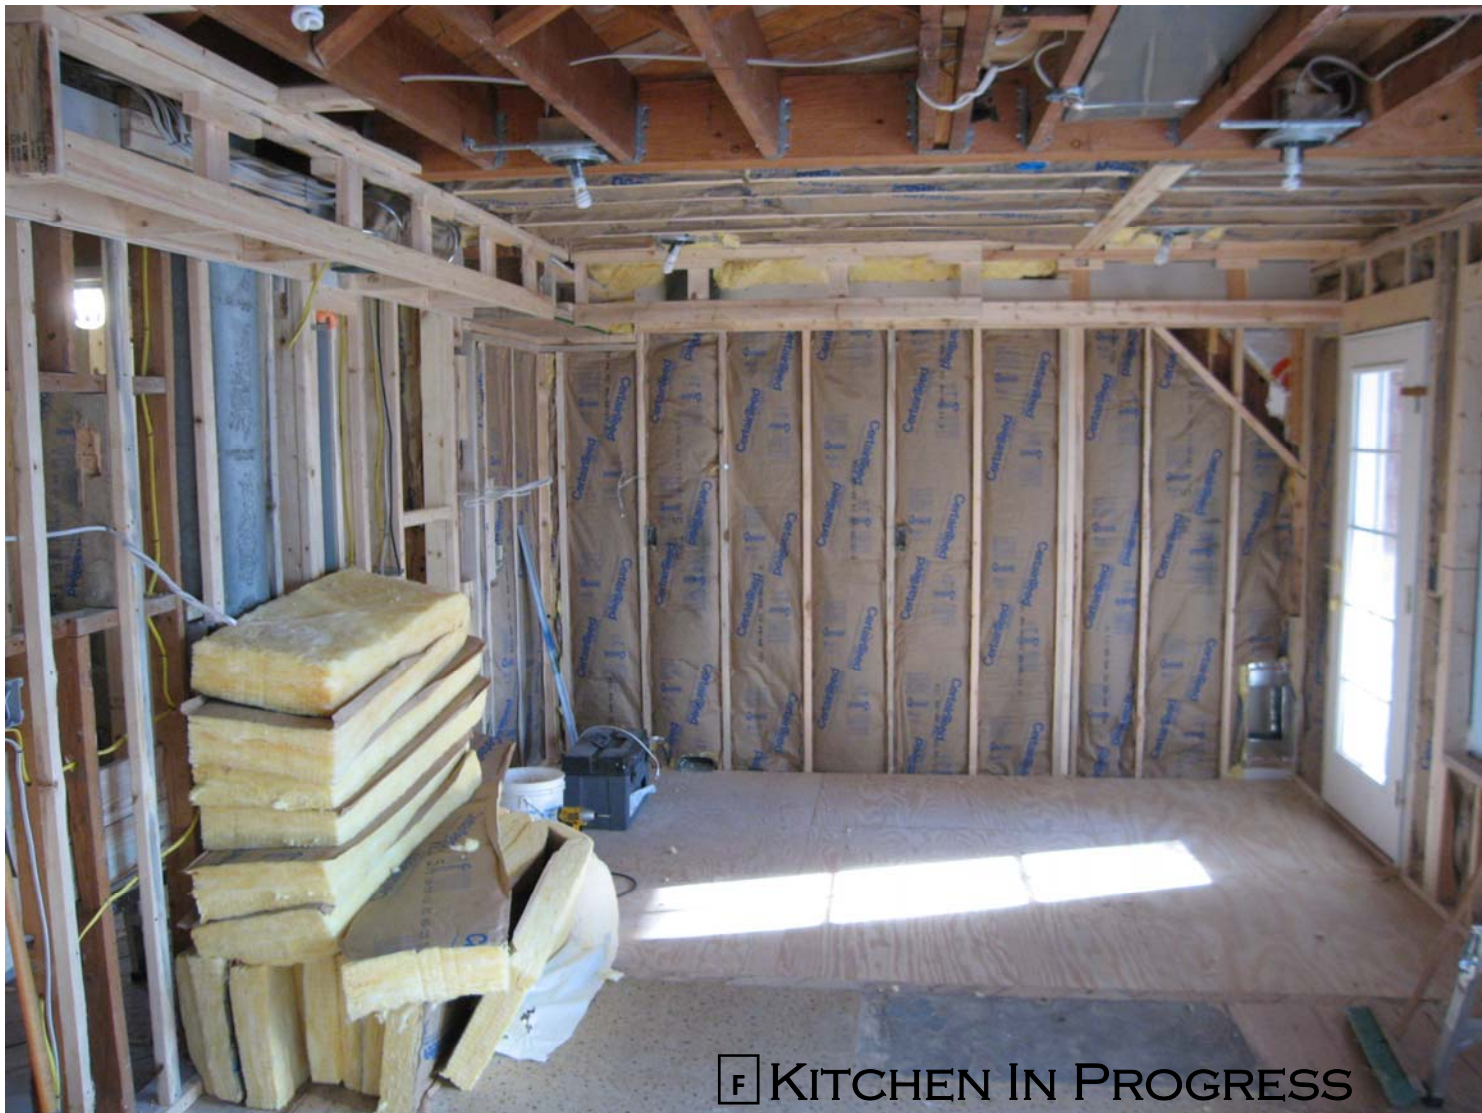
CHALLENGE #2—SQUARING UP THE KITCHEN

The existing kitchen/breakfast area was extremely chopped up. Lots of different traffic patterns separated the main kitchen from the pantry and the fridge. Many ins and outs, bumping awkwardly into the garage and the screened porch. Mix of slab-on-grade, crawlspace, and basement lead to uneven floor levels. One bricked bearing wall divided the space.

Brick was supported above with a lintel. The bearing wall was replaced with another string of LVLs. These were set flush with the second floor joists, leading to a uniform ceiling in the kitchen.

The existing floor was torn up, and new insulation was put in. Floor joists were adjusted and furred, giving a uniform floor throughout.

All the odd bump-outs were torn down. New exterior walls were built to create a uniform, rectangular space.

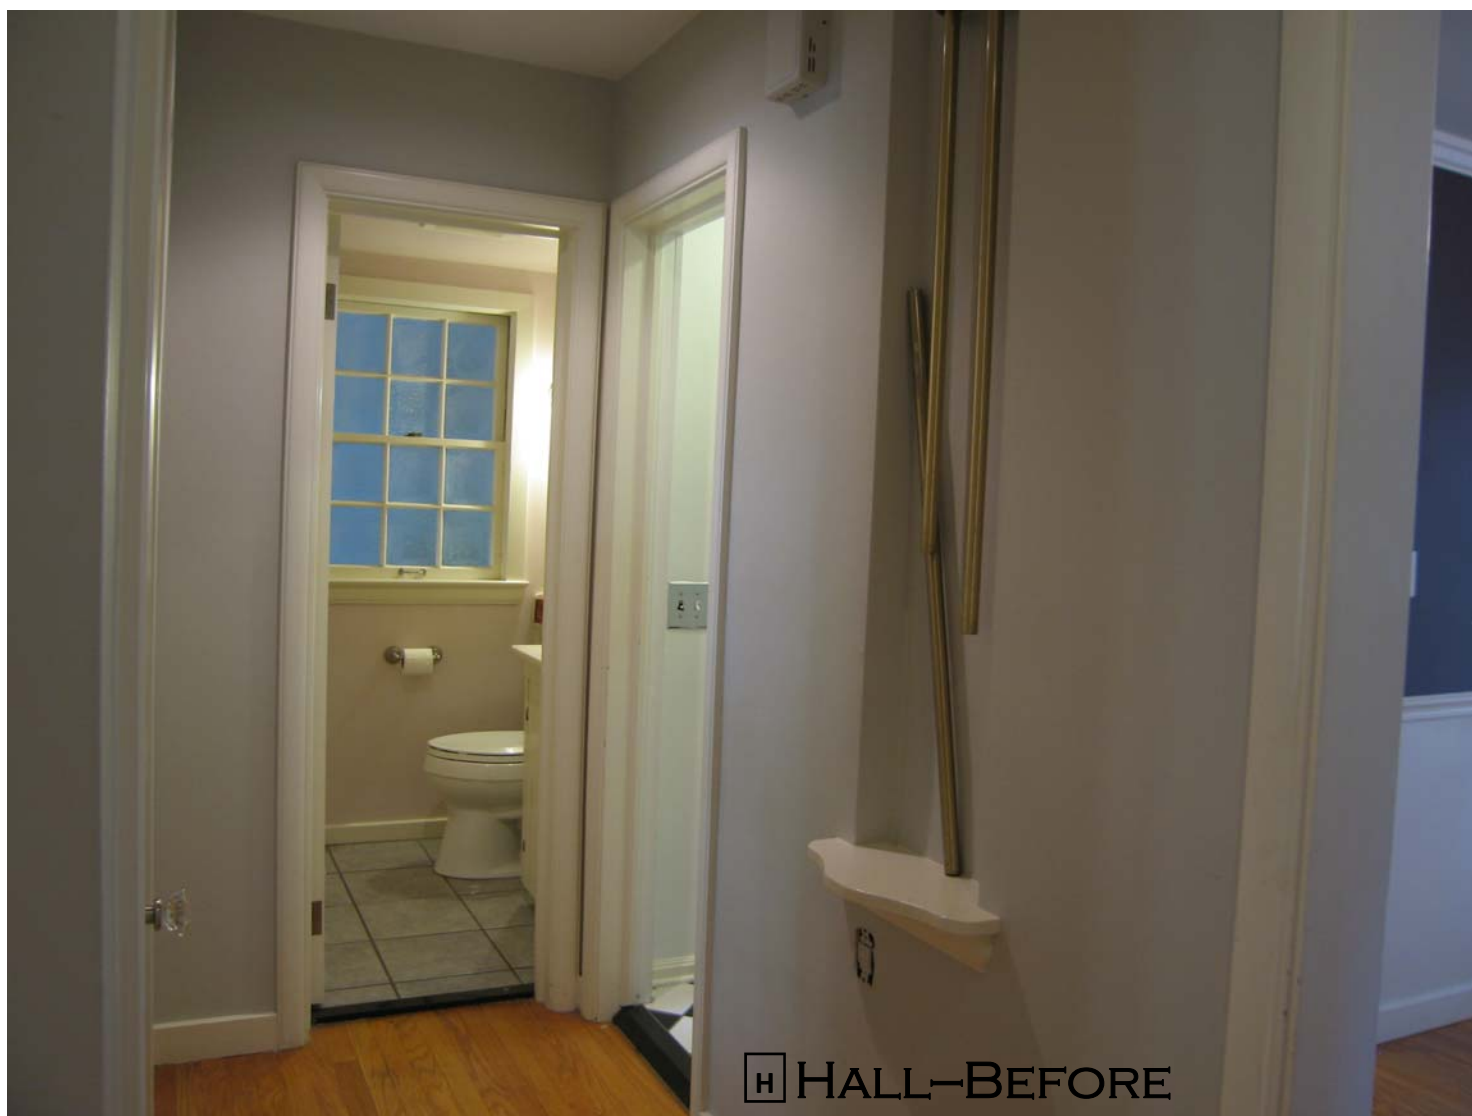
CHALLENGE #3—LOCATING THE MUDROOM

There was no true mudroom in the house. The existing entrance area off the garage was small almost entirely occupied by whatever door was open. Poor for a household with three small children and their backpacks, coats, and boots.

The ideal location was occupied by the first floor full bath. With two full-baths upstairs, we were able to reduce this down to an half bath, and shift it out of the main traffic pattern.

This blocked the original door the study. We turned this complication into an advantage. We created a gracious arch into the study, making the front entrance feel more spacious.
