## **CLINE AVENUE BRIDGE ASSESSMENT**

## **Project Description**

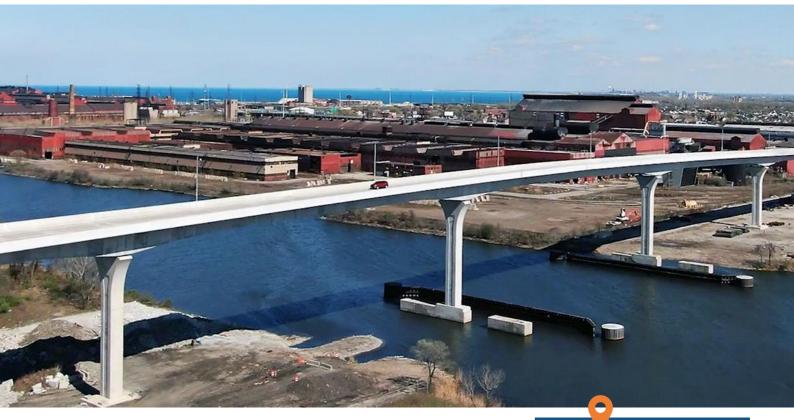
Inspectors for the Indiana Department of Transportation (INDOT) had observed unusual patterns of cracking, spalling and efflorescence in the bridge. National Bridge Inspection Standard (NBIS) inspection efforts identified significant longitudinal and transverse cracking in the bridge deck, as well as cracking in the webs and diaphragms.
