The Development of Modern Steam 4: Advanced Internal Boiler Water Treatment

Ing. Shaun T. McMahon

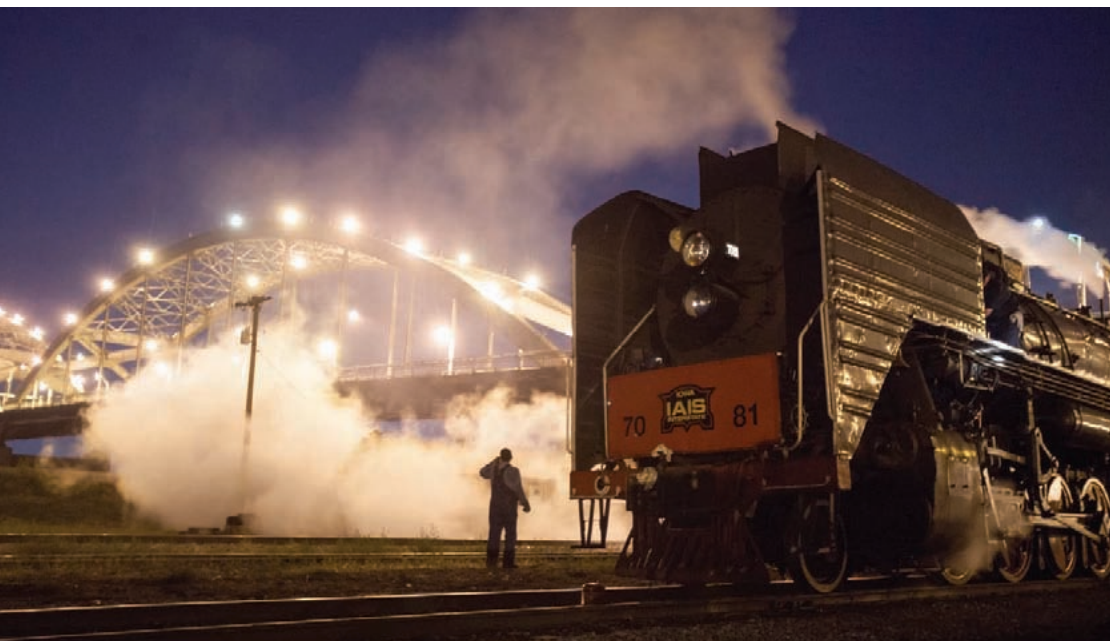
Often quite dramatic, blowing down the boiler removes sediment from the lowest reaches of the system, where it tends to settle. This image shows Iowa Interstate QJ locomotive 7081 blowing down its boiler in Rock Island, Illinois on July 29, 2011. Photograph by Scott Lothes and courtesy of the Center for Railroad Photography and Art - railphoto-art.org.

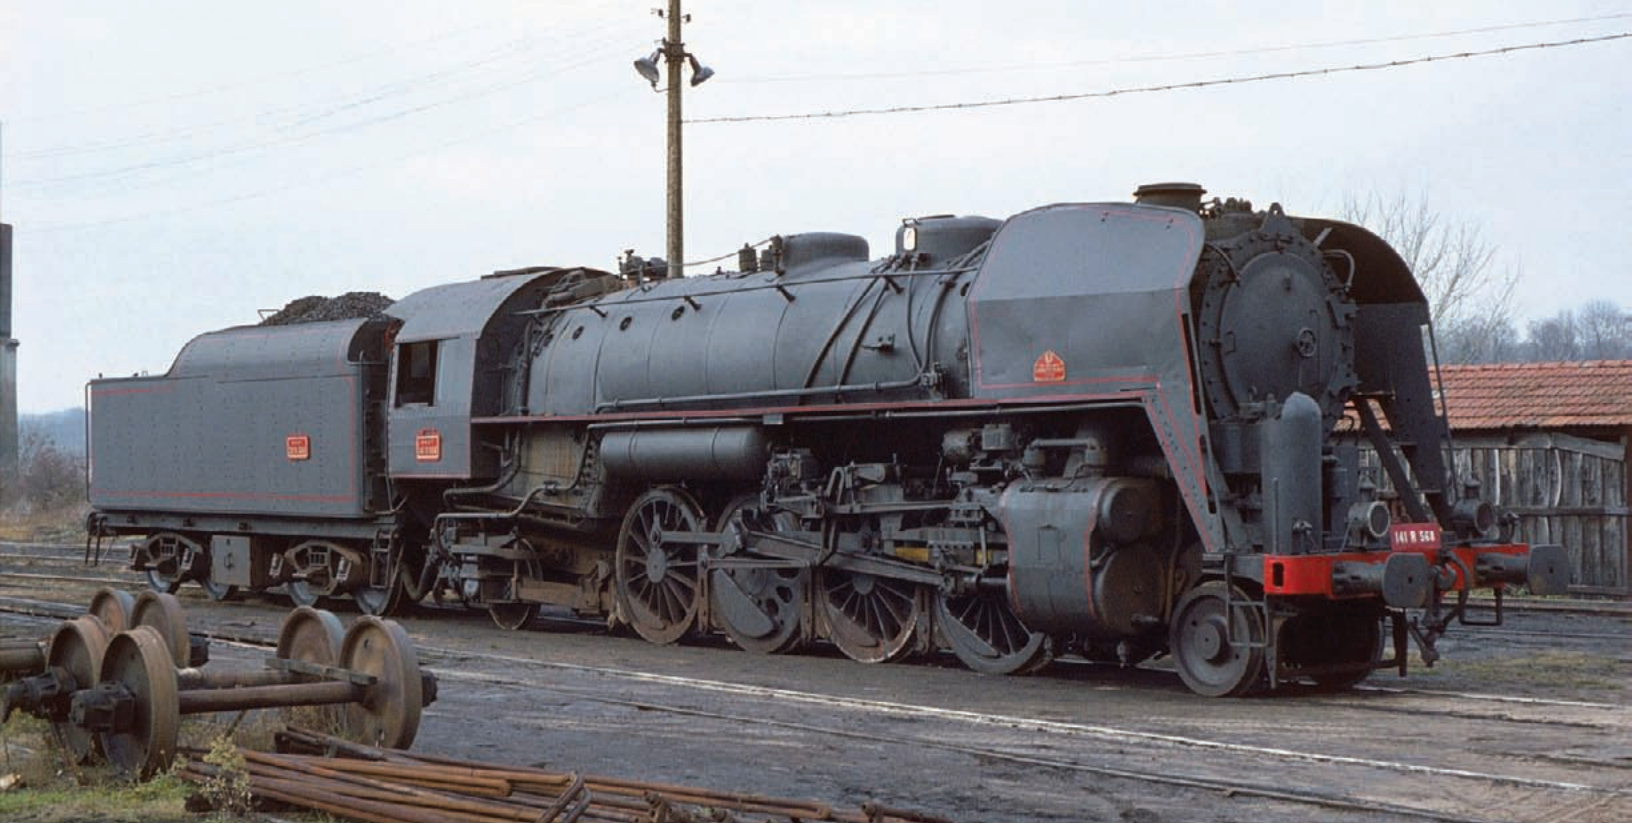
A nearly unbelievable success, the TIA water treatment was employed by the SNCF at its Nice locomotive depot in connection with a fleet of North American-built 141R locomotives, such as the one shown above. The treatment was so successful in reducing boiler maintenance costs that three locomotives, numbers 1156, 1158 and 1159, were able to operate a cumulative 5,500,000 miles with fewer than 900 man hours of maintenance attributable to the boiler, or an equivalent of approximately 0.2 man hours per 1000 miles of operation. In total, SNCF reduced boiler maintenance costs associated with the locomotives 90% while operating the locomotives with washout intervals twice that permitted in the U.S. The image above is of 141 R 568 built by the BALDWIN LOCOMOTIVE WORKS in 1946, photograph by Dider Duforest on November 11, 1981 - wikimedia commons.

chemical action of tannin on a soda environment and, at temperatures of locomotive boilers, on the calcium encrusting salts. This system employed a 'disencruster,' consisting of carbonate of soda, phosphate of soda, caustic soda and tannin introduced into the feed water by a distributor. Following the Second World War, a number of older French locomotives as well as some of the newly arrived 141R class were used to prove the efficacy of the new program before fleet-wide deployment. It so significantly reduced problems relating to scale buildup in locomotive boilers, that many boiler repair shops on the SNCF system were closed.

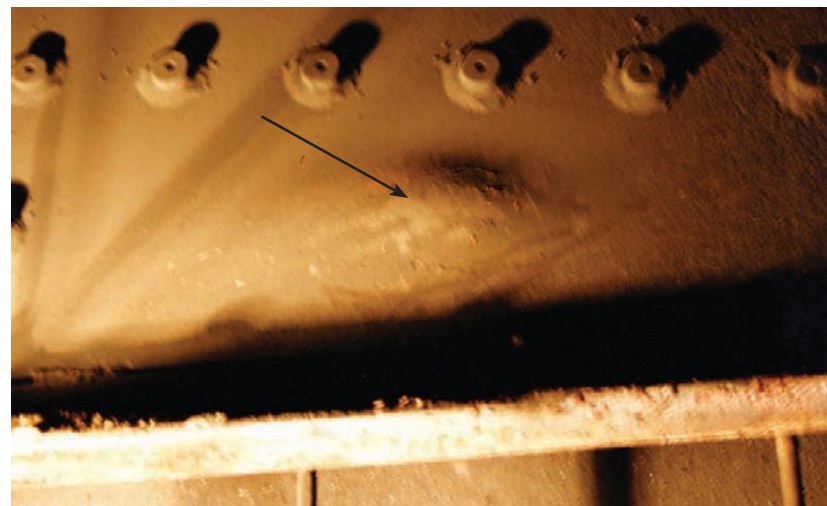
A bulging side sheet is an indication of overheating resulting from excessive scale buildup, as shown in this image of the inside firebox side sheet of 'Camila.'

Holes drilled in the outer firebox reveal a water space nearly completely encrusted with scale and mud. This is the inverse side to the photograph of the bulge shown on PAGE 9.

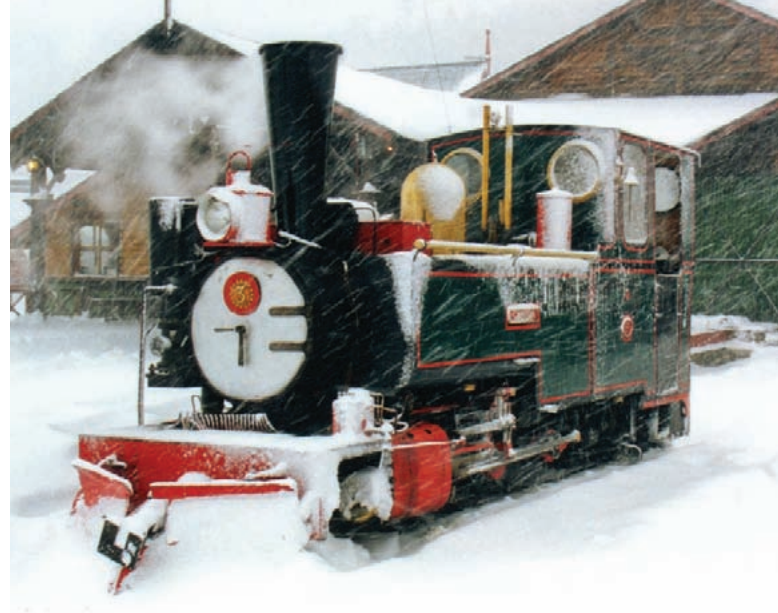
Rain, sleet, or snow, the trains must run. This image shows locomotive 3, ‘Camila,’ when in service on the railway post-rebuild and Stage 1 modification. Note the stack profile indicative of an advanced exhaust.

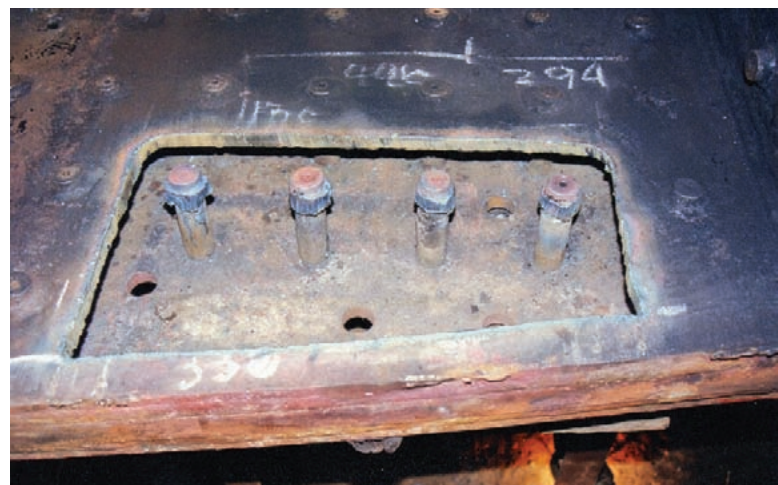
With a chunk of steel removed for making a patch, this image shows the corrosion on the sheets resultant from poor water treatment.

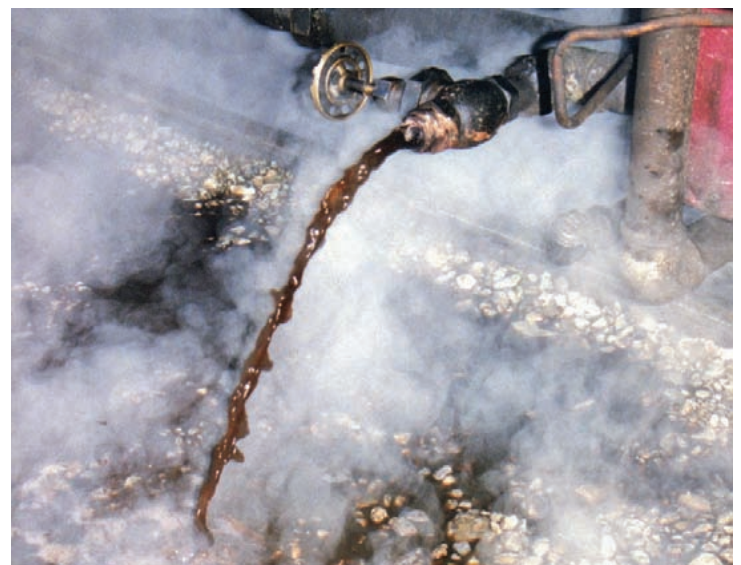
Even darker brown is acceptable, as is evident with this image of just-off-of-steam hot boiler water draining from the boiler of 'Camila.' With PT, the levels of TDS required are not harmful to the boiler.

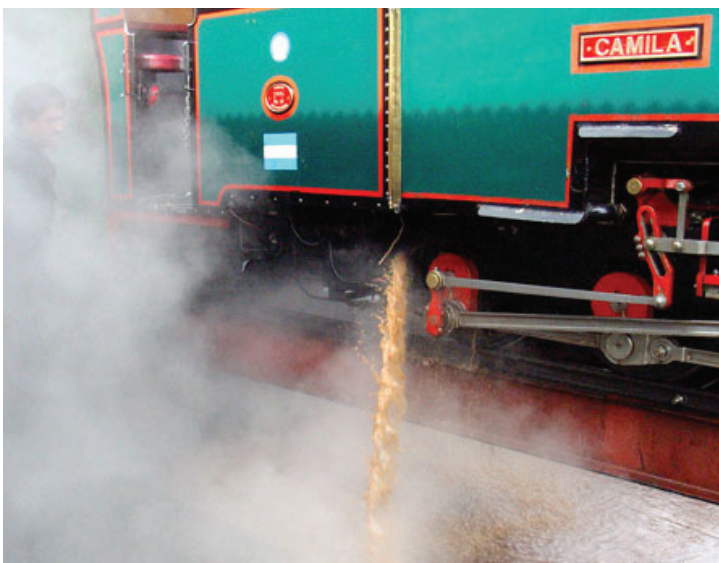
Step 1: Drain the Boiler Washout plugs are opened on the top of the boiler to vent and on the bottom of the boiler to drain out the initial boiler water in the system.

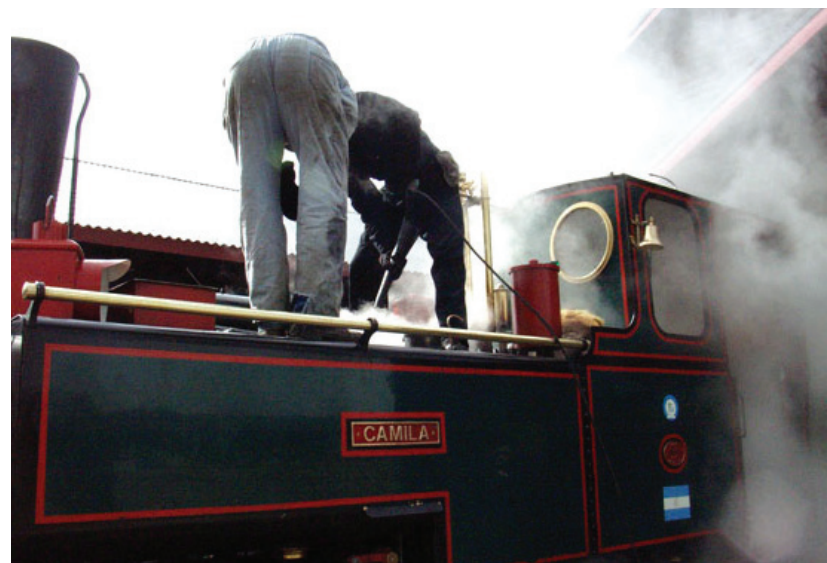
Step 2: Hot Power Wash the Boiler after the boiler water has been drained, a high-output steam cleaner is used to wash all interior surfaces of the boiler reachable from strategically-placed wash out plugs.

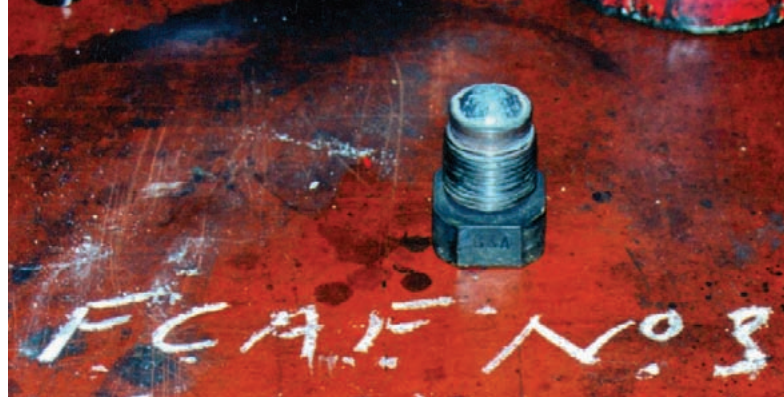
This diagram and photo show the fundamentals of the fusible plugs. The diagram at LEFT shows three types of plugs. In each case, a core of lead alloy is cast such that, in the case of low water, that core melts prior to the softening of the sheets, causing water to pour onto the fire and put it out. The image at right shows the plug from FCAF No. 3. Note the different metal in the core of the plug

assessing the particular failure that we were faced with. They were also found to be lacking in certain safety features such as fusible plugs [SEE CAPTION ON PAGE 14] and a second water glass; all defects that were corrected during subsequent shoppings.

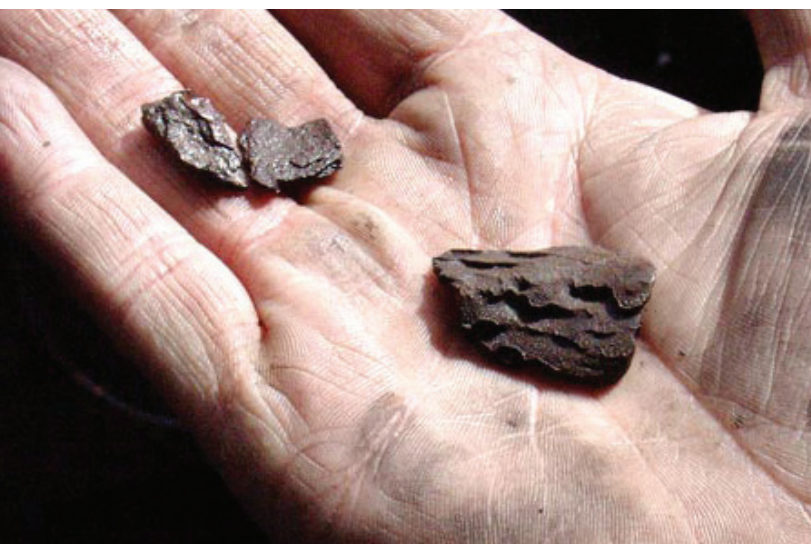
Following the initial application of PT, these large chunks of scale began to wash out of 'Camila's' boiler. The high pH level of the boiler water, combined with other chemicals, stripped this scale from the boiler.

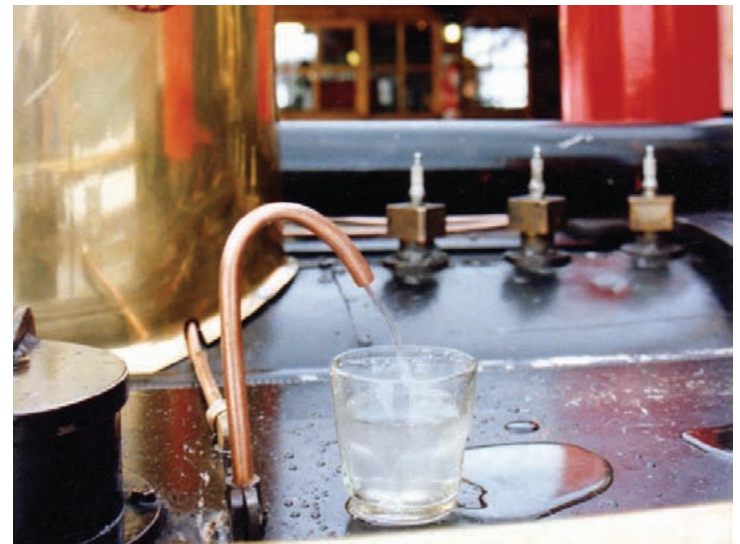
Despite the brown water, pure steam is generated in the boiler for propulsion. This take-off spout pulls steam from the dome and is used for purity trials. Compare the color of this water to that on PAGES 12 and 13.

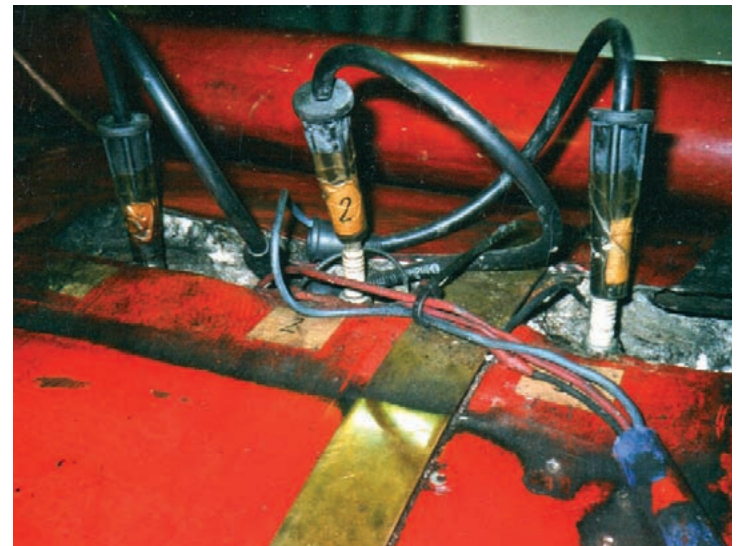
Once installed in the boiler, the electrodes feed a central processing unit that indicates whether water (or foam) is in contact with the end of the device. This informs crews as to whether the antifoam is adequate.

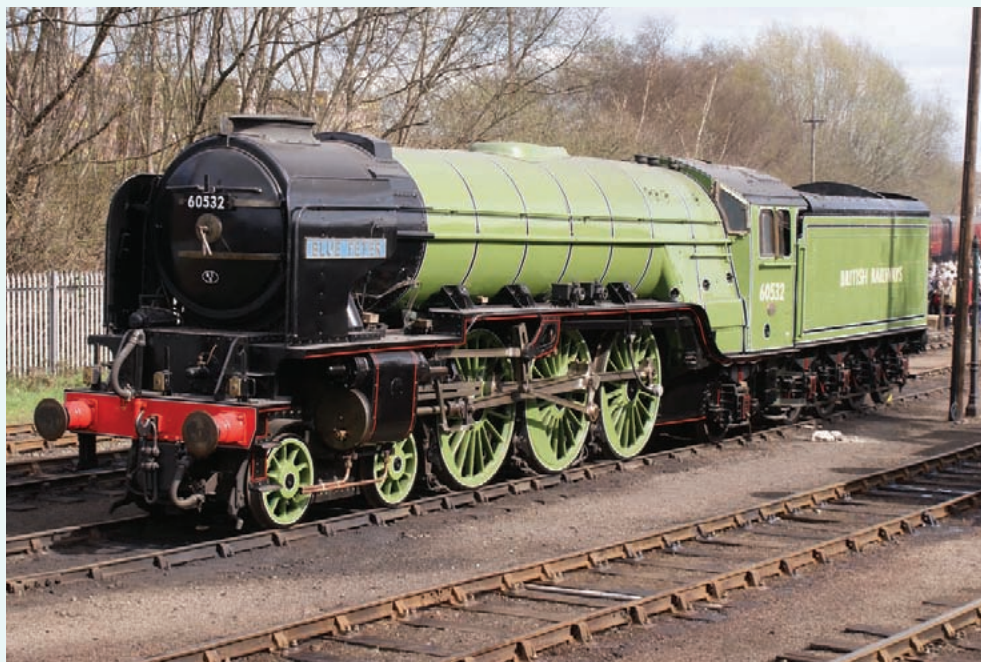
A Victim of Catastrophic Priming, the locomotive in this image is BRITISH RAILWAYS A2 PEPPERCORN CLASS 4-6-2 number 60532, named "Blue Peter." While starting a train on the mainline in 1994, the locomotive began to slip. The engineer controlled the initial slip by closing the throttle, but by opening it quickly to regain acceleration, the engineer inadvertently sucked additional water into the dry pipe and superheaters. This caused the throttle valve to jam open and, when the engineer went to center the reverser, the non-powered screw wound device broke free from his hand (causing significant harm to the engineer) and put the locomotive into full forward gear. The engine spun its wheels uncontrollably, destroying the cylinder heads and the motion. The locomotive underwent an 18 month rebuild and returned to service in 1996. Photograph by Hugh Llewlyn, wikimedia commons.

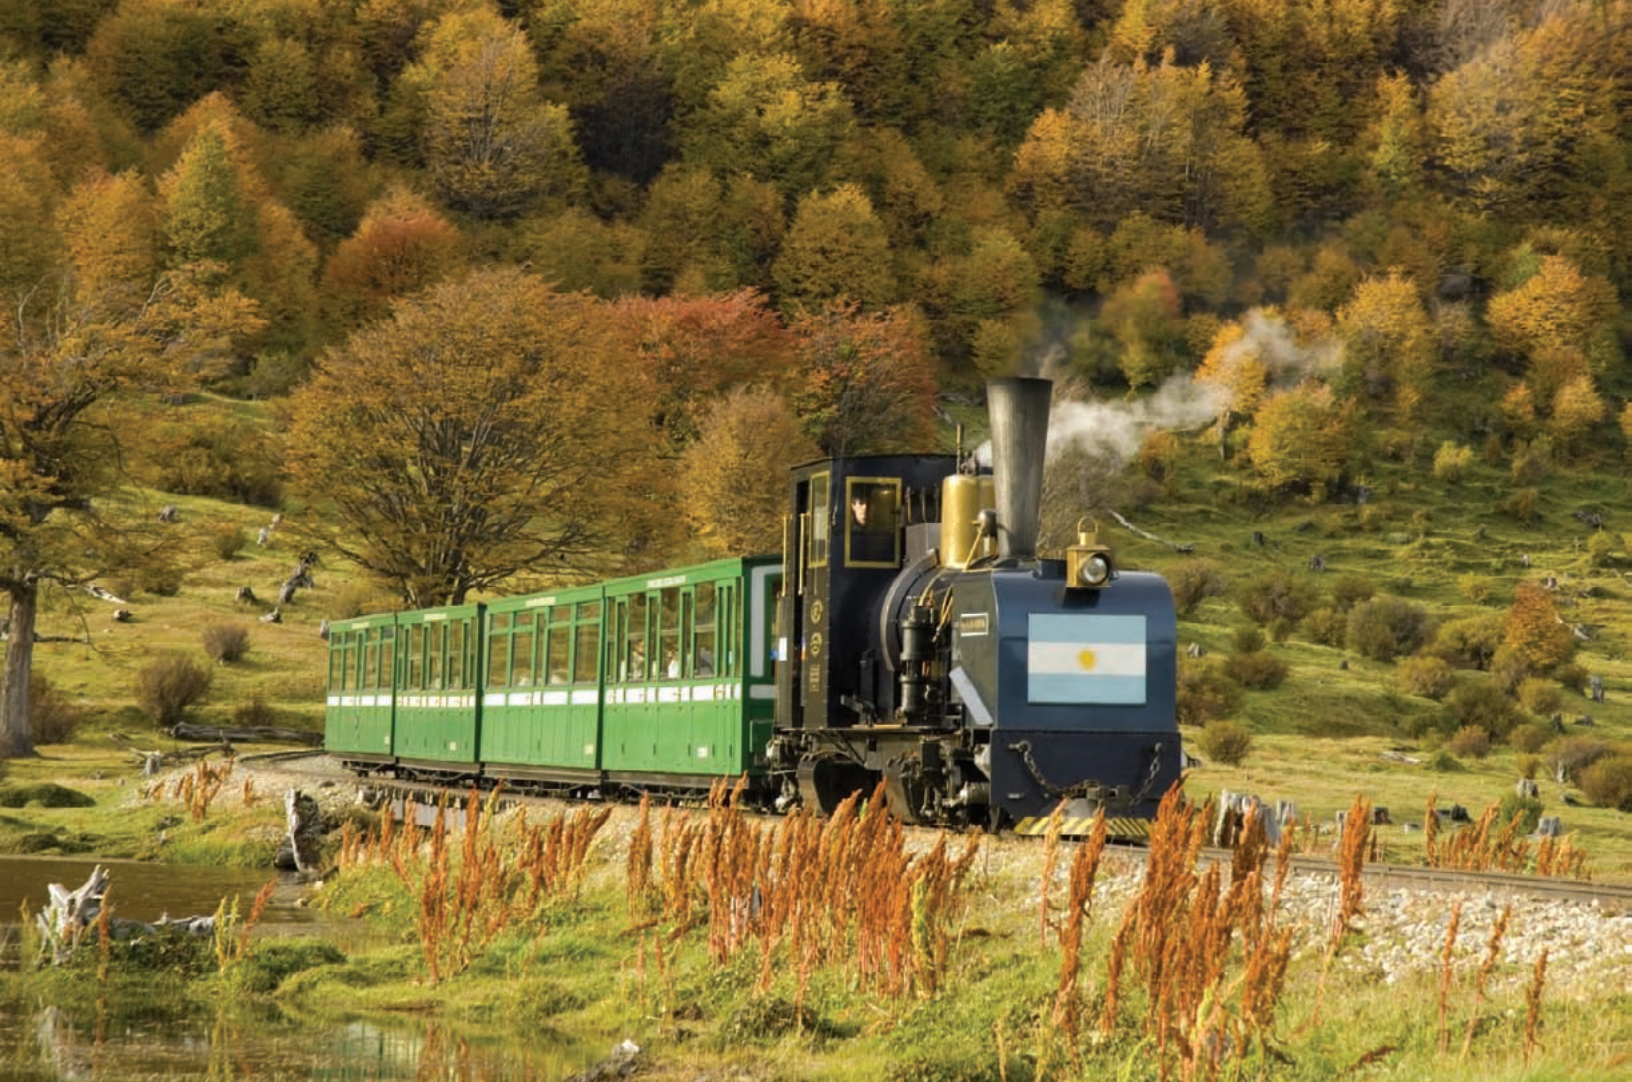
Locomotive number 2 'L.D. Porta' hauls a typical Autumn train in the national park portion of FCAF's right-of-way. This FCAF promotional image shows how efficiently the locomotive steams (note the lack of smoke) and the beauty of its surroundings.

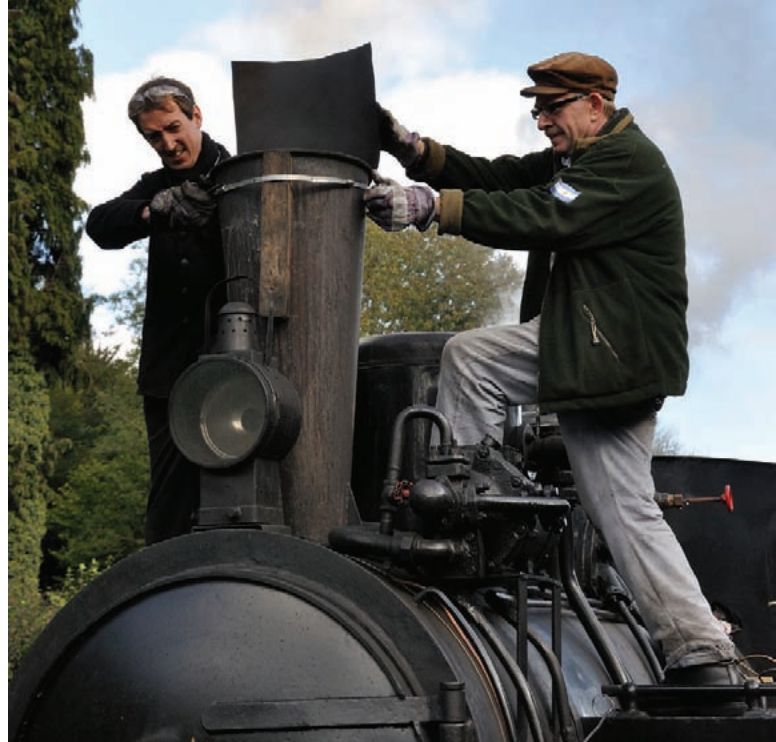
The Author, at RIGHT, is shown affixing a test apparatus to a locomotive during steam purity trials on the WELSHPOOL & LLANFAIR LIGHT RAILWAY in 2012.
