Case study:  
**Lorrina**

Project location: Braidwood, NSW  
Size: 102 ha  
Participants: Andrew Bullock  
& Justine Isemonger  
Project updated: May 2023

This project aims to restore Lorrina's natural hydrological processes for improved environmental, aesthetic and production outcomes.

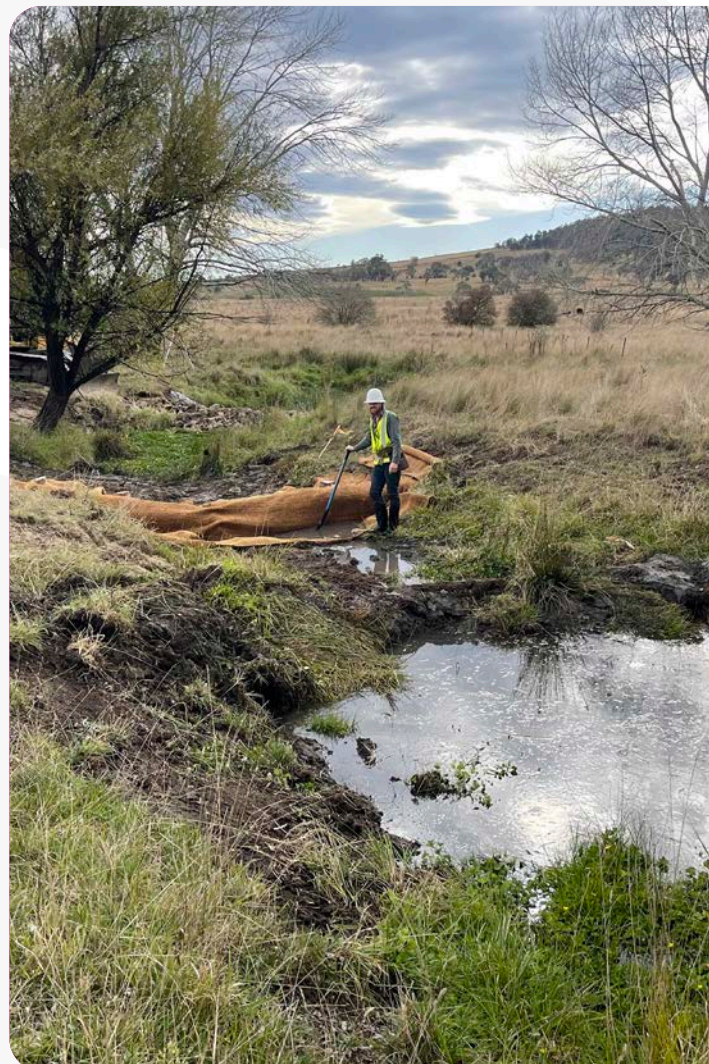
**Above:** Rock weir (foreground) and log-sill weir (background) during the first flow-over event following construction. The rock weir provides backwater to the downstream side of the L4 structure.

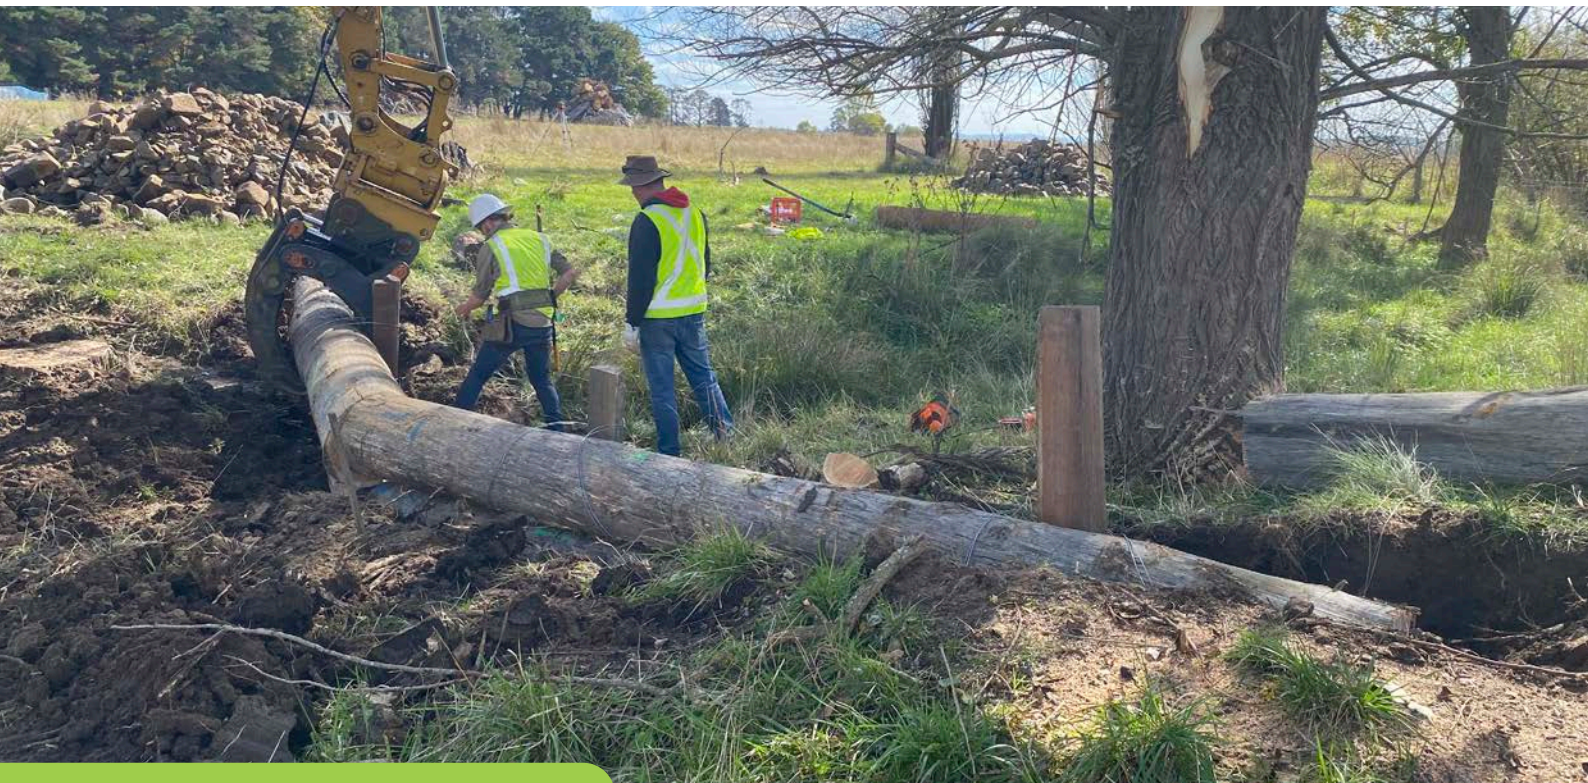
**Above:** Log-and-sill weir construction of top log weir.

**Right:** A series of rock weir structures along Brushy Hill Creek. Soon after completing the work the area received 50 mm of rain over two days. The pools filled up and a gentle flow began through the new rock riffles.

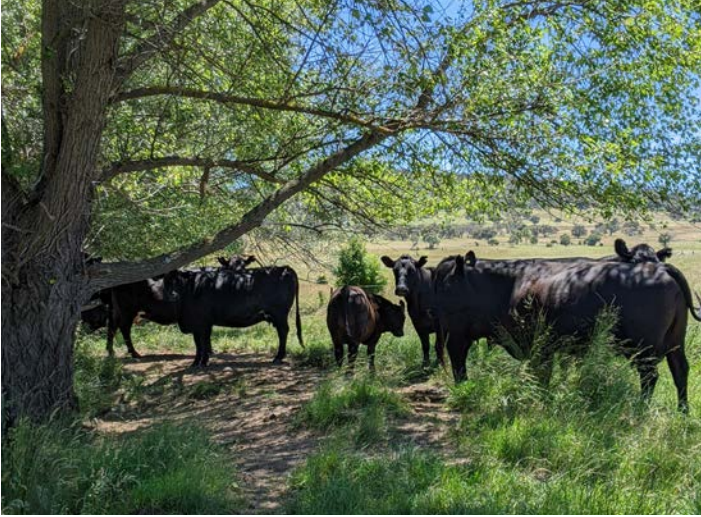
**Top:** Cattle previously had unrestricted access to Brushy Hill Creek which damaged riparian vegetation and contributed to erosion.

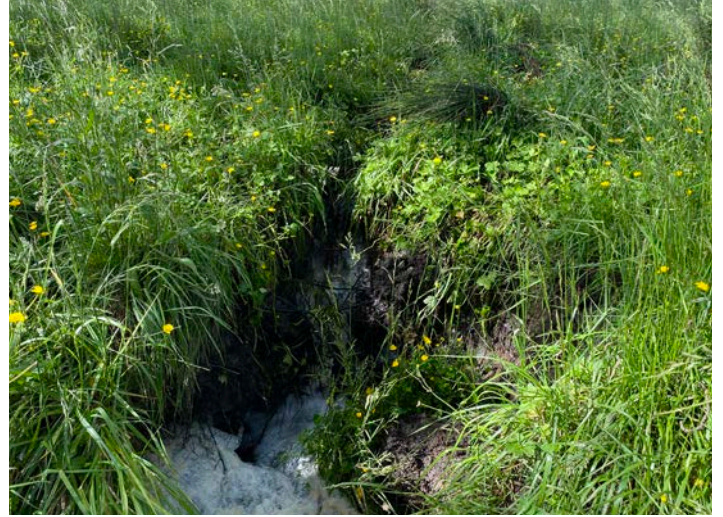
**Top:** An active headcut along a tributary of Brushy Hill Creek as a result of erosion and high velocity flow.

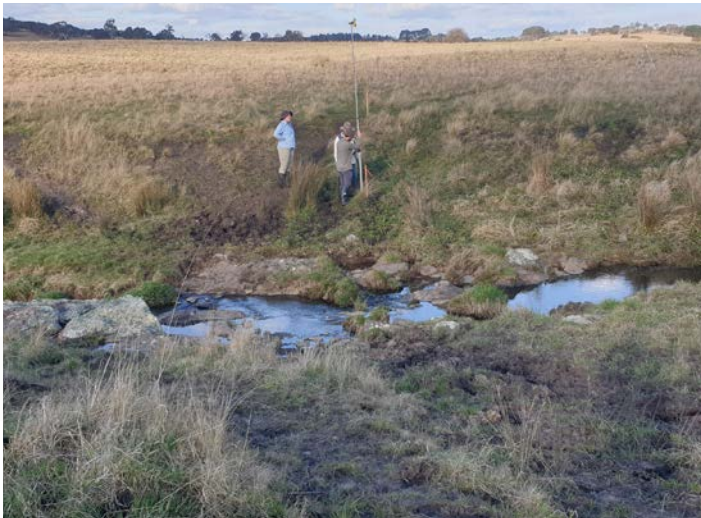
**Above:** Creek crossing before construction works.

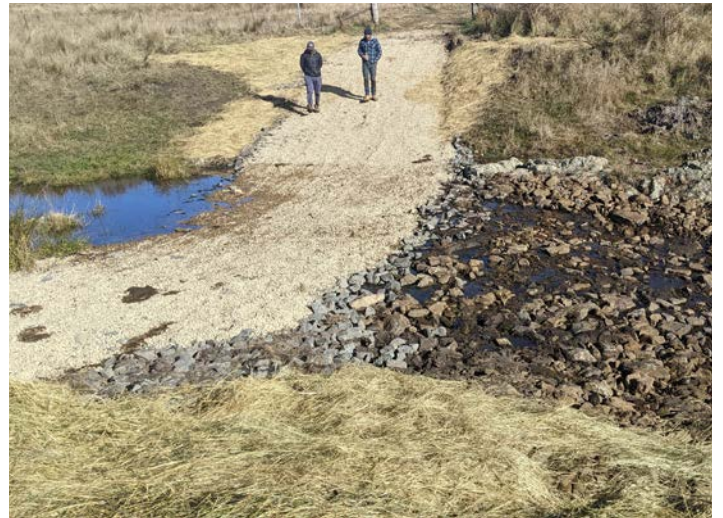
**Above:** Upgraded creek crossing after restoration works.
