Case study: Centralian Project

Project location: Australian Central Rangelands, NT.
Country: Anmatyerre & Arrente
Size: Approx. 8,000 hectares across four properties, all within 200kms of Alice Springs.

The intent of this project is to demonstrate drought resilience at scale and assess the environmental and economic outcomes of landscape rehydration in this arid, pastoral landscape. Working landscape rehydration demonstration sites were designed and constructed on creek catchments at the four participating stations.

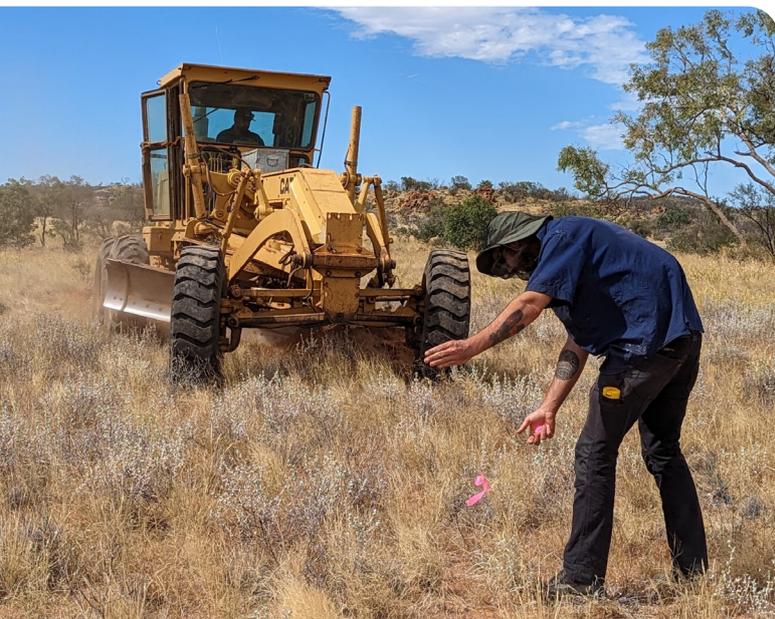
Above – Inspecting a contour bank at Narwietooma station.

Left – Shane guides a grader during the construction of a contour bank.

To complement in-stream structures such as earth banks and further spread water across the landscape, **contour banks** were installed at key locations. These are designed to capture and slow water flow and re-distribute water away from the lower landscape and out onto the scalded floodplains and drier ridges. The contours are designed with emergency overflow sills for extreme flood events, ensuring their longevity and reducing the risk of bank failure.

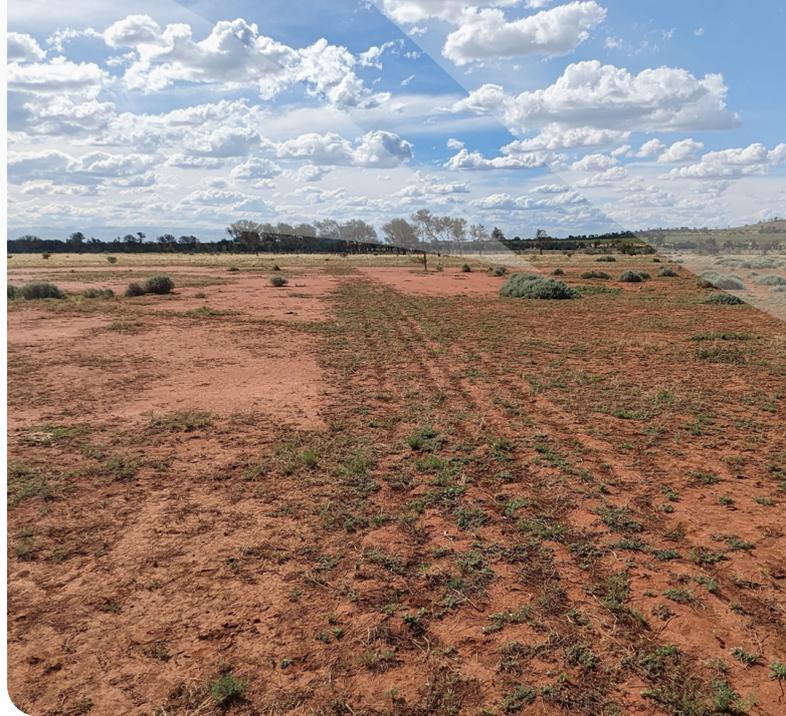
Above – Six months after these riplines were made, vegetation has established within the ripped area and upslope where seeds deposited after rain.

Shallow riplines across scalded areas of the floodplain are another simple, low risk, but very effective solution for increasing the surface roughness of the soil. This technique slows the flow of water across formerly compacted and bare soil surfaces, increasing infiltration as well as deposition of seeds and organic material.

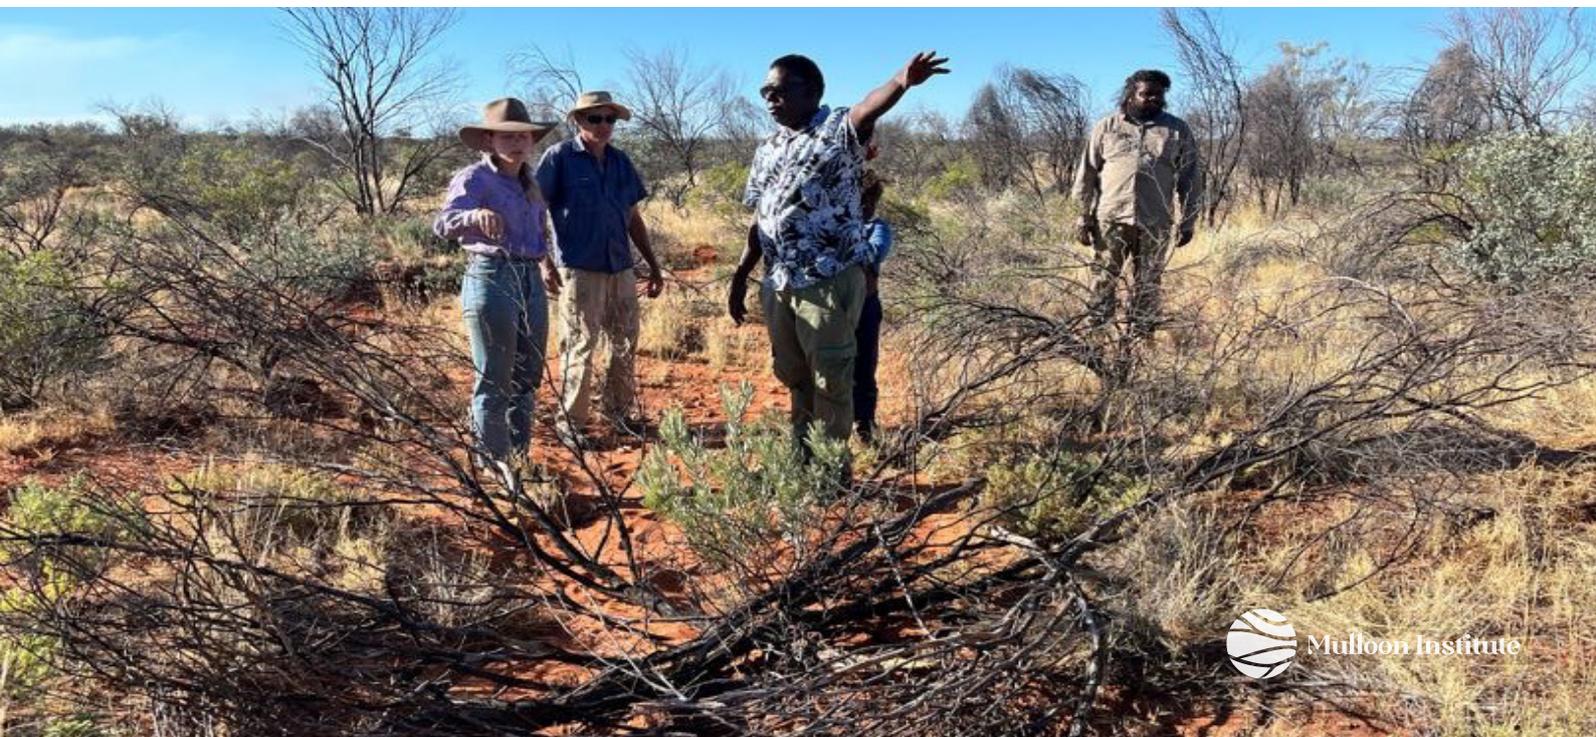
Below – Lance and Erin work with James and Clayton, Aboriginal Rangers from the Central Land Council to construct a simple brush weir.

Brush-weirs are a good example of small scale, low-risk solutions that can be repeated across the landscape. Depending on the location and site conditions, the brush weirs constructed for the Centralian project varied in scale and complexity

and are all classed as ‘flow-through’ structures as water flows through them. Brush weirs ranged from the placement of heavy logs and large branches to form ‘leaky weirs’ within a deeply eroded water channel, to fine branches and brush placed against steel pickets or natural features such as trees, bushes or the bank in minor gullies and headcuts. This technique enables vegetation to regenerate and repair eroded channels and gullies, restoring ecological function back into the landscape.

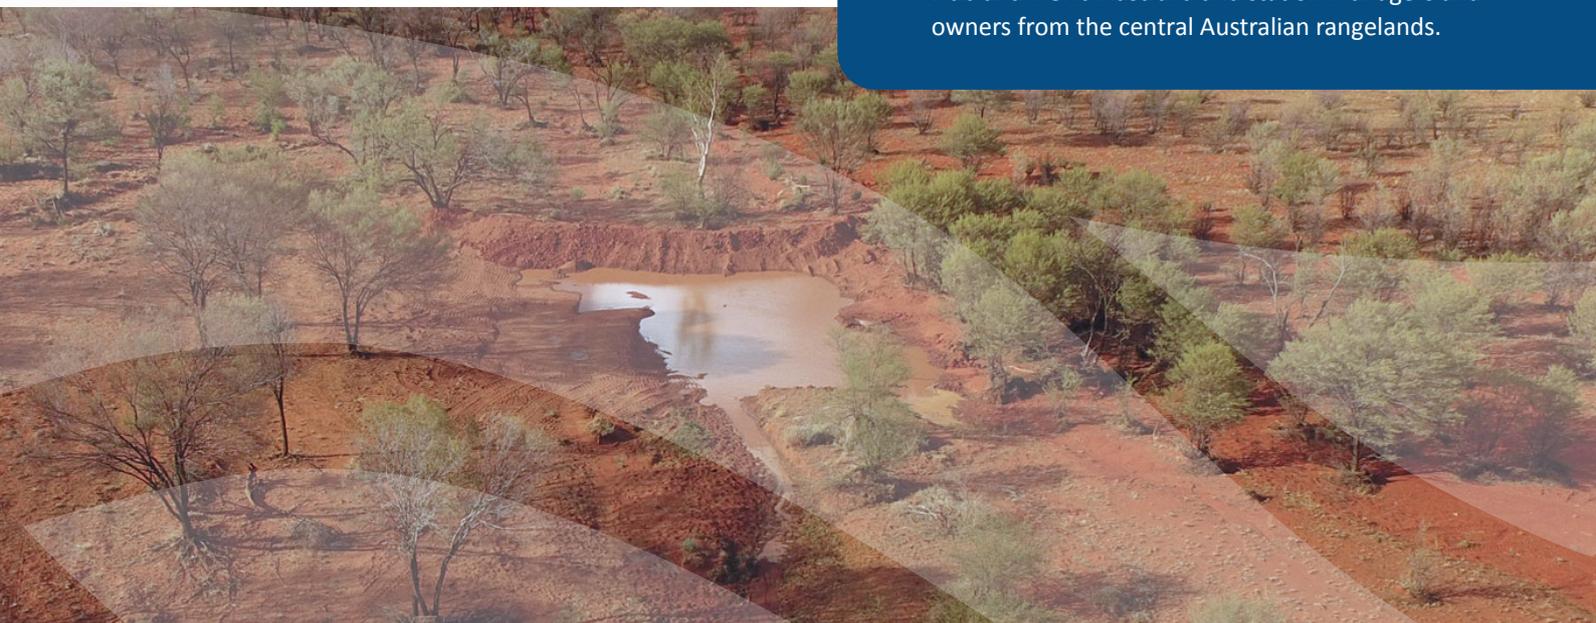
Below: An earth bank constructed along an incised channel at Glen Helen Station. 8mm of rain fell the day after construction.

Earth banks are an example of a ‘flow-around’ structure and were constructed within highly eroded

channels to absorb the energy of the flowing water and force the water to pool upstream of the bank. Rising water can safely overflow to the side and around the bank out onto the floodplain with far less destructive energy, where it will infiltrate into the soil and rehydrate the landscape. The pooling water re-establishes a ‘chain of ponds’ with successive earth banks occurring along a particular watercourse. This stored water remains accessible to wildlife and livestock for longer periods, and slowly infiltrates to increase groundwater recharge and soil moisture. With increased soil moisture, vegetation soon regenerates, increasing productivity and the resilience of the ecosystem.
