# Avalon Deconstruction Report

Gig Harbor BoatShop

March 15, 2015

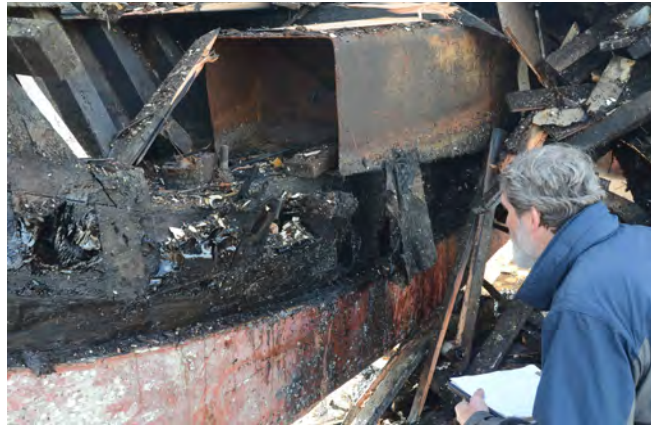
- Deconstruction was halted periodically to allow for Jack Becker and Tim Lee to gather construction details, primarily from Avalon's backbone – stem, forefoot, keel, sternpost, horn timber, rim timber, and stern lifts.

Jack Becker retrieving Avalon construction details 3/5/2015

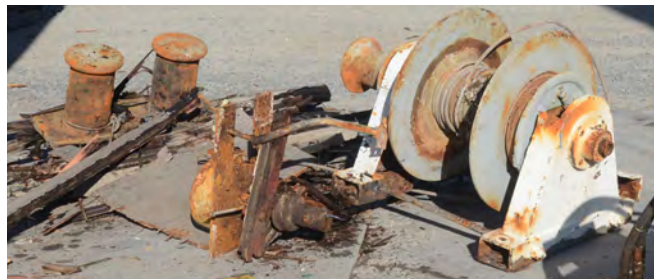
Avalon hardware 3/5/2105

**Hardware, Deck Gear, and Vessel Accoutrements** – Avalon had been stripped of near everything of value, including near all bronze hardware and notably the cast bronze Skansie Ship Building Co. nameplate and ship's wheel. Approximately 30 artifacts were recovered.

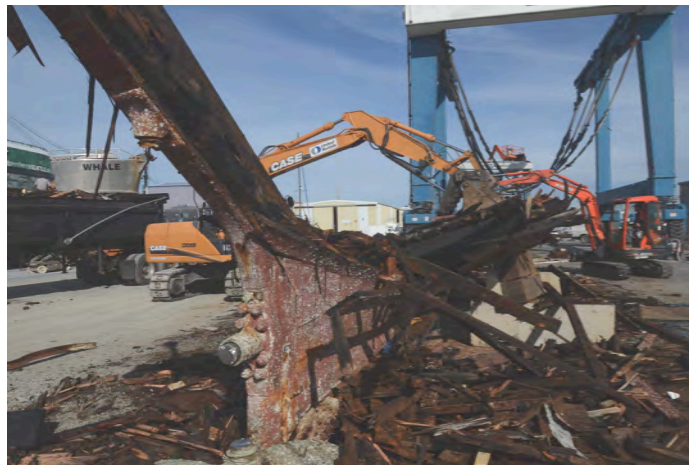
Avalon – backbone, late afternoon 3/5/2015 Port Townsend, WA

**Hull – Topsides, Bottom and Structure, frames, backbone, sister keels, etc.** – Surprisingly the Avalon, from the sheer line down was in remarkably good condition for an 84 year old vessel. Many of the fastenings inspected were near new in appearance, including stern lift drifts, planking boat nails and garboard spikes. The bent oak frames were largely in good condition, the sawn fir frames aft were in good condition and most hull planking was in fair condition. The deck beams were in fair condition. The backbone, including sister keels, engine beds, stem, rim timber, horn timber, sternpost and stern lifts were all in remarkably good condition.
