PERISHER RANGE PROJECTS 2016 - 2017

Project Summary Report for Consultative Committee Meeting

November 2016

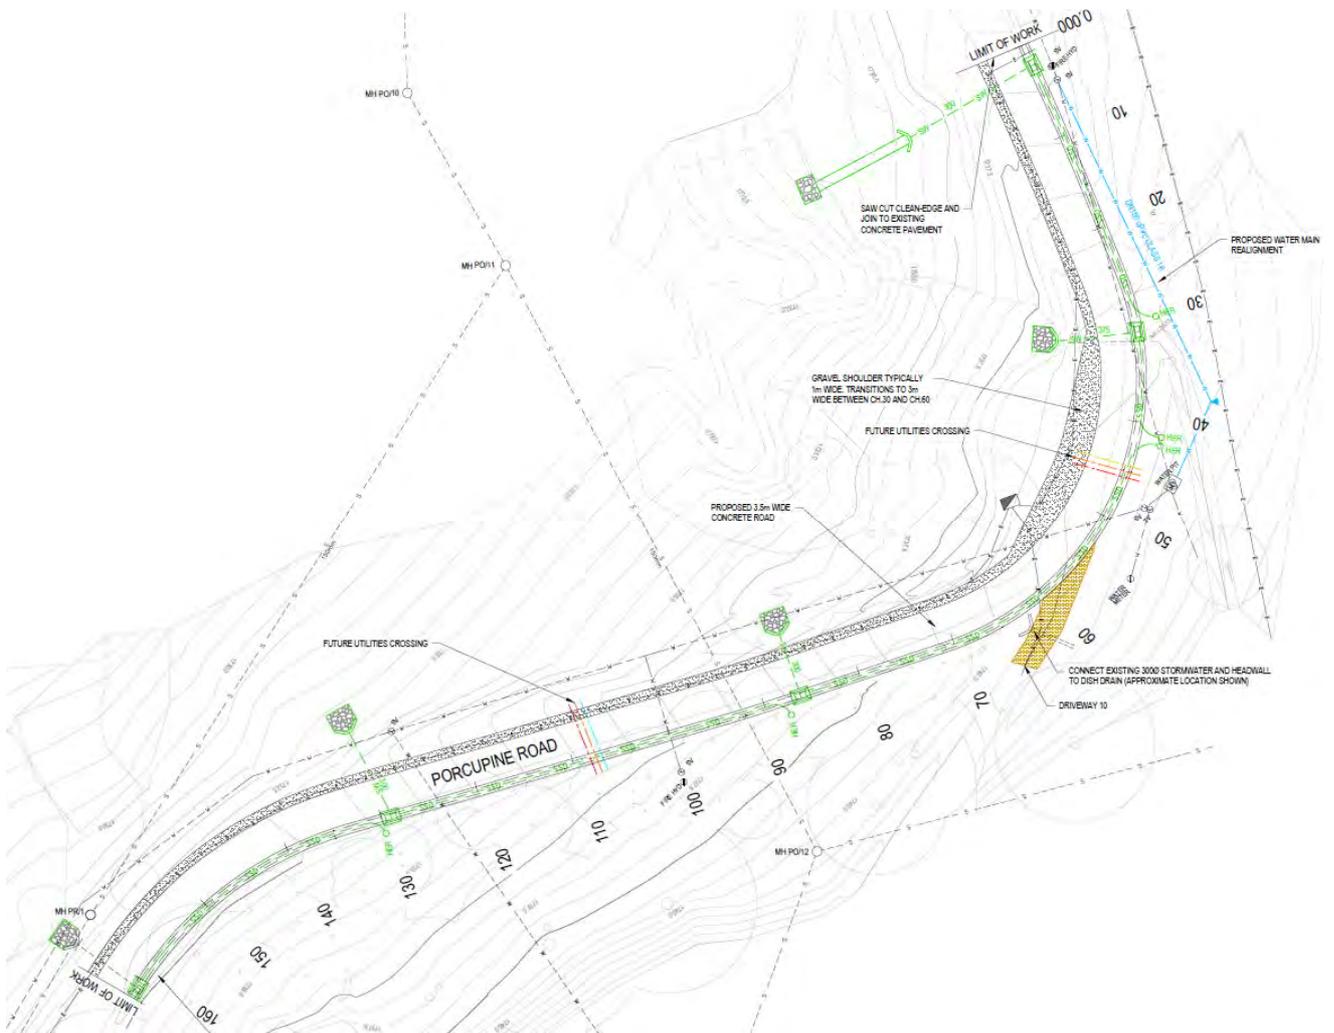
The primary capital works project proposed for the upcoming summer period is the concreting of approximately 160 metres of Porcupine Road. The expected cost of this project \$300k, including approximately \$35k expected to be associated with water main installation/diversion costs. The works will cause some temporary road closures and communication with affected lodges has commenced as well as looking into alternative access arrangements during the road closure periods.

This section of work was identified as the highest priority road upgrade following an evaluation of the most effective use of the funds to reduce known erosion issues and maximise user benefits. Plate 1 below shows the impact on surrounding vegetation from the loss of road base due to heavy rainfall from this section of road.

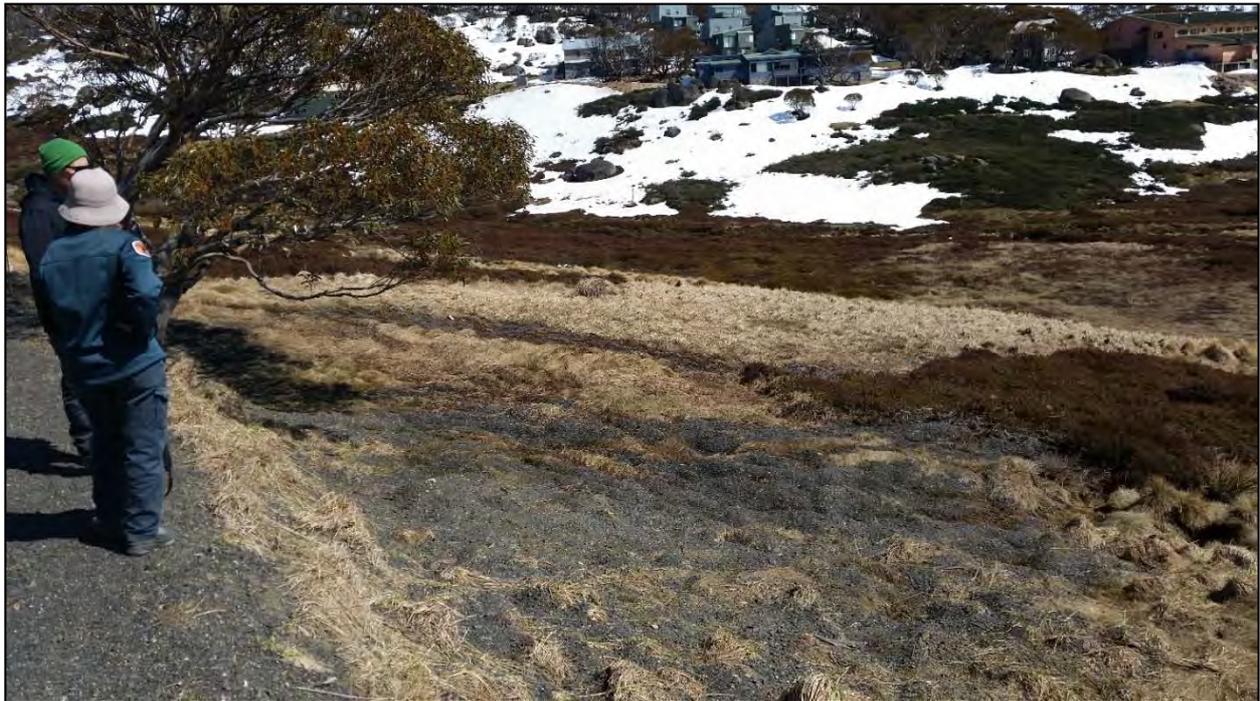
Plate 1 Loss of road base/sediment from Porcupine Road due to heavy rainfall over 2016 winter.

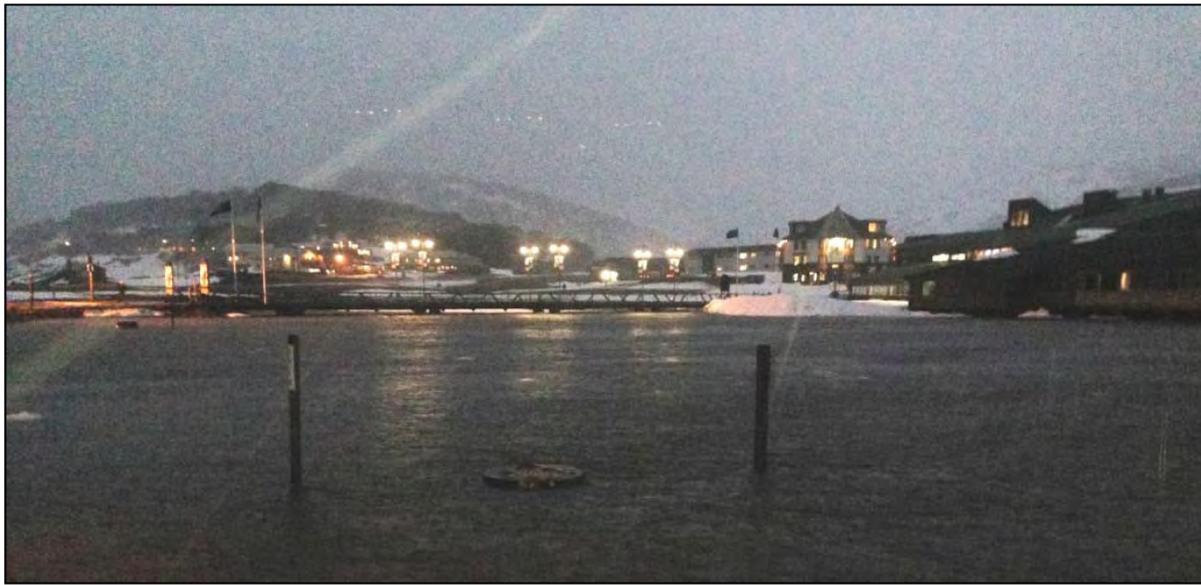
Plate 3 Perisher Creek in flood with manhole PO/1 in foreground (photo taken 22 July 2016).

On 22 July 2016, a significant weather event delivered a large amount of rainfall (148 mm) and associated strong winds to the Snowy Mountains region. This unprecedented winter rainfall event delivered a record volume of inflow into the Perisher STP (4.6 ML) and the loads on the sewage reticulation network exceed the pumping capacity at two locations resulting in the overflow events at Perisher SPS No. 2 and Smiggin Holes SPS.

All relevant authorities and stakeholders were notified of the overflow events in accordance with the Perisher Range Sewerage System Pollution Incident Response Management Plan. Other operational issues caused by the rainfall event included the isolation of North Perisher for several hours as vehicle bridges were submerged due to the high level of Perisher Creek.

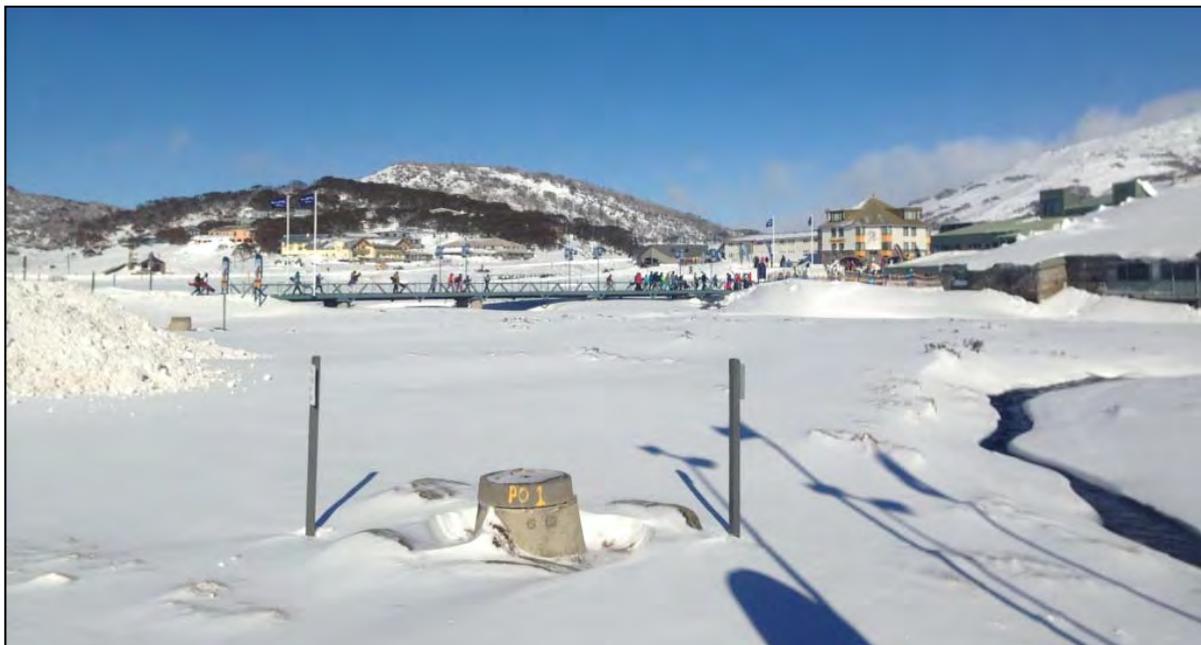
Plate 4 Perisher Creek in normal winter conditions (photo taken 28 July 2016).
