# King George V Willowstick Survey

Atkins used Willowstick to position diaphragm wall and stop leakage through 6.2km long embankment dam

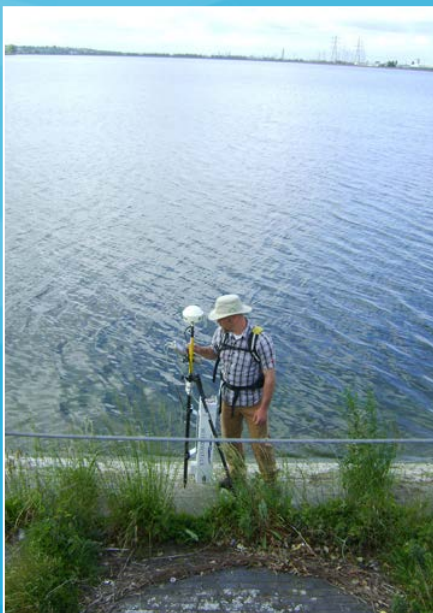
Willowstick reading on the upstream face

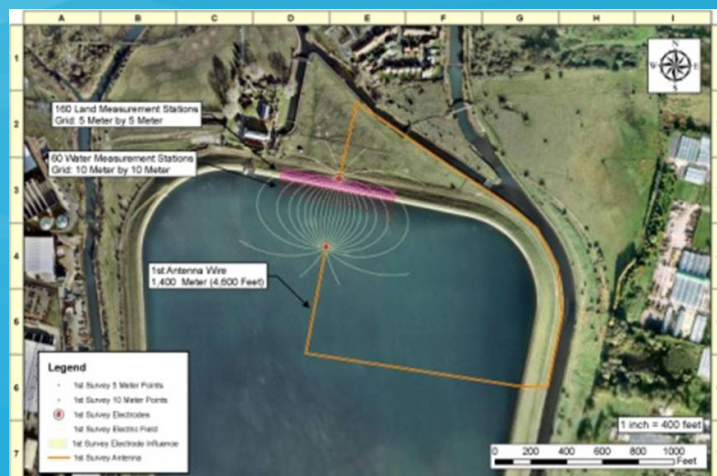
Example of survey layout
