Wimbleball Dam Willowstick Survey

Atkins use Willowstick to significantly reduce cost of remediation scheme at concrete dam

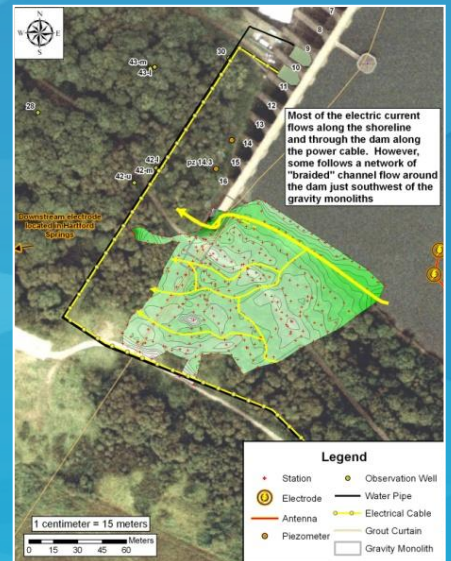
The Willowstick survey quickly identified a completely different leakage path than previously assumed. No leakage was detected under the dam itself and, despite what was initially assumed, the grout curtain was performing as designed. Instead a series of channels seeping around the end of the concrete buttress section were discovered.

Plan view of the surveyed leakage paths through the left abutment

As a result the degree of proposed grouting work was dramatically revised down delivering a 90% cost saving to the client.

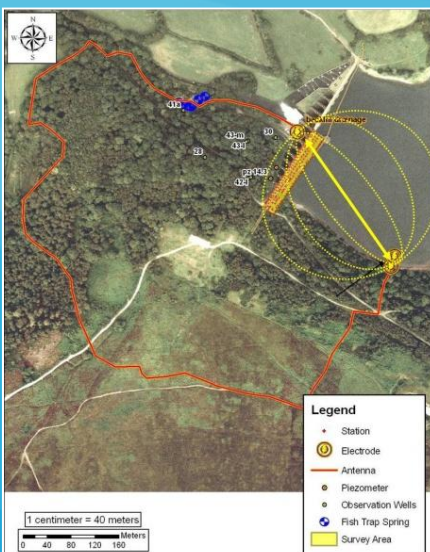
A plan view of one of the survey layouts
