# USING TECHNOLOGY TO IDENTIFY SEEPAGE OUT OF A DAM IN SOUTH AFRICA

The Rust de Winter Dam is located on the Elands River within the "Rust-de-Winter" Nature Reserve in the Limpopo Province, South Africa. The dam was built in 1934 to supply irrigation water and serve as a strategic reserve for the Rhenosterkop Dam located 40km downstream. To improve the dam's flood handling capacity in 2011 the South African Department of Water and Sanitation raised the dam 2.7m, and increased the length of the dam from 200m to 248m. The dam owners had been monitoring seepage for a number of years, with this type of dam it would be a natural reaction to assume that the leak was through the upstream membrane where there are many joints. However, they were unsure of its exact cause leading them to engage Willowstick Technologies to complete a Magnetometric Resistivity (MMR) investigation with the purpose of identifying any seepage flow paths at the dam.

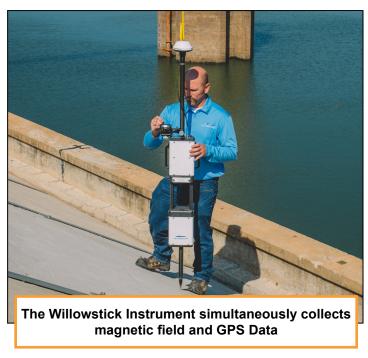
An electric current was injected into the subsurface and the resulting magnetic field was measured using the Willowstick instruments.
