Inspectors Find a Second Balcony at Berkeley Complex at Risk of Collapse

June 17, 2015

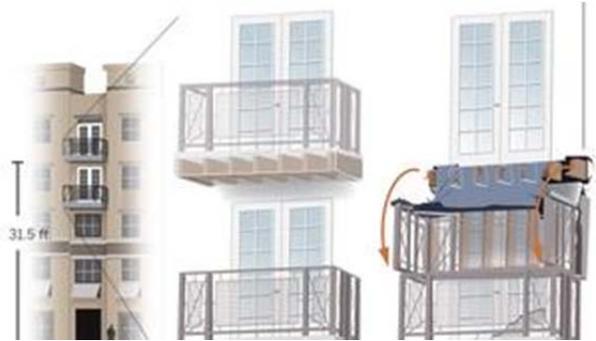
A fifth-floor balcony collapsed before 1 a.m. Tuesday and sent 13 people plummeting 40 feet to the pavement. Six students, including five from Ireland, were killed and seven were injured in the fall.

Experts theorized that water damage may have caused Tuesday’s collapse.

“It appears to be a classic case of dry rot, meaning water intruded into the building [and] rotted the wood” that supported the balcony, said Gene St. Onge, a civil and structural engineer in Oakland. With more than a dozen people on the balcony, “it gave way. It didn’t have enough residual strength, and it failed.”

St. Onge said the broken wooden beams protruding from the building that had held up the balcony showed what looked like signs of dry rot.

There are other clues that the wood had rotted. There is visible mold in one of the broken wooden joists. And it broke into short fibers at the failure point, a sign of dry rot; if the wood had not rotted, “you would see long slender splinters. It would look like a broken baseball bat,” said Bernard Cuzzillo, a consulting engineer who has a doctorate in mechanical engineering at UC Berkeley who visited the balcony scene Tuesday.

And when you look at what used to be the floor of the balcony, much of the wooden joists that once supported it have disintegrated.

The seven horizontal wooden joists that supported the balcony broke. The deck folded straight down 90 degrees, while the guardrail assembly flipped upside down.

With the deck flipped, it's possible to see the condition of the balcony's floor. "You will notice when you look through those things, you see a bunch of vertical lines. Those vertical lines correspond to where the joists had been attached at the bottom of the deck assembly," he said.

"And the very startling thing is that only remnants of the joists remain in those locations," Cuzzillo said. "You're basically looking at what had been the joists, lined up now vertically, and now mostly gone, because they're rotten. So basically, almost all that's left of the joists are its shadows."
