Report: Ceramic Water Filters After 3.5 Years of Continuous Use in Community Homes Caminos de Agua

By Dylan Terrell, Executive Director
January 30th, 2017

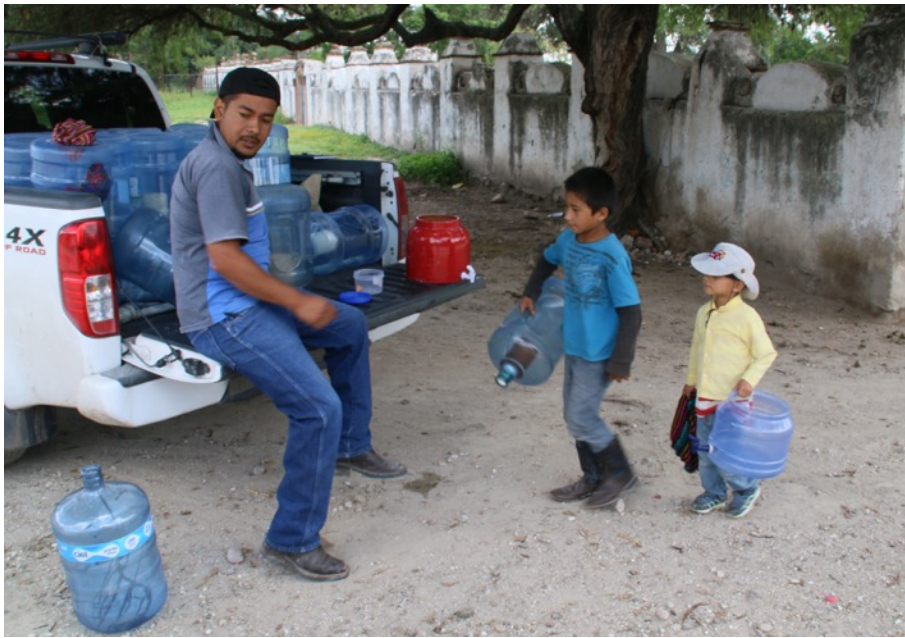
Upon initial visual inspection, many of the filters did not look like they were in great shape. It was clear that some systems were maintained and cleaned often over the years. However, many systems were clearly not cleaned regularly as silicon connections were blackened or greened and many of the plastic containers were discolored. Further, some of the filters appeared discolored and in some cases to be physically degrading. If anything, it was obvious

Top Right: Kids come to change out used filter system in Juan Gonzalez; Top Left: Ceramic filter after 3.5 years of use. Discoloration and some physical degradation is visible.

Despite the minor breakthrough on three systems, all of the filters are still in-line with World Health Organization standards. Caminos de Agua is currently working on new filter designs, to make filter replacement significantly easier. Further, we will be modifying recommendations for filter maintenance and change-out based on what we have found with this latest round of testing. For instance, although many highly degraded filters still performed exceedingly well, to be conservative, simple recommendations on filter change-out due to ceramic degradation would be easy to implement and safeguard against potential breakthrough.

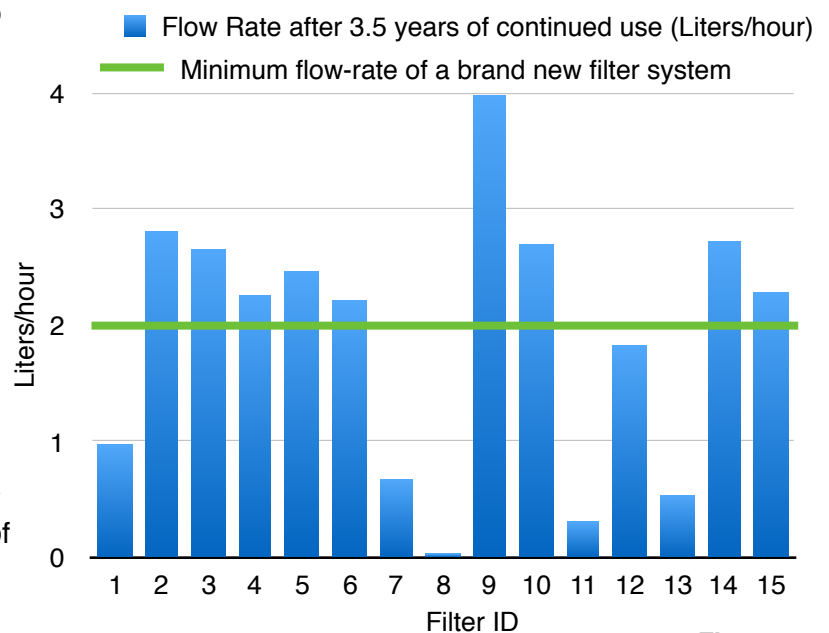
Figure 1

Before looking at water quality, Mitchell ran flow tests on all of the systems to make sure the water “quantity” would still be sufficient for a family. Two-thirds of the filter systems tested continued to perform well, producing between 1.8 and 4 liters/hour. Four of the five systems producing less than 1 liter/hour still produced sufficient drinking water for at least 6 adults if maintained full most of the time. One system, however, was only able to produce an abysmal 42 mL/hour, even after extensive cleaning.

For the most part, flow-rate appears to drop off over time; however, nearly all of the systems continued to produce sufficient drinking water with the majority still surpassing baseline standards for brand-new filter systems (figure 1). One filter system was completely clogged and unusable.

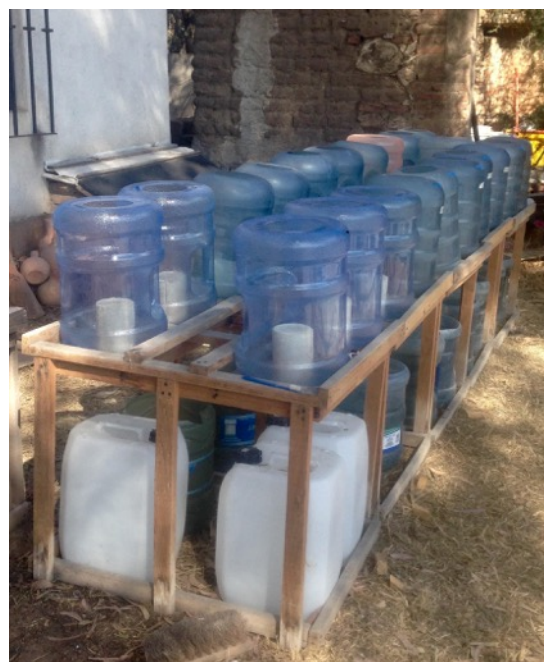
the 15 filter systems were tested. The flow-rate on system 8 was far too low to collect a useable sample. The systems were filled with the test water and samples were taken from each system, processed, and incubated for 24 hours at 35.5°C (+/- 0.5°C) per Mexican regulations.

Used filter systems set-up for flow and biological testing.
