# Sensor Industries

## Santa Monica Case Study

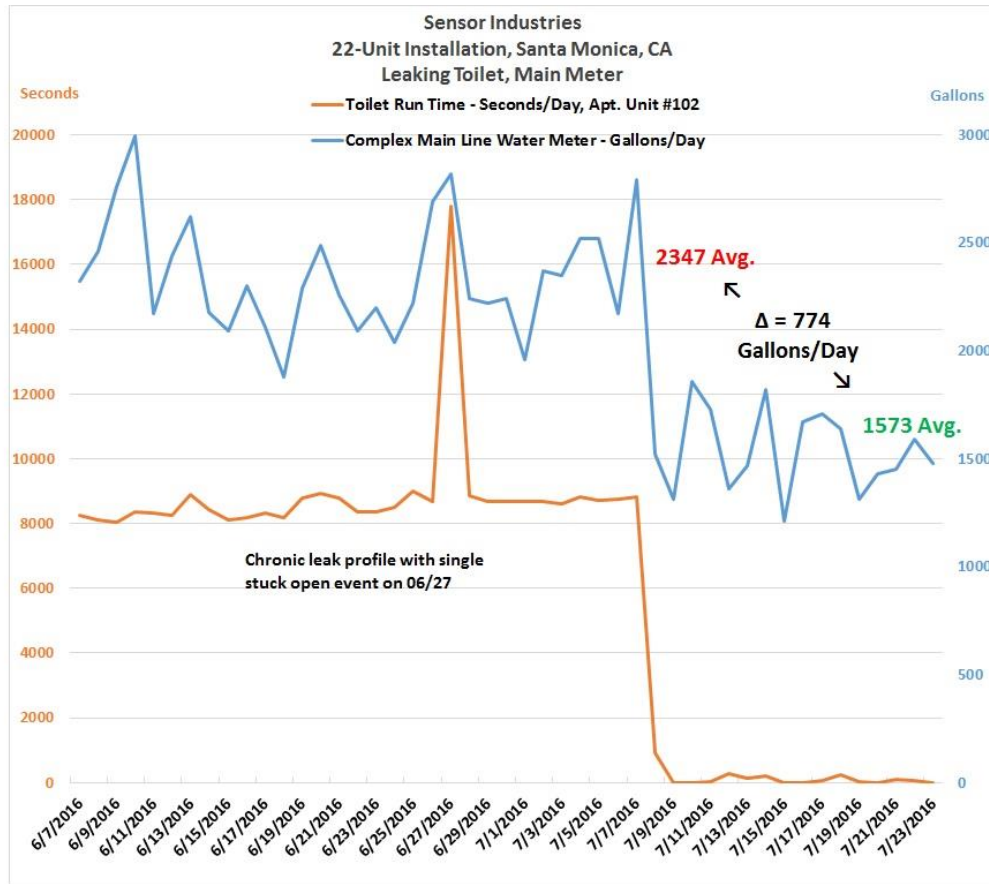
The subject property consists of 22 units containing 27 toilets. A WaterR8 System was installed on June 6, 2016. In addition to The WaterR8 Toilet Leak Detection System, a WaterR8 Mirror Meter was installed between the city meter and the building. The Mirror Meter allows real-time tracking of water flow to the property for all purposes. It is the Blue Line on the graph below. Along with a couple of minor leaking toilets, one toilet was identified which was leaking in excess of 8000 seconds, approximately 135 minutes, per day (see graph, Gold Line). We designate these gross leaking toilets as "rogue" toilets. The chronic leakage was caused by a defective flapper valve. In addition, it had one stuck open event on 6/27 resulting in

almost 3 hours of continuous run time. On 7/9, the toilet was repaired and water usage dropped, on average, 774 gallons per day as indicated. As can be seen on the chart, this one rogue toilet was using 33% of all the water, being used by all the tenants, for all purposes.

In effect, fully one third of the water bill, costing just over \$250.00 per month, was being consumed by the hidden overhead of one rogue toilet. The cost of the WaterR8 System for this size of property would require an investment of only \$2,650.00 which, in this case, will be recaptured in just over 10 months. Applying a 5% CAP Rate to the \$3,000/year water cost savings equates to \$60,000 in lost Net Worth if the apartment complex is either sold or refinanced with status quo operating expense.
