## CE 8930 – Structural Health Monitoring, Spring 2014

### 9<sup>th</sup> Class Exercise

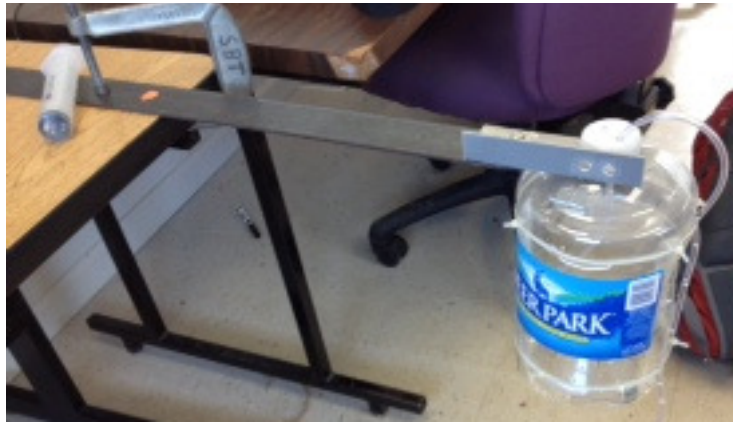
Recall that when the bottle attached to the tip of the cantilever was full, the beam was considered to be 100% healthy. Your group must have recorded the time steps when 25%, 50% and 75% of the water was lost. Each group is asked to identify these four regions and plot the data points corresponding to these regions with different colors.

Figure 1: The cantilever beam with mass loading.
