A Study of the Effectiveness of Colloidal Activated Carbon as an In-Situ Treatment to Mitigate PFAS Migration in Groundwater at a Michigan Army National Guard Site

Patricia Byrnes Lyman

Ryan E. Moore, CHMM

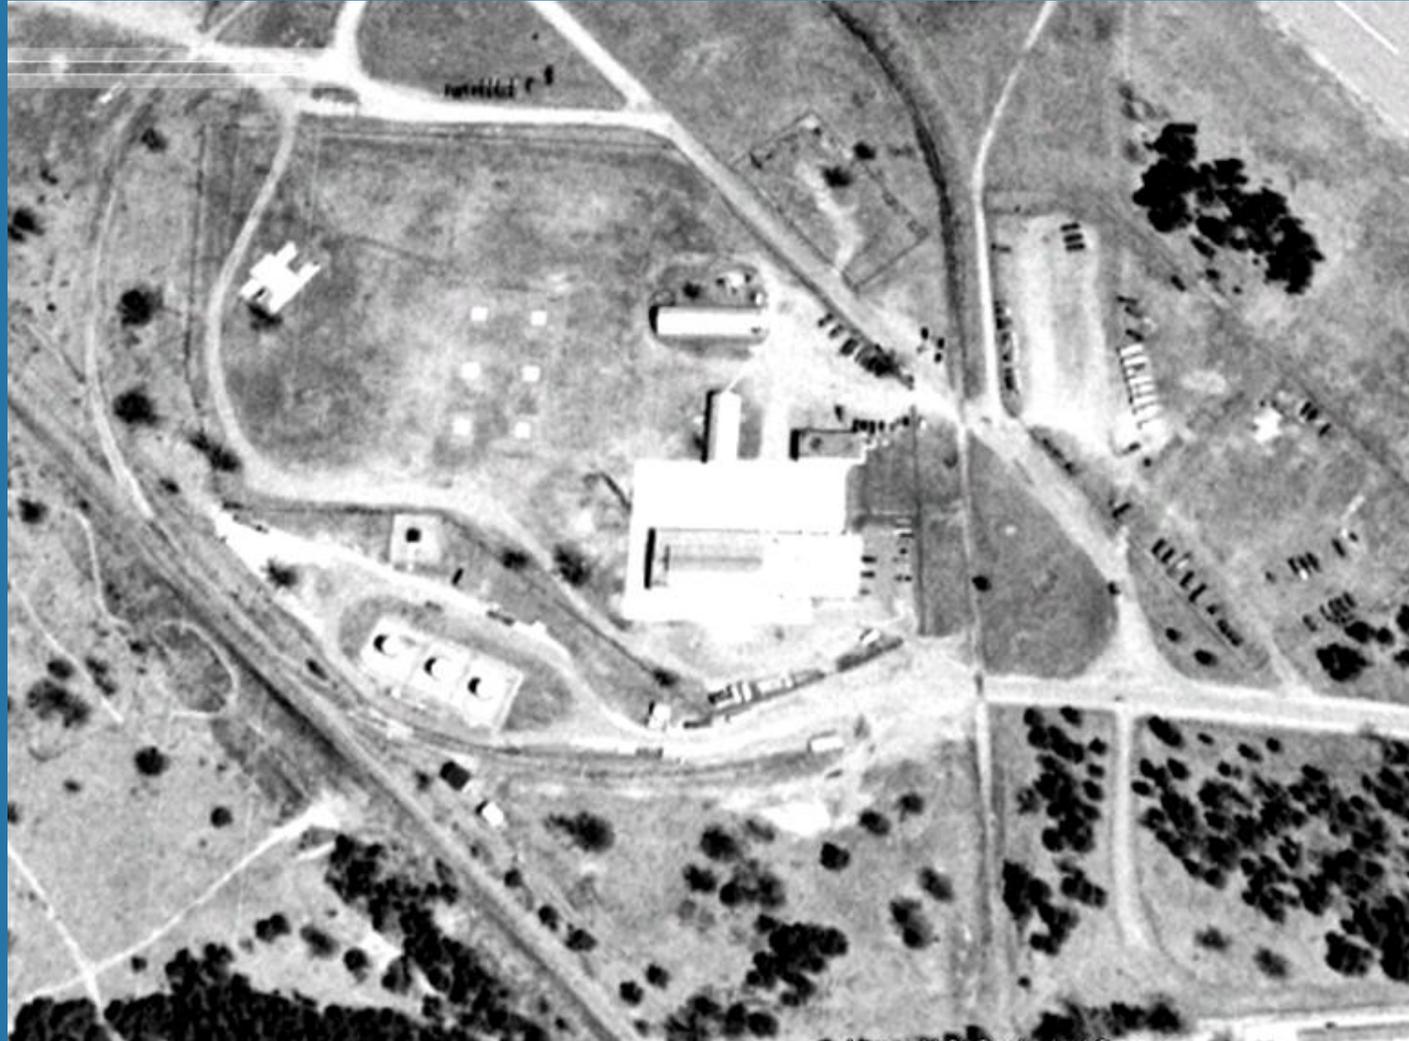
Former Bulk Fuel Storage Area

*1994 Photo

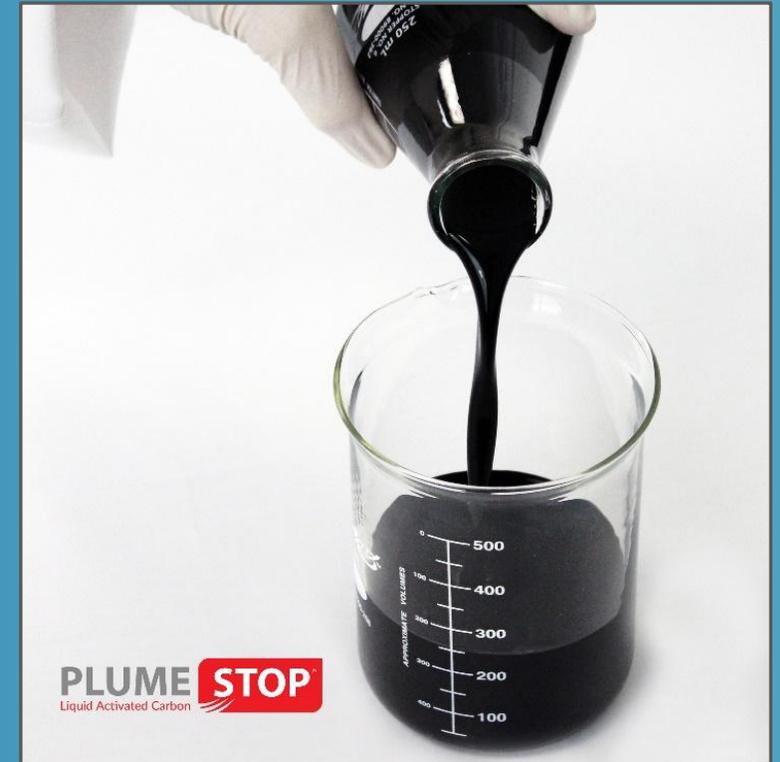
- Size: 1 – 2 μm
 - 2-3 OOM smaller than GAC (500-1,000 μm)
 - Size of a red blood cell
 - Suspended in water/polymer
 - Distributes widely at low pressure
 - Extremely fast sorption
 - Huge surface area
 - Converts polluted aquifer into purifying filter

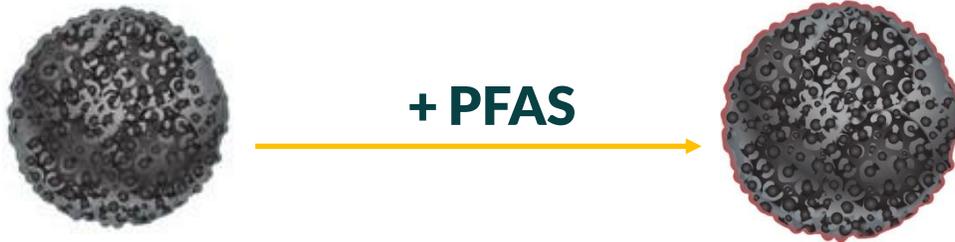
Granular Activated Carbon (>500 μ m):

Slow sorption due to limited surface area exposed to solute

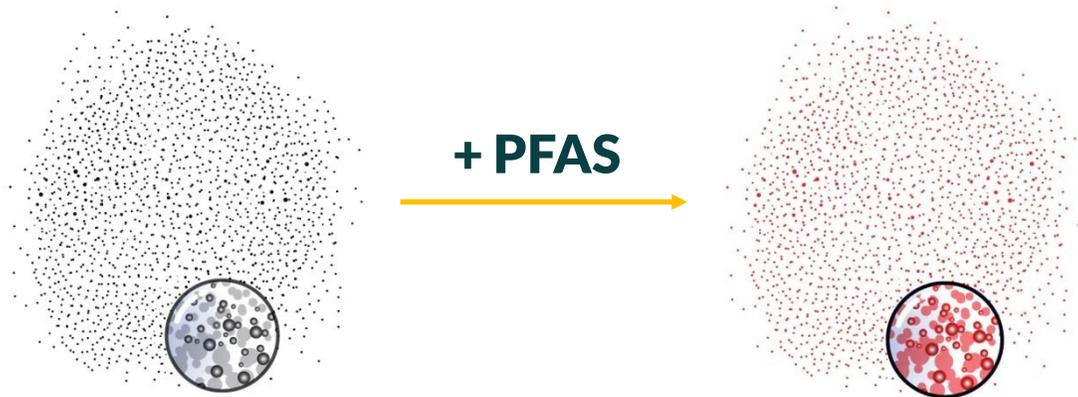
Colloidal Activated Carbon (1-2 μ m):

Rapid sorption and more complete use of sorption sites

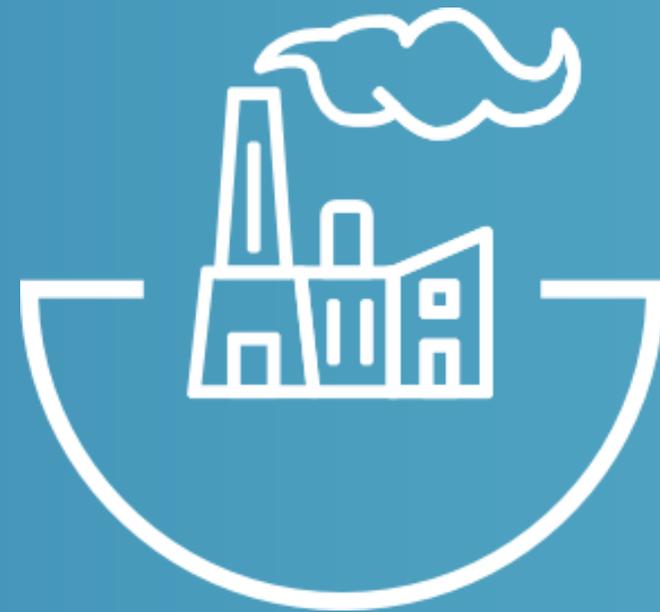
RETARDATION FACTOR: PS + PFAS

A Retardation factor (R) of 1 means the contaminant is moving at the same rate of GW

R of 10 means the plume is traveling 1/10th the rate of GW

PFOA

- The R of a 100 µg/L plume is 570

PFOS

- The R of a 100 µg/L plume is 2,000

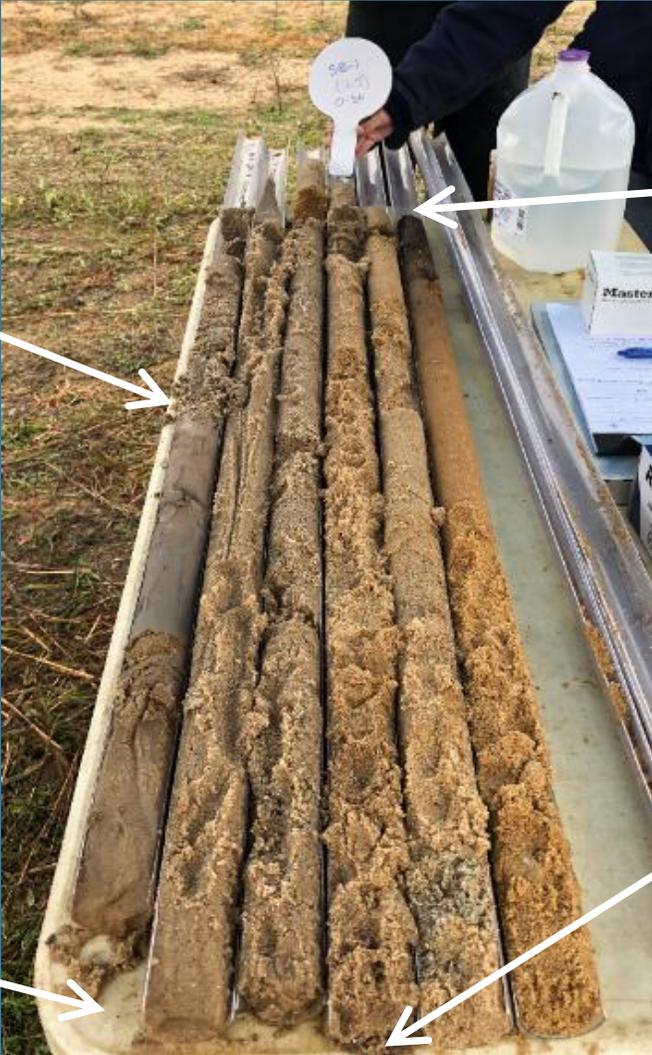
PS-Distribution Confirmation

27 feet bgs

0 feet bgs

15 feet bgs

30 feet bgs

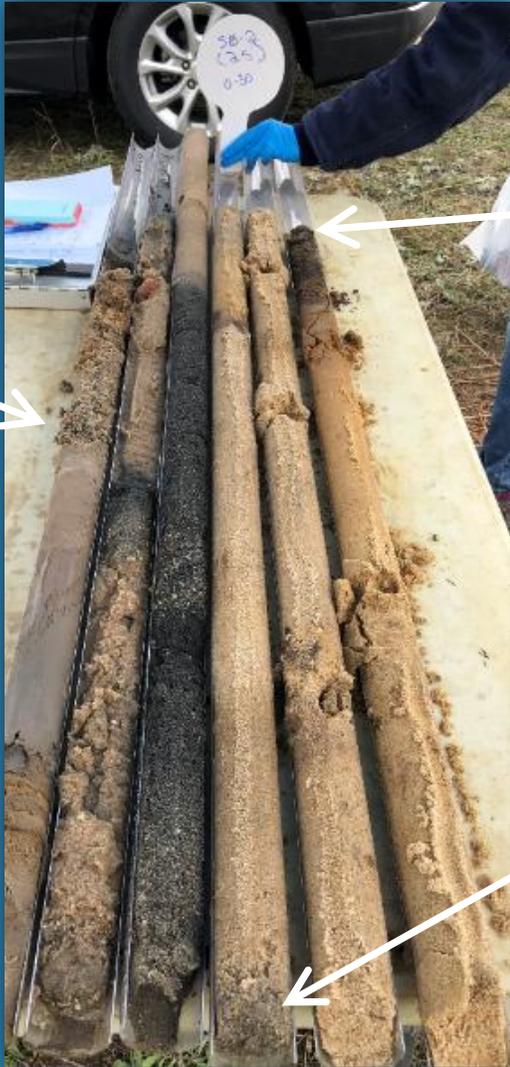
PS-Distribution Confirmation

27 feet bgs

0 feet bgs

15 feet bgs

30 feet bgs

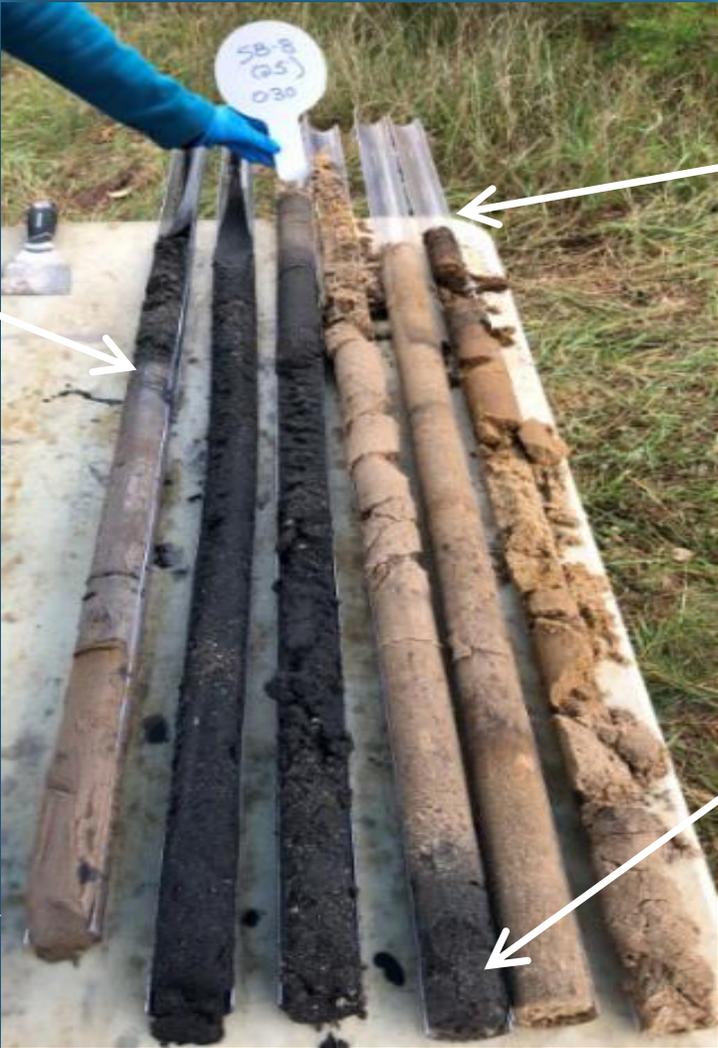
PS-Distribution Confirmation

27 feet bgs

0 feet bgs

15 feet bgs

30 feet bgs

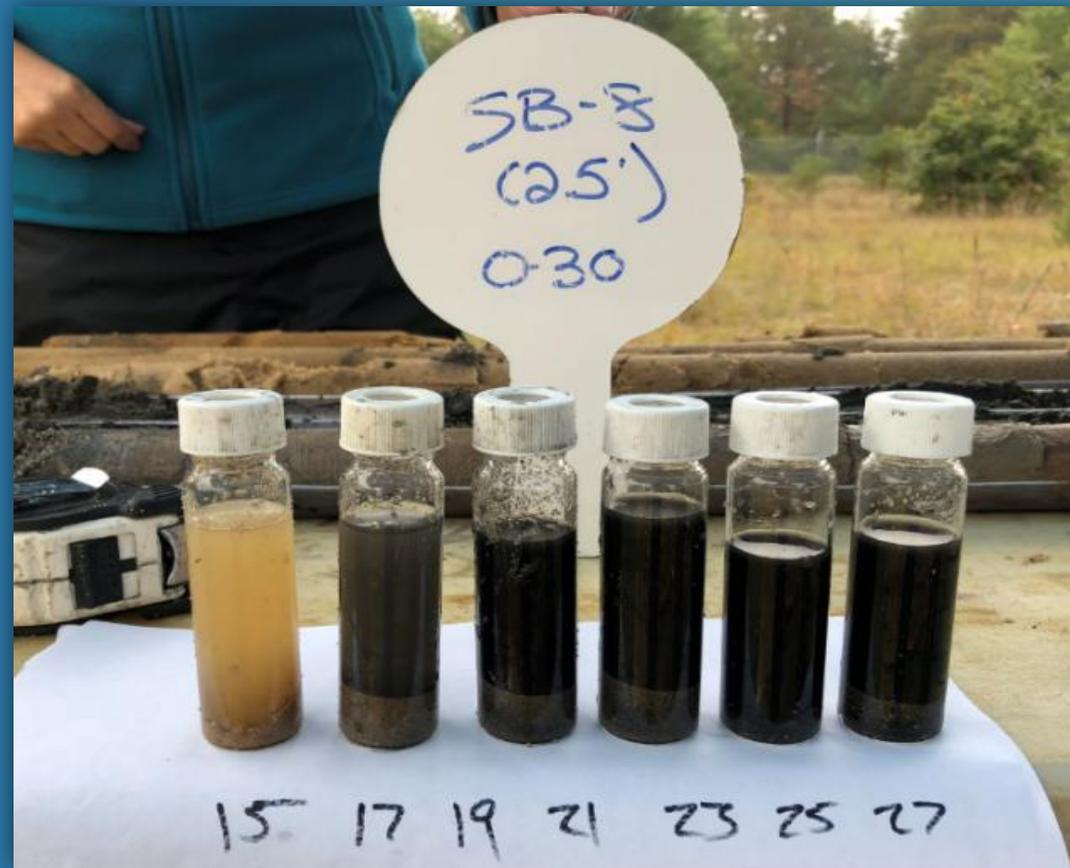
PS-Distribution Confirmation

Soil Vial Shake Test
