**22nd IWC International Symposium
Wooden Heritage Conservation:
beyond disciplines**

Conservation of Wooden Tserkvas in Ukraine: A New Initiative

Yuri Yanchyshyn¹ and Myron Stachiw²

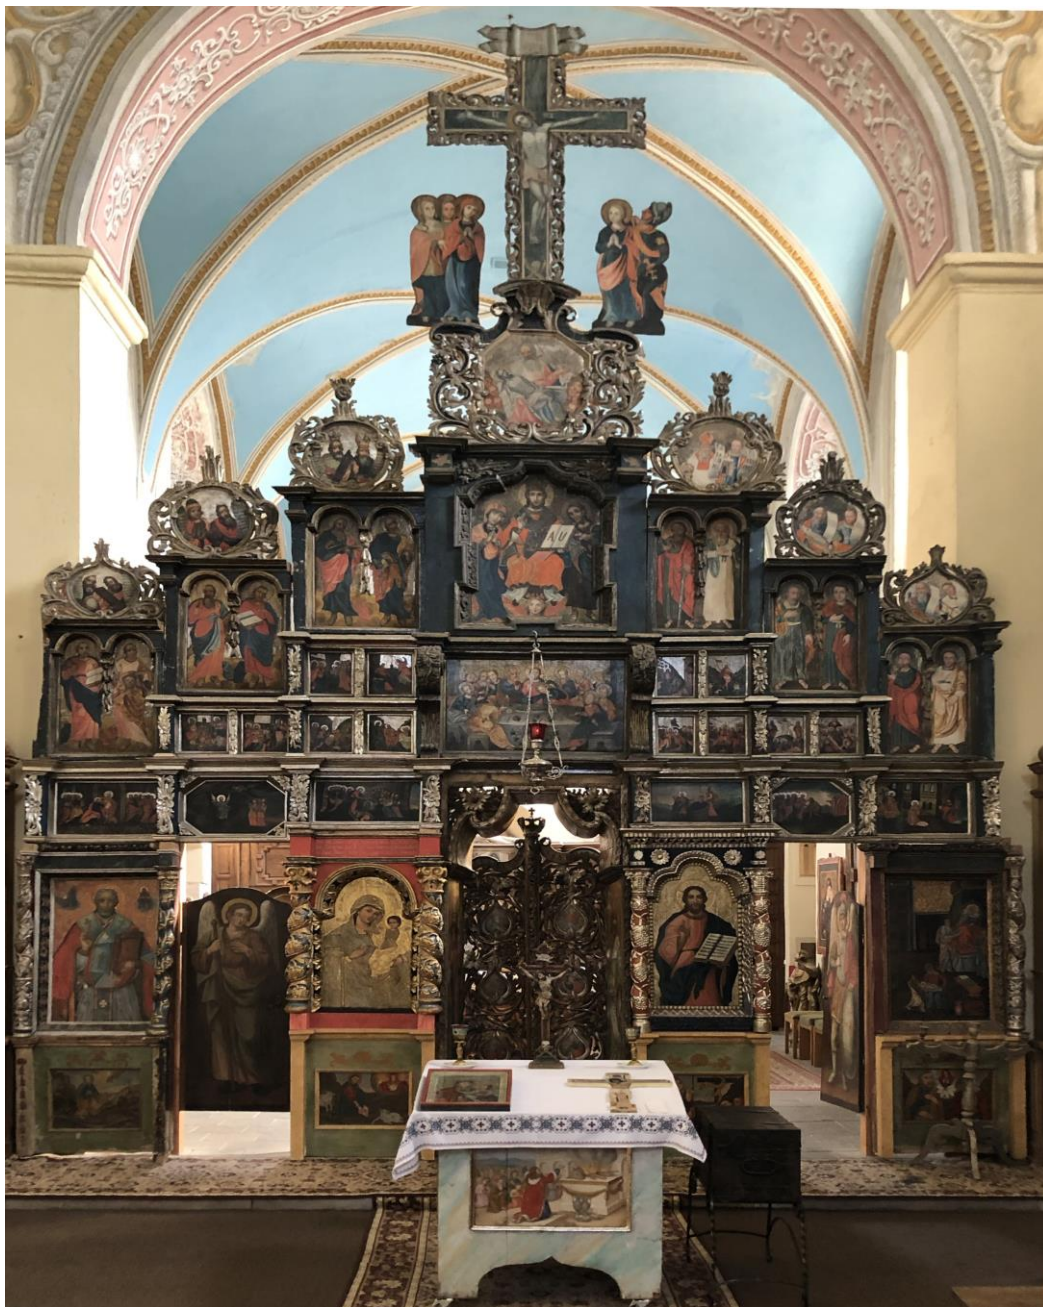
Figure 2, Church of St. Klymenta 1895 - iconostasis circa 18 c.

Careful investigation revealed that this iconostasis was composed of elements from several different iconostases, contrary to perceived historical interpretation. This practice was not unusual, whereby iconostases and their parts were re-sited to other churches for various reasons. Among these was the replacement of older churches with new buildings and new iconostases. The replacement iconostases were then often reconfigured and combined with elements from other iconostases to fit the new architectural space. The iconostasis in St. Klymenta is one such example. A comparison of photographs of the installation in the church in Krups'ke with that of the re-installation in the church of St. Klymenta in Lviv. A comparison illustrates that the latter reproduced the configuration of the Krups'ke installation reasonably accurately. However, it became clear that the original Krups'ke installation was a combination and reconfiguration of iconostasis elements from more than one source, as illustrated by measured drawings completed by workshop participants.

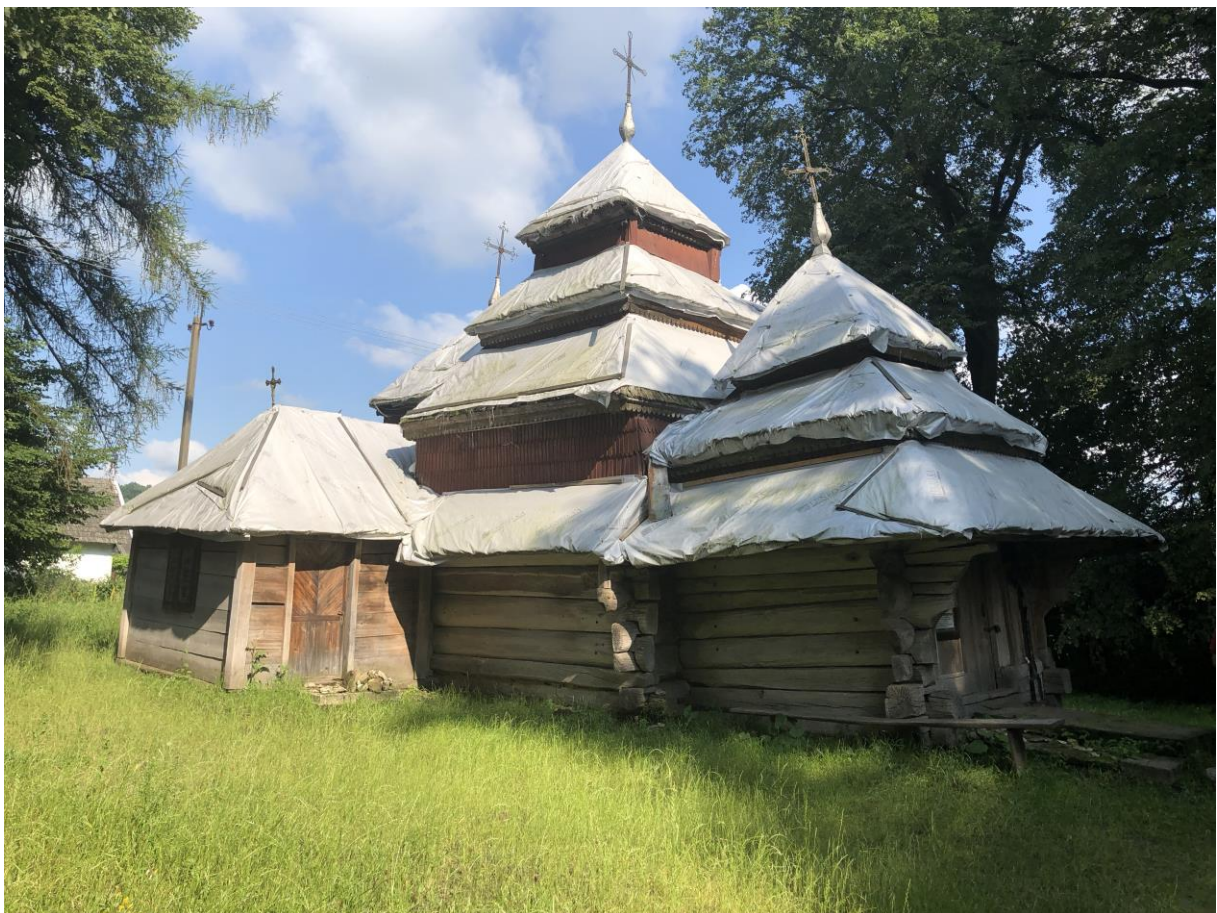
Figure 4, Tserkva of the Theophany circa 17c. – village of Kuhayiv

The tripartite, horizontal log structure with three, open log towers was constructed of hewn and rounded oak timbers with variously notched corner joints. The roof surfaces were originally covered with long, riven, feather-edged and grooved shakes called gonty, mentioned previously.

Workshop participants encountered a building covered with tarps applied five years ago to prevent further water infiltration. This procedure proved to be unsuccessful.

The issue of pronounced water penetration has always been a prominent concern with these complex constructions of multiple roof towers. By the early 20th century, the two end towers had already begun to lean inward due to structural damage resulting from water penetration. The construction of connecting roof crickets between the towers appeared to offer a solution, as shown in this early 20th c. photograph. However, restoration of the church in the 1970s and 1980s to its original configuration included removal of these roof crickets. Unfortunately, this removal was not accompanied by adequate preventive measures against further water penetration in the valleys between adjacent towers, and resulted in additional deterioration and inward leaning of the towers.

This neglected preventive measure also contributed significantly to the deterioration of the walls below the valleys. An additional aspect of water damage was revealed by the bowing and distortion of the church's walls as a result of the settlement of the building's underpinnings and sills. Other damage included extensive insect infestation, which is still active and results in further damage to the timbers.

Measured drawings executed by workshop participants when compared to earlier renderings and images documented the continued settlement and sagging of the structure. Further observations revealed that the structure had been raised multiple times to replace sills and lower timbers using traditional methods over the past three centuries, as documented by large peg holes in the wall logs used to attach vertical timbers on the interior and exterior of the structure. The structure was then lifted using wedges and levers from below utilizing notches in the vertical timbers.

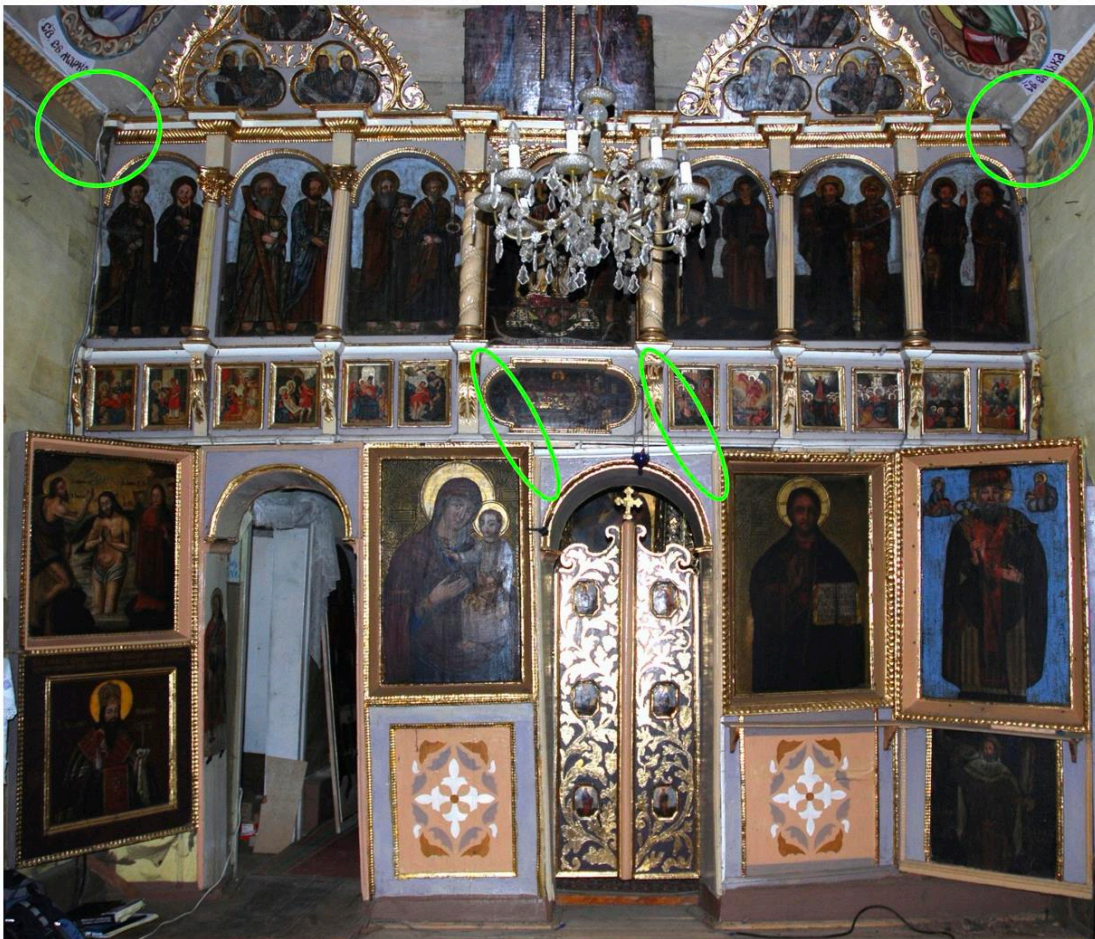
The iconostasis of this church provided another example of the re-siting and marriage of elements of at least two iconostases, illustrated by the missing end columns and mitered joints, and the misaligned rows of icons and doorways through the iconostasis into the apse.

Excavation on elements of the iconostasis revealed original silvering and polychromy beneath multiple paint layers, or in the case of the deacon's doors, of original polychromy hidden beneath later paint layers. Preliminary UV analysis revealed restoration overcoat layers on selective icons.

Figure 5, Church of the Theophany circa 17c. – village of Kuhaiv *iconostasis: a marriage of various elements.*

These preliminary findings call for more advanced future analyses. The 2019 workshop was a pilot program – a first attempt at organizing a workshop such as this in Ukraine. Planned future workshops will address these limitations and assist in planning a more comprehensive and analytical approach to the process of conservation assessment.
