Inspection Report

Property Address:
451 S School Street
Goodman MO 64843

Coltrane Inspection and Handyman Service, LLC

Date: 7/10/2017	Time: 09:00 AM	Report ID: 20170709-School
Property: 451 S School Street Goodman MO 64843	Customer: Meagan Caswell	Real Estate Professional: Keith Landrum Keller Williams

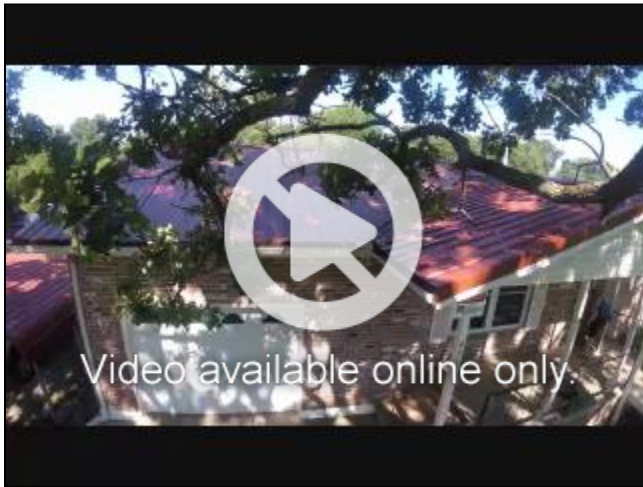
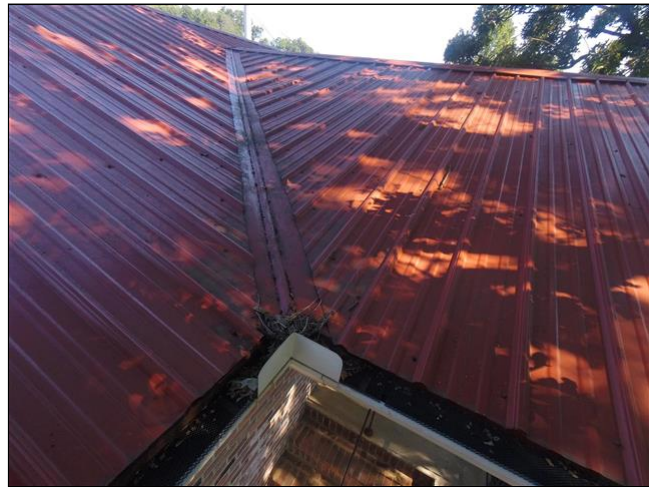
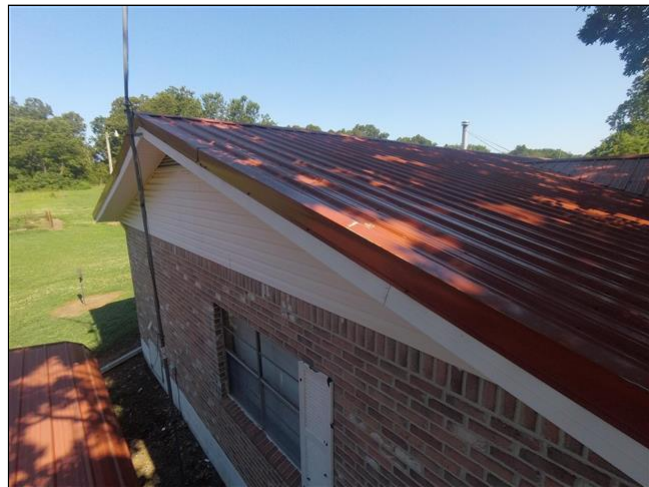
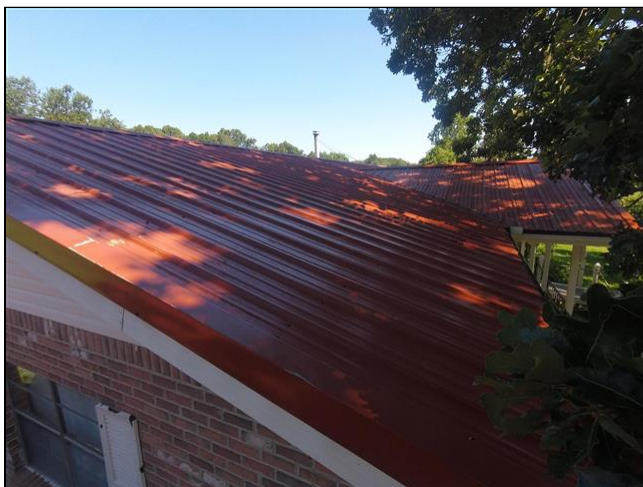
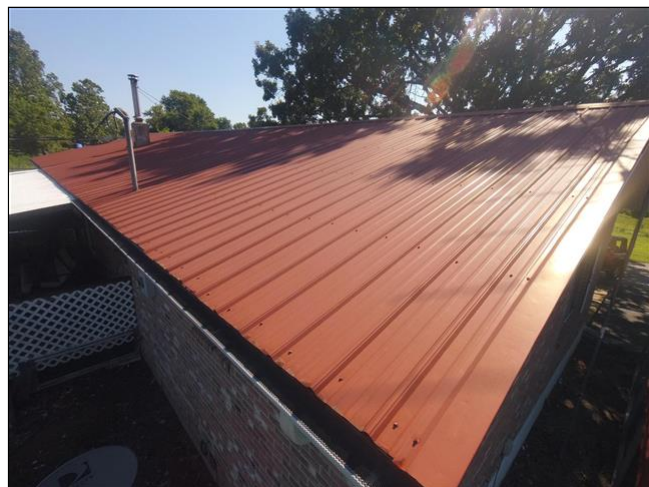
1.0 The metal roof coverings appeared to be alright at time of the inspection; however, rubber gasket seals around the screws may be near the end of their life expectancy. The caulking between the covered porch and the roof is deteriorated. Suggest contacting a roofing contractor for further evaluation.

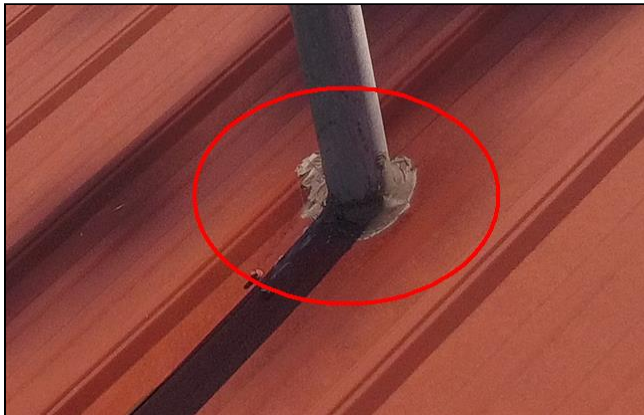
1.2 Item 1(Picture)

1.2 Deteriorated caulking around several roof penetrations as well as the chimney step-flashing. Suggest repairing and replacing as needed.

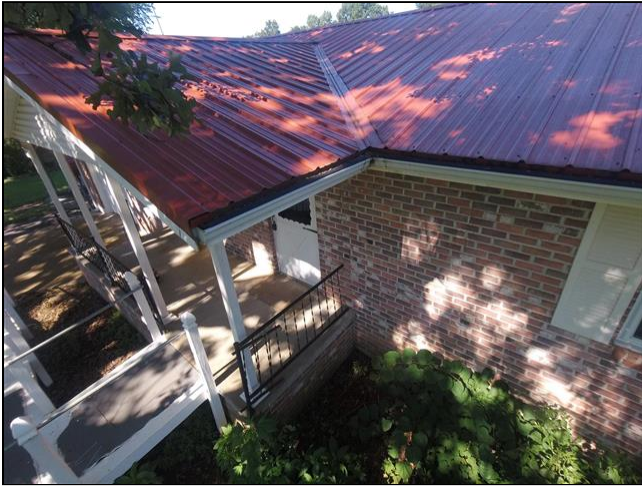
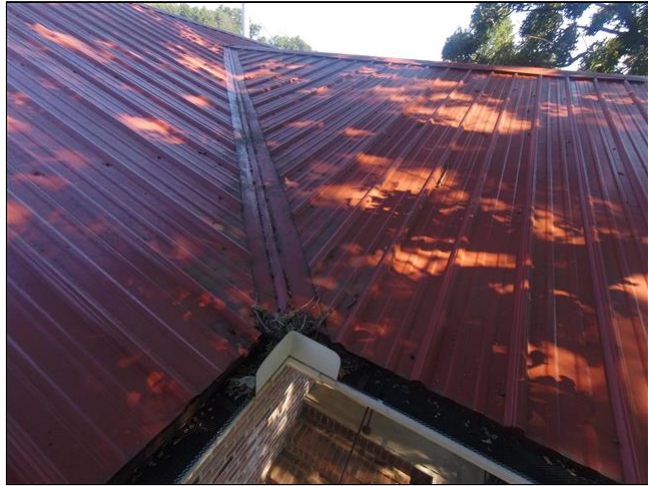
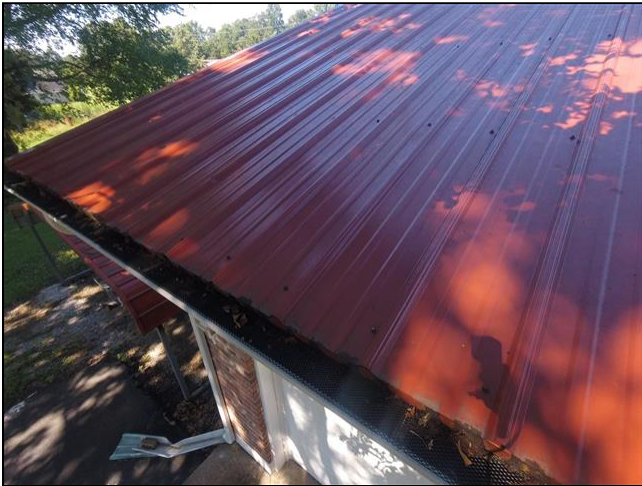
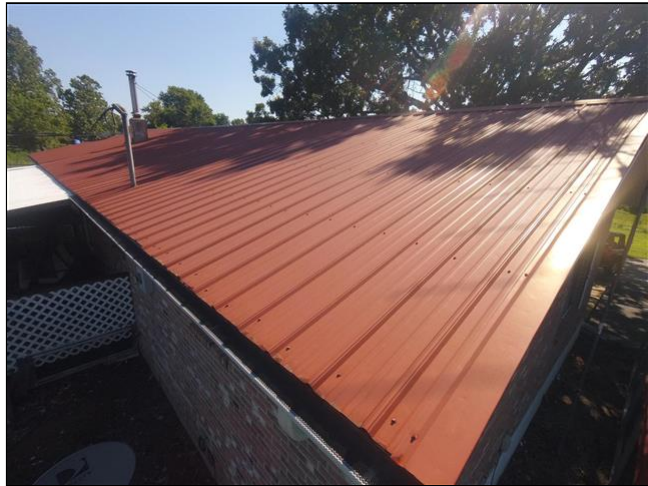
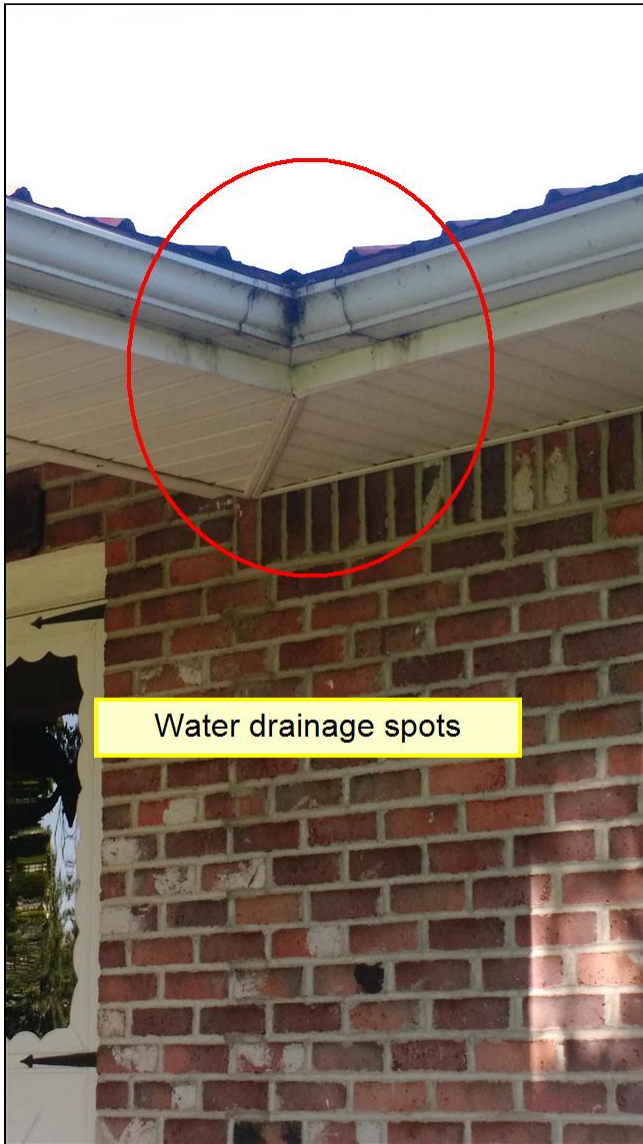
1.3 Drainage system was clear of clutter at time of inspection but there were signs of apparent water leaks due to buildup near the front right corner of the front porch. The downspouts had homemade extensions that were in poor shape.

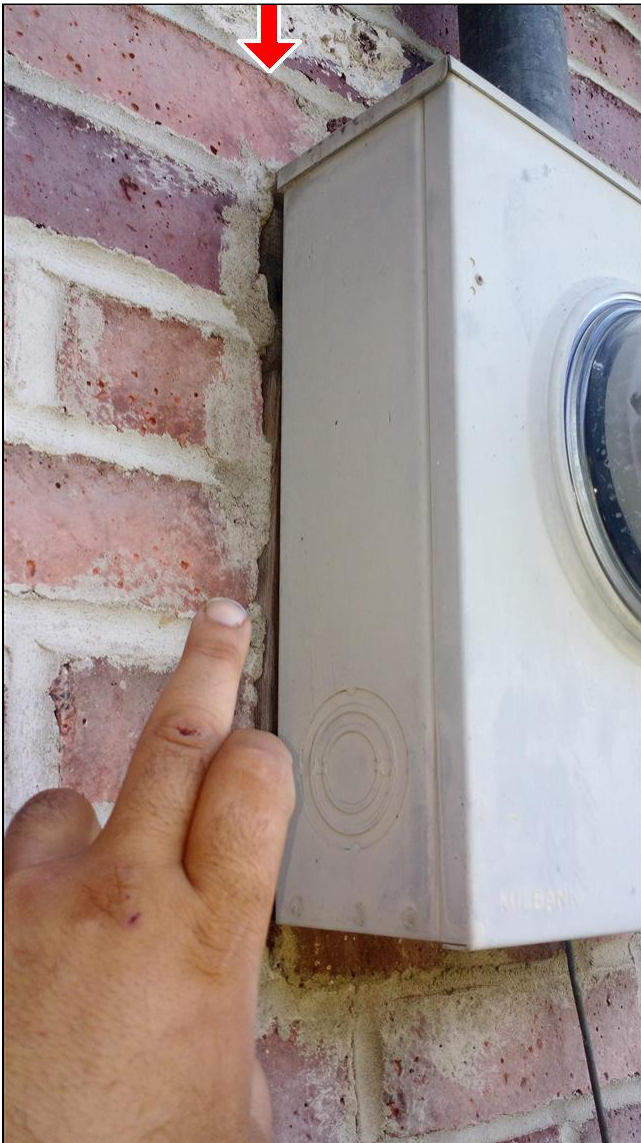
2.0 Item 1(Picture)

2.0 Throughout the exterior of the house, there are areas where the mortar has chipped out and needs to be re-pointed. Around several of the exterior hose bibs and crawspace vents, the bricks have cracked. Suggest contacting a licensed contractor for further evaluation.

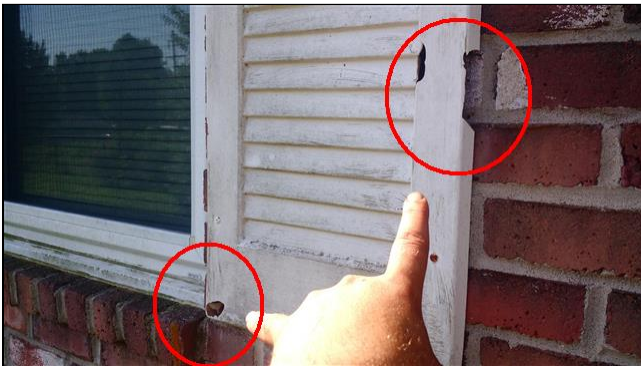
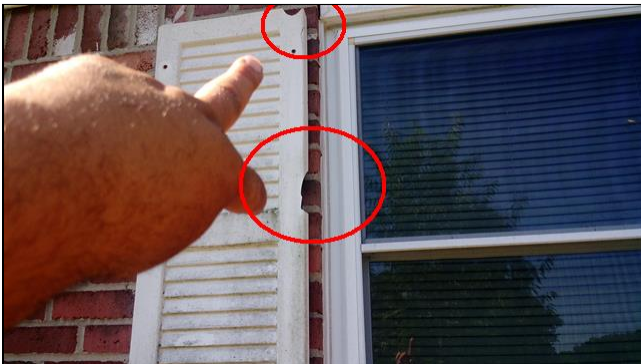
2.2 Most of the shutters have loads of dry-rot and need to be replaced.

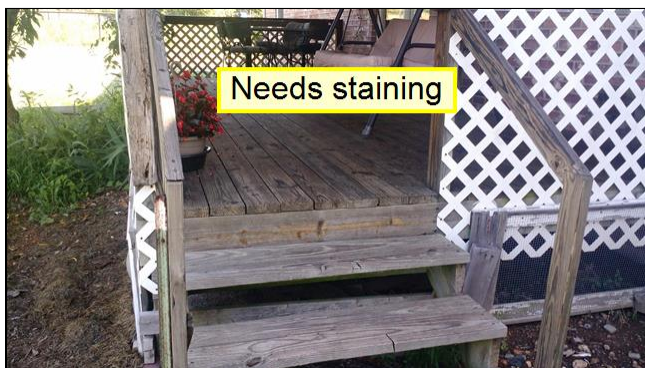
2.3 The covered deck needs to be power washed and stained. Suggest contacting a paint contractor. The handrails need vertical ballasts spaced every four inches. There are saw cuts in the center of the deck steps and could have possibly hindered their structural integrity. The wheelchair ramp showed sign of wear. The front porch handrails were not attached at the right of the front door. The handrail near the ramp is missing.

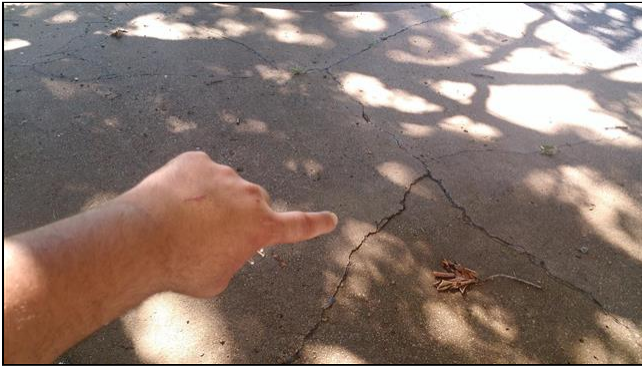
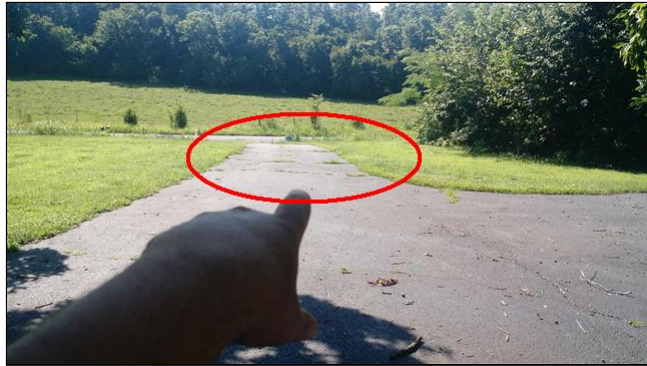
2.4 Portions of the driveway are cracked and need to be resurfaced.

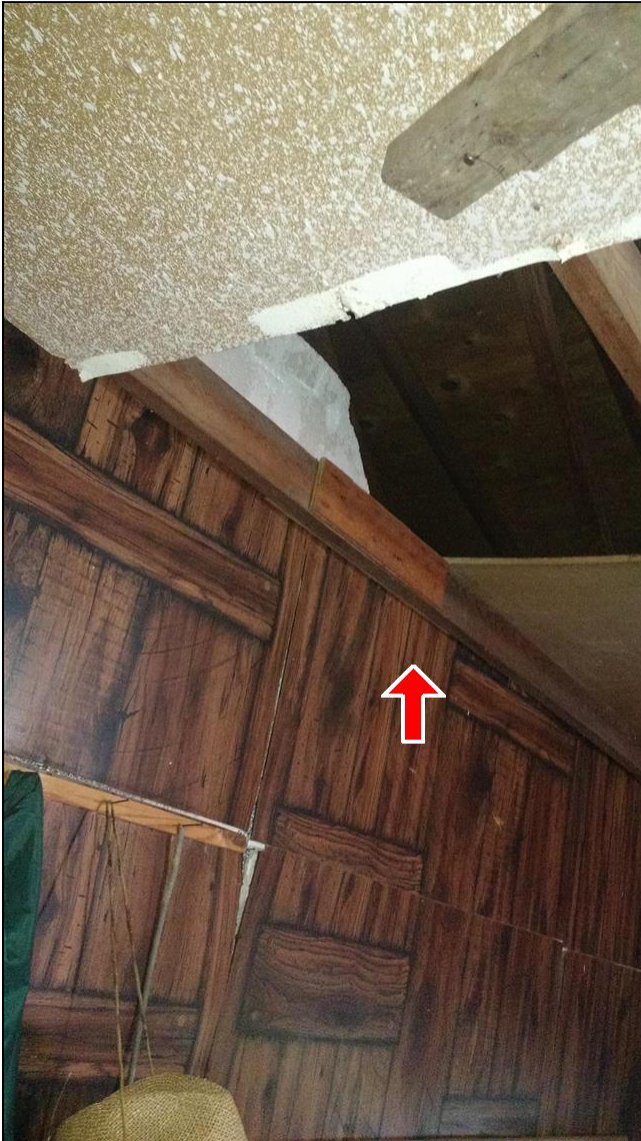
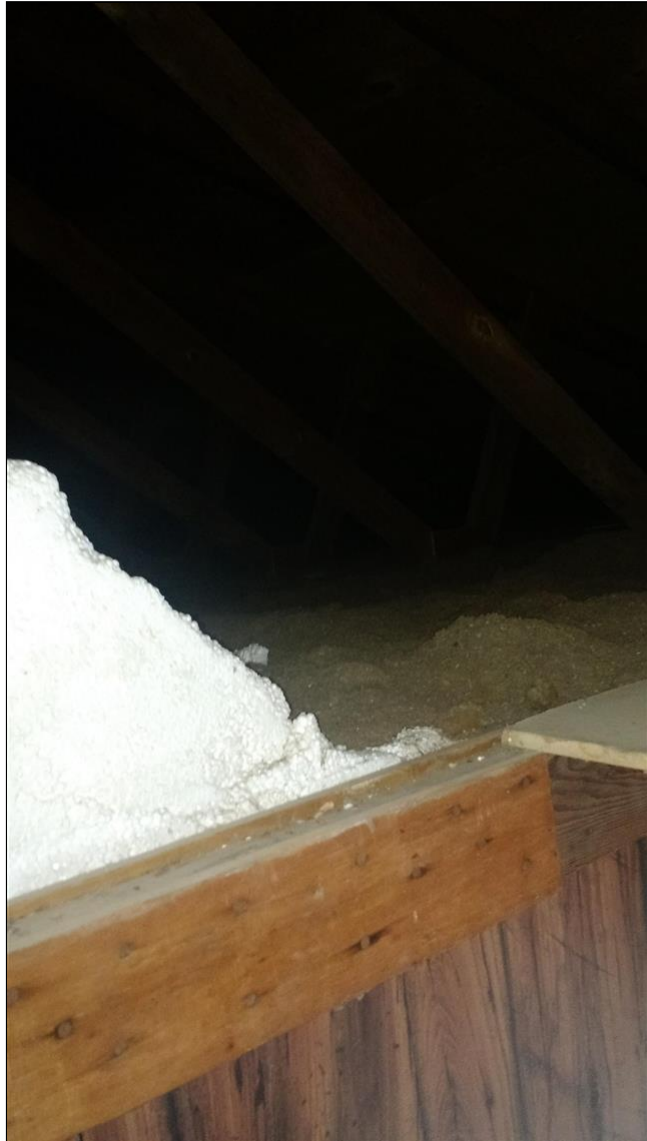
3.1 There is no firewall separation between the garage and living areas. This a major defect and could allow noxious gasses to enter the living areas of the home.

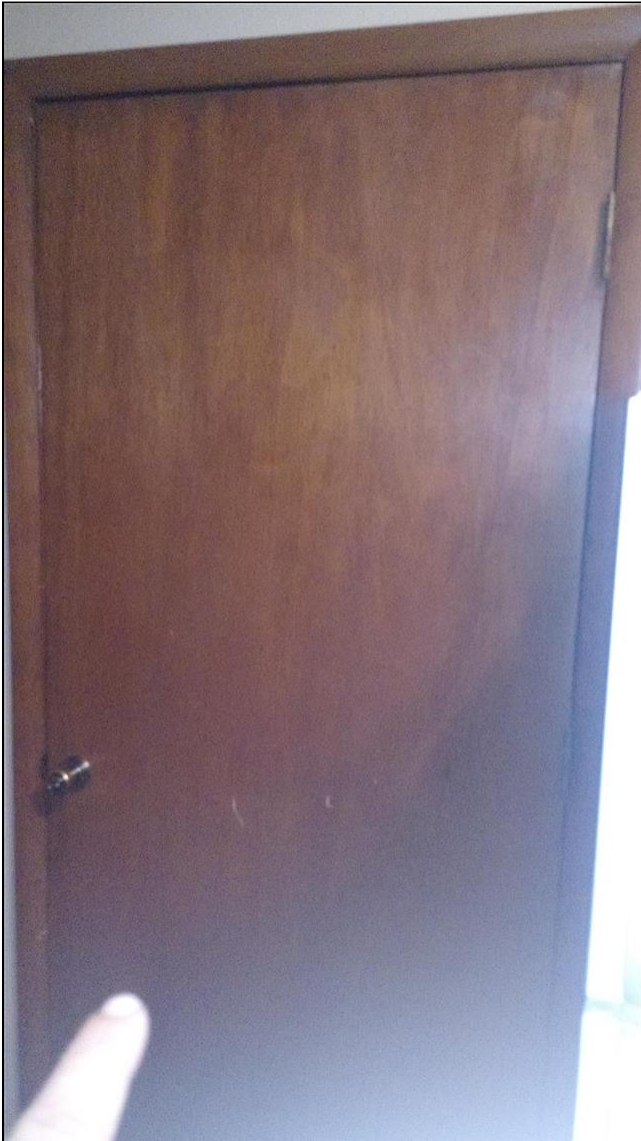
3.4 The interior garage door was hollow and not fire rated. The door also has no seals. This is a major defect because it allows noxious gasses to enter the living areas of the home. This needs to be replaced with a fire rated exterior door with seals.

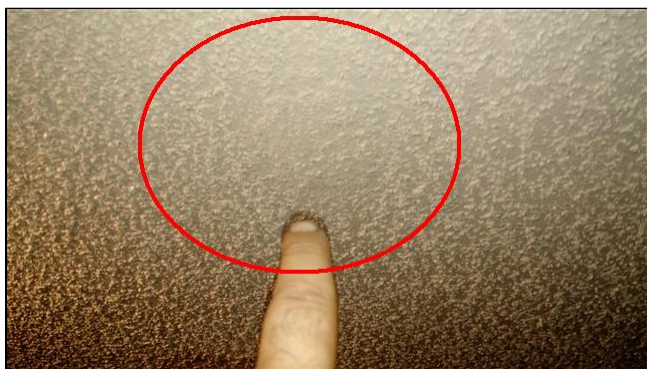
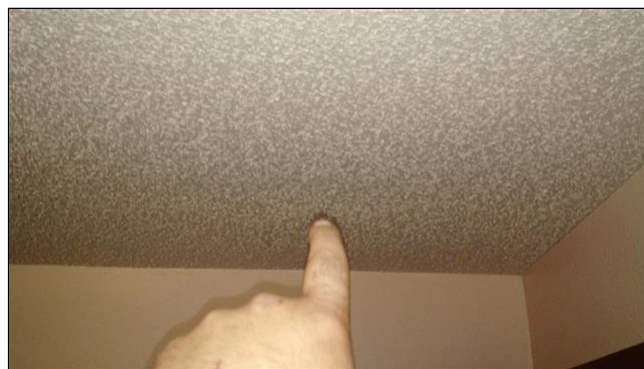
4.0 Several former drywall patches were observed in the second bedroom at the time of the inspection.

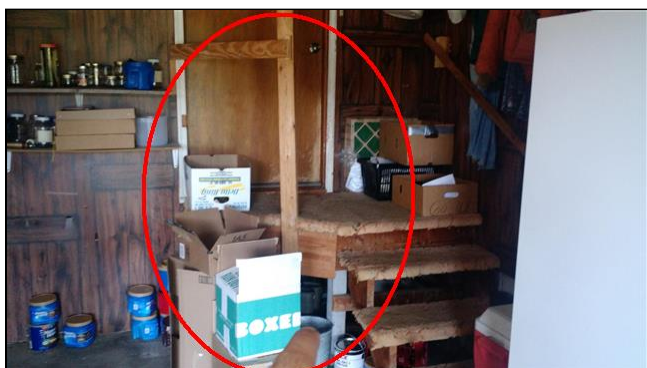
4.3 Item 1(Picture)

4.3 There was a make-shift handrail leading up the stairs from the garage. Suggest contacting a contractor to do any repairs necessary.

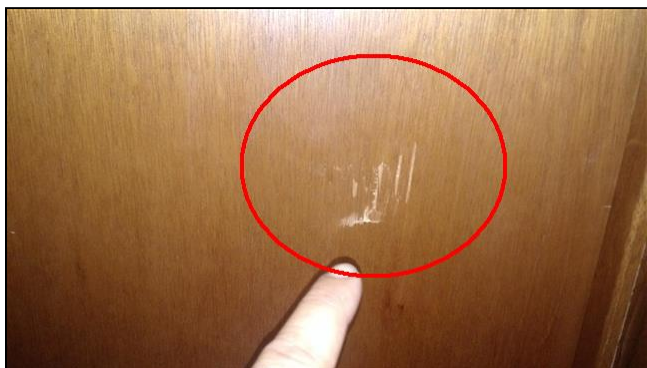
4.5 Item 1(Picture)

4.5 There was a whole knocked into the master bedroom door that needs to be replaced.

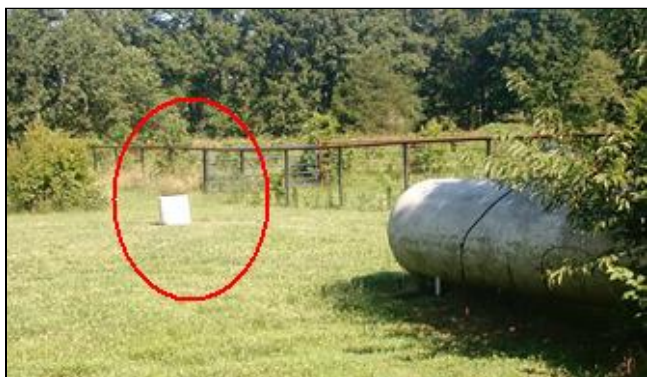
6.3 Item 1(Picture)

6.3 The main shut-off valve is at the well.

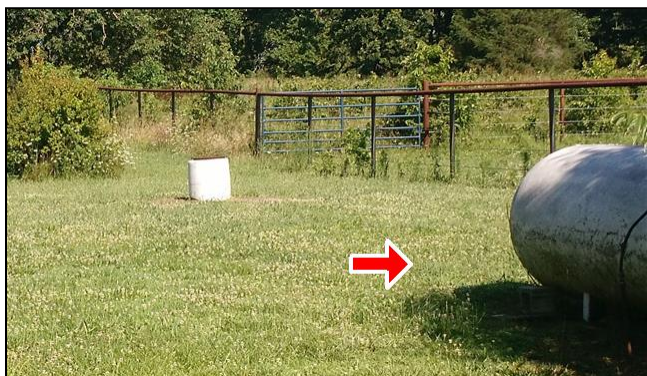
6.5 Item 1(Picture)

6.5 Main propane shut-off valve is at the propane tank.

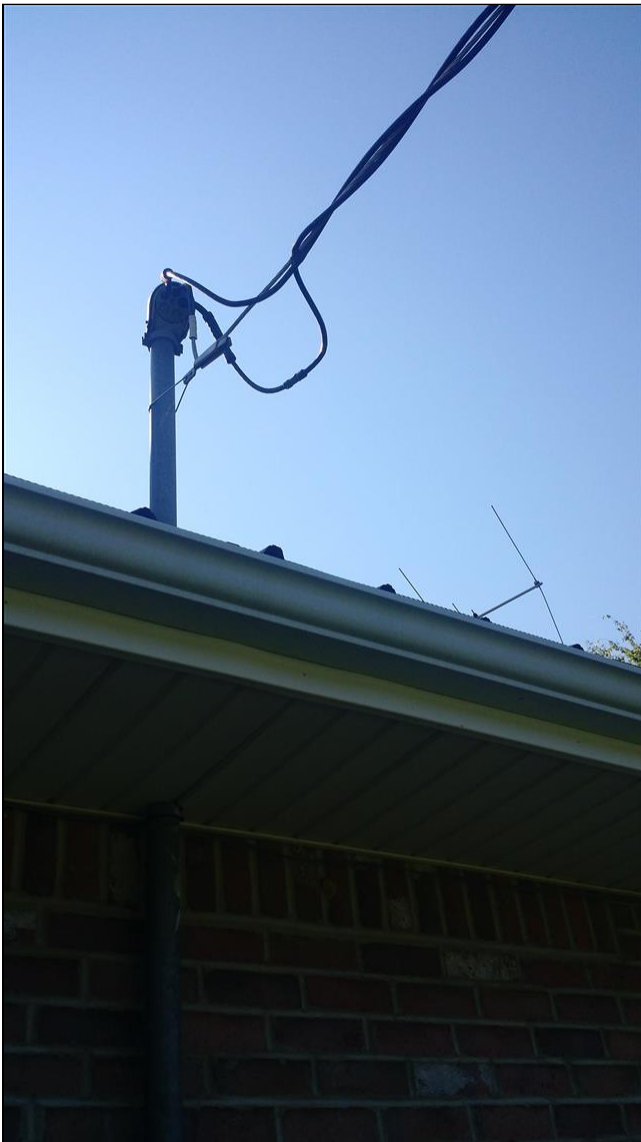
7.0 Item 1(Picture)

7.0 Service entrance conductors and drip loops looked adequate at time of inspection.

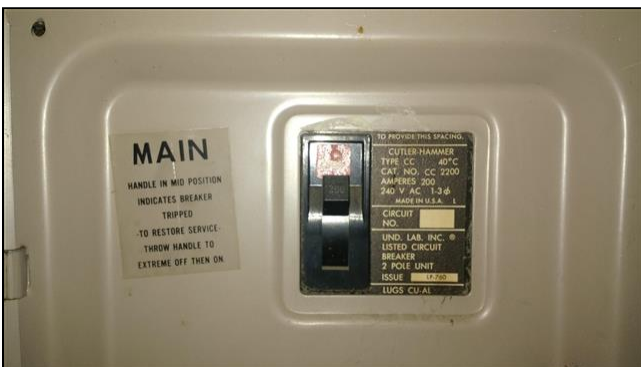
7.2 Item 1(Picture)

7.2 200 amp service.

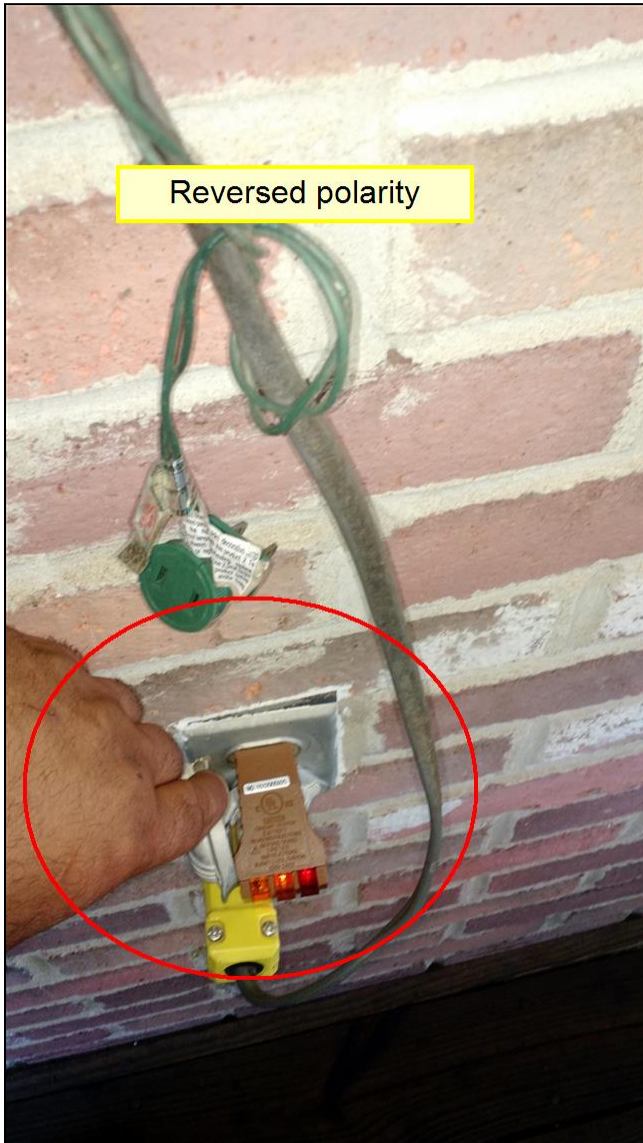
7.4 Item 1(Picture)

7.4 The outlet to the left of the sliding glass door has reversed polarity. This is a major defect. Suggest contacting a licensed electrician to for further evaluation and repairs.

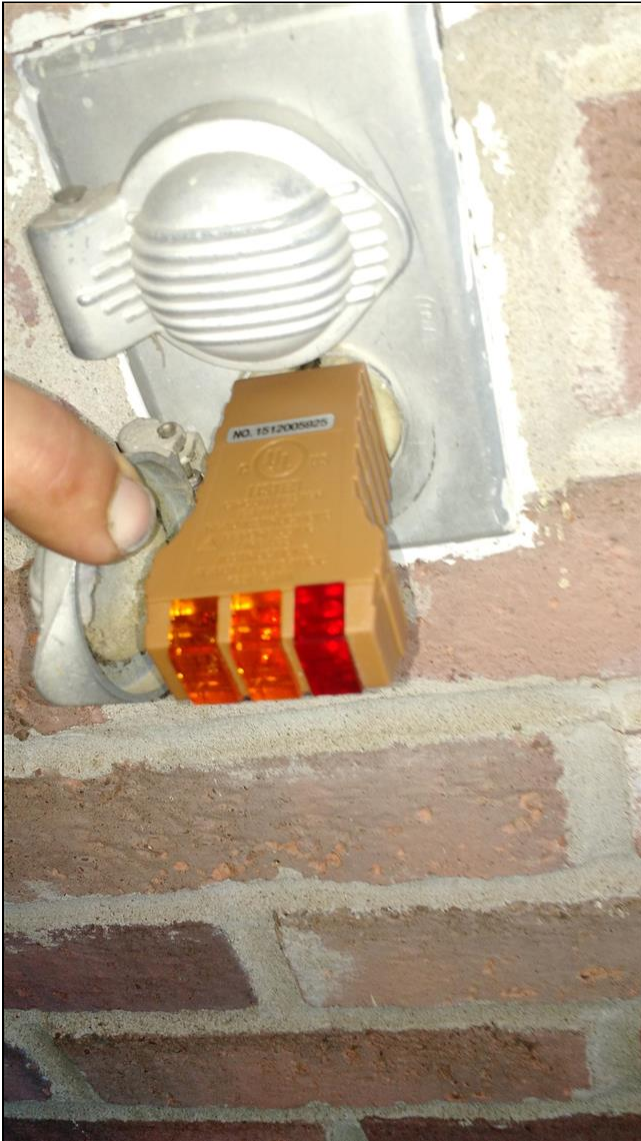
7.5 Item 1(Picture)

7.5 None of the exterior outlets or outlets in the kitchens and bathrooms were GFCI protected at time of the inspection. All outlets within six feet of an interior water source and all exterior outlets need to be GFCI protected. Suggest having an electrician make any repairs necessary.

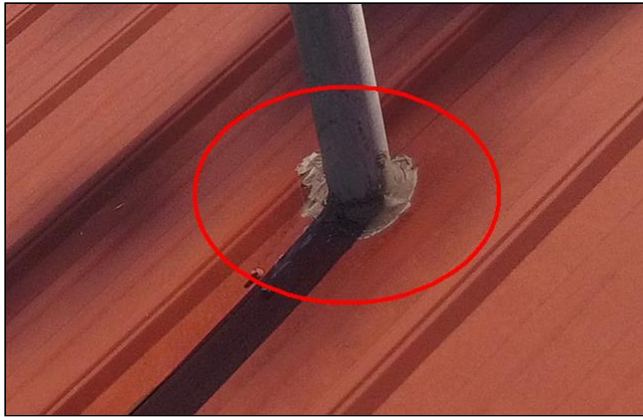
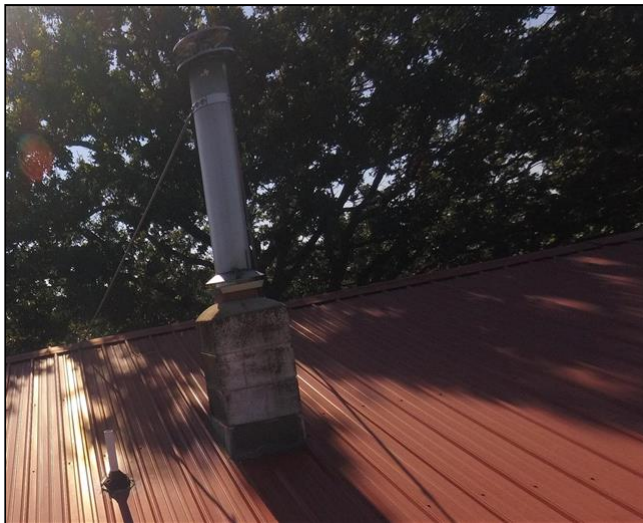
Deteriorated caulking around several roof penetrations as well as the chimney step-flashing. Suggest repairing and replacing as needed.

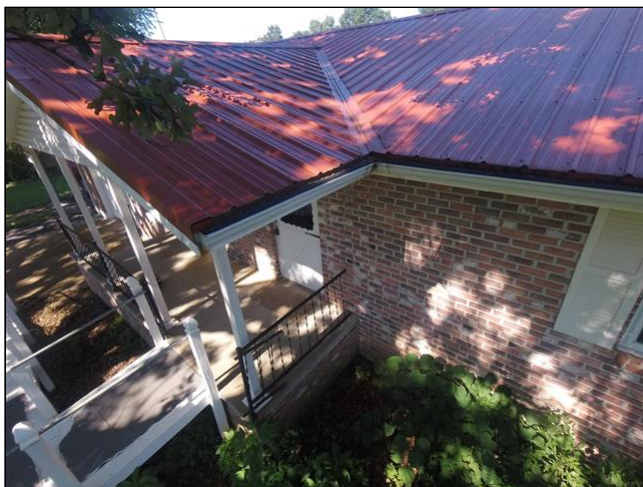
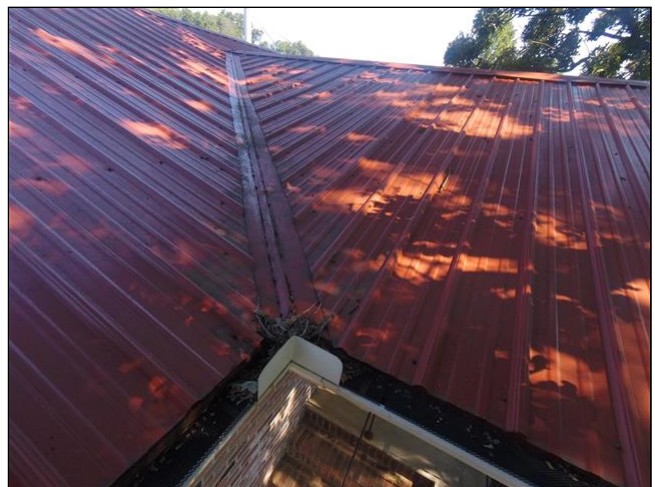
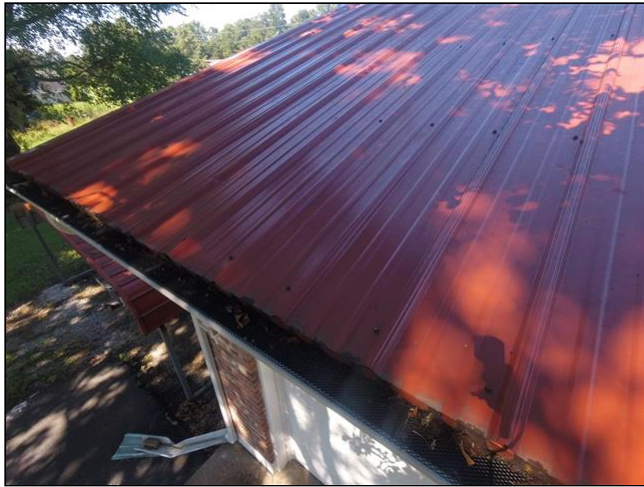
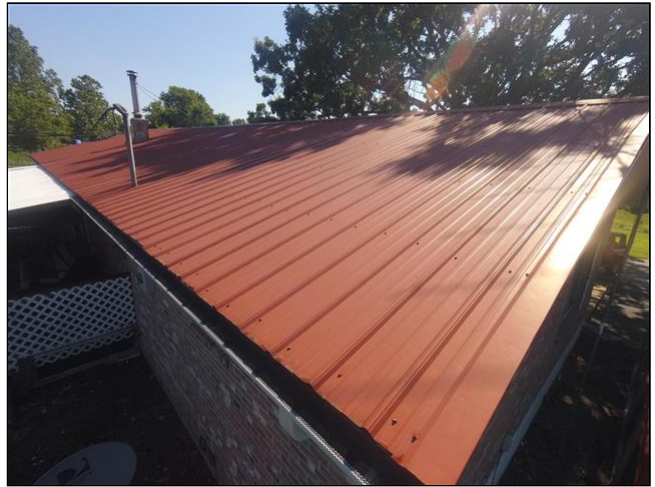
Drainage system was clear of clutter at time of inspection but there were signs of apparent water leaks due to buildup near the front right corner of the front porch. The downspouts had homemade extensions that were in poor shape.

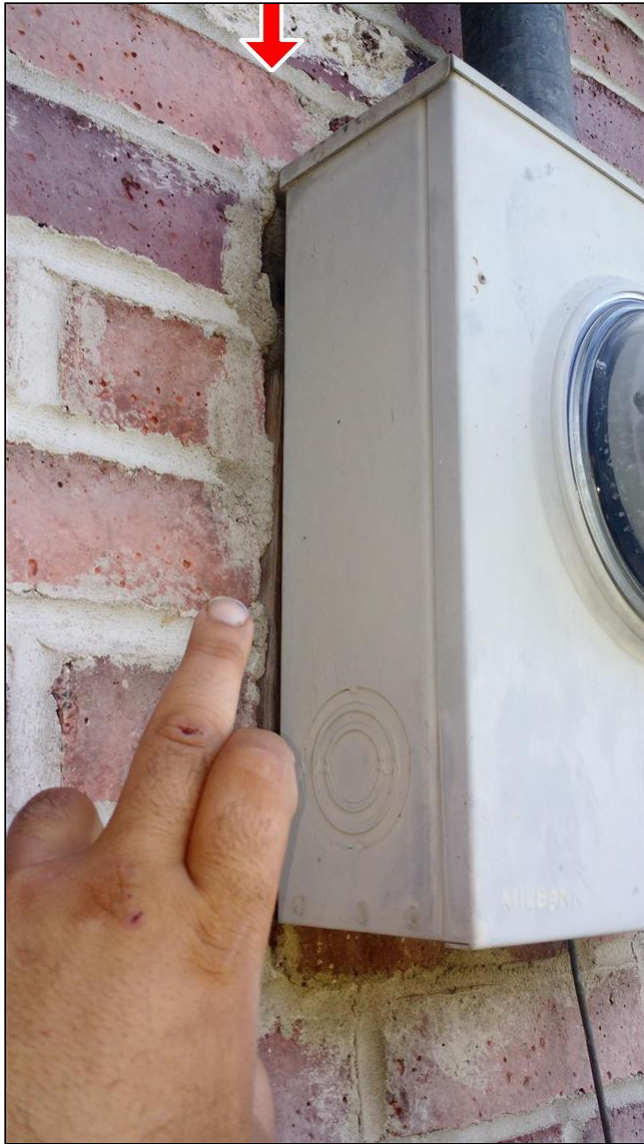
Throughout the exterior of the house, there are areas where the mortar has chipped out and needs to be re-pointed. Around several of the exterior hose bibs and crawlspace vents, the bricks have cracked. Suggest contacting a licensed contractor for further evaluation.

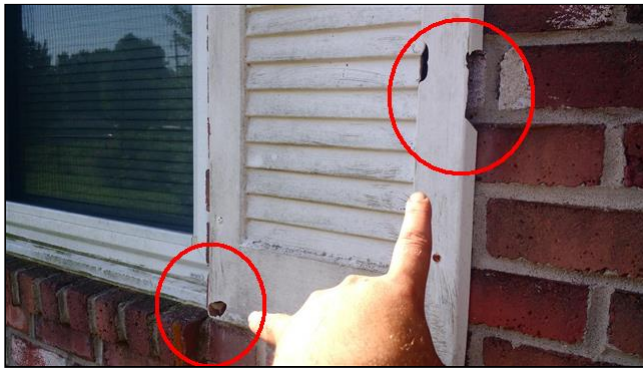
2.2 Item 1(Picture)

Most of the shutters have loads of dry-rot and need to be replaced.

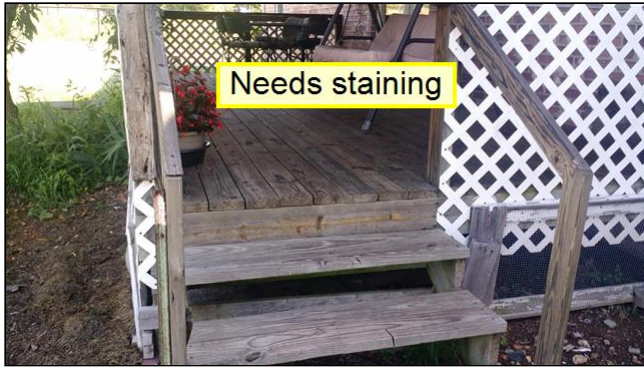
The covered deck needs to be power washed and stained. Suggest contacting a paint contractor. The handrails need vertical ballasts spaced every four inches. There are saw cuts in the center of the deck steps and could have possibly hindered their structural integrity. The wheelchair ramp showed sign of wear. The front porch handrails were not attached at the right of the front door. The handrail near the ramp is missing.

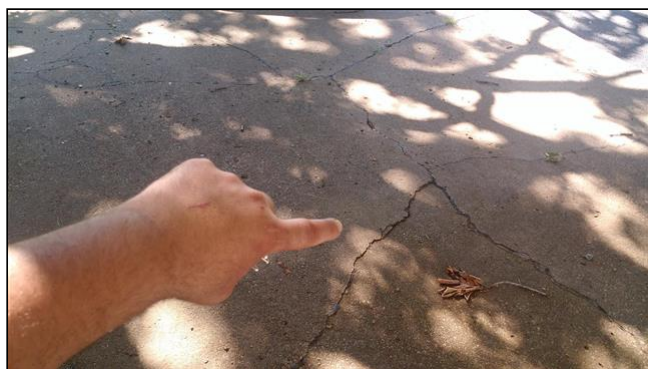
2.4 Item 1(Picture)

Portions of the driveway are cracked and need to be resurfaced.

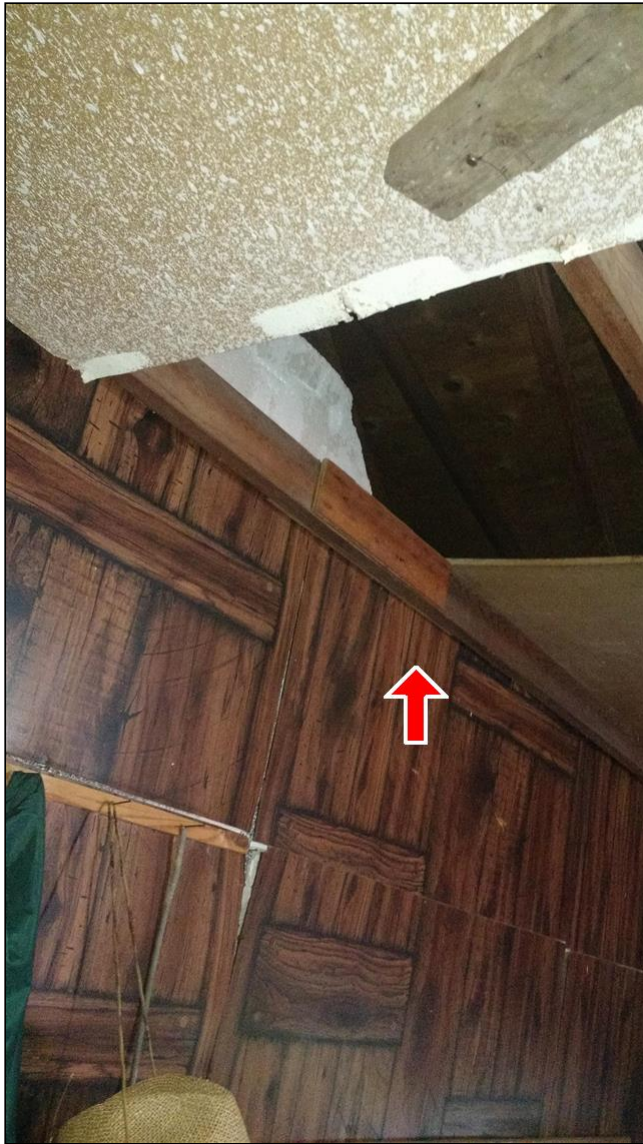
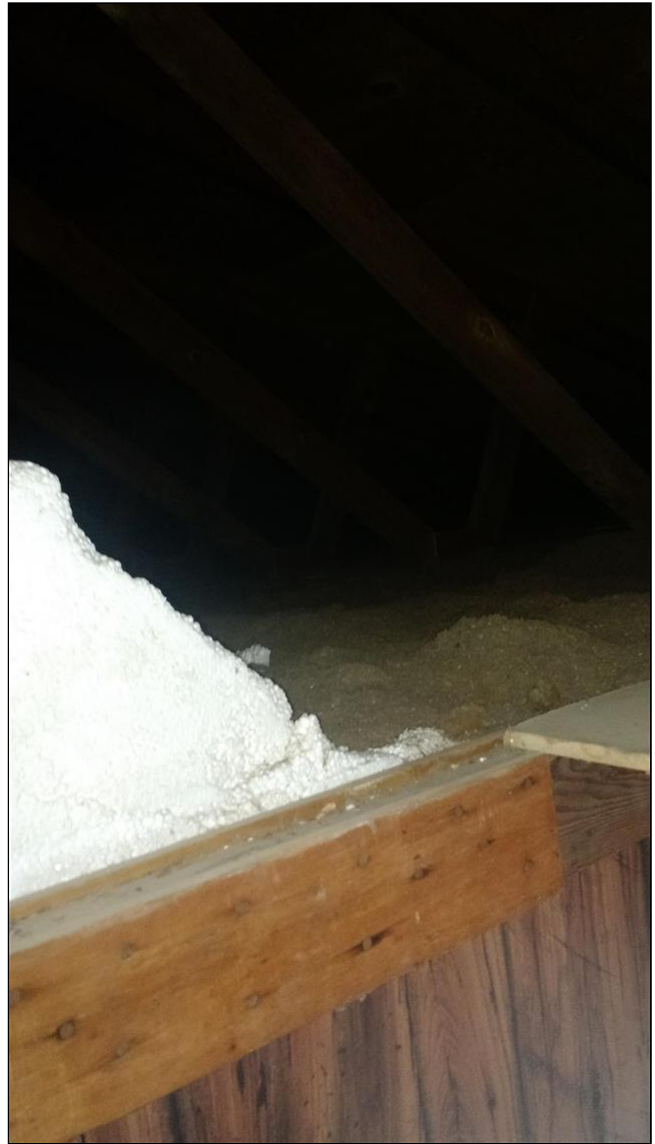
There is no firewall separation between the garage and living areas. This a major defect and could allow noxious gasses to enter the living areas of the home.

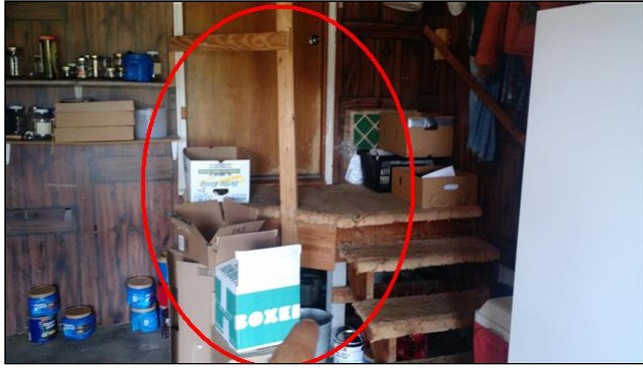
4.3 Item 1(Picture)

There was a make-shift handrail leading up the stairs from the garage. Suggest contacting a contractor to do any repairs necessary.

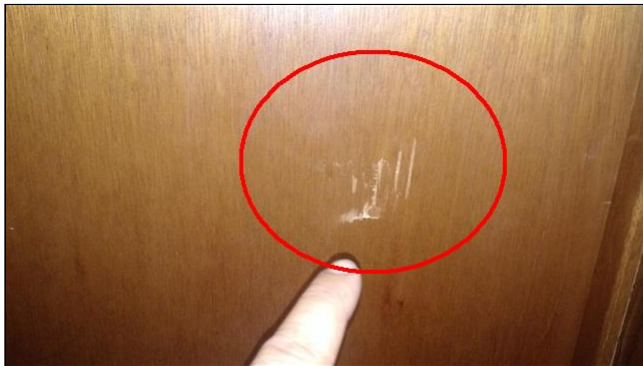
4.5 Item 1(Picture)

There was a whole knocked into the master bedroom door that needs to be replaced.

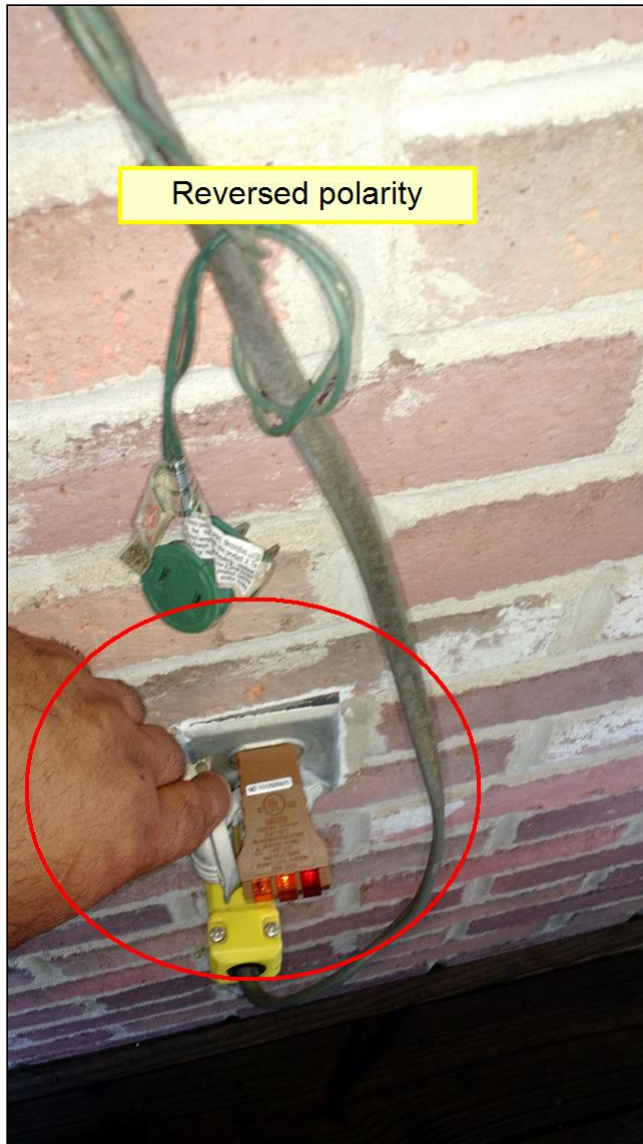
7.4 Item 1(Picture)

The outlet to the left of the sliding glass door has reversed polarity. This is a major defect. Suggest contacting a licensed electrician to for further evaluation and repairs.

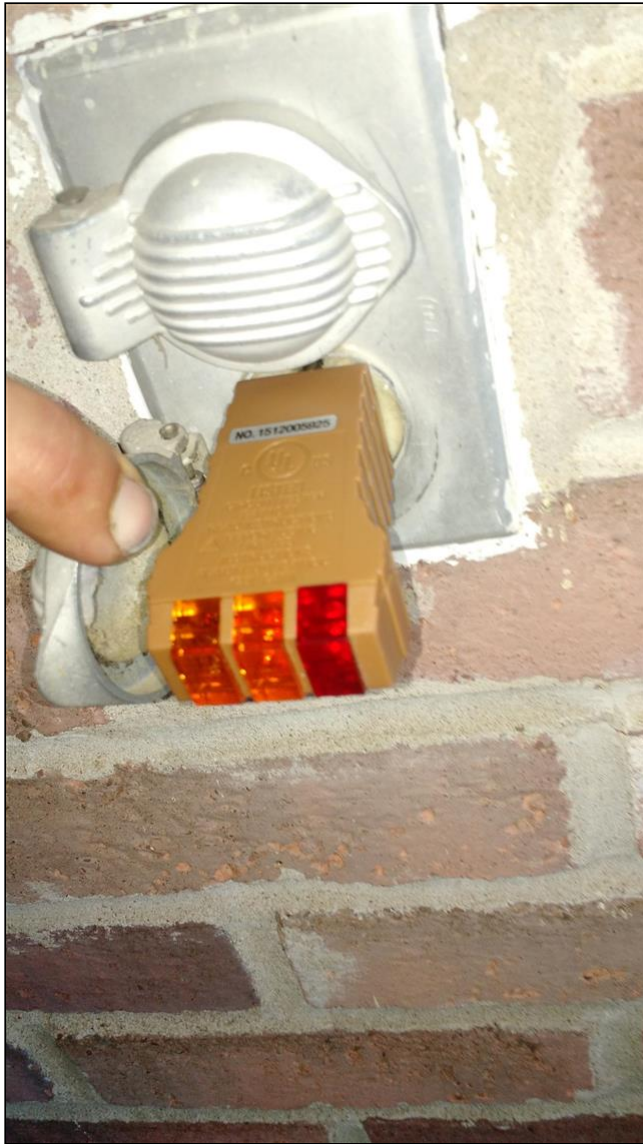
7.5 Item 1(Picture)

None of the exterior outlets or outlets in the kitchens and bathrooms were GFCI protected at time of the inspection. All outlets within six feet of an interior water source and all exterior outlets need to be GFCI protected. Suggest having an electrician make any repairs necessary.
