Assessment of Environmental Stressors in the Indian Mill Creek Watershed

Rajesh Sigdel

A Project Report Submitted to the Graduate Faculty of

Grand Valley State University

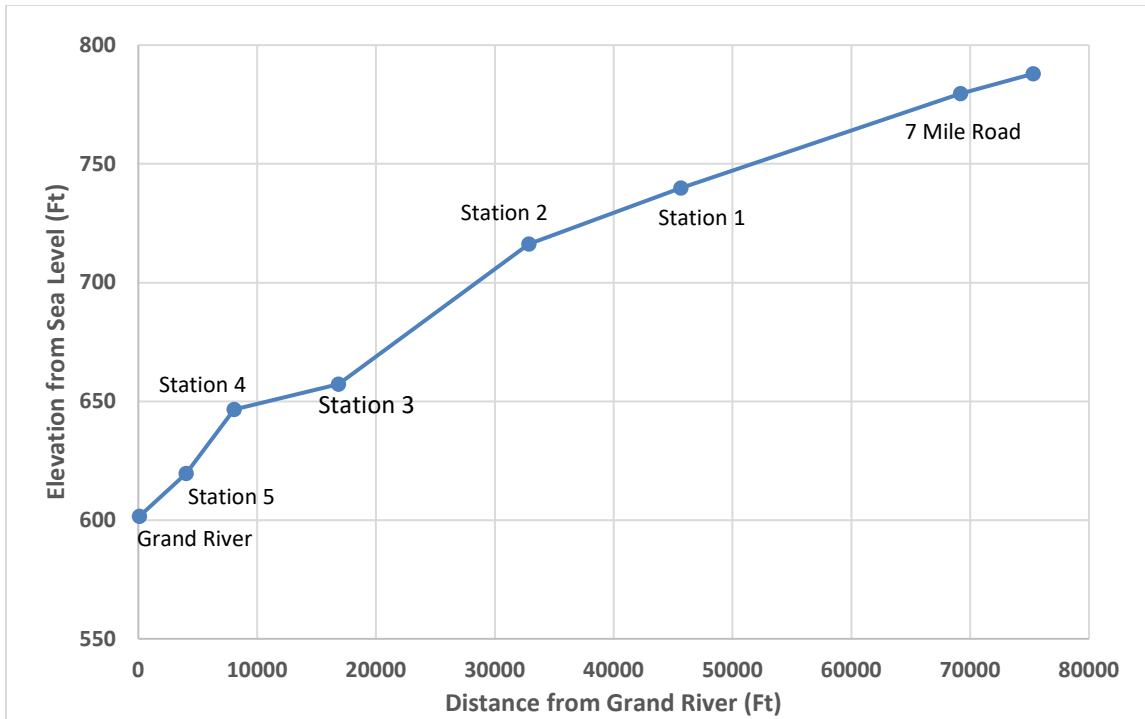
Figure 2. Elevation profile Indian Mill Creek as a function of distance from the Grand River.

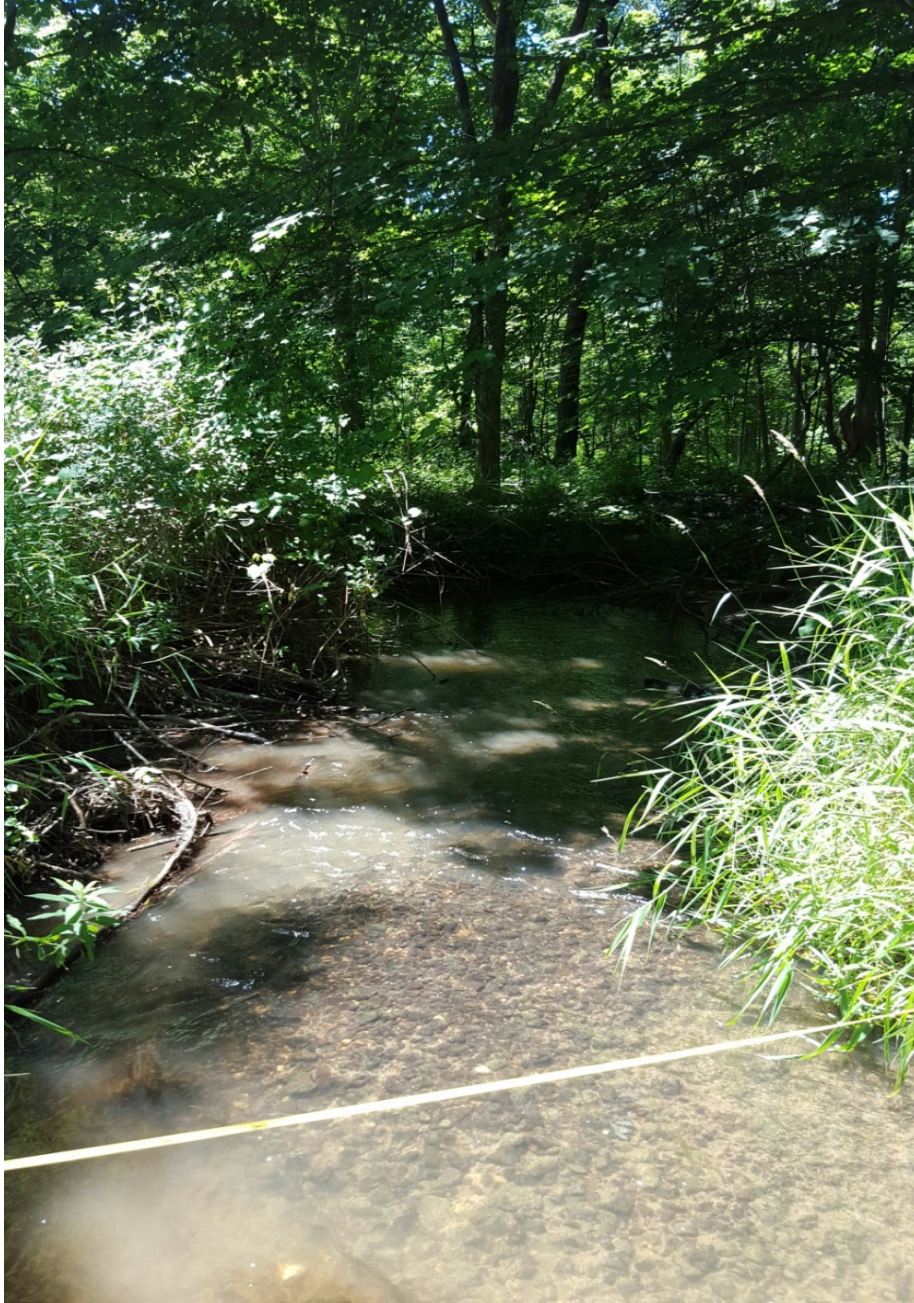
Figure 11. Station 2, Boy Scouts of America property in the City of Walker, MI.

Station 2 (Figure 12) was located off the Walker Avenue on the Gerald R. Ford Council Boy Scouts of America building (43.021898, -85.730992 [WGS 1984]). This station was below the Highland Golf Course. The station had intact riparian vegetation and the flow was moderate. The stream channel width was 2.5 m and the substrate was medium gravel and sand.

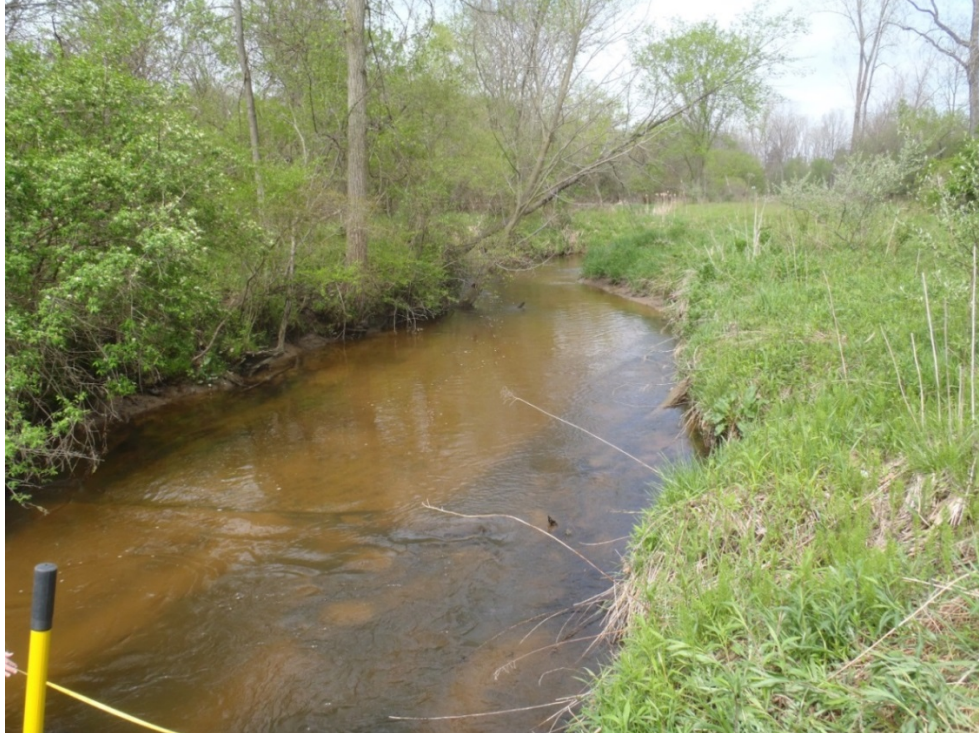
Figure 12. Station 3, Walker South (after the confluence with Brandywine Creek in the City of Walker, MI).

Station 3 (Figure 13) was located south of Walker Avenue below the confluence with Brandywine Creek (43.000663, -85.718531 [WGS 1984]). Stream discharge and width increased at this station and the substrate consisted of gravel and sand. The north bank of Station 3 was cleared and vegetation consisted grasses whereas the south bank had riparian shrubs and trees. Plastic netting was present along the north bank to help control erosion (Figure 14). Walker Ditch empties into Indian Mill Creek below Station 3 and appears to be a significant source of bedload sand (Figure 15).

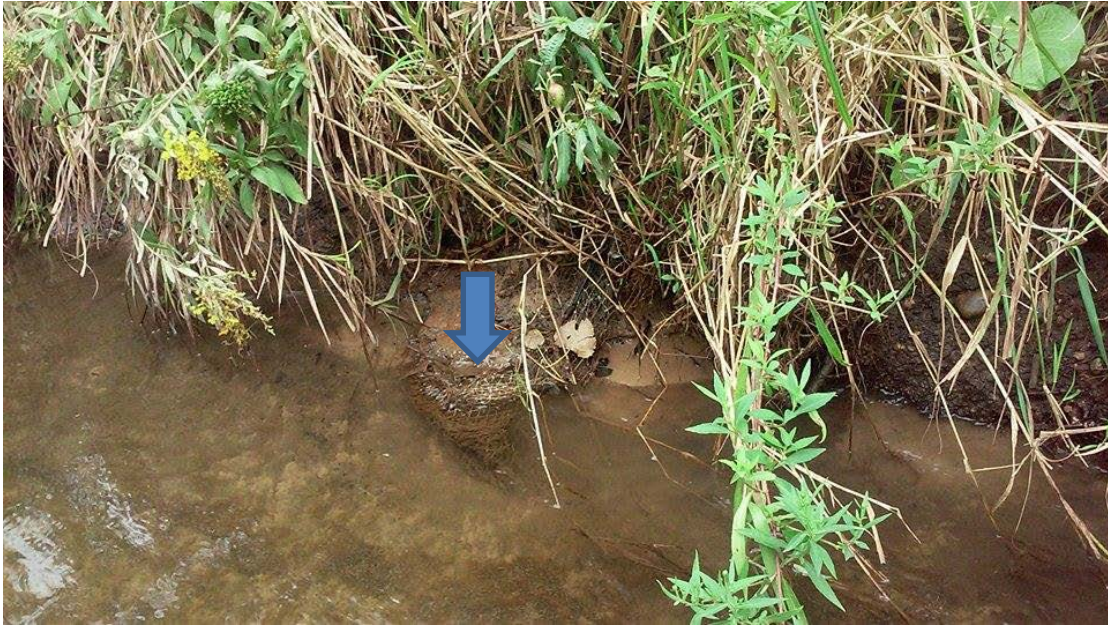
Figure 13. Plastic netting at Station 3 of Indian Mill Creek.

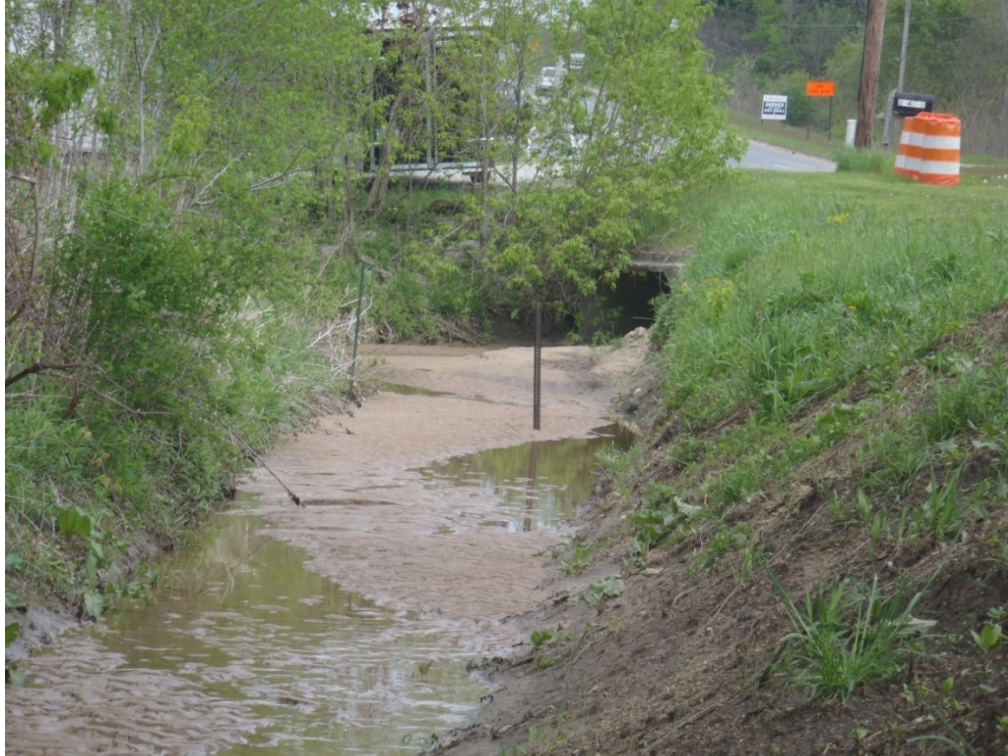
Figure 14. Sedimentation in Walker Ditch.

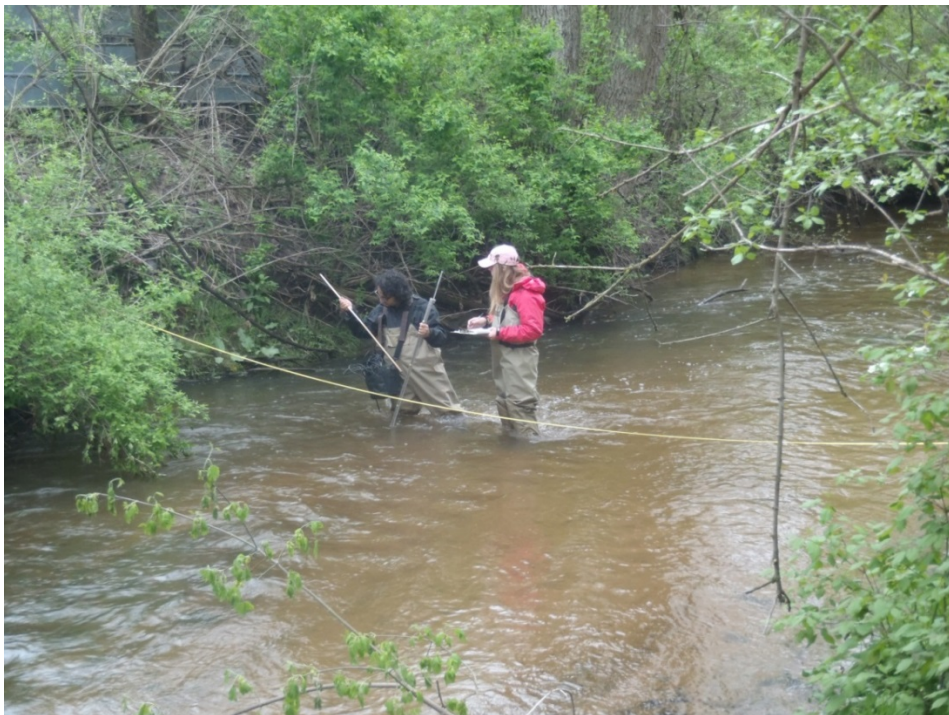
Figure 15. Station 4. North of Richmond Park.

Station 4 (Figure 16) was located north of Richmond Park (42.998049, -85.692500 [WGS 1984]). This site also was used by the MDEQ study in 2009 where they determined the stream did not meet the coldwater fisheries standard. The south bank of Station 4 had riparian trees and shrubs; however, the north bank had a fenced-in salvage yard with very little riparian vegetation. The substrate consisted of sand with some gravel.

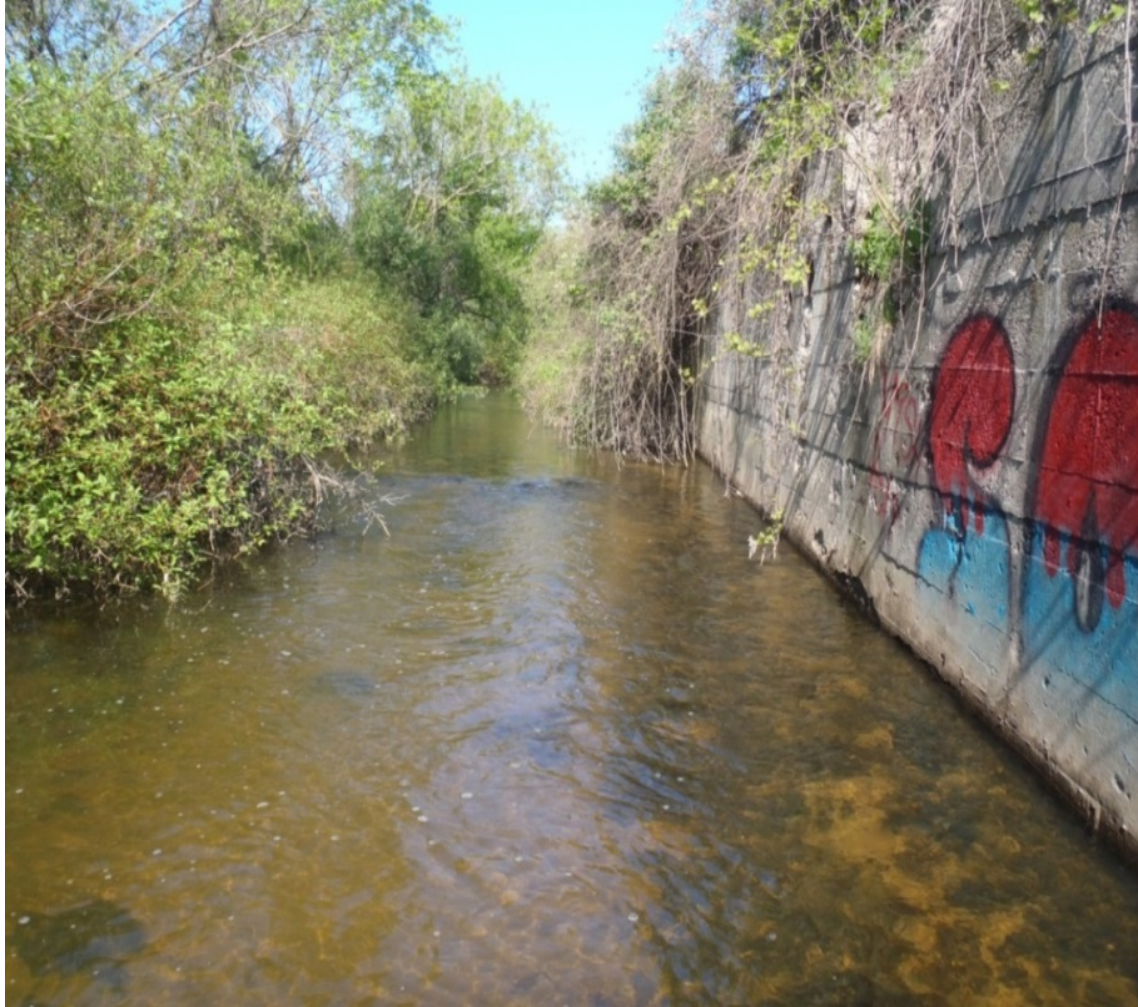
Figure 16. Station 5 of Indian Mill Creek Watershed.

Station 5 (Figure 17) was located off Elizabeth Avenue, 1 Km from the confluence of the Grand River (42.995708, -85.682006 [WGS 1984]). The north bank of Station 5 was a concrete wall and the south bank had some riparian shrubs. The velocity of the water was moderate at this site during all of our field visits and the substrate consisted of rocks and coarse gravel imbedded with sand.

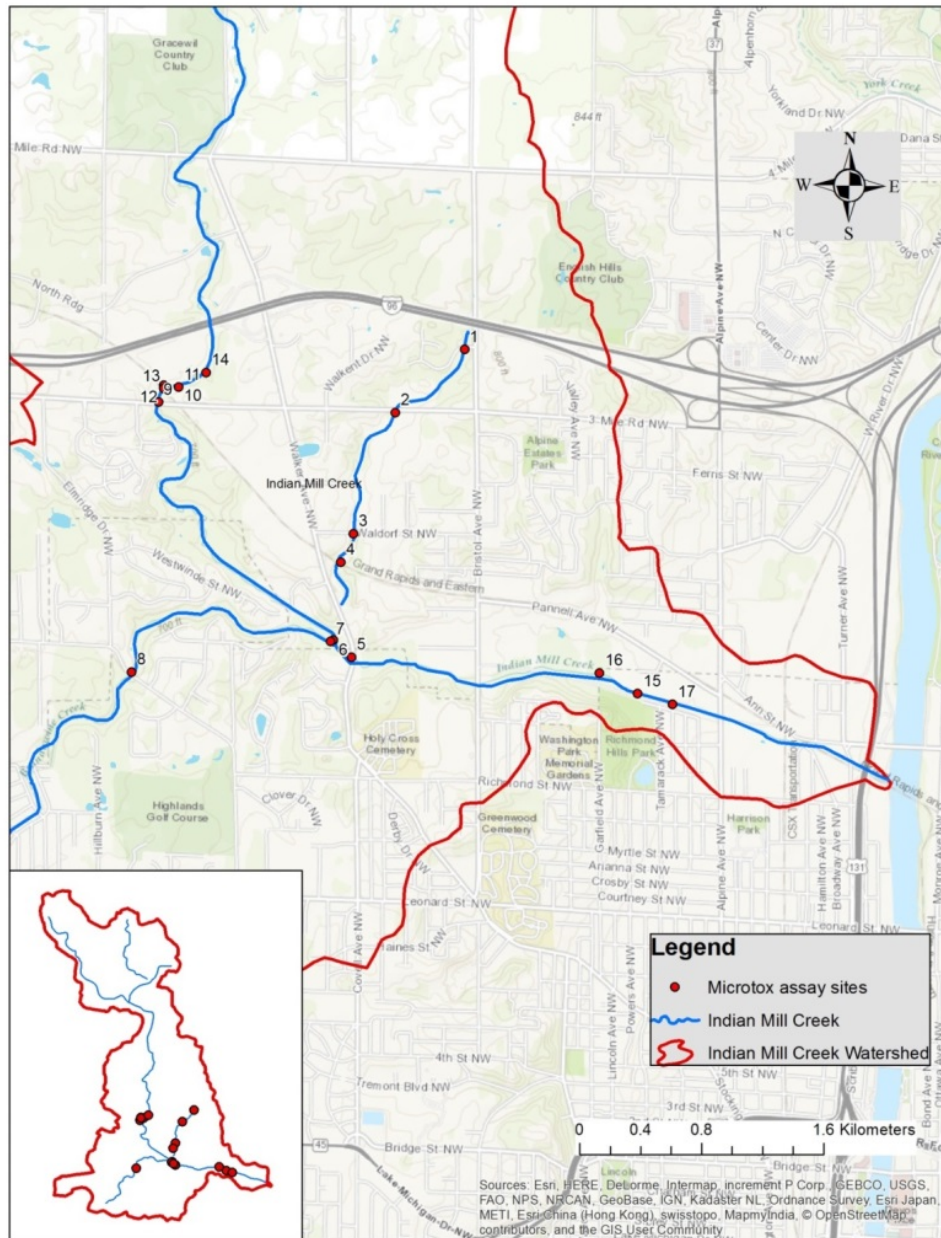
Figure 17. Microtox toxicity assessment sites in Indian Mill Creek Watershed (2016).

Eighteen sites were used for the Microtox assessment of stormwater toxicity (Figure 18).

Eighteen different sites of Indian Mill Creek were assessed using Microtox assay. Station 3, Station 4, storm drains, the main channel of Indian Mill Creek, Brandywine Creek, and Walker Ditch were included in the study sites. The assay does not show any toxicity in the main watercourse of Indian Mill Creek, however, the seeps and stormwater drains might contain toxic chemicals (Table 10) as toxicity was detected.

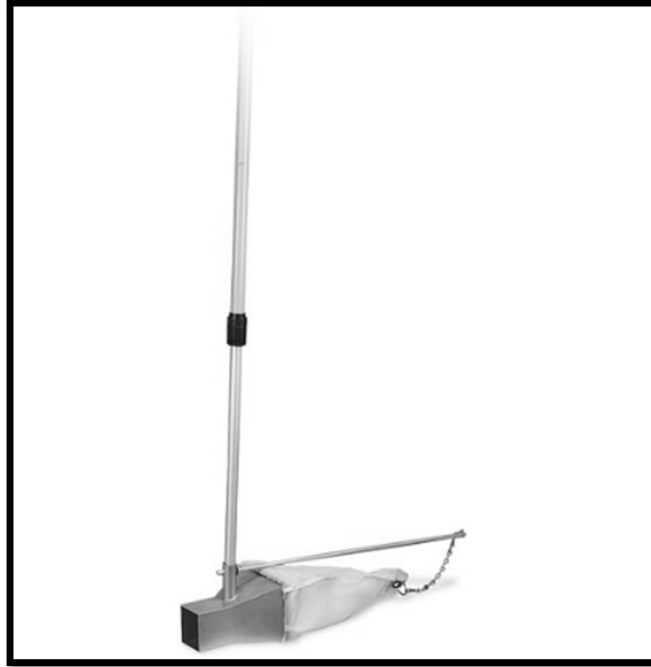
Figure 18. Helley- Smith bedload sampler.

Sediment transport occurs in streams as suspended material and as bedload. The suspended sediments are transported at the same velocity of the fluid (Vanacker, 2014) whereas bedload travels by rolling, siltation or through sliding. The Helley- Smith bed load sampler (Figure 10) is designed to collect bedload in a basket type sampler through pressure difference (Helley-Smith, 1971). The sampler consists of a frame, sample bag and a nozzle. Bunte et al. (2008) studied

transport rates in eight sites in coarse bedded Rocky Mountain stream using Helley- Smith bed load sampler. They found that the sampler is very effective in capturing fine gravel, even less than 4 mm. Emmett (1980) also studied the Helley Smith bed load sampling efficiency and concluded that the sampler has a near-perfect sediment trapping efficiency for the particles sizes between 0.50 to 16 millimeters. Similarly, the sampler also had a high efficiency for the particles smaller than 0.50 millimeters in their research.

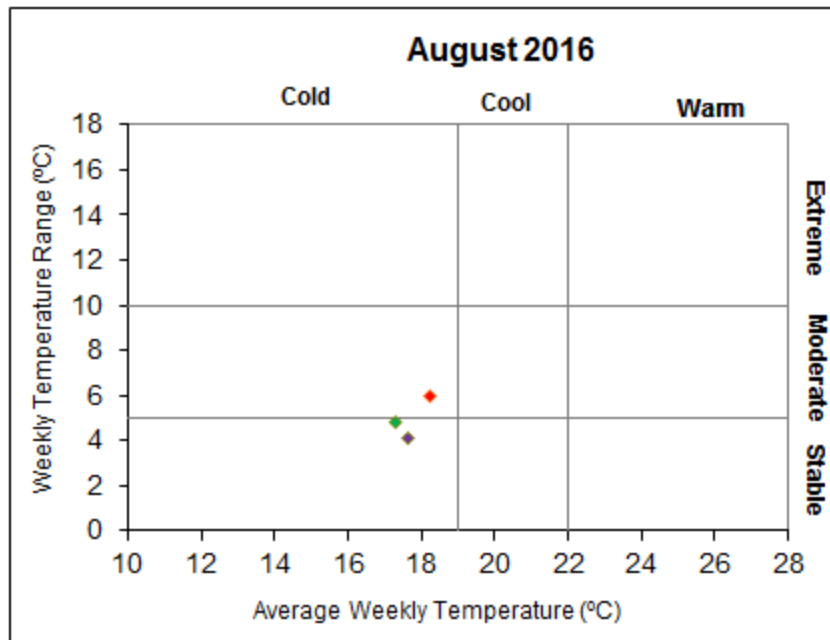
Figure 19. Average weekly temperature of Indian Mill Creek- July and August 2016. Site 2 ♦, Site 3 ♦, Site 4 ♦

In the month of July, Station 2 had the highest average weekly temperature of 17.71°C (Figure 21). Station 3 had the average weekly temperature of 16.68°C and Station 4 had average weekly temperature of 16.98°C. Both the Station 2 and Station 3 had an average weekly temperature fluctuations range above 5°C (5.95°C and 5.21°C, respectively). Station 4 had an average weekly temperature fluctuation range below 5°C (4.08°C). Similarly, Station 2 had the highest mean weekly temperature in August 2016 with 18.24°C. Mean maximum weekly temperatures at Station 3 and Station 4 were 17.29°C and 17.63°C, respectively. Station 2 had the highest weekly temperature fluctuation range among all sites with 5.97°C. Both the Stations 3 and

Station 2 had average weekly temperature fluctuation range below 5°C (4.82°C and 4.08°C, respectively).

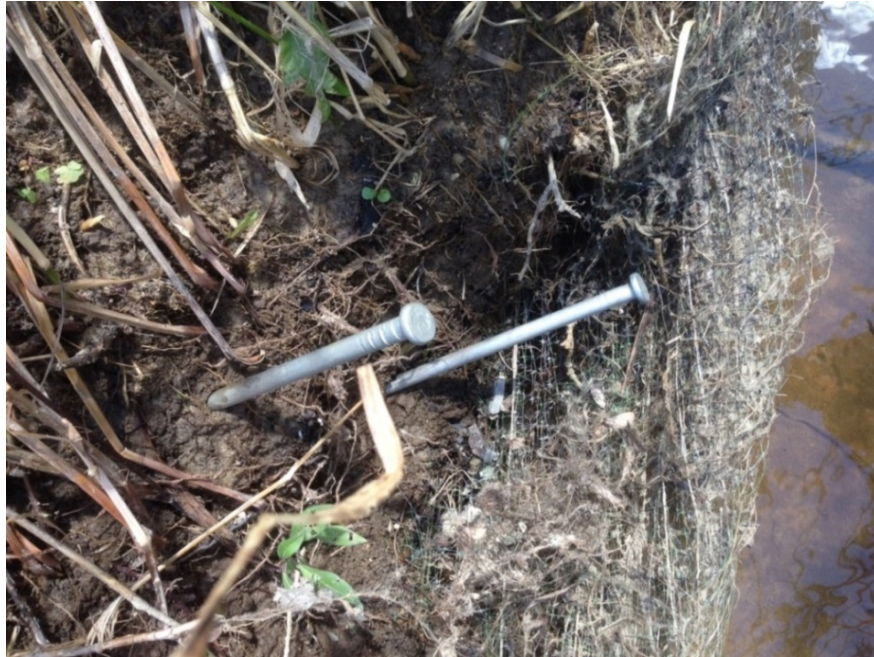
Figure 20. Exposed erosion pins at Station 3.

Station 1 had very little degradation (Table 5) as the scour chains were still exposed. Station 2 had both erosional and depositional zones indicating that the creek was trying to shift its course. Scour chain results the highest aggradation rates at Station 3 and Station 4.

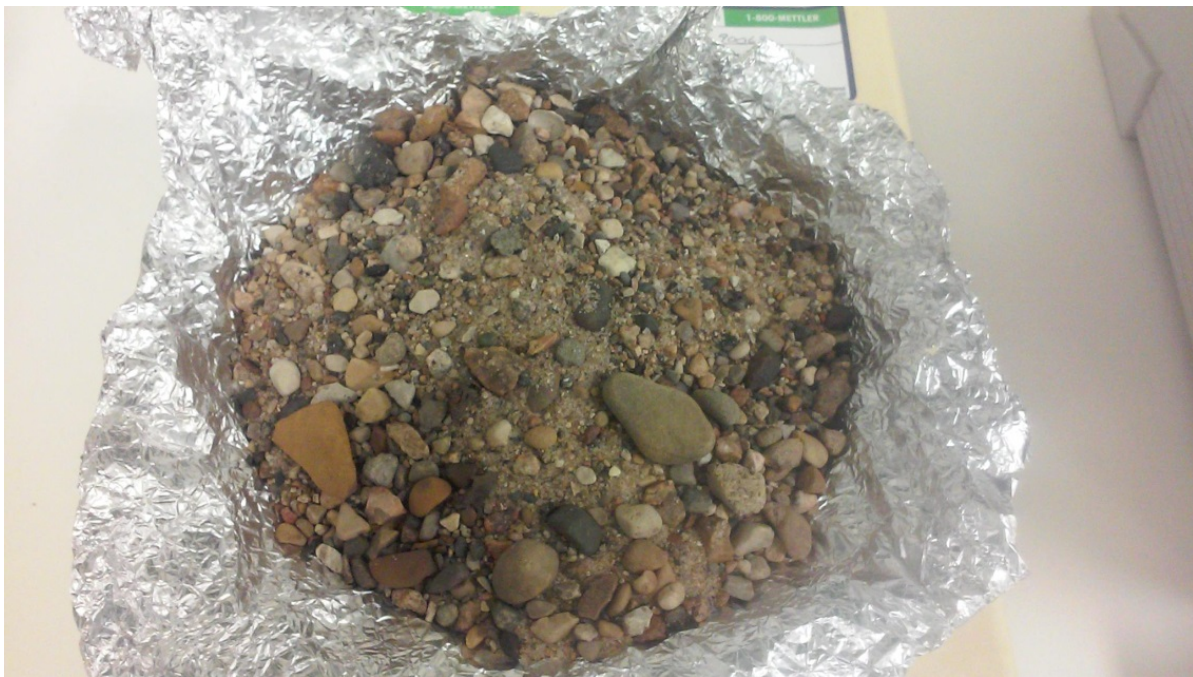
Figure 26. Bedload of Station 4 of Indian Mill Creek (September 8, 2016).

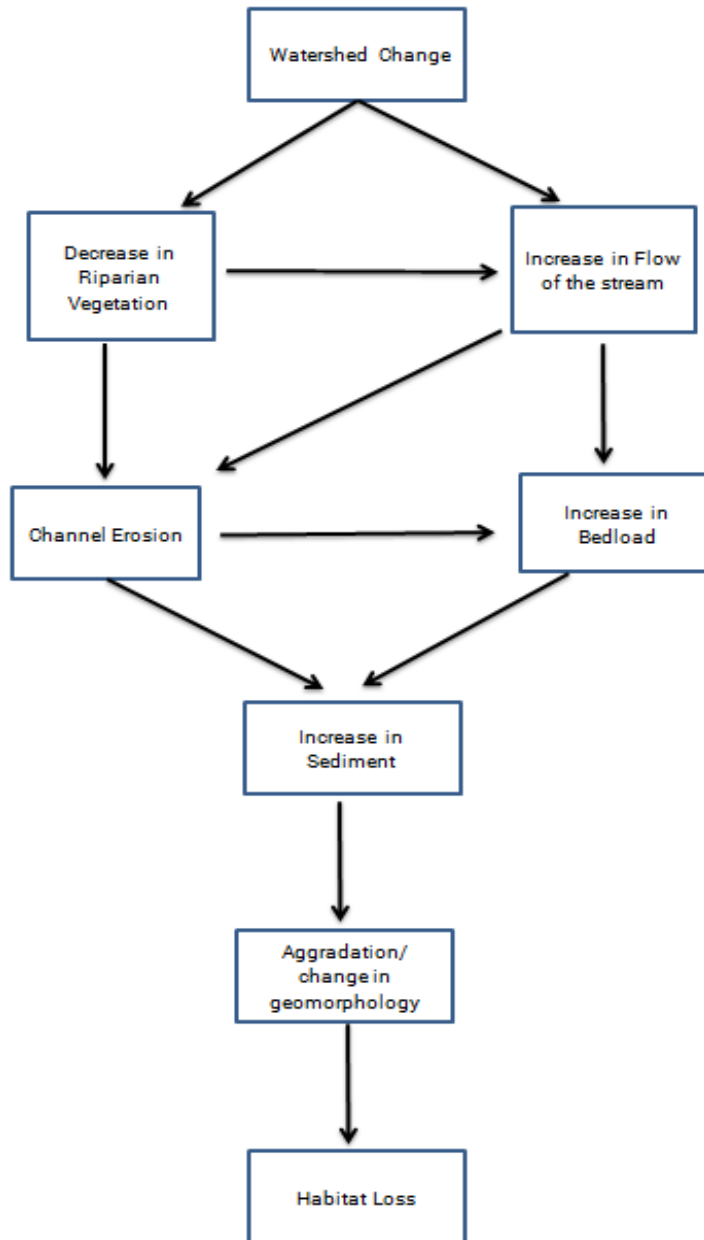
Figure 28. Schematic diagram of factors leading to habitat loss in Indian Mill Creek.

The habitat survey also showed there were several breaks in riparian vegetation along the bank of the creek at Station 3, Station 4 and Station 5, which could destabilize hydrology and increase sediment inputs resulting in impairments to benthic macroinvertebrate and fish communities (Meyer et al., 2005). Similarly, the channel sinuosity was reduced significantly to drain agricultural land and enhance stormwater removal. Urbanization and impervious surfaces alter stream hydrology and habitat resulting in a common pattern of impairments referred to as
