Collaboration in Remediation Practices using Geophysics and Soil Sampling

Mike Law, DMT Geosciences Ltd.
Tamara Tiessen, Stantec Consulting Ltd.
Margot Ferguson, Envirosearch Ltd.
Monica Brightwell, ATCO

5/25/2022 Calgary, AB

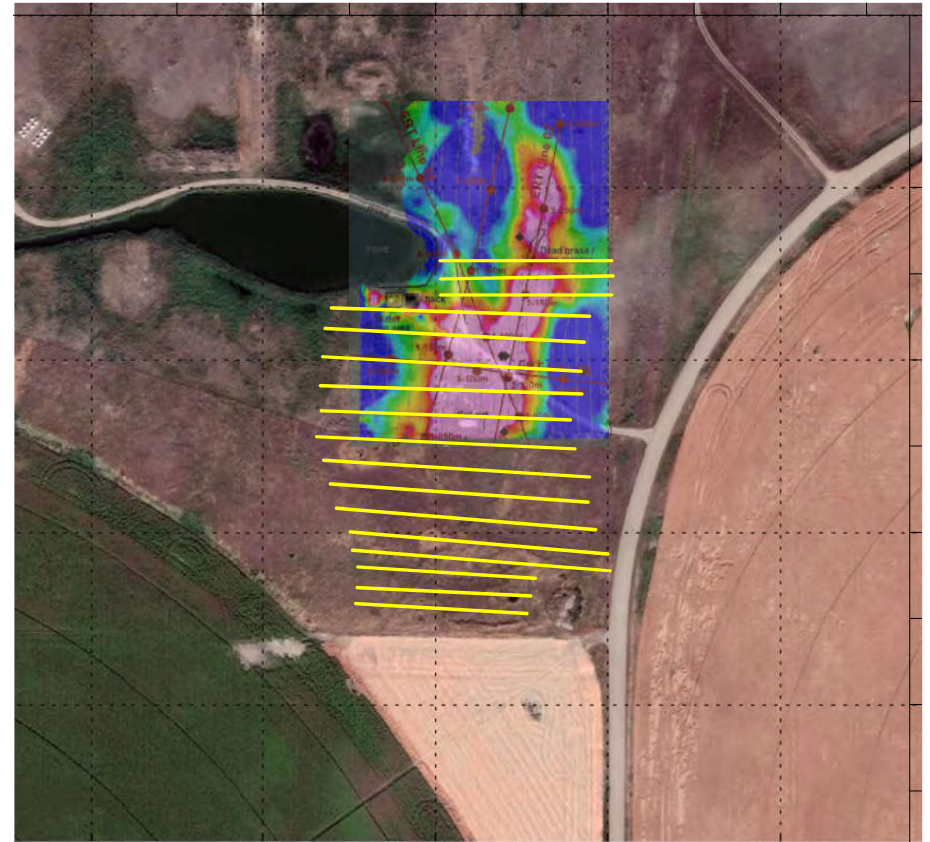
- Previous EM31 results shows lateral delineation
 - No vertical delineation...
- Rapid Conductivity Volume (RCV) survey to cover lease area and delineate down to approx. 20 mbgs

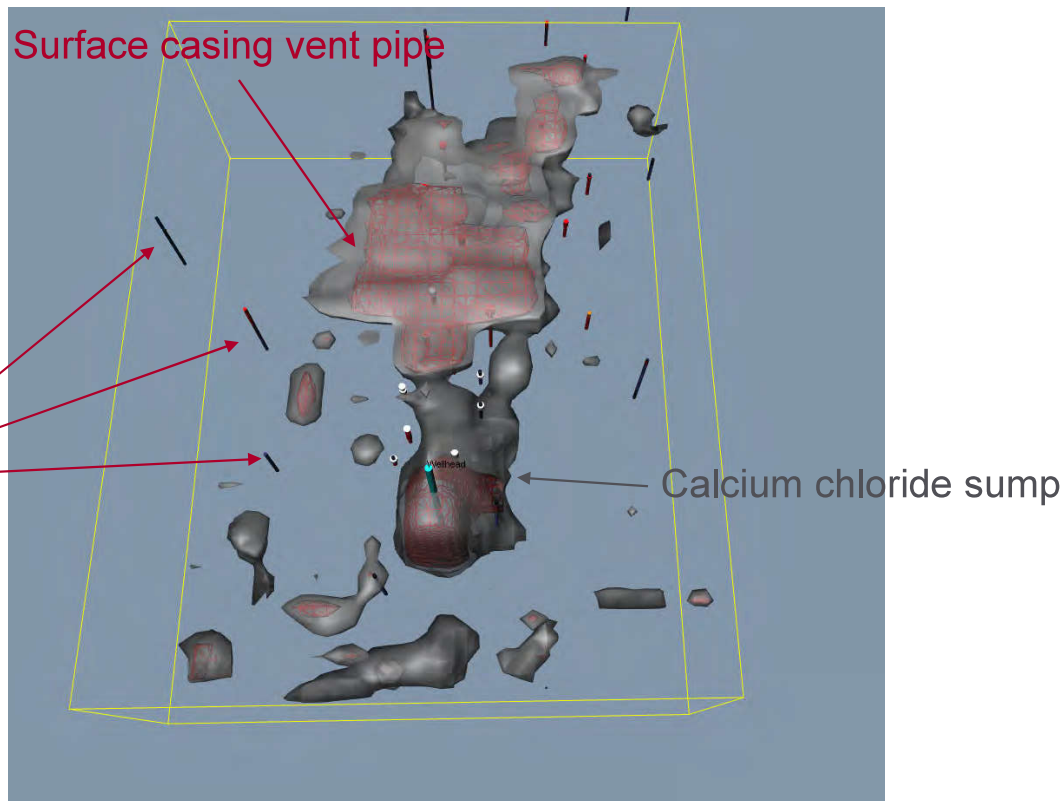
- **Two different contaminant sources identified:**

- Well center and Calcium Chloride Sump (deep)
- Surface casing vent pipe (shallow)

- **Boreholes shown:**

- 2021 sampling Program to target geophysical anomalies

- **2021 Sampling program showed good correlation with the RCV survey – geophysics can be used for salt impact delineation and volume estimation (with care)**
- **Two main sources identified:**
 - Well center and calcium chloride sump → deeper impact
 - Surface casing vent → shallower impact
- **Concerns for closure:**
 - Deep impacts have possible implications for domestic water well use and river
 - Shallow impacts have possible implications for ecological receptors (i.e. plant-rooting zone and irrigation lagoon)

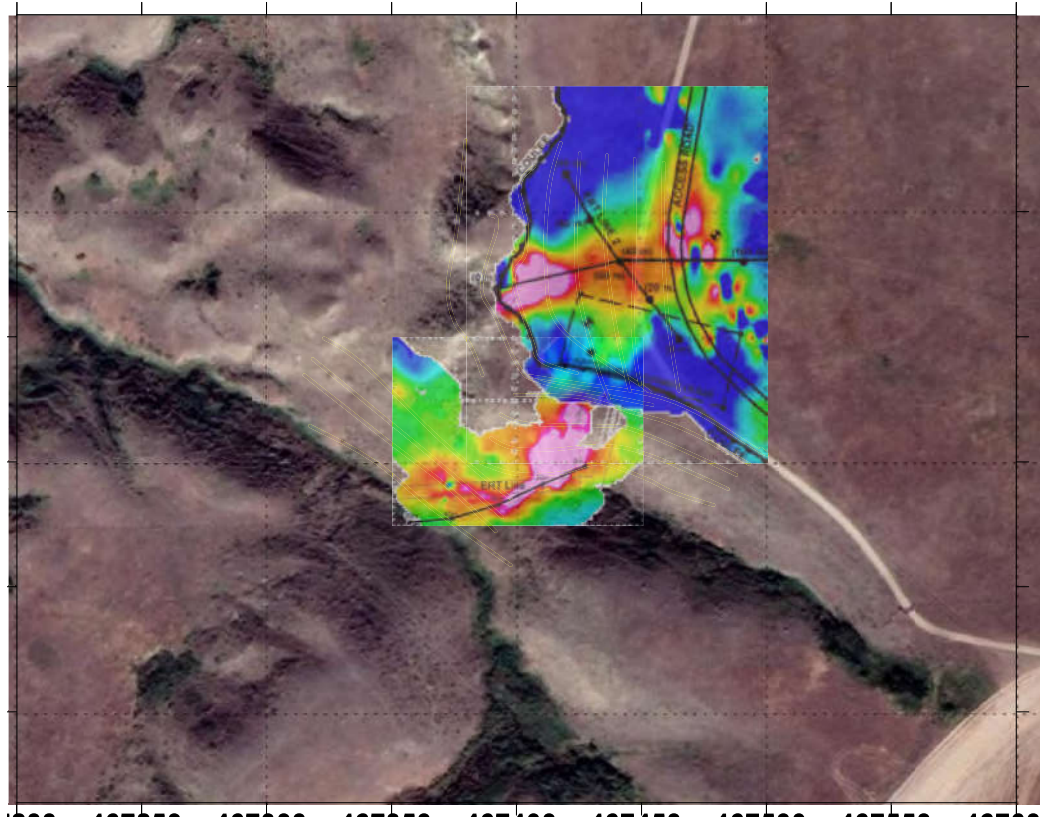
- EM31 surveys show impacts near the surface

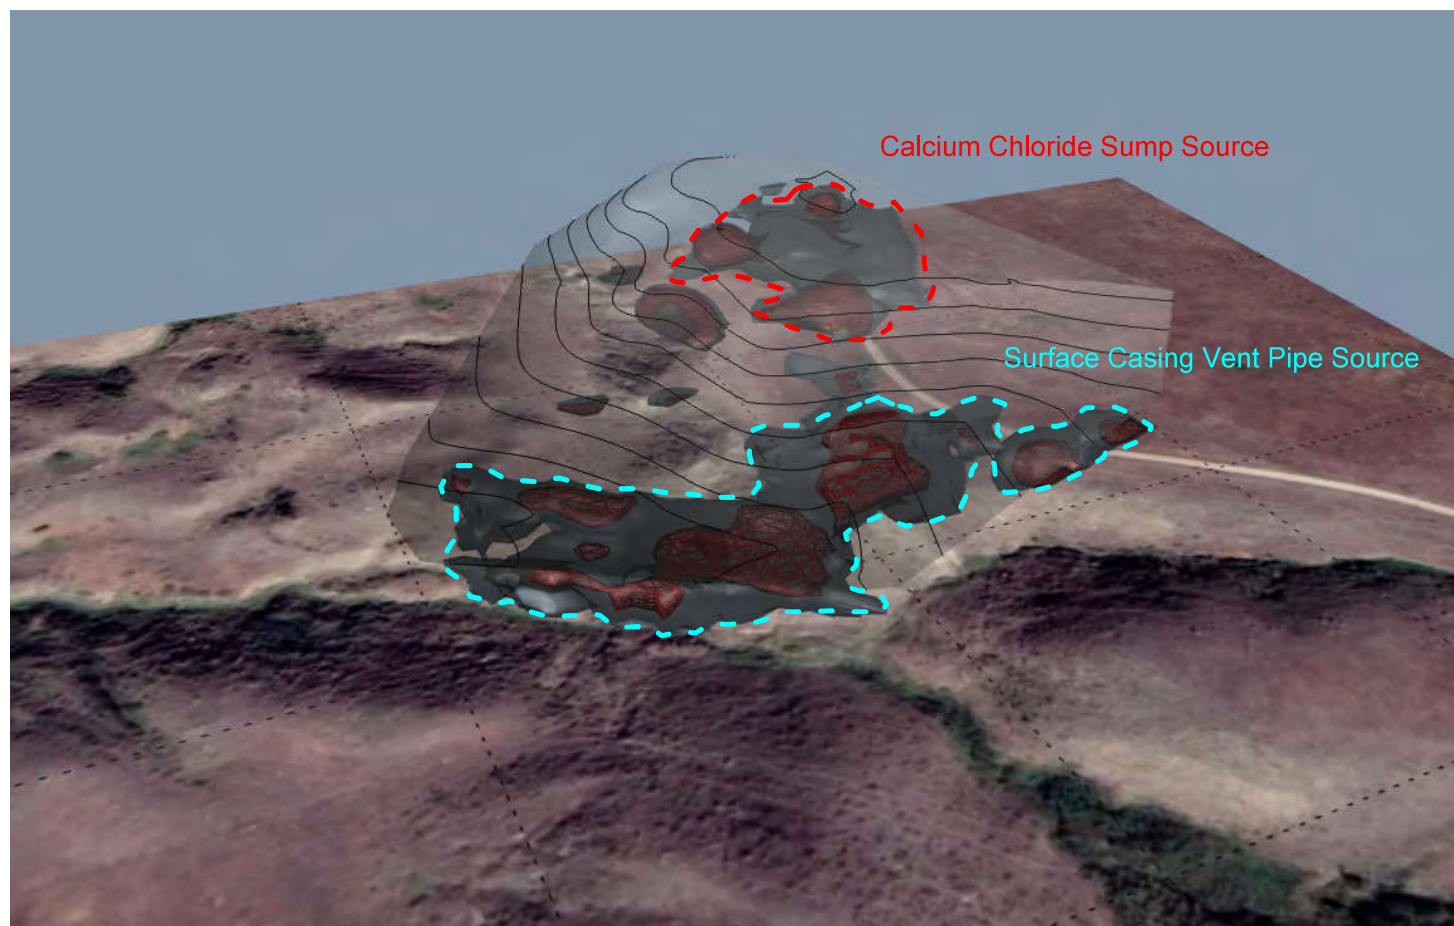
- **Two different sources mapped:**
 - Calcium chloride sump
 - Surface casing vent pipe

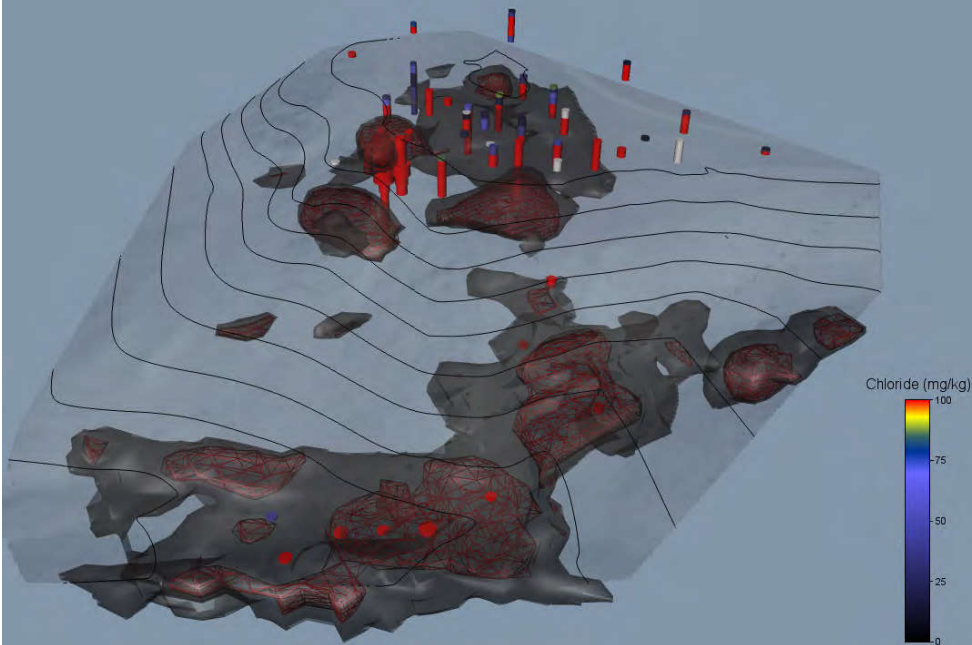
Pre-2021 borehole sampling

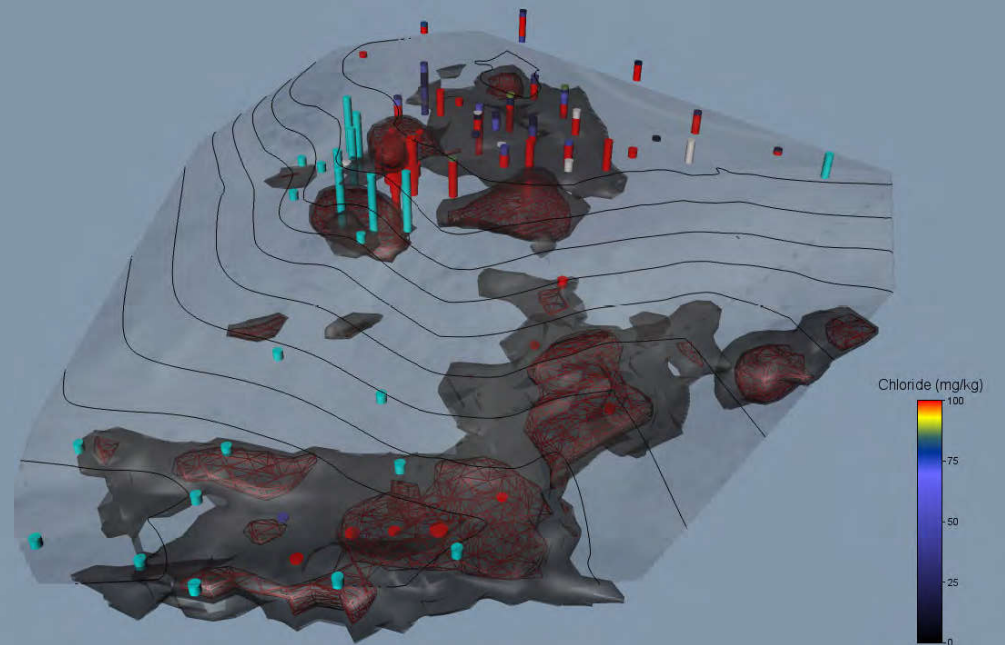
Planned borehole sampling

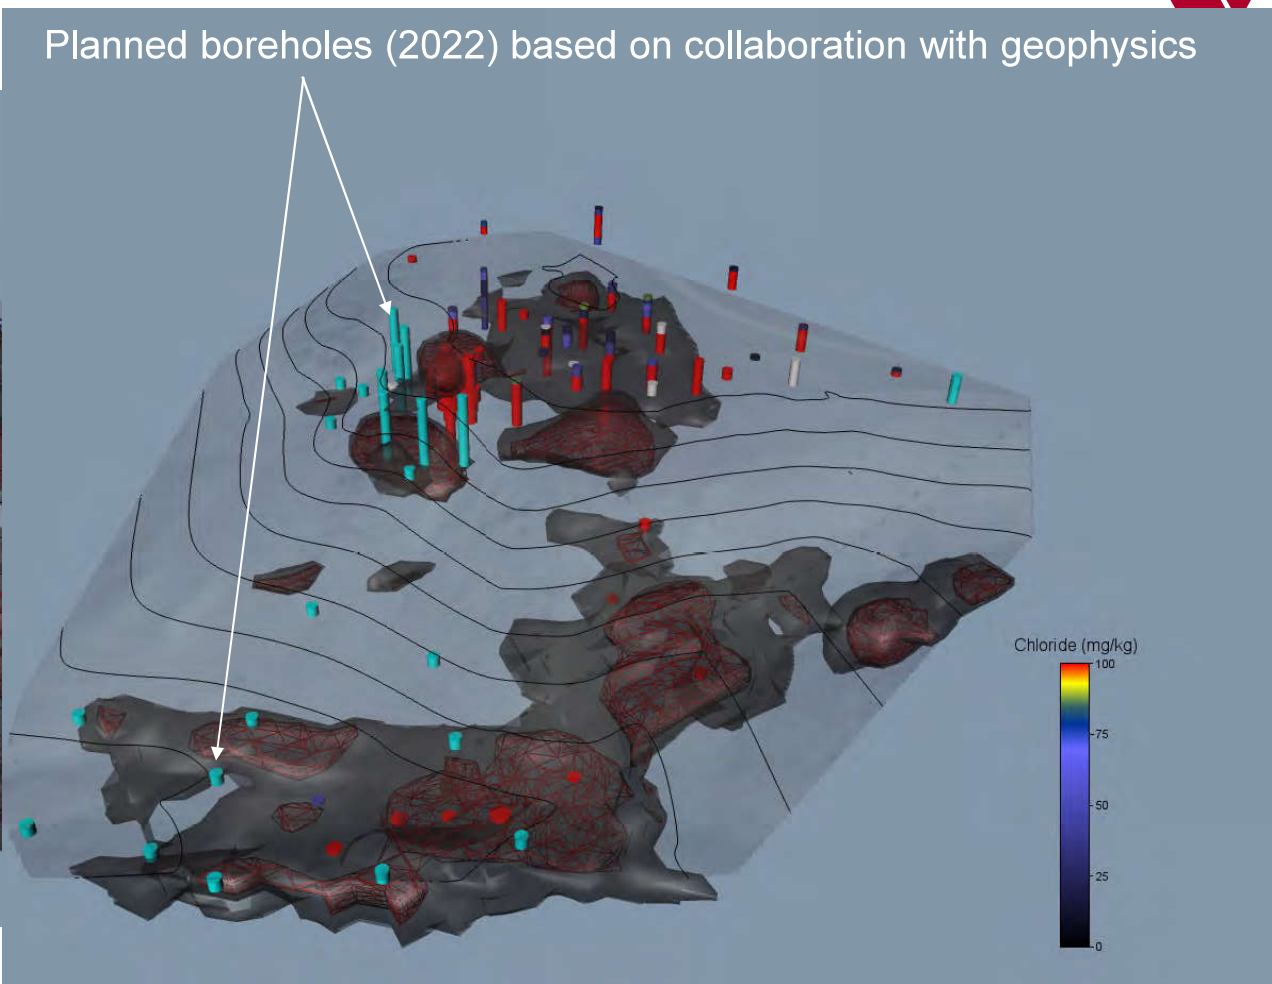
Planned boreholes (2022) based on collaboration with geophysics

- Pre-2021 sampling showed good correlation with the most recent geophysical program → geophysics relied on heavily for impact delineation
- Planned borehole samples (shown in cyan) are targeted based on the pseudo-3D model, improving efficiency and cost effectiveness of the sampling strategy
- Geophysics aids with complicating factors:
 - Sensitive vegetation and wildlife – sweeps required every survey
 - Pre-contact stone circles limit the sampling area
 - Steep topography limits the ability to sample deeper (i.e drill rig)
