The Fatal Engineering Flaw Behind the Deadliest Building Collapse in U.S. History

PMI popularmechanics.com/science/a37180943/hyatt-regency-collapse/

Aug 10, 2021

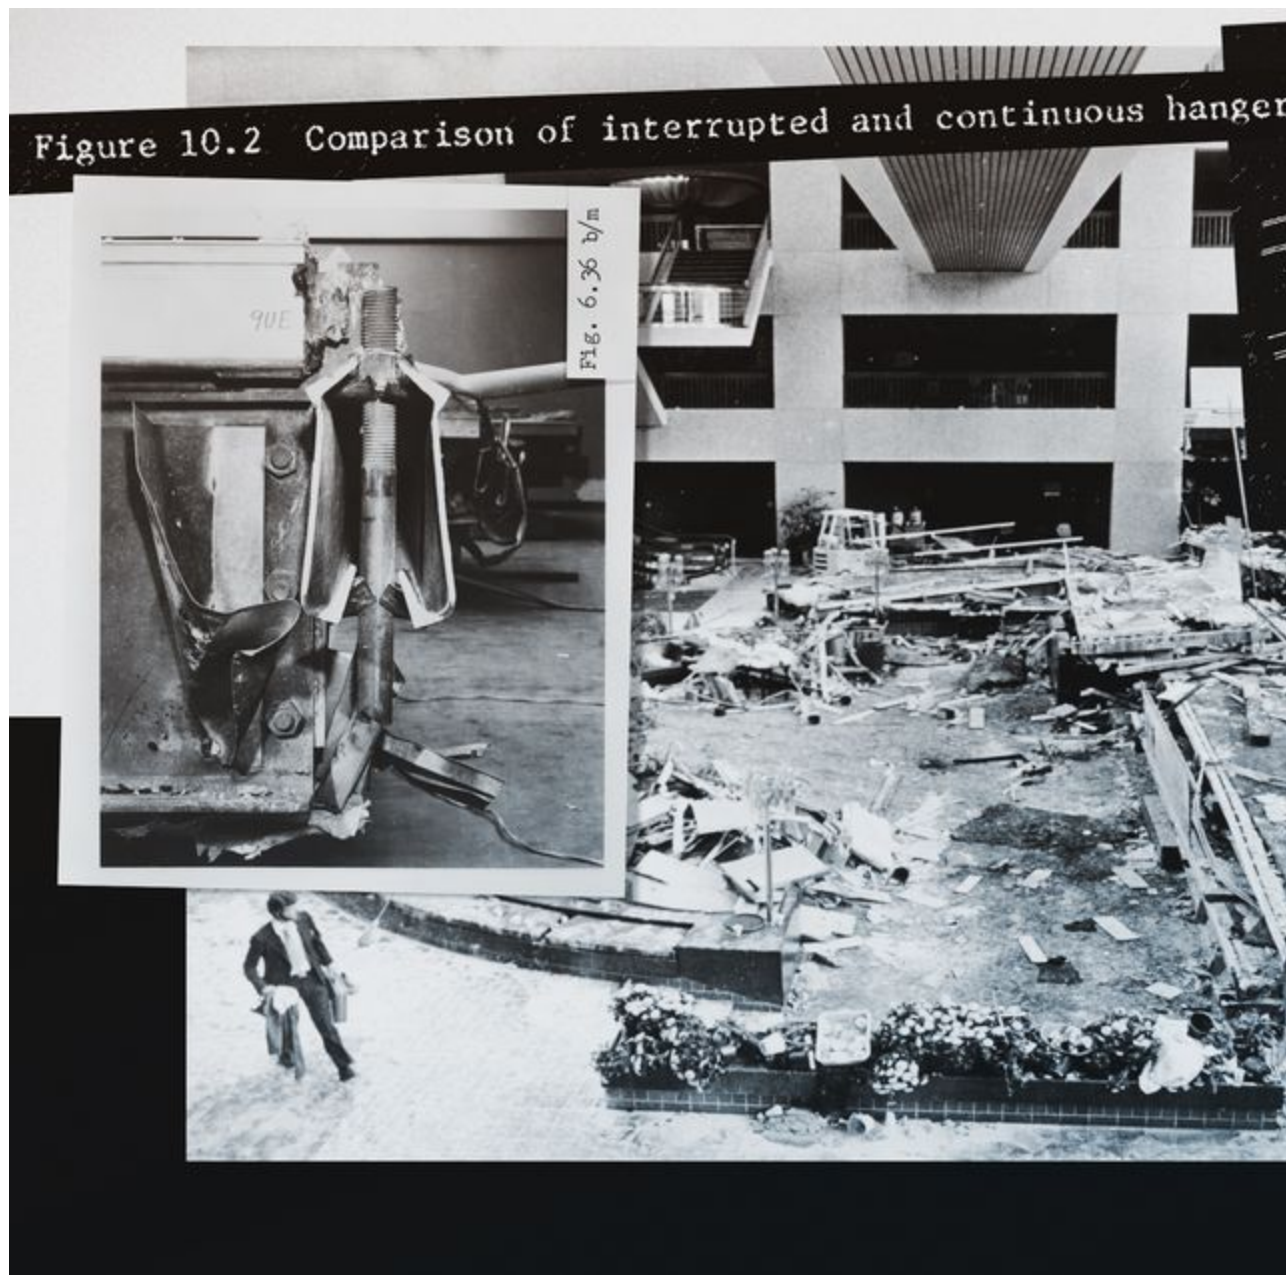
Created by Jesse Southerland using AP Photo and Courtesy Dept of Commerce

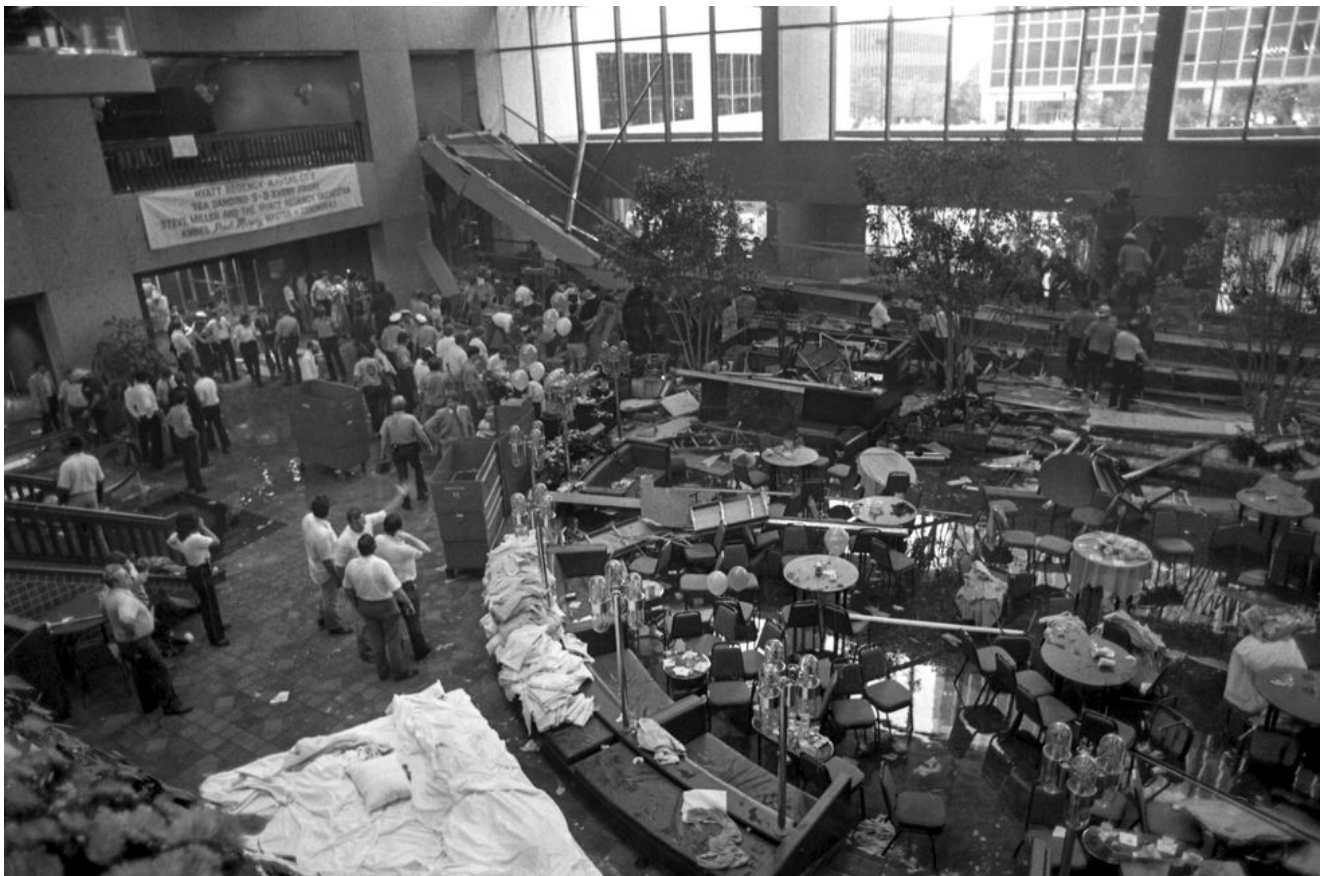
The walkways collapsed onto the lobby of the Hyatt Regency hotel during a Friday night tea dance.

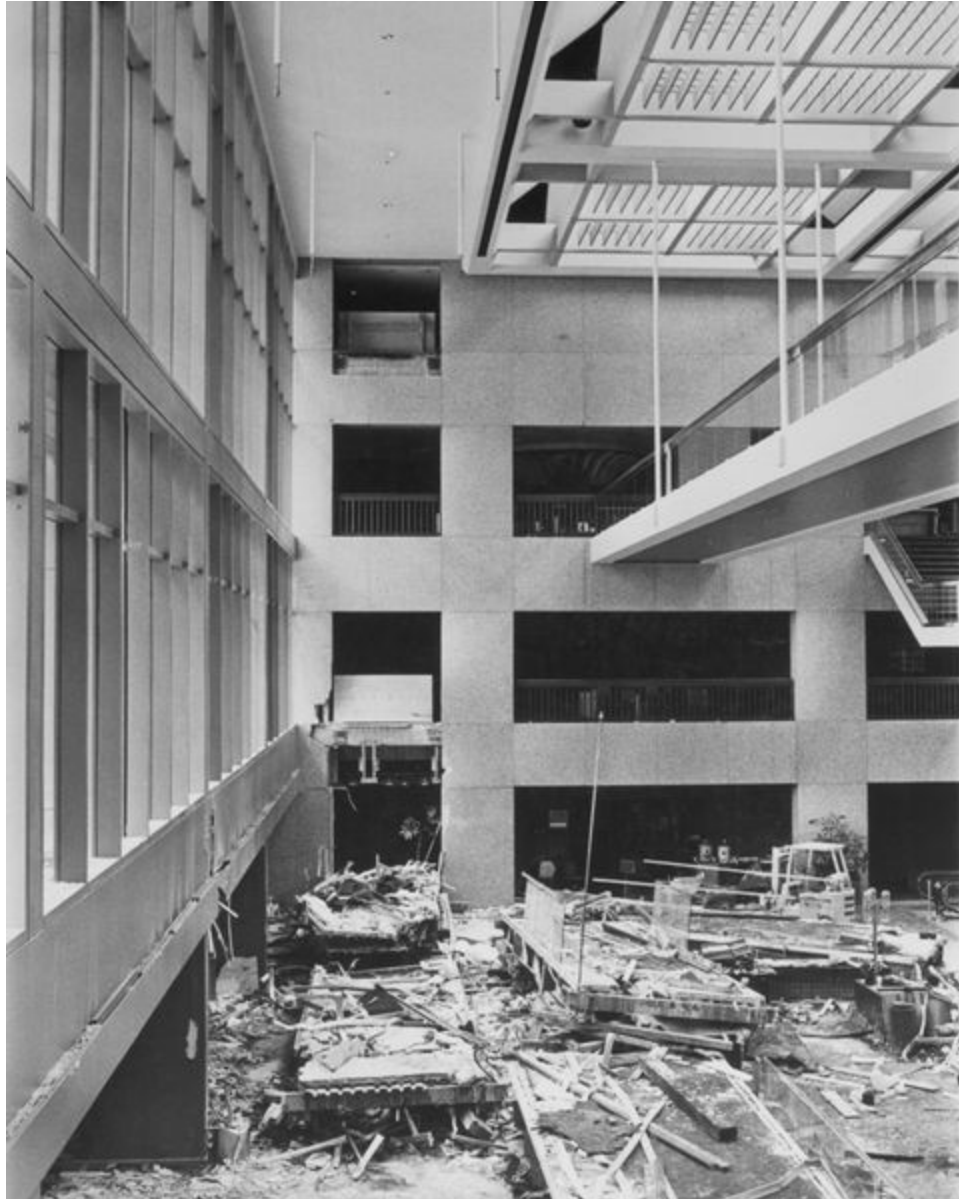
The area where the second- and fourth-floor walkways had been, one hanging directly above the other. The third-floor walkway, still intact, hangs on the right.

Breaking through the supports that anchored it to the ceiling, the fourth-floor walkway plummeted 30 feet and slammed into the second-floor walkway, which then collapsed and fell to the floor.

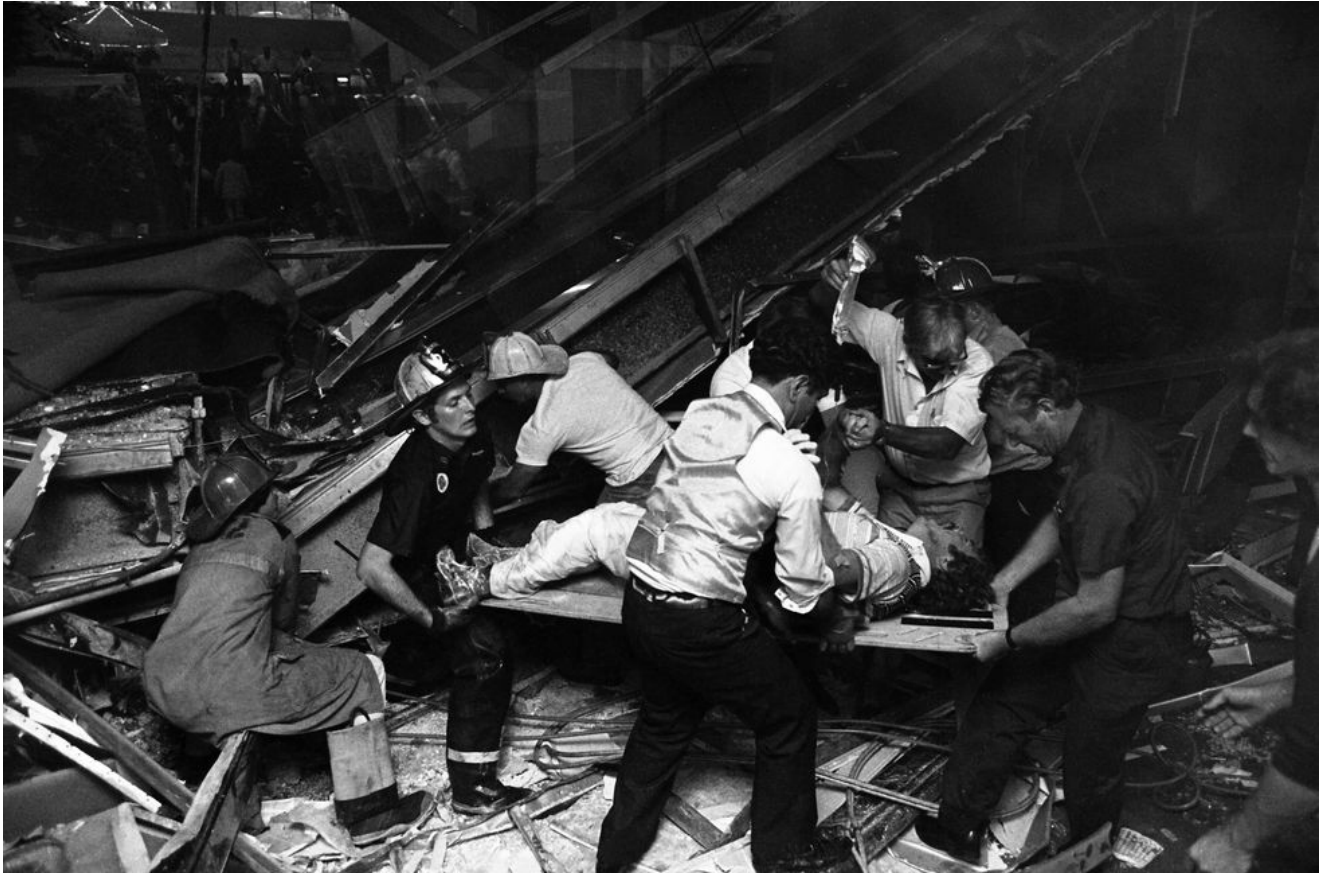
Firefighters rescue people from under a collapsed walkway.
Bettmann/Getty Images

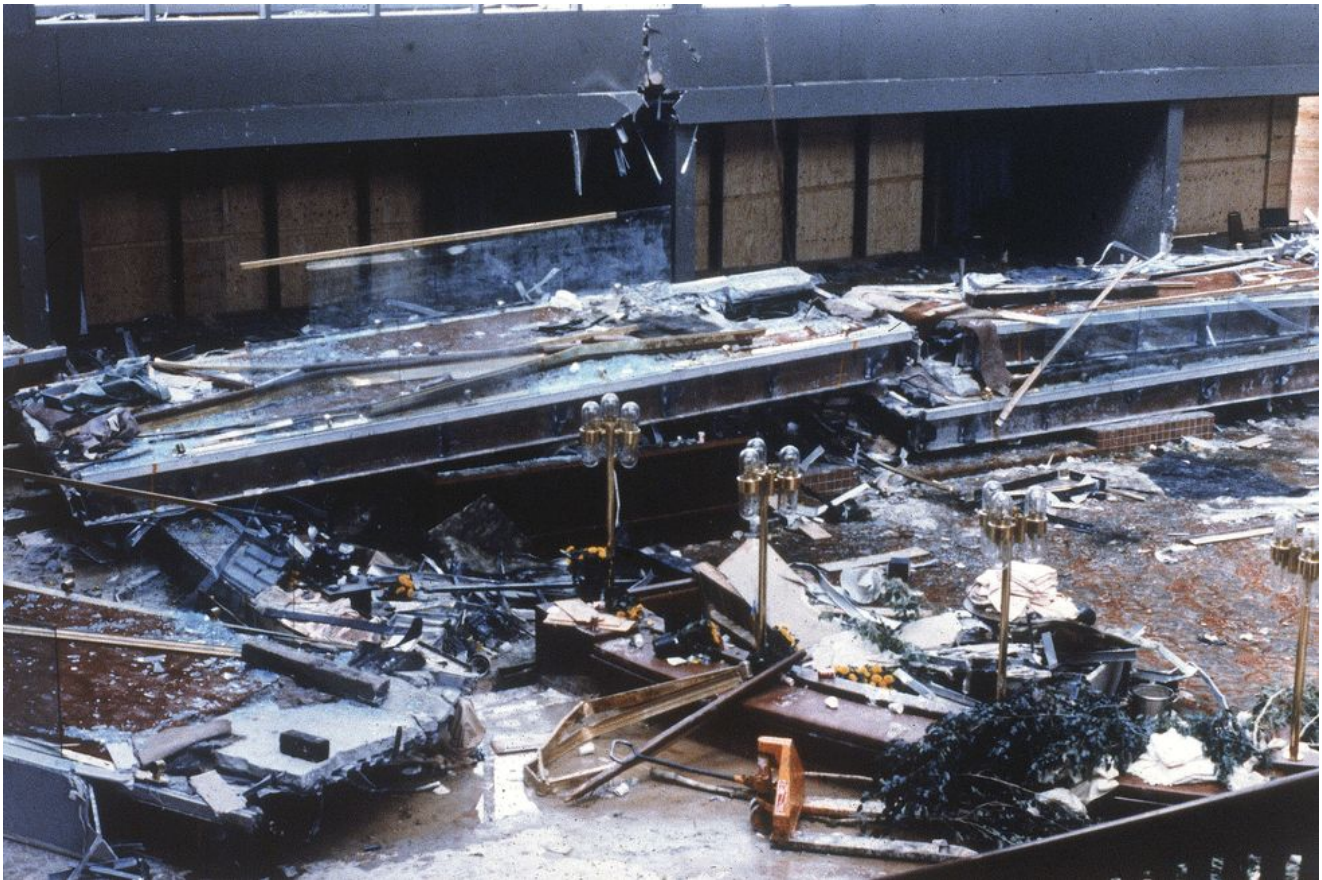
Wreckage of the walkways in the hotel lobby.
AP Photo/Pete Leabo

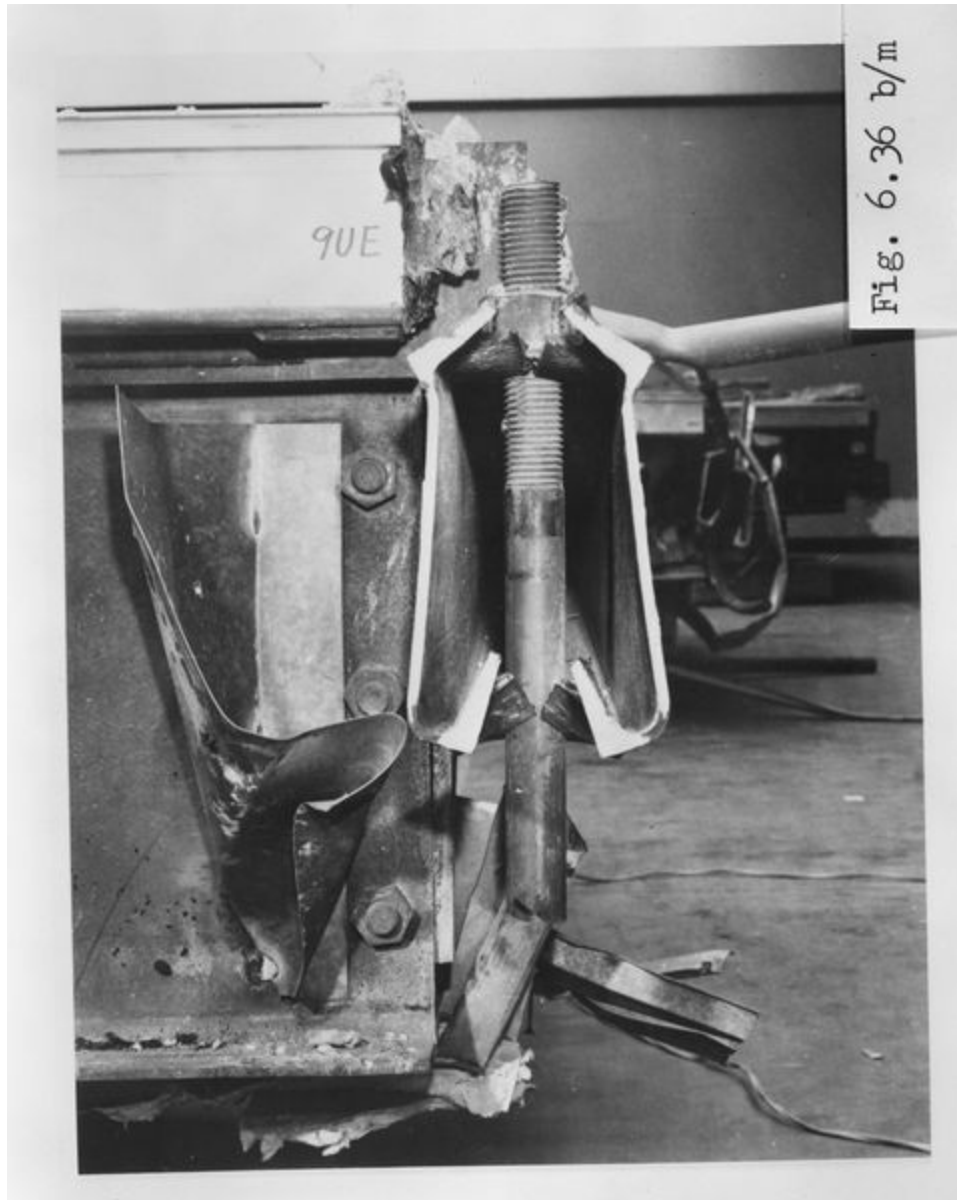
A front view of a beam section from one of the collapsed walkways.
Department of Commerce. National Bureau of Standards/National Archives

On the night of the collapse, one of the nuts on the middle box beam on the underside of the fourth-floor walkway finally pulled through the weld of the steel flanges. The load on the rod was so heavy that the nut made the walls of the channel cave in.
