Wandsworth Common Management and Maintenance Plan

Volume 1: Understanding Wandsworth Common

Prepared by LUC in association CFP, Bosky Trees, SYSTRA and Rees Bolter Architects

September 2019

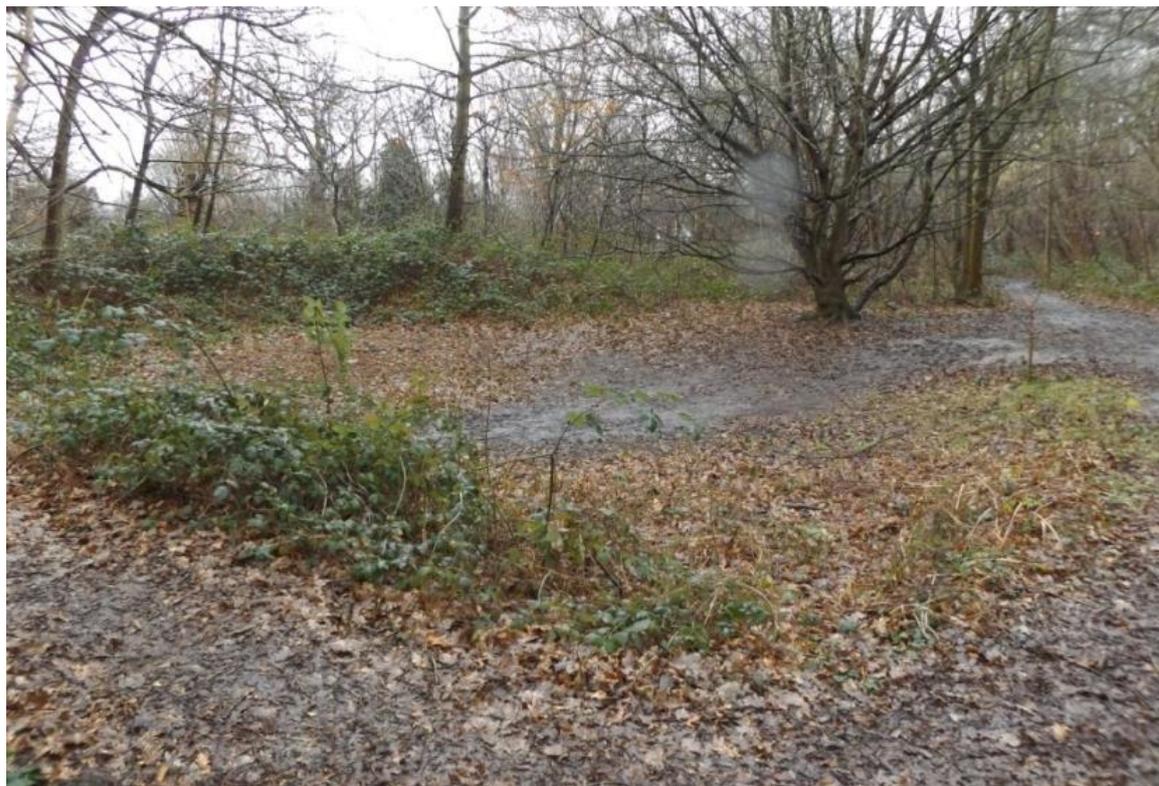
Figure 7.1 Ephemeral pond in The Scope

- 7.12 The only water-features on the Common today are the ornamental lakes west of the railway, the Three Island Pond beside Bolingbroke Grove and two ephemeral features; a small ephemeral pond in The Scope (at the time of the site visit in January 2018, this was empty of water), and an extension to the north of the ornamental lakes for amphibians in 2000.

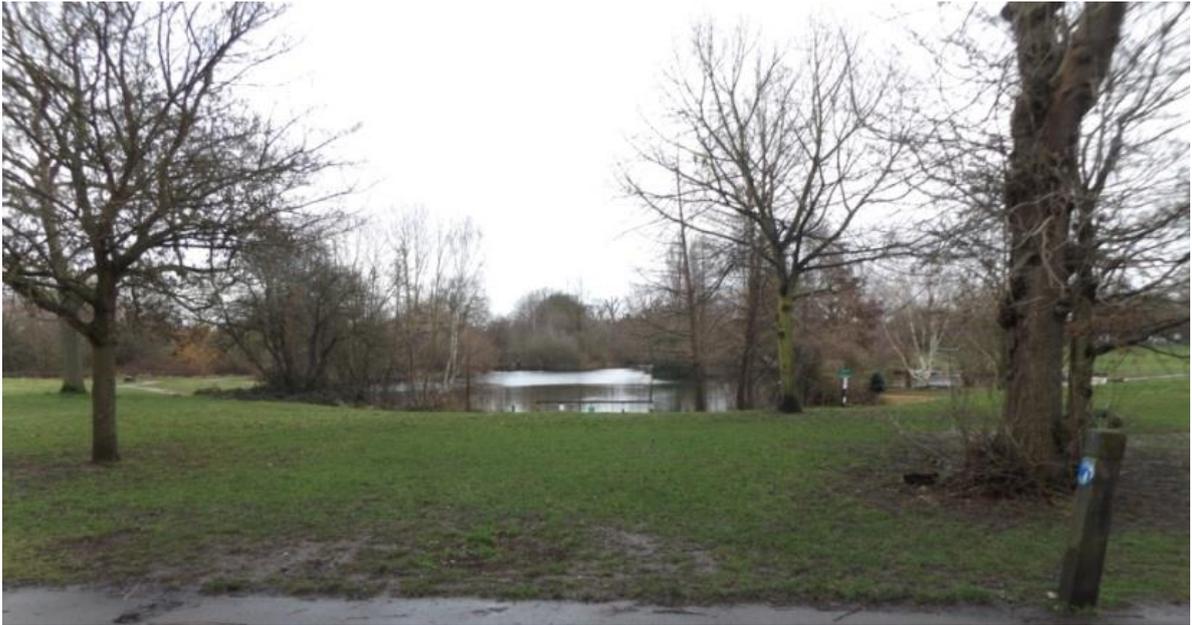
Figure 7.3 Fishing lake viewed from the east

- 7.16 The ornamental lakes (the wildlife and fishing lakes) at the centre of the site have no formal water-feed and in the absence of any other obvious source can only be presumed to therefore be in some degree of connection with the local water table. The water level in the lakes fluctuates in response to the longer-term weather pattern, indicating that it is responding to groundwater rather than surface run-off.

- 7.17 The lake level is allowed to drop from its wet-weather level by up to 10" in drier periods before the Council tops the pond up using a mains feed. This typically takes place three or four times a year and involves lifting the water-level back up by about 5-6" which corresponds to a level just below the overflow crest. Each fill takes about a day to complete.
- 7.18 During particularly severe wet weather, the wildlife lake has been known to overflow at the northern end, allowing water to flow along the adjacent path to a low point towards the railway footbridge and down onto the railway cutting (**Figure 7.5** overflowing water flows along path in background towards the left direction. Railway cutting is beyond the fence).

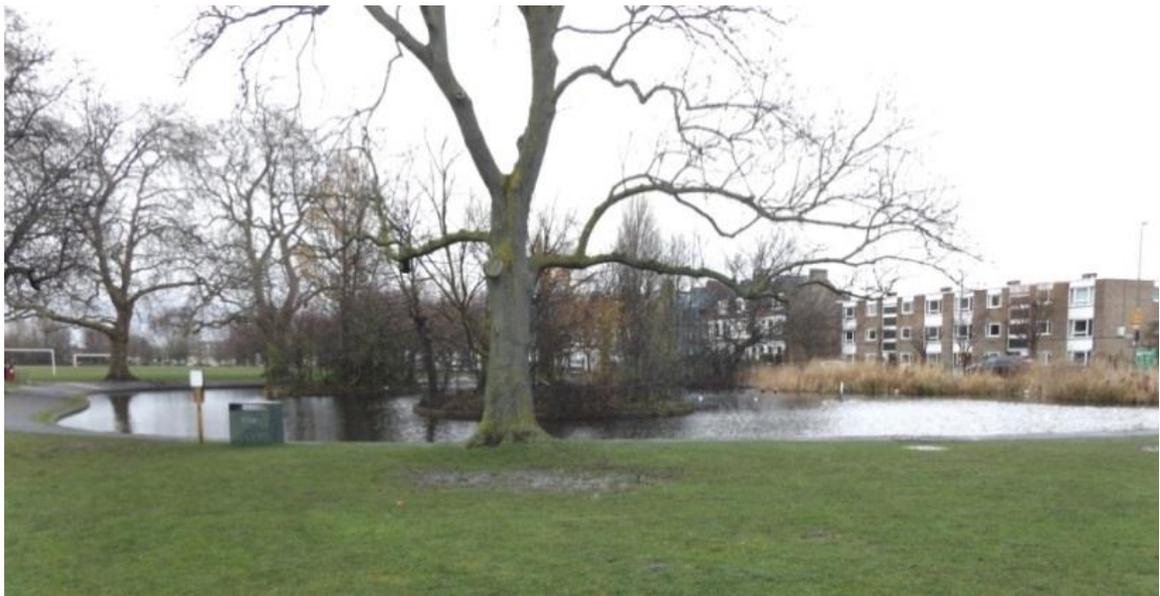
Figure 7.6 Three Island Pond

- 7.19 The Three Island Pond also has no apparent formal water feed, though there is an inlet believed to be from an old land-drain system serving some of the nearby pitches. The system's age is unknown and it is no longer reportedly effective. The pond is also believed to be effected by groundwater levels, although it has not known to overflow.

- 7.20 An aerator pump has been installed in Three Island Pond and runs continuously. Previous attempts to aerate the Pond (and the lakes) naturally using underwater vegetation have been

unsuccessful as it has been eaten by waterfowl. The Pond's water level drops in similar manner to that in the lakes in drier periods and requires occasional top-up from a mains feed.

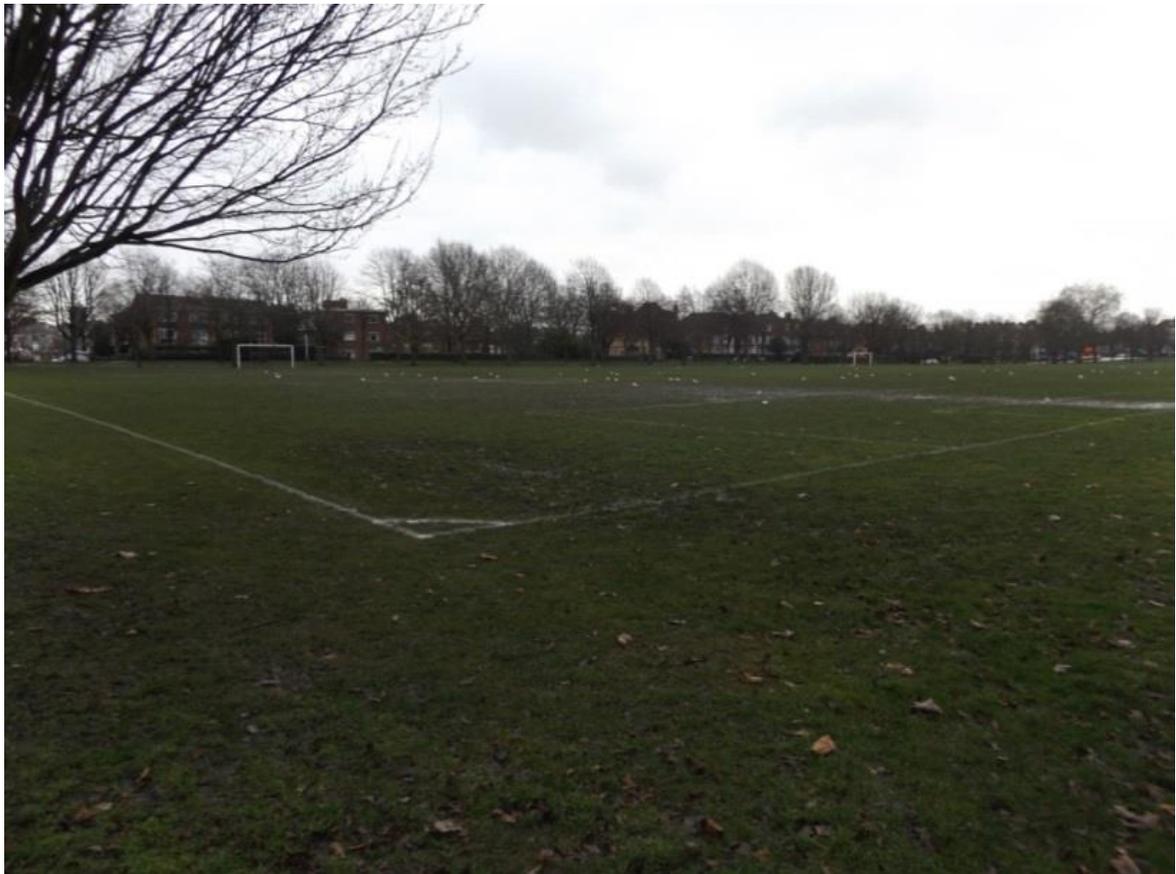
Figure 7.7 Bolingbroke Fields (southern section)

- 7.23 Two major sewers cross the Common, aligned broadly south to north and east to west.
- 7.24 The Bolingbroke Fields pitches are the main area of land-drainage problems on the Common, due to the need for maintaining usable playing surfaces on ground that, without improvement, is unsuitable for such intense use in wet weather. On average the pitches are deemed unusable for about four weekends every season but this varies if the weather is drier or wetter than usual. Drainage works were undertaken on the pitches during 2018. The effectiveness of this work will be monitored and if they prove successful further works will be undertaken if necessary.

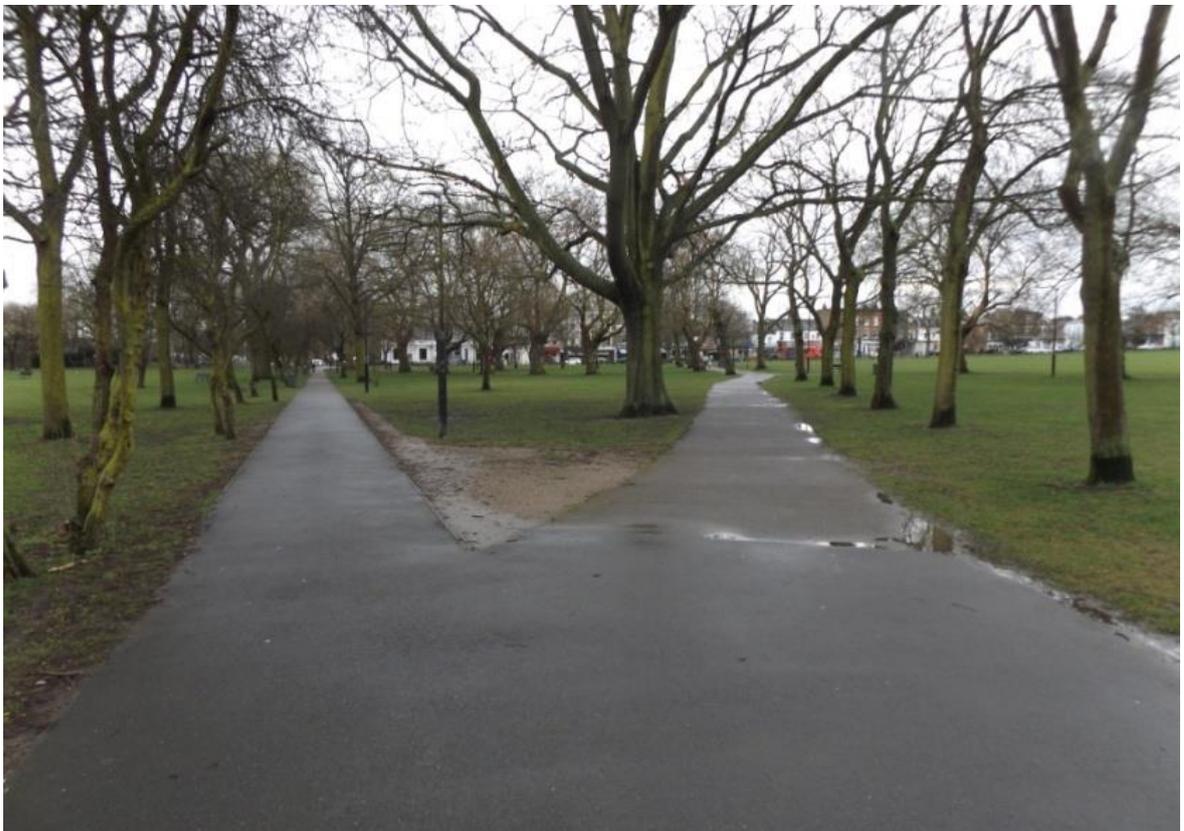
Figure 7.9 Footpaths near Bellevue Road showing typical marginal conditions

7.25 The margins to the various paths across the Common do not suffer greatly from run-off damage exacerbating soft ground.

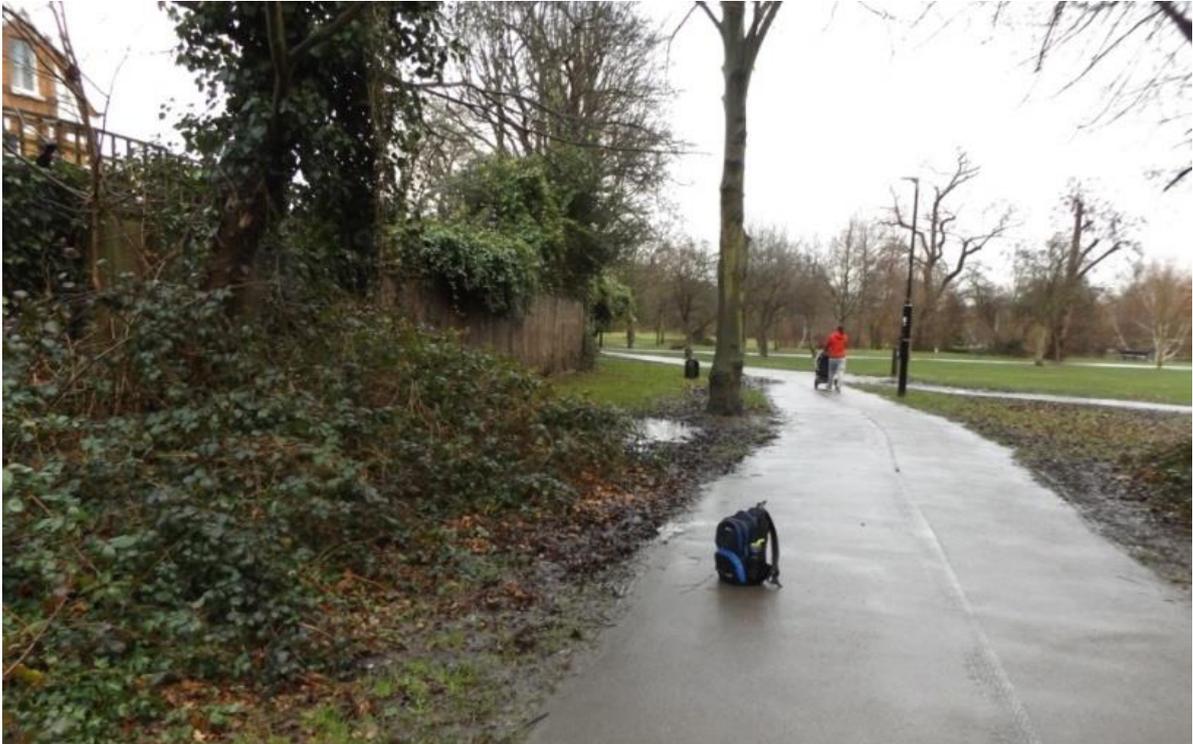
Figure 7.10 Location of waterlogged land

- 7.26 There is one location where marginal ponding and water-logging is a particular problem, to the point that it has generated occasional comments from local residents, beside a junction of paths behind housing at the corner of Routh Road and Baskerville Road. There is no obvious source of greater-than-usual run-off and it may simply be no more than the local path levels holding slightly more water back on the outer margin of the path surface that exacerbates waterlogging of the soil and/or a patch of soil that is locally less pervious.

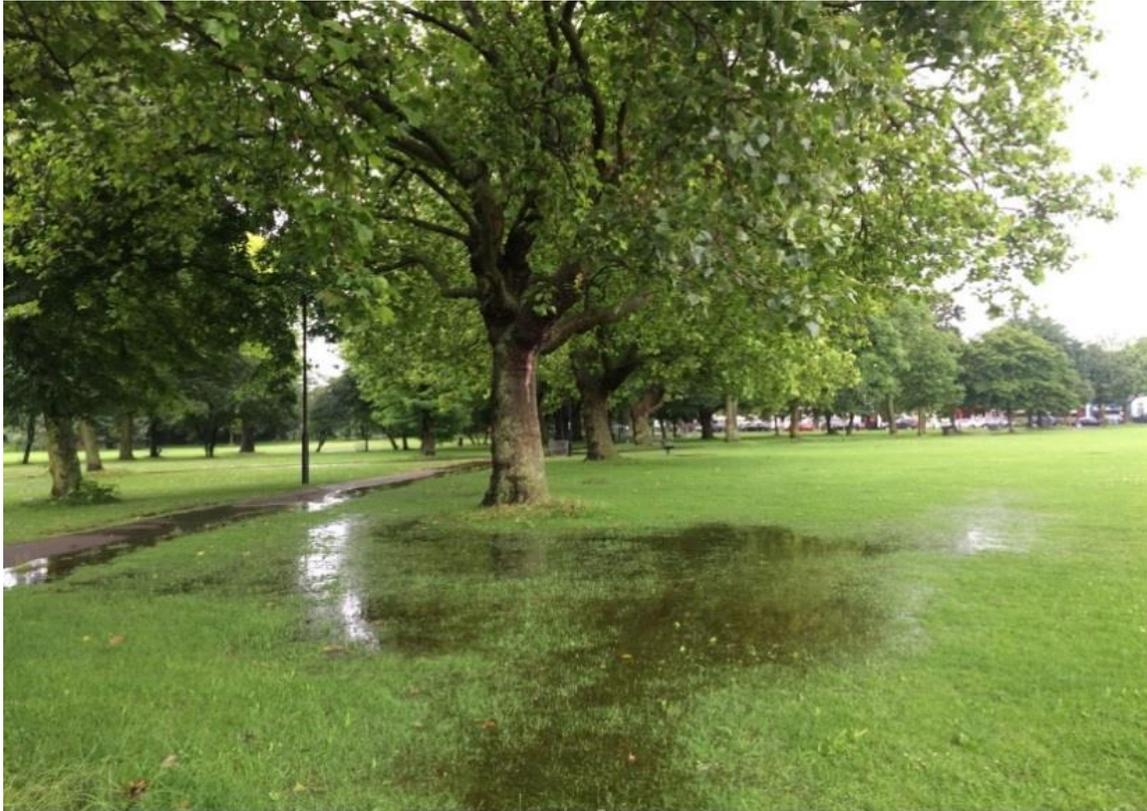
Figure 7.12 Puddling after heavy rain on Bellevue Fields near junction (MAC/FOWC)

- 7.27 Occasional local ponding or waterlogging has also been reported during the consultation process on areas adjoining the paths leading northwards from Bellevue Road and abutting Trinity Road on the south-western side of Bellevue Fields. The field south of the café and north of the lakes and the margins of the cricket-pitches field are also reported as being prone to waterlogging and/or suffering from high levels of informal use (e.g. personal trainers and their clients) during such conditions. Compaction is made worse by runners frequently jogging alongside the surfaced paths in several locations across the Common, as well as areas where groups gather such as outside the playground.

7.28 Ultimately, even unpaved land will be unable to accept rainfall in the most severe conditions without generating some surface flows, whether from waterlogging or from sheer intensity of rainfall exceeding the rate at which the water can physically soak into the soil. The behaviours exhibited in these pictures are natural at least in part but the Common's usage contributes to this behaviour by compacting unpaved surfaces so that they lose some of their natural function in this respect. An expectation that the Common remains well-drained and free from surface ponding in

any or all circumstances is unreasonable. The desires of users need to be balanced with what is practical for a landscape intended to be as natural as possible in the context of an urban common setting (rather than a manicured municipal parkland setting). Extensive land-drainage works to control and prevent such incidences as those illustrated in some of the photos are likely to cause more problems than they solve.

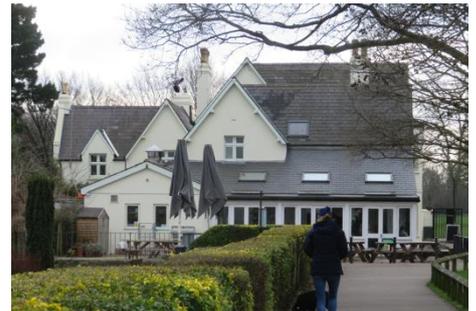
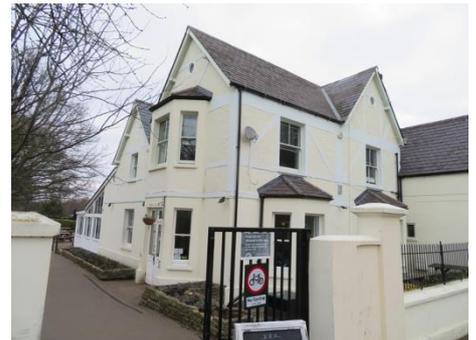
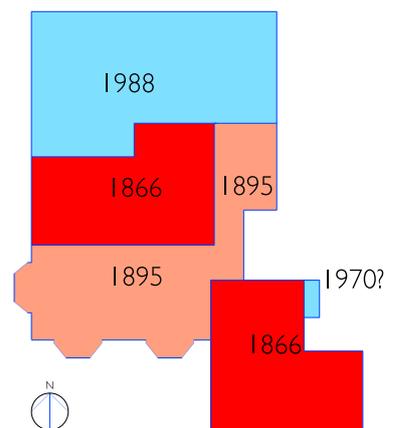
Built structure	Description
Skylark Café / Neal's Lodge and Neal's Cottage	<p>A complex group, formerly the farmhouse of the farm leased to Mr Neal in 1885, and became known as Neal's Farm. Mapping of 1866 shows the footprint of two L shaped buildings, which by maps of 1895 had been connected but were probably still laid out as two domestic properties. The status of the larger property increased through the addition of bay windows and substantial additional rooms. Large northward extension of about 1988 increased the building footprint to the current café capacity.</p> <p>The current layout comprises a café on most of the ground floor entered from the west and north and two self-contained vacant dwellings entered from the east. Internal repair works to the dwellings were commenced but have been suspended pending legal action over proposed use of the buildings.</p> <p>Condition: Fair except for the incomplete internal repairs to the dwellings.</p> <p>Significance: Some significance as the former farmhouse and as an architectural focal point for the buildings on the common.</p> <p>Potential: Uses of the currently unoccupied areas are likely to be dependent on the outcome of recent legal action.</p>

Building from north

Building from SW

Outline of phasing

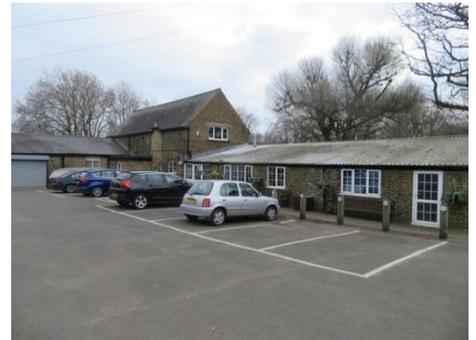
Park offices from north-west

All built on top of a brick boundary wall running along the south side of the farmyard. The wall matches other sections along the railway and is therefore presumed to date from about 1856. The western part is now laid out as single storey offices, much remodelled north wall, PVC windows and modern low pitched roof. The eastern part is of two storeys, brick with a slate roof. The upper storey extends over storage accessed from the east range.

Condition: Fair but many western areas are of insubstantial construction and eastern areas much altered.

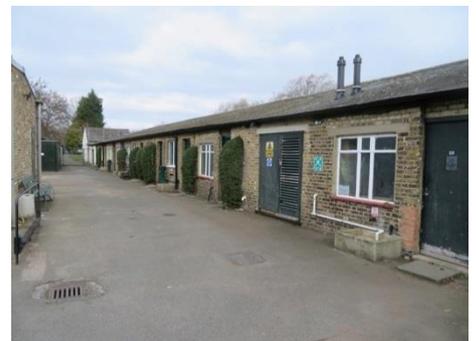
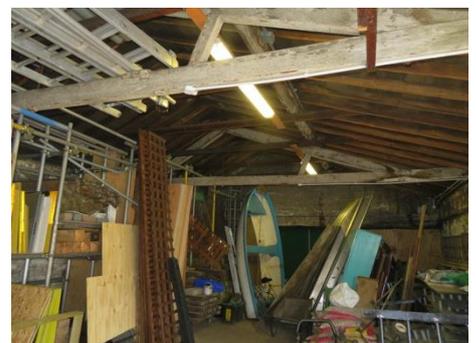
Long single storey range abutting and built onto a brick wall along the east side of the farmyard. The wall matches other sections along the railway and is therefore presumed to date from about 1856. Slate roof on timber roof structure, including at least some original trusses. Now arranged as a series of changing rooms, a boiler house and store. Metal windows and metal clad timber doors.

East range from south

The present buildings appear to match the footprint of those shown on the map of 1866.

Significance: Some historical significance as a surviving element of the original farmstead.

Store interior

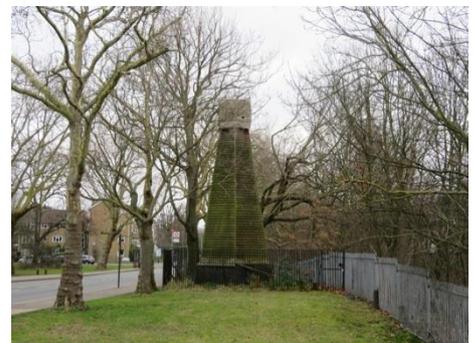
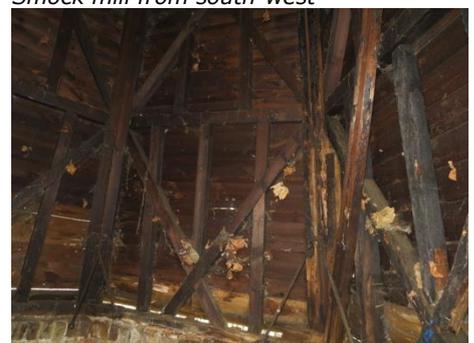
Significance: Of considerable significance as one of about eight surviving drainage smock mills.

Smock mill from south-west

Smock mill interior

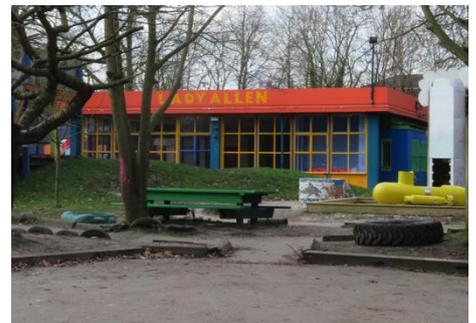
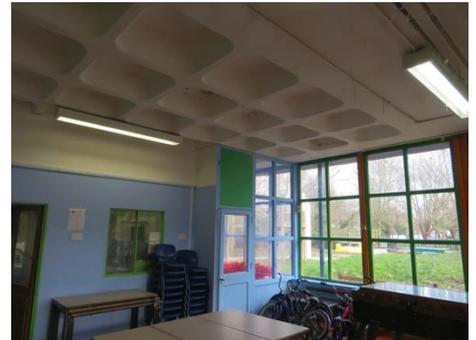
Potential: The building requires significant investment to place it in good order but could accommodate a range of possible uses within the existing primary structure.

Lady Allen building exterior

Lady Allen building interior
