Envelope Maintenance Case Study - Concept Design

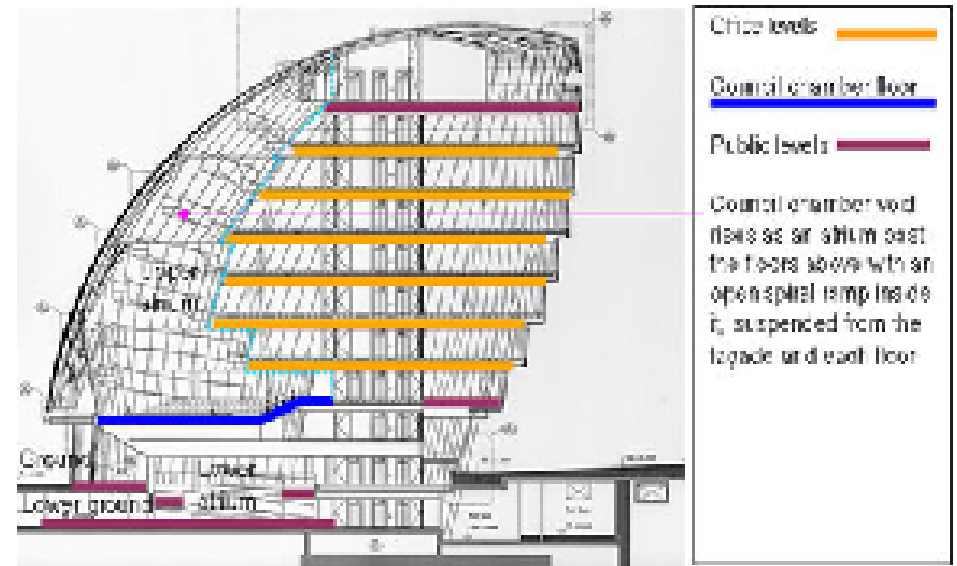
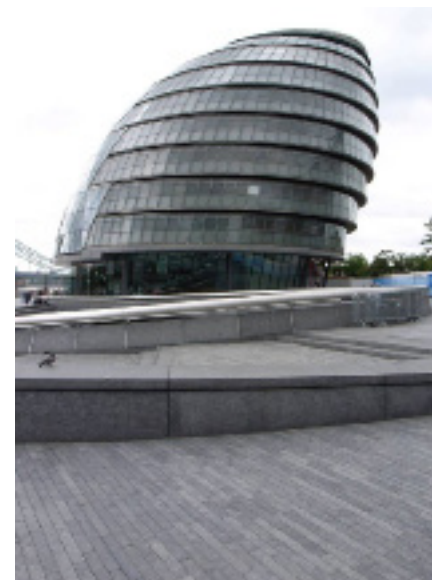
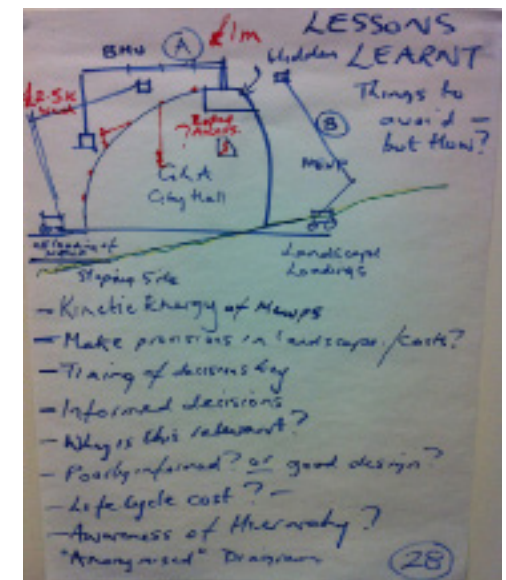
BMU discounted on cost and public area location of machine. Roped access not designed into cladding fabric or structure.
MEWP's used requiring hard landscape.

Poor cleaning, broken windows from boom impacts, high costs in use, bad publicity.

Capital v Revenue costs and other practicable factors to be compared in the decision making process at early stages of the project rather than just the safety Working at Height 2005 Regulation hierarchy.
