Fragile Domed Roof-light Refurbishment - London Coliseum

The Problem/Challenge

To refurbish the existing stained glass fragile domed rooflight to prevent water ingress and allowing backlit illumination.

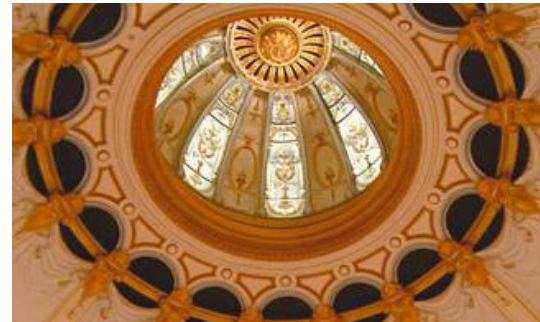
Roof light from below

A glass fibre outer dome was installed by crane for weatherproofing purposes. The inner glass domed roof-light was repaired from a birdcage scaffold within the auditorium.

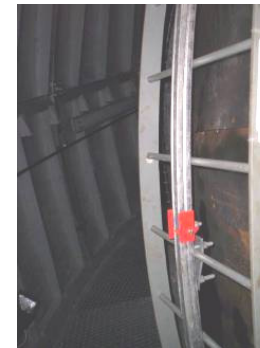
Curved rotating ladder + slide-lock eg. Glide lock fixed rail ladder climbing system

Access to the upper curved areas of glass is via a curved ladder gantry with a slide lock harness attachment.

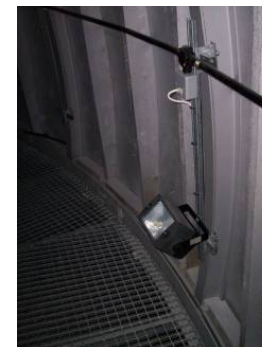
Walkway and up-light

Maintenance walkway installed between the two domes with a high level fall restraint cable fixed to the outer dome.

Easily accessed light fittings fitted at low walkway level reflect off the underside of the outer dome to illuminate the rooflight.
