GLASS ROOF CLEANING AND MAINTENANCE STRATEGY – LONDON COLISEUM

The Problem/Challenge

The design team for the London Coliseum refurbishment project needed to establish a how new glass barrel vaulted roof could be cleaned. It was built above the refurbished foyers and was designed to follow the original form. The geometry of the new glass barrel vaulted roof meant that there were difficulties in gaining safe access for cleaning and maintenance.

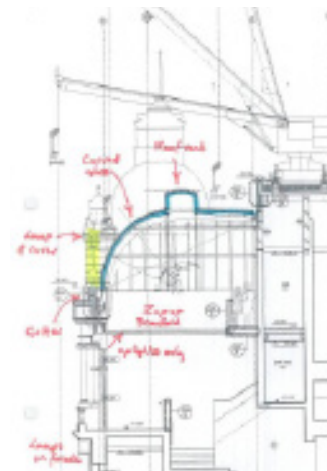
Final BMU Design

After consultation with specialist access contractors, a Building Maintenance Unit (BMU) with an 11 metre jib and one man cradle was selected. Planning constraints influenced the rejection of other options, eliminating the initial proposed use of a travelling curved gantry that would have been visible from street level. Increased structural works were required to support and conceal the BMU behind the tower at roof level.

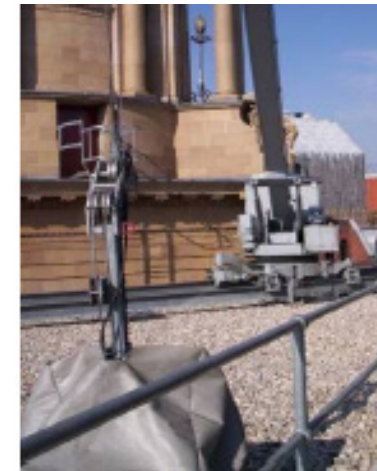
BMU Solution

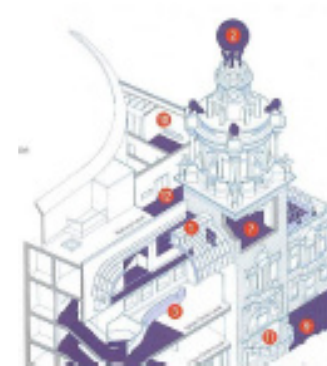
Cut away view of roof
