Suspended ceiling access

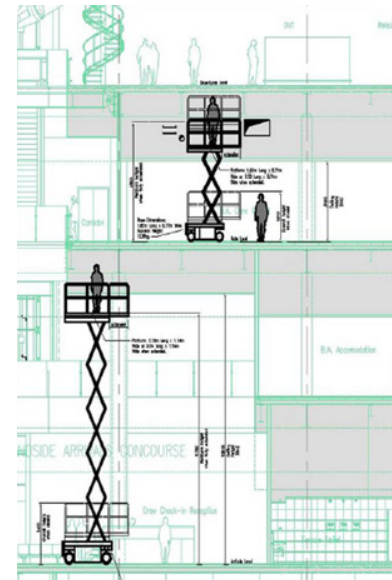
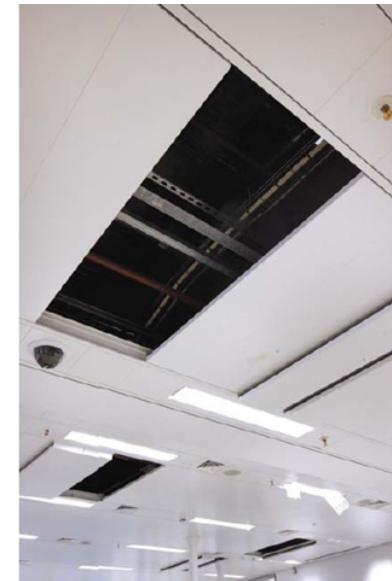
- The selection of 600 x 600 panel size was challenged and large ceiling panels were substituted. These enable access by systems such as mobile elevated work platforms (MEWPs)
- Panels were hinged or had sliding mechanisms so that they could be safely opened.
- The openings in the ceiling and the services running in the voids were designed to provide adequate space for a working platform to be raised between them, giving access to the full height of the void.
- No services were placed in any remaining inaccessible areas.
